2020 Beach Monitoring Survey

TOWN OF SULLIVAN'S ISLAND, SC

Elko Coastal Consulting, Inc. | June 2020

2020 Beach Monitoring Survey: Town of Sullivan's Island, SC

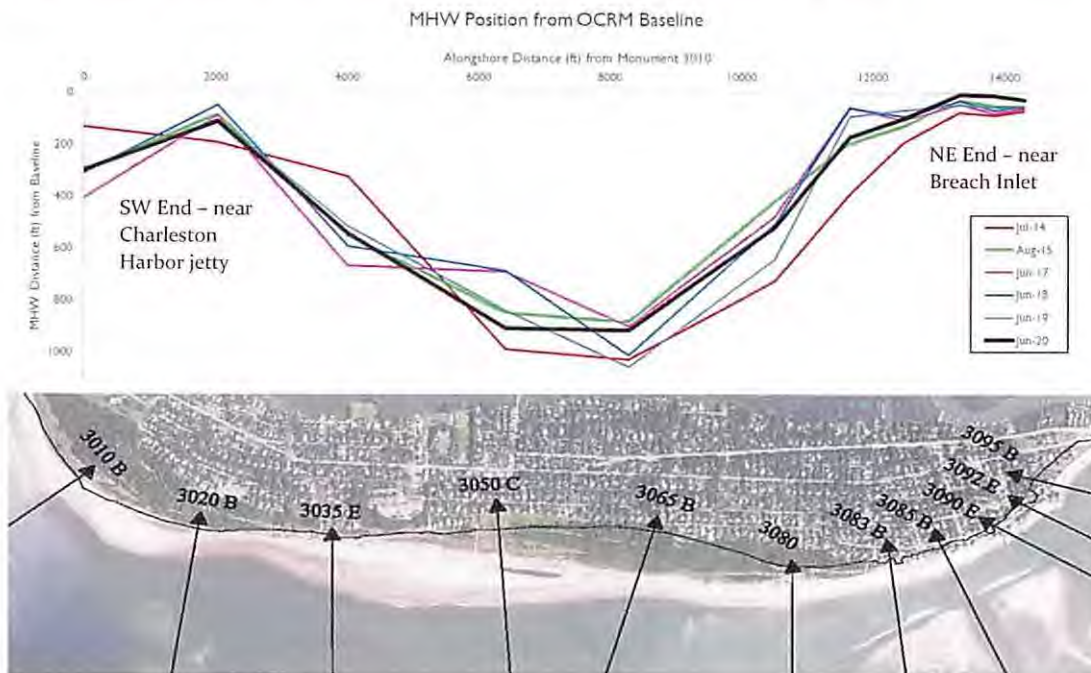
During the study period, the Sullivan's Island shoreline changed dramatically between 2014 and 2015. Between 2015 and 2019, the shoreline gradually recovered back to near the 2014 position in most cases (Figure 5). During the last year, between 2019 and 2020, the shoreline along the northeastern 2/3 of the island retreated again to near 2015 conditions. Average shoreline change between 2019 and 2020 was 13.5 ft of landward movement (erosion). Several areas were flagged in previous monitoring reports and are discussed below.

The northeast end of the island, between Monuments 3090 and 3095 and adjacent to Breach Inlet, was flagged in the 2016 report. It is under continual erosional pressure due to the southwesterly migration of Breach Inlet, but has been stabilized by erosion control structures. Minor shoreline change has occurred along this northeastern end between 2015 and 2019 (i.e., stability); however, shoreline erosion was measured during the last year of monitoring between 2019 and 2020 (Figure 5). The small distance between the shoreline and the OCRM baseline suggests erosional pressure and the need for continued monitoring. There is little storm damage protection at this location.

At the sandbar attachment point, near Station 26 (OCRM Monument 3065), the shoreline moved about 140 ft landward between 2019 and 2020. This location is represented by the bottom of the curve of the lines near 8,000 ft alongshore (Figure 5). This suggests that a sandbar attachment event occurred in 2018 and 2019, and that sand is now spreading out

Figure 5. Annotated MHW Position graph aligned with the aerial photo from Figure 2, illustrating the change in shoreline position from 2014 to 2020, as well as the distance between the shoreline and baseline. Note the scale shows wider (larger) shoreline widths toward the bottom to correspond with the map.

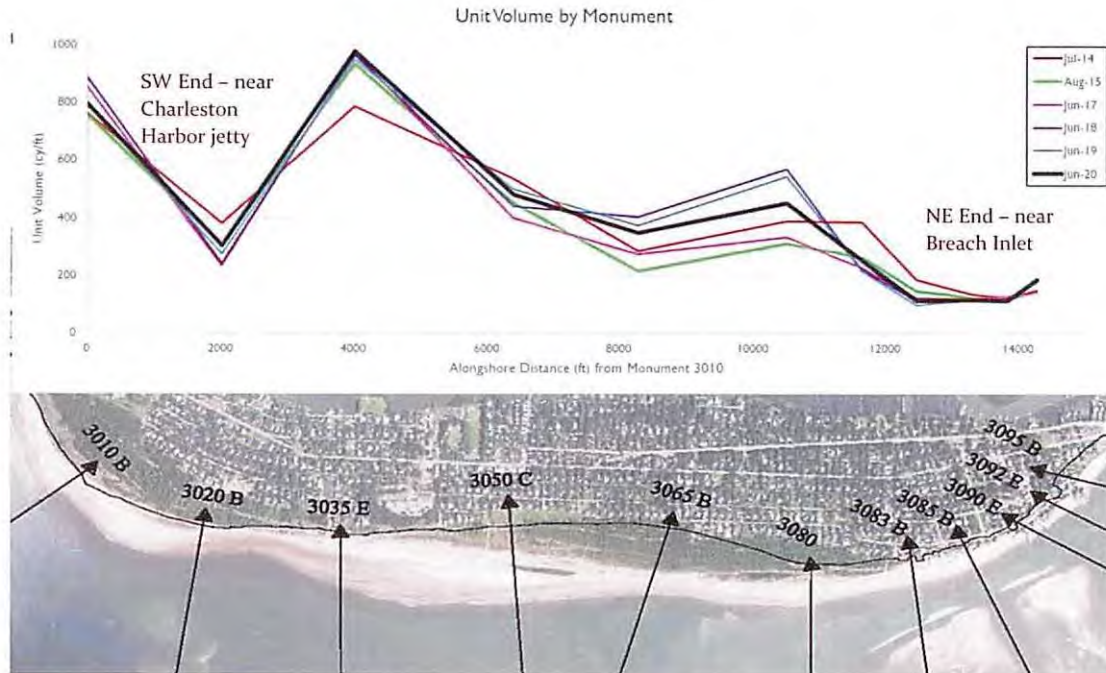
As suggested in the MHW analysis, northeastern Sullivan's Island has less storm protection in place than the rest of the island. Despite the narrowing beach, the average unit volume to the depth of closure (DOC) has been stable at near 130 cubic yards per foot (cy/ft) from 2016 to 2020. The rest of the island has at least 200 cy/ft of volume along each measured profile (Figure 6).

The other end of the island, near Charleston Harbor, has exhibited remarkably stable unit volume measurements over the last four years. Between monuments 3020 and 3035 (Sta. 19 west to the Sand Dunes Club), very little volume change has been measured. As is expected adjacent to inlets, monument 3010, closest to the channel is more dynamic.

During this monitoring period, as in 2015, the central portion of the island (between Monuments 3050 and 3080) lost volume as sediment from the sand bar attachment event spread out. However, volume did not decrease to the 2015 level. This suggests that while the island is not building (prograding) seaward in terms of shoreline position, it is gaining volume along the central portion. Most of this volume increase is due to sand accumulation in the dunes and backbeach. The next section details this volume increase and other specific changes using beach profile data from each monument.

Figure 6. Annotated Unit Volume graph illustrating the change in unit volume at each profile from 2014 to 2020. Note the scale shows larger volumes toward the top of the plot.

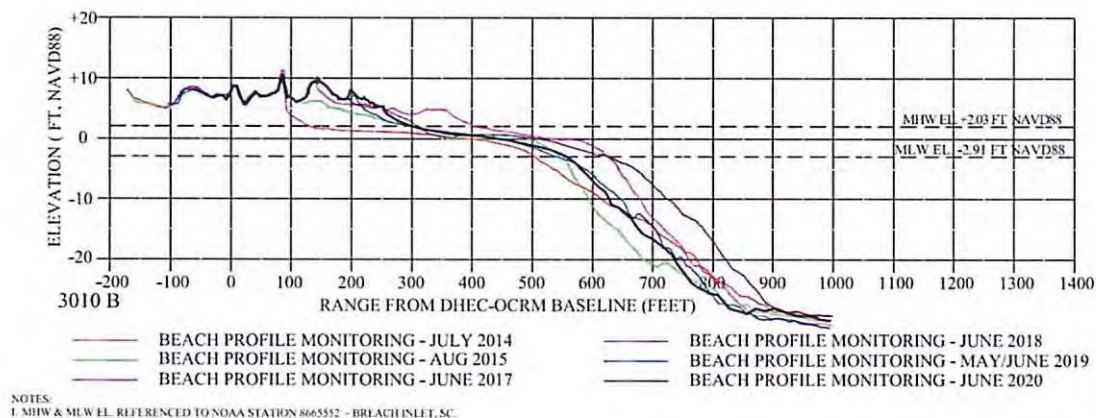
This is the southwesternmost OCRM Monument on Sullivan's Island, located along the long beach access path at Station 16 with the nature trail. The beach is located on the Charleston Harbor side ("inside") of the jetty. Consistent with the measured beach profile data (Figure 7), observations indicated that the dunes had advanced seaward up to 50 feet as compared to the 2019 conditions (Figure 8). However, the beach was narrow at about 15 feet wide and eroding with a small 6-inch scarp. Significant storm rack had accumulated along the back beach, all the way up to the toe of the dune (Figure 9). No dune overtopping was evident. According to the 2020 volume calculation, this profile has a unit volume of 793 cy/ft. This is the same unit volume as in 2019.

Figure 7. Beach profile monitoring data from 2014-2020 in cross-section view at Monument 3010.

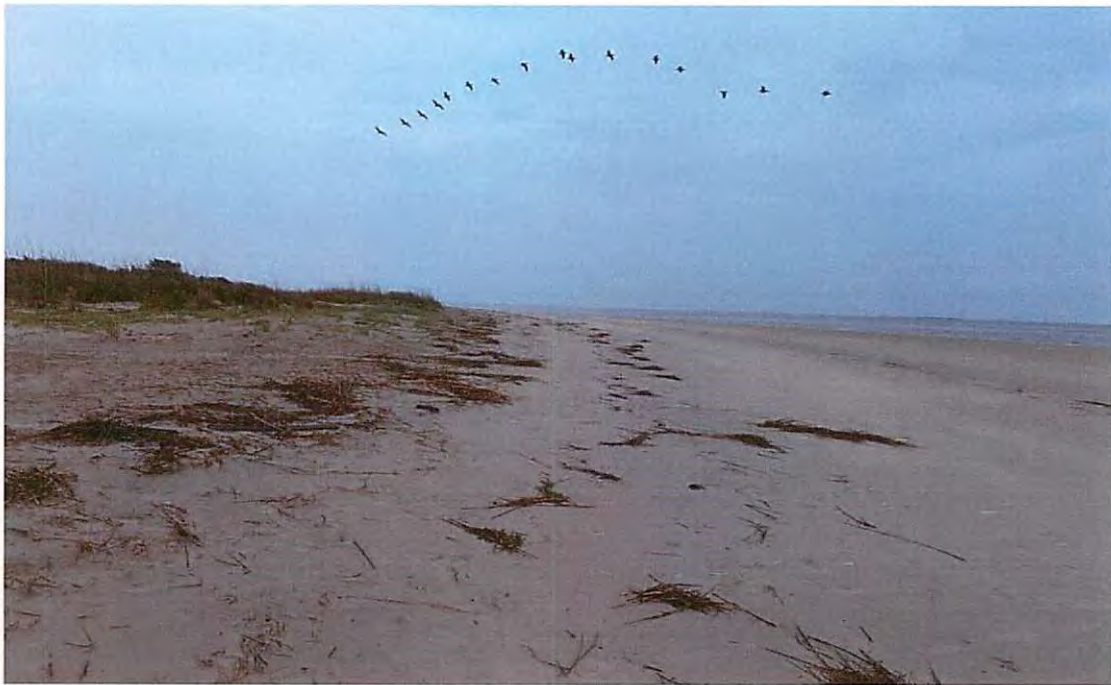
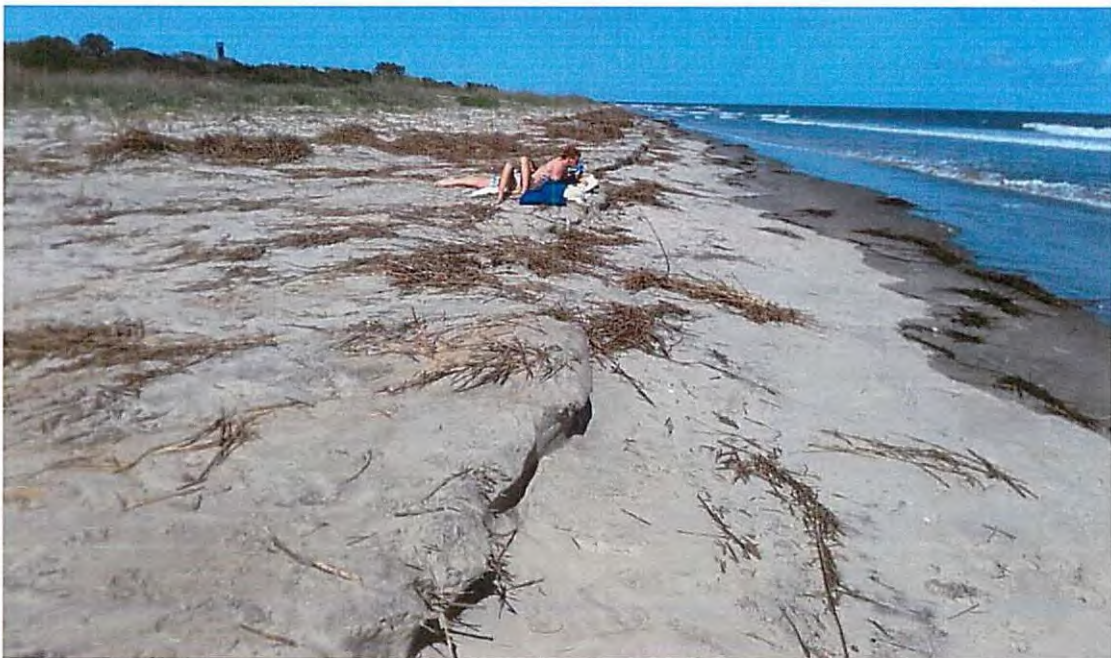
Figure 8. Ground photo taken at Monument 3010 looking east on June 6, 2019 (top) and June 2, 2020 (bottom). Note the narrower beach but increased vegetation on the dune in 2020.

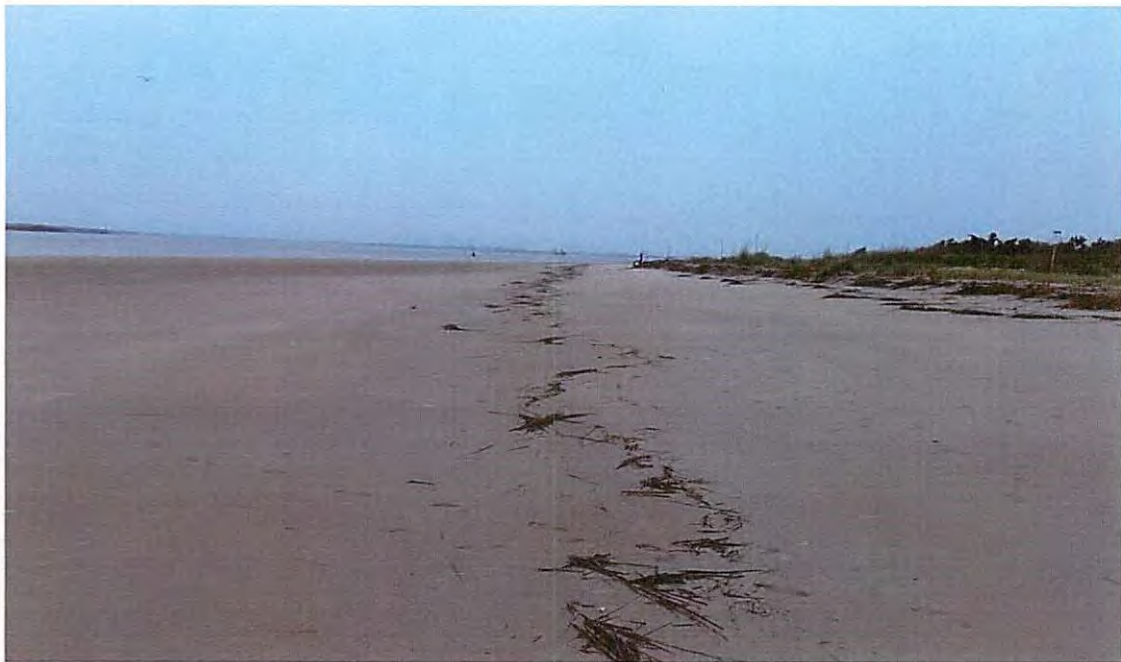
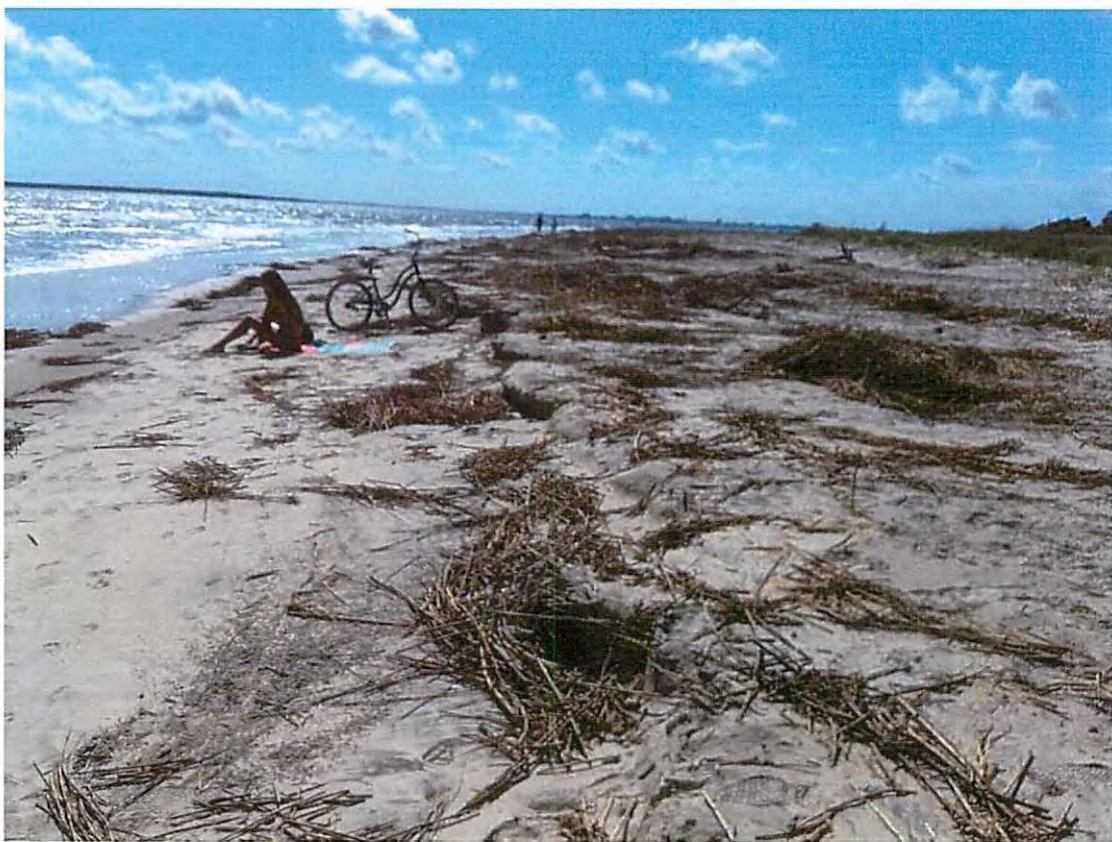
Figure 9. Ground photo taken at Monument 3010 looking west on June 6, 2019 (top) and June 2, 2020 (bottom). Note the higher elevation of the backbeach in 2020.

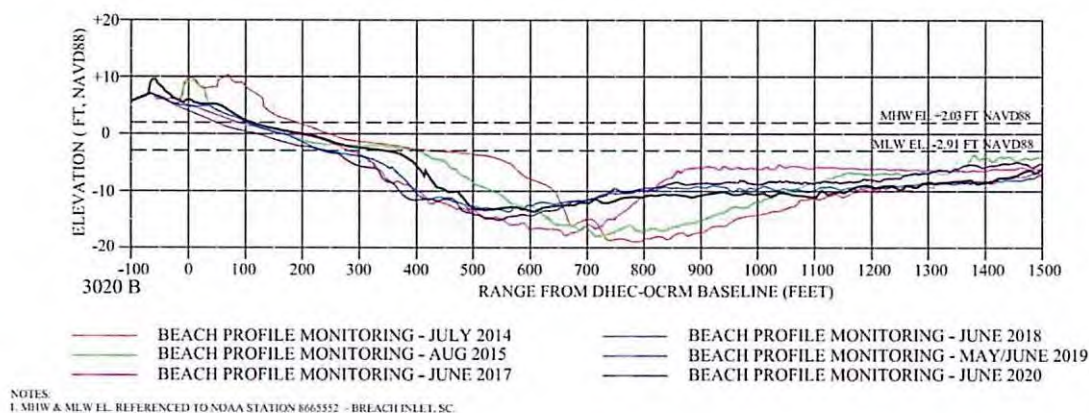
Monument 3020 is located along the long beach access path at the Sand Dunes Club. Significant erosion had taken place here since 2014 that included loss of a large dune and submerged nearshore sand body (Figure 10). Considerable recovery occurred during this monitoring interval (2019-2020). A dune has been reestablished farther landward of the eroded 2014 dune and the beach berm and nearshore sand body accreted.

According to the 2020 volume calculation, this profile has a unit volume of about 305 cy/ft, which is in stark contrast to the surrounding accretional areas. This monument is influenced by its location downdrift of the Charleston Harbor jetty.

Figure 10. Beach profile monitoring data from 2014-2020 in cross-section view at Monument 3020.

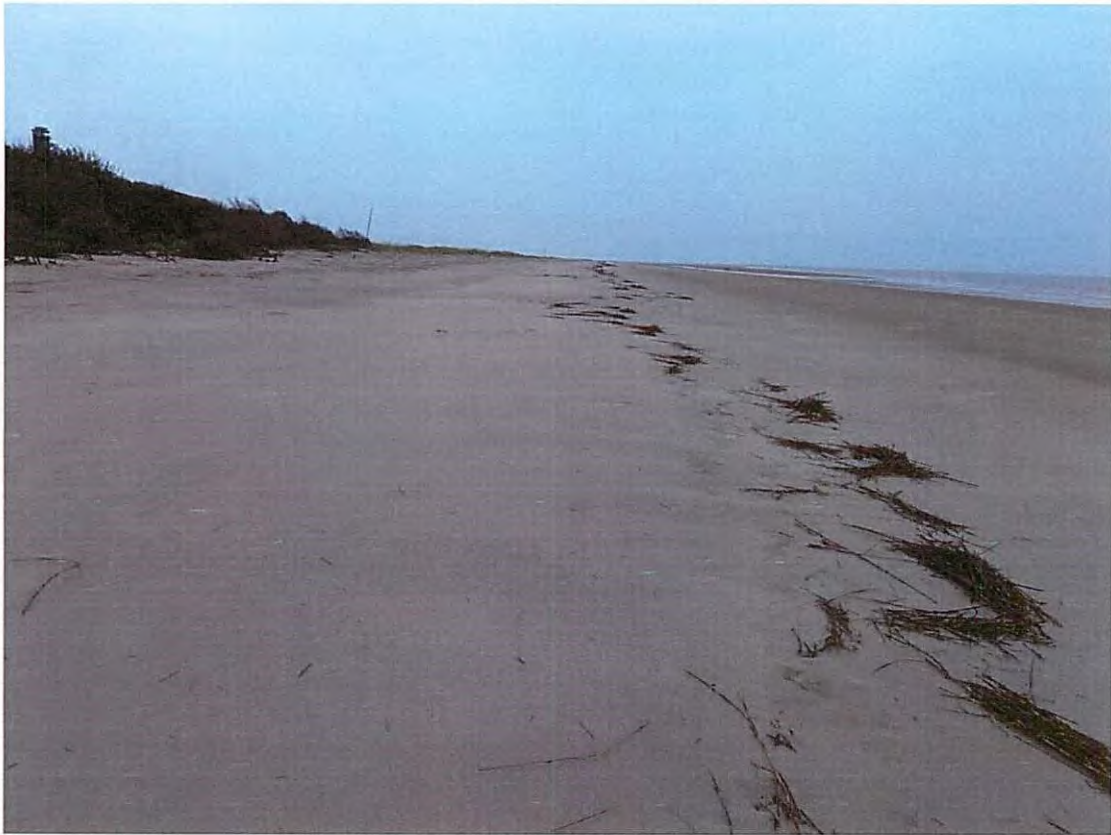
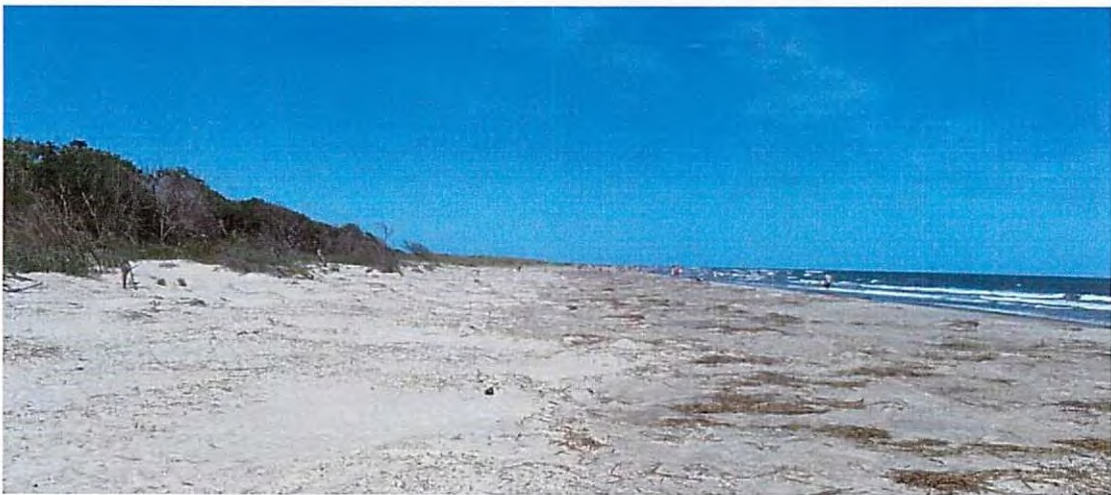
Beach observations confirmed that the recovery that began in 2019 continued in 2020 with a 2-ft high dune advancing seaward along the back beach to the high tide line. Dead trees along the dune line were buried with sand. The beach was accreting with at least 35 ft of dry beach at high tide. A sand bar had attached to the updrift beach and the beach berm accreted (Figure 11). Dune recovery continued (Figure 12).

Figure 11. Ground photo taken at Monument 3020 looking northeast on June 6, 2019 (top) and June 2, 2020 (bottom). Notice the evolution of the sand bar attachment on the beach to the northeast.

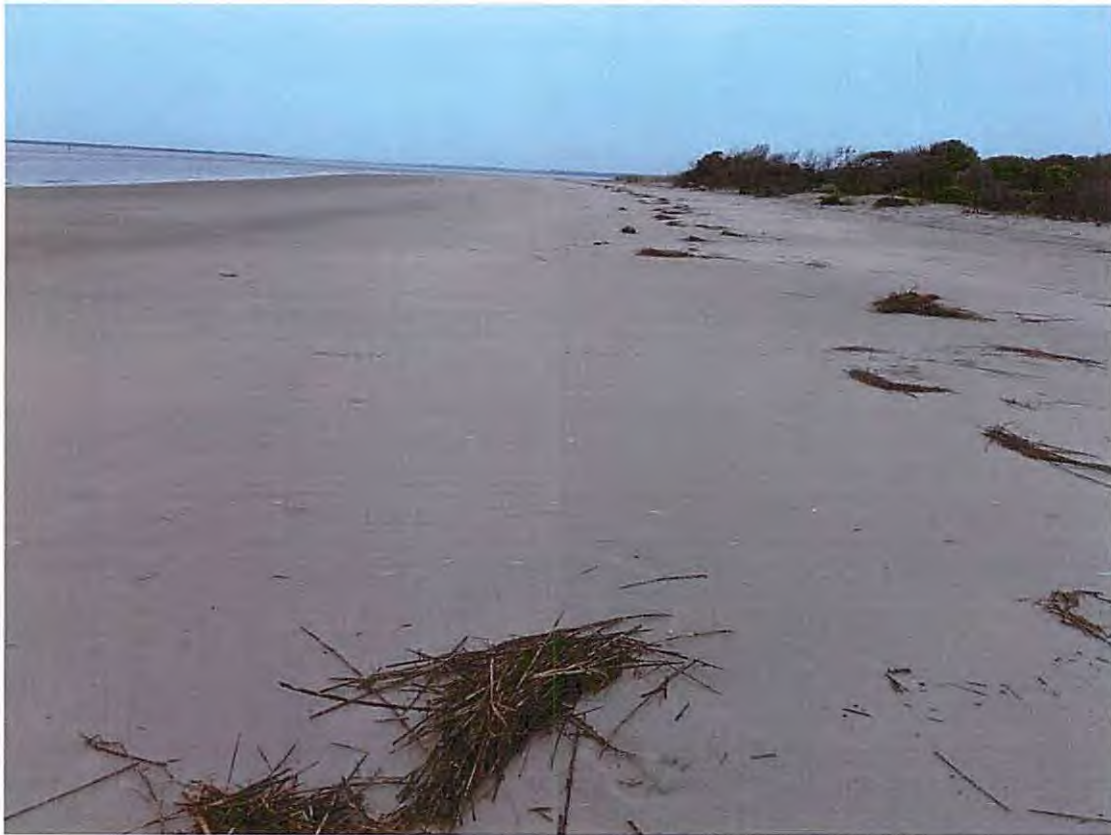
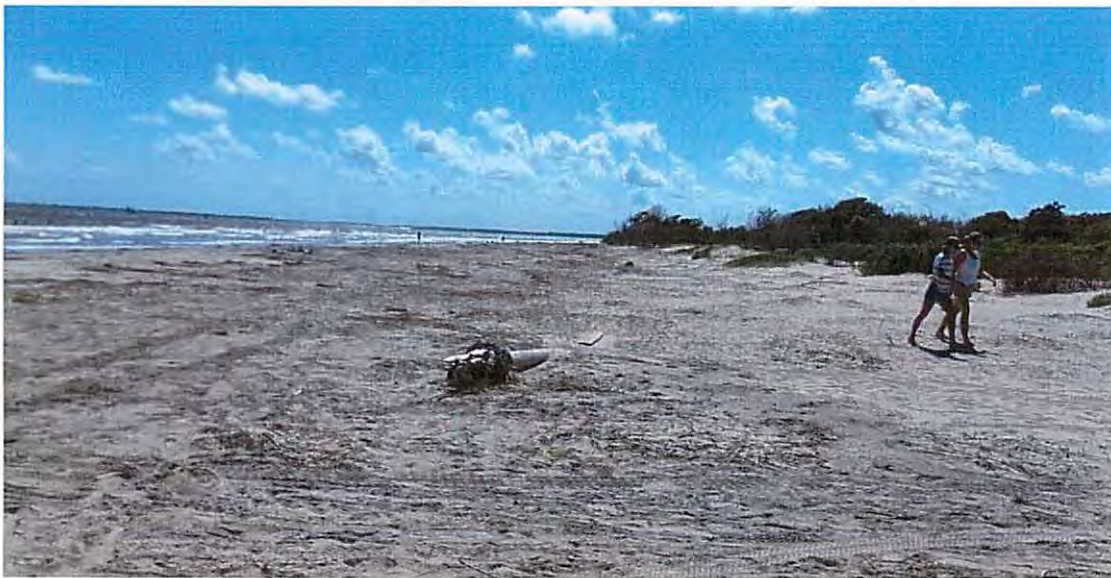
Figure 12. Ground photo taken at Monument 3020 looking southwest on June 6, 2019 (top) and June 2, 2020 (bottom). Note the recovery of dune vegetation to the southwest in 2020.

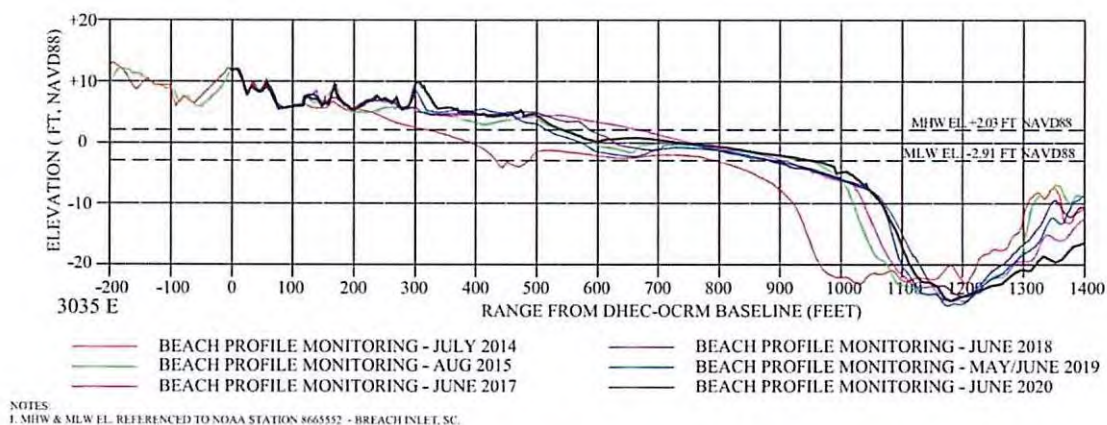
Monument 3035 is located along the long beach access path at Station 19. This area has been the beneficiary of recent sandbar attachment events (Figure 13). The beach has been wide and accreting for the last several years. A new primary dune has formed since 2014. In 2020, beach observations confirmed that a wide backbeach with a distinct berm slope break existed (Figure 14 and Figure 15). Additionally, the backbeach was covered with incipient dunes in the form of small, hummocky mounds seaward of the primary dune line. Evidence of past ponding landward of this area was observed, which is common at this location.

According to the 2020 volume calculation, this profile has a unit volume of 980 cy/ft. The beach profile at this monument is influenced by the sediment trapping effect of the Charleston Harbor jetty.

Figure 13. Beach profile monitoring data from 2014-2020 in cross-section view at Monument 3035.

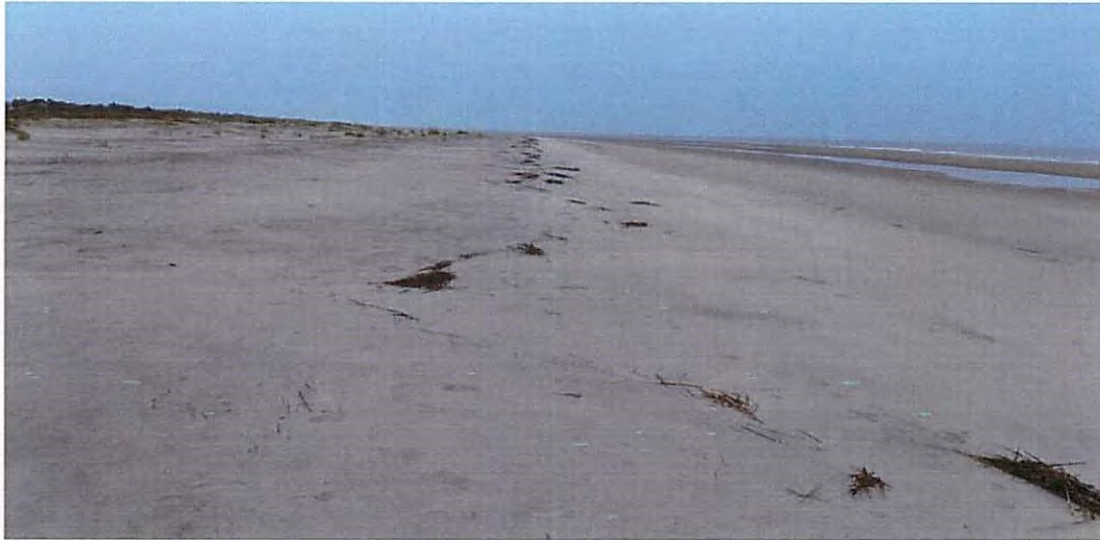
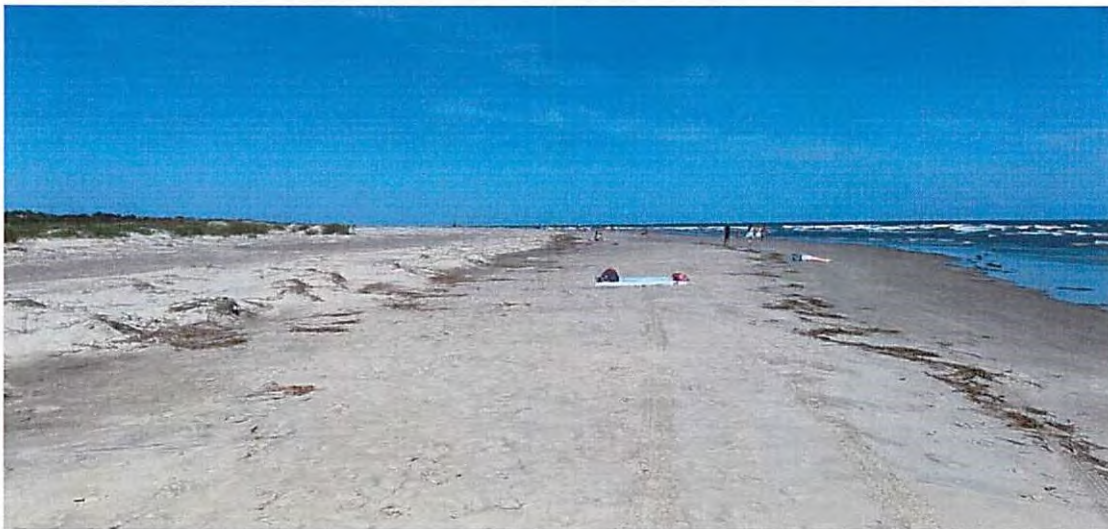
Figure 14. Ground photo taken at Monument 3035 looking northeast on June 6, 2019 (top) and June 2, 2020 (bottom). Note increased elevation of the backbeach.

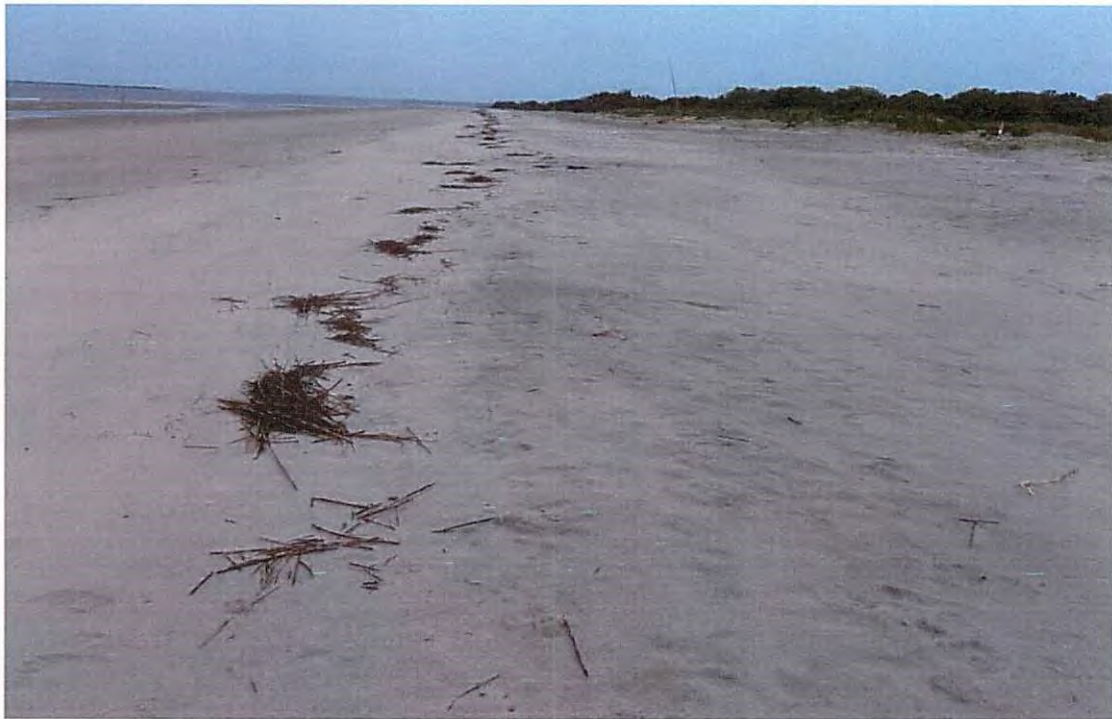
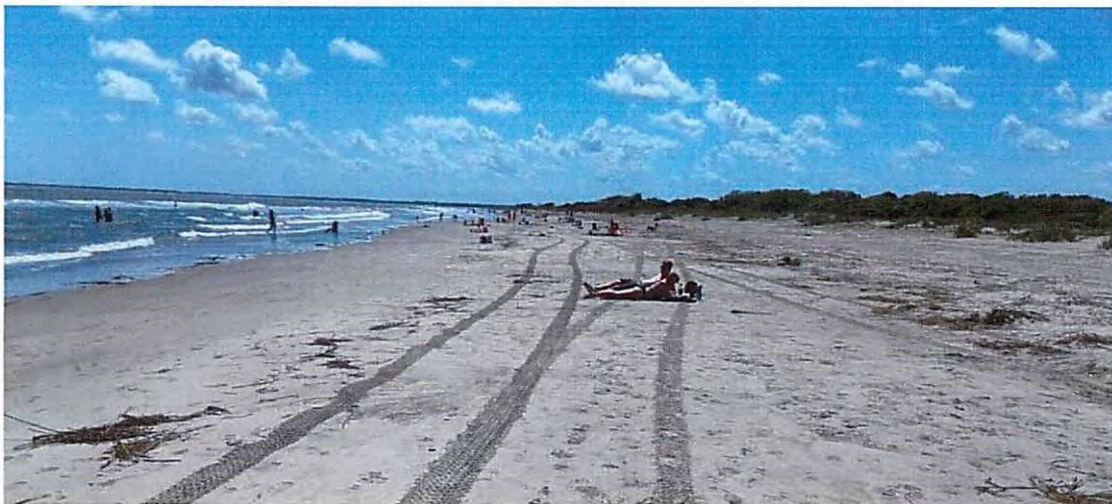
Figure 15. Ground photo taken at Monument 3035 looking southwest June 11, 2019 (top) and June 2, 2020 (bottom). Note the higher berm elevation.

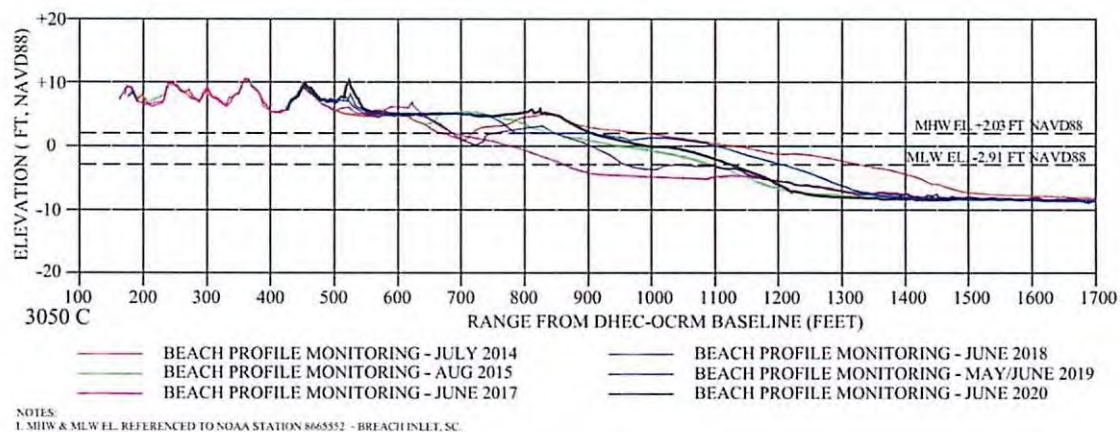
Monument 3050 is located along the long beach access path at Station 22.5 in the center of the island. Beach profile data indicate the onshore transport of the recent sand bar attachment events that occurred here in 2014 and 2018-19 (Figure 16). Over the last five years, sediment from these attachment events have welded to the shoreface and resulted in the 2020 beach which includes a wide berm and new, tall primary dune.

According to the 2020 volume calculation, this profile has a unit volume of 480 cy/ft. The beach profile at this monument benefits from its location updrift of the Charleston Harbor jetty. Sand volume has been relatively stable at this profile fluctuating between 400 and 500 cy/ft and the shoreline position has also fluctuated considerably. The data indicate stability rather than uninhibited accretion and progradation.

Figure 16. Beach profile monitoring data from 2014-2020 in cross-section view at Monument 3050.

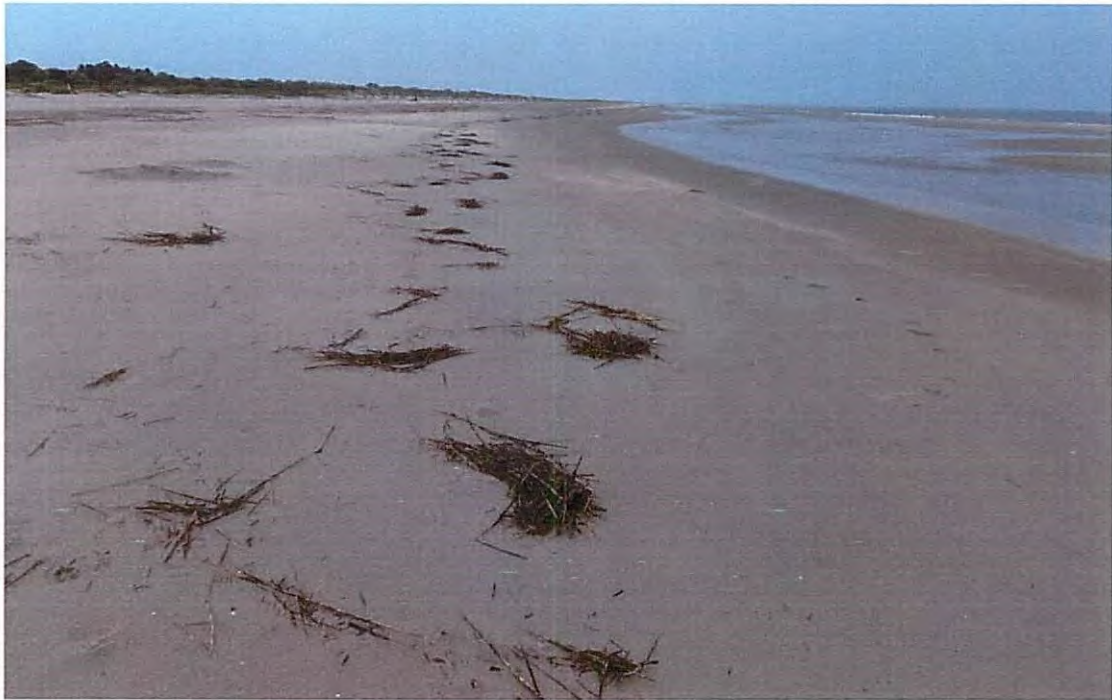
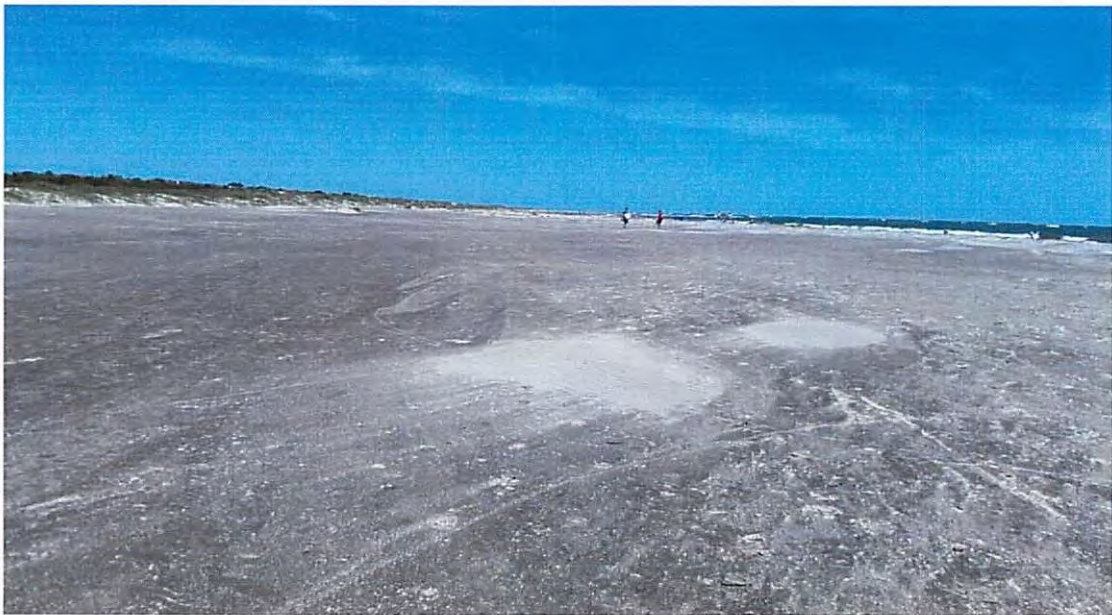
The beach observations confirm that the 2020 beach was over 100 ft wide and accretional. The dunes were healthy with new growth and the backbeach was covered with incipient dunes and coppice mounds (small starter dune-like features). Evidence of past backbeach ponding was observed.

Figure 17. Ground photo taken at Monument 3050 looking northeast on June 6, 2019 (top) and June 2, 2020 (bottom). Note the sandbar attachment in 2019.

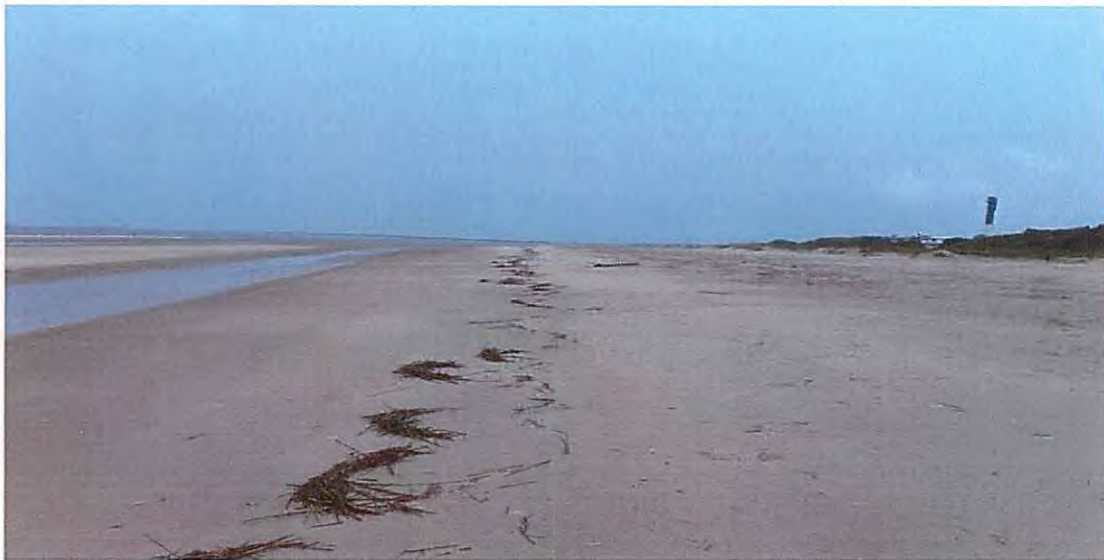
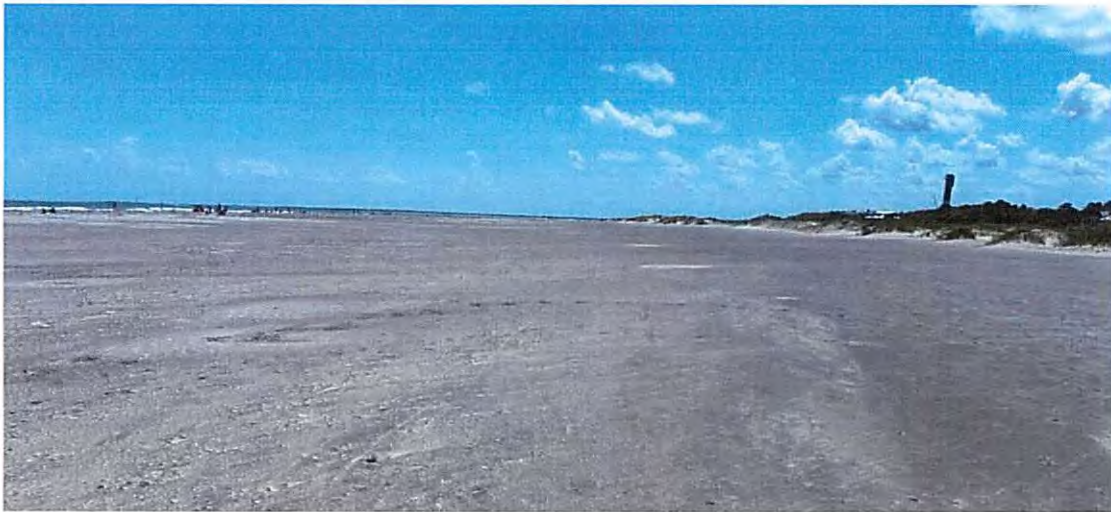
Figure 18. Ground photo taken at Monument 3050 looking southwest June 6, 2019 (top) and June 2, 2020 (bottom). Note the sandbar attachment in 2019.

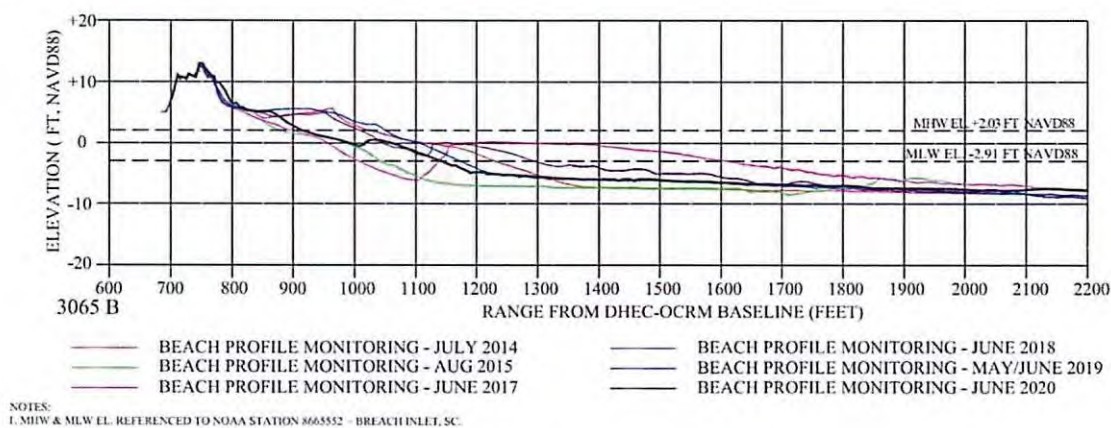
The profile goes through cycles of erosion and accretion as new sand bars attach and the sand is dispersed alongshore. For example, past beach profile data indicated substantial beachface erosion following the 2014 attachment event (Figure 19) as the sediment spread along the beach. In 2020, beach width was reduced considerably as sand from the 2019 sand bar attachment spread downdrift.

Figure 19. Beach profile monitoring data from 2014-2020 in cross-section view at Monument 3065.

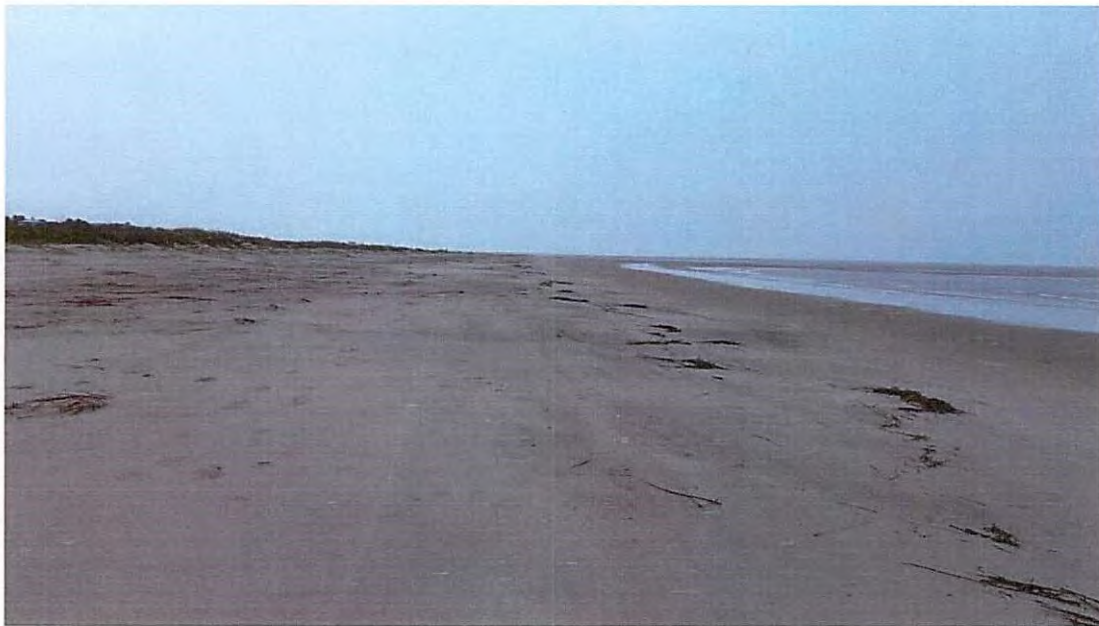
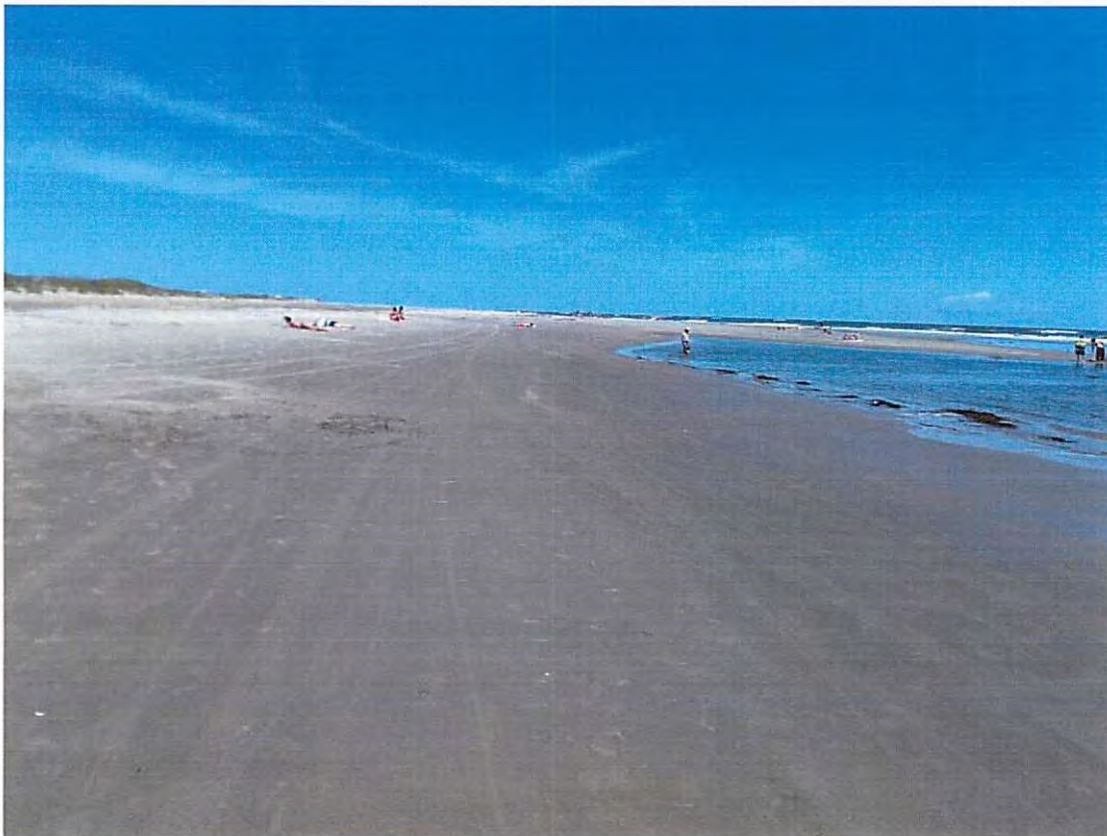
Beach observations confirm that the beach had narrowed to about 70 ft wide at high tide (Figure 20 and Figure 21). Consistent with the other profiles on the island, the primary dune was building seaward with new growth and no sign of overtopping despite considerable rack debris along the back beach. According to the 2020 volume calculation, this profile has a unit volume of 350 cy/ft.

Figure 20. Ground photo taken at Monument 3065 looking northeast on June 6, 2019 (top) and June 2, 2020 (bottom). Note the sandbar attachment point.

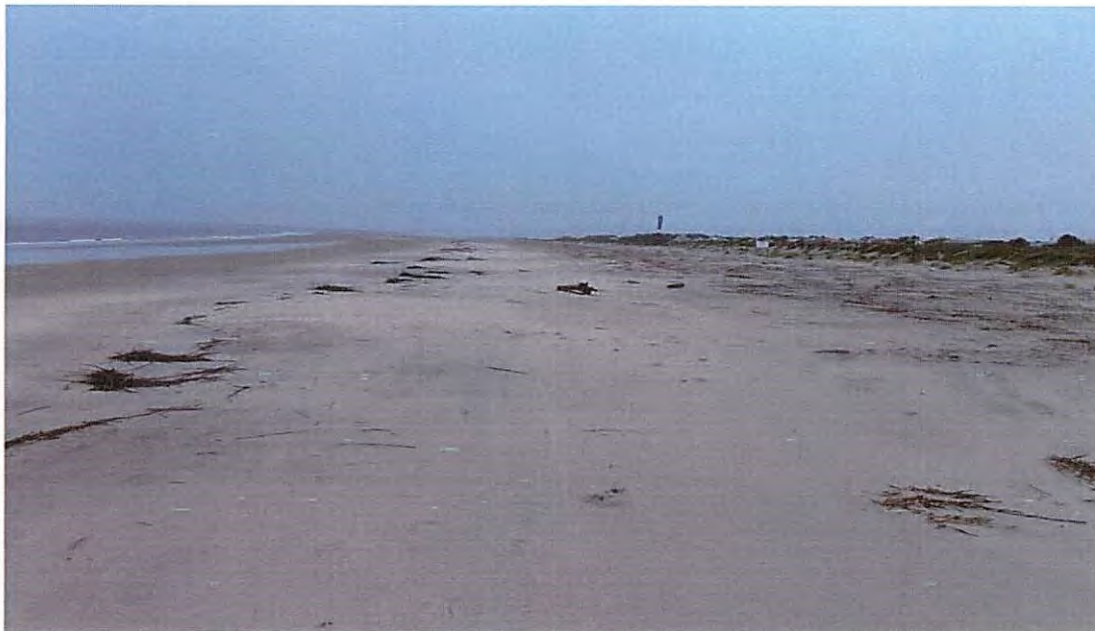
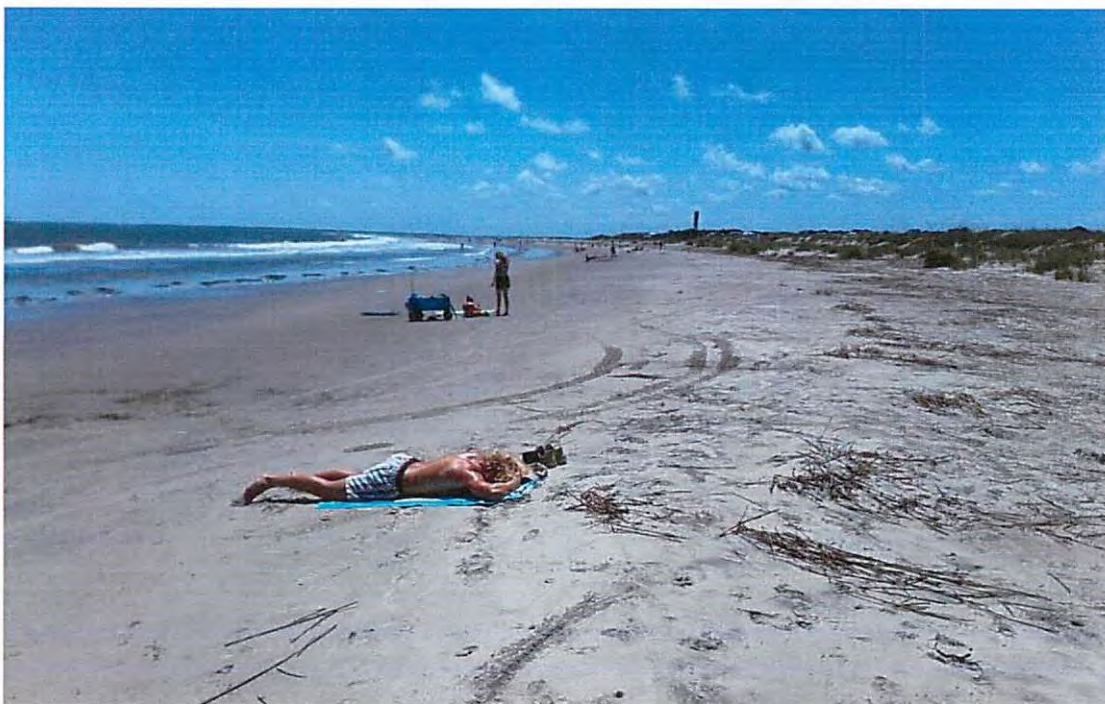
Figure 21. Ground photo taken at Monument 3065 looking southwest on June 6, 2019 (top) and June 2, 2020 (bottom). Note the incipient dunes on the backbeach in 2020.

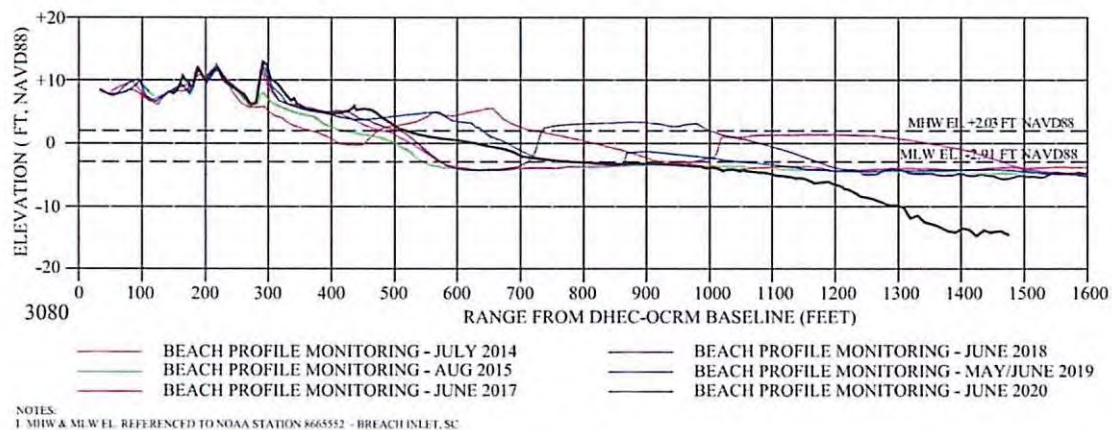
The sand bar attachment point was located just to the west of this monument in 2019. In 2020, the sand bar had attached to the shoreface and was spreading out (Figure 22). The primary dune and the beach berm both accumulated sand and advanced seaward.

According to the 2020 volume calculation, this profile has a unit volume of 450 cy/ft. This profile displayed the largest volume loss over the last year due to sand from the attachment event spreading out alongshore.

Figure 22. Beach profile monitoring data from 2014-2020 in cross-section view at Monument 3080.
