2020 Beach Monitoring Survey

TOWN OF SULLIVAN'S ISLAND, SC

Elko Coastal Consulting, Inc. | June 2020

2020 Beach Monitoring Survey: Town of Sullivan's Island, SC

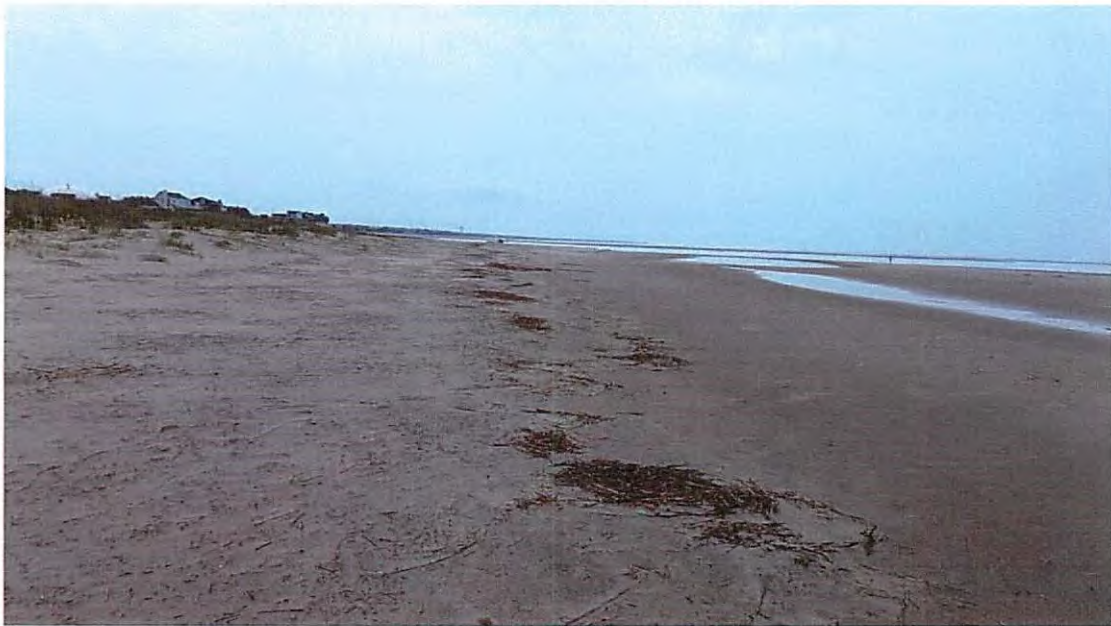
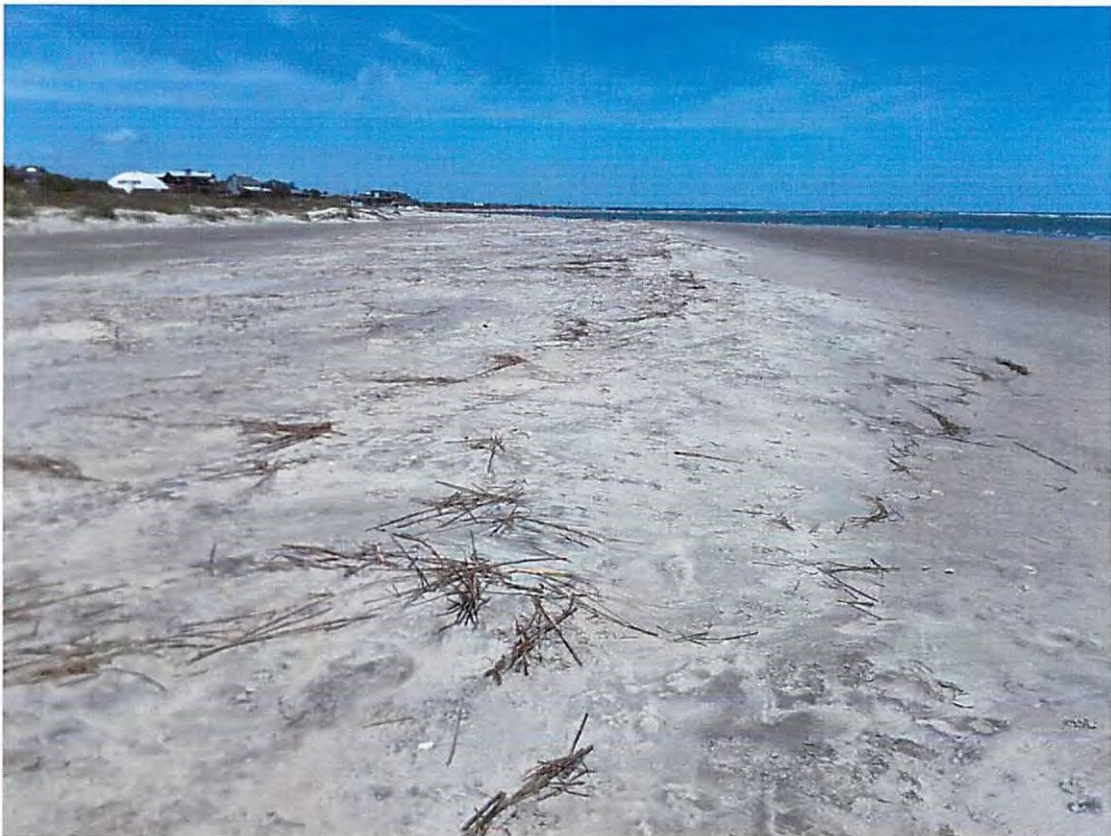
Beach observations confirm that the beach at this location was 90 ft wide at high tide, the primary dune was advancing, and incipient dunes were developing along the back beach (Figure 23 and Figure 24). There was evidence of past back beach ponding, but none was observed in 2020 and no signs of dune overtopping were observed.

Figure 23. Ground photo taken at Monument 3080 looking northeast on June 11, 2019 (top) and June 2, 2020 (bottom). Note the sand bar attachment in 2019.

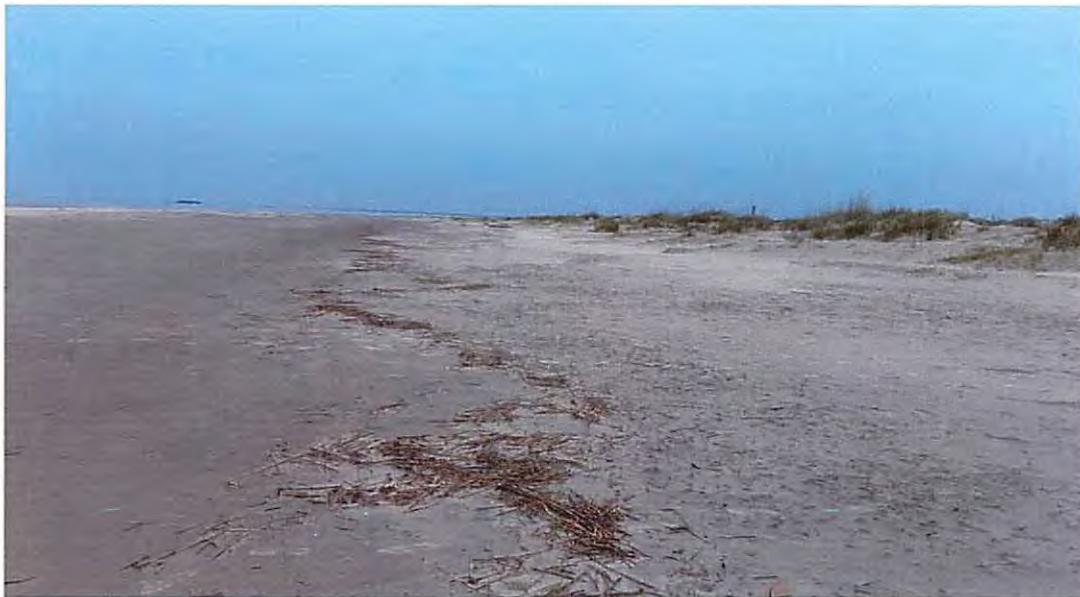
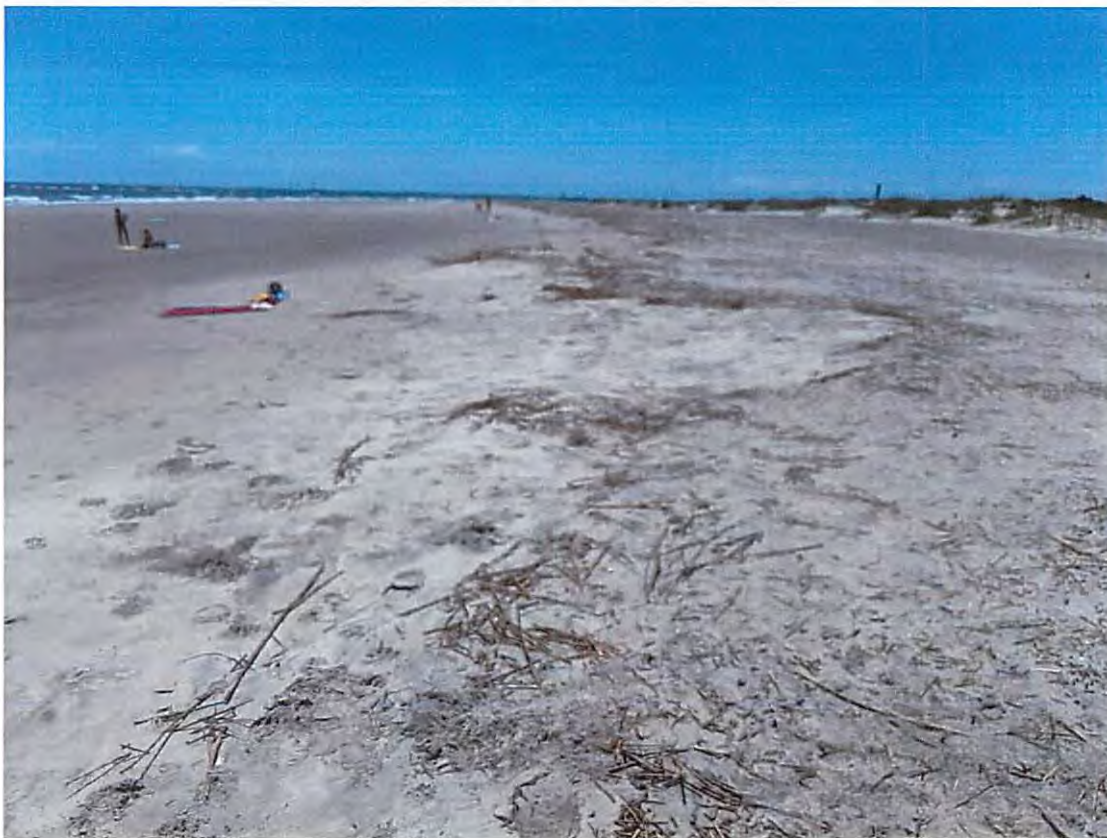
Figure 24. Ground photo taken at Monument 3080 looking southwest on June 6, 2019 (top) and June 2, 2020 (bottom).

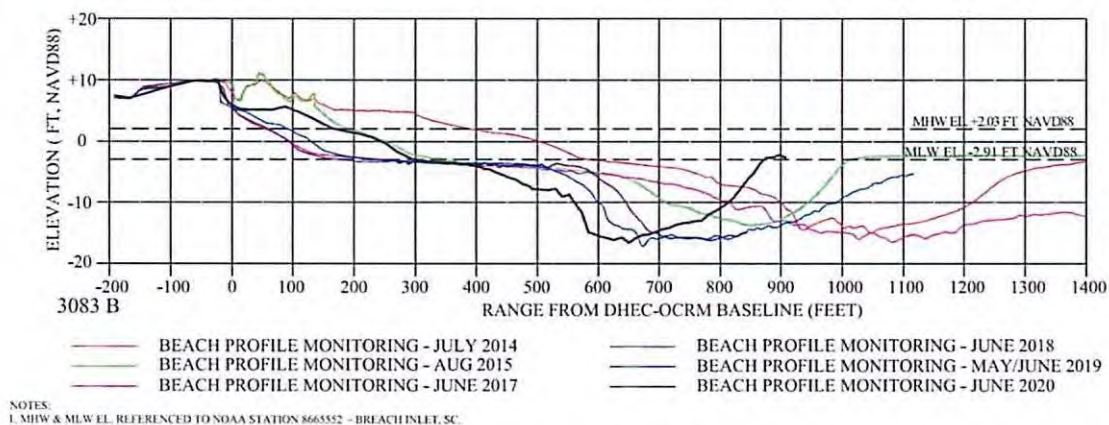
Monument 3083 is located near Station 29 and is in an area of critical erosion. This profile represents the southwest end of the groin field along northeastern Sullivan's Island. The shoreline here has retreated nearly 300 ft since the last sand bar attachment event in 2014 (Figure 25), including the loss of three rows of low sand dunes. In 2020, some beach recovery was measured. The shoreline advanced 80 ft seaward between 2019 and 2020 due to sand from the most recent attachment event migrating to this area. The backbeach accumulated a significant amount of sand covering the previously exposed seawall and sand bags that had been placed and/or exposed at the toe of the dune scarp (Figure 26). Groins and seawalls continue to dominate this portion of the island, but recovery was observed.

According to the 2020 volume calculation, this profile has a unit volume of 252 cy/ft, about 40 cy/ft larger in 2019.

Figure 25. Beach profile monitoring data from 2014-2020 in cross-section view at Monument 3083.

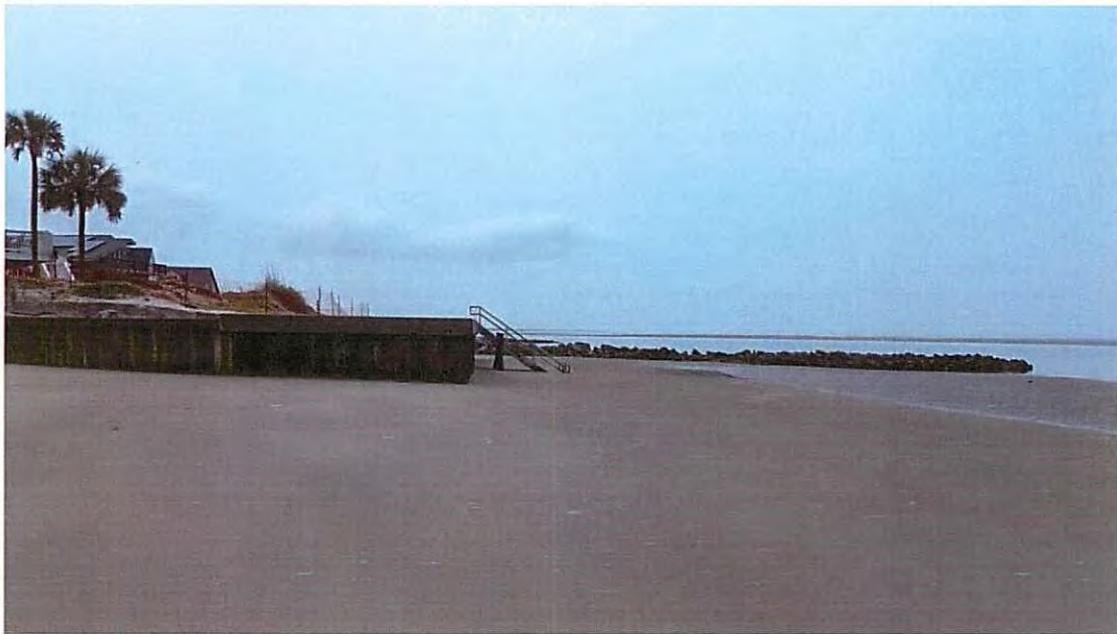
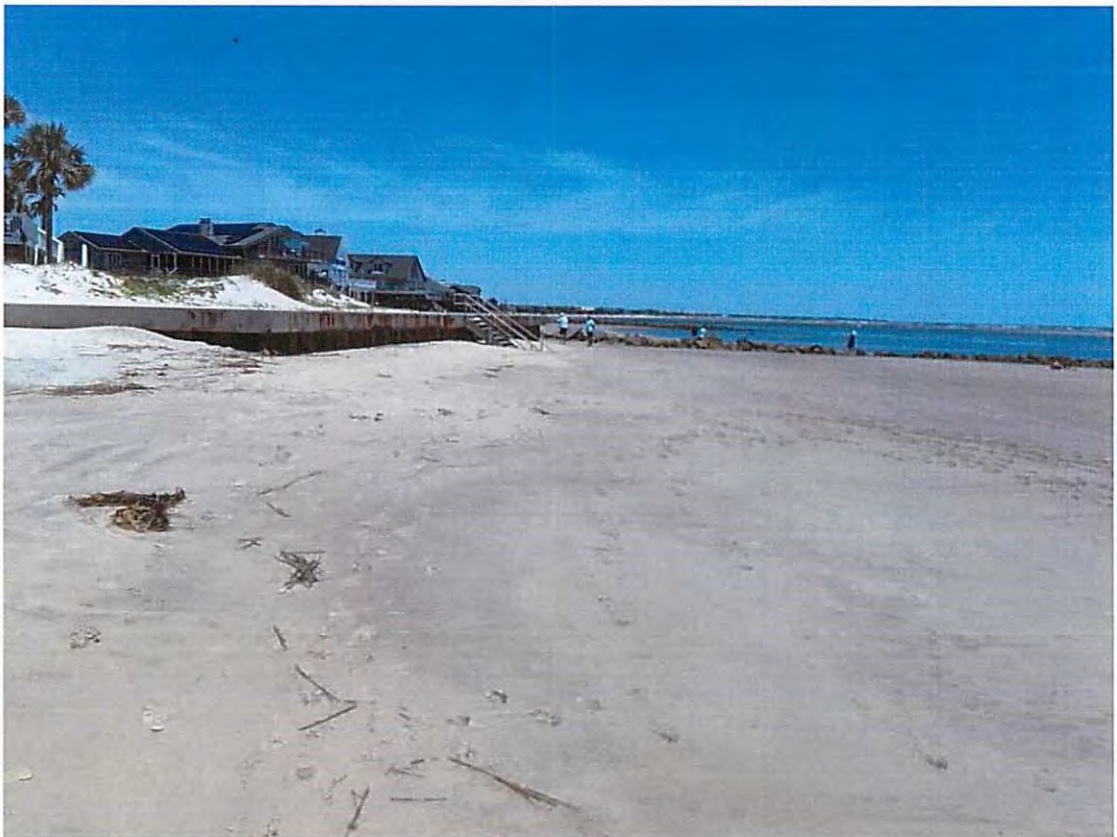
Figure 26. Ground photo taken at Monument 3083 looking northwest on June 6, 2019 (top) and June 2, 2020 (bottom). Note the increased beach width in 2020.

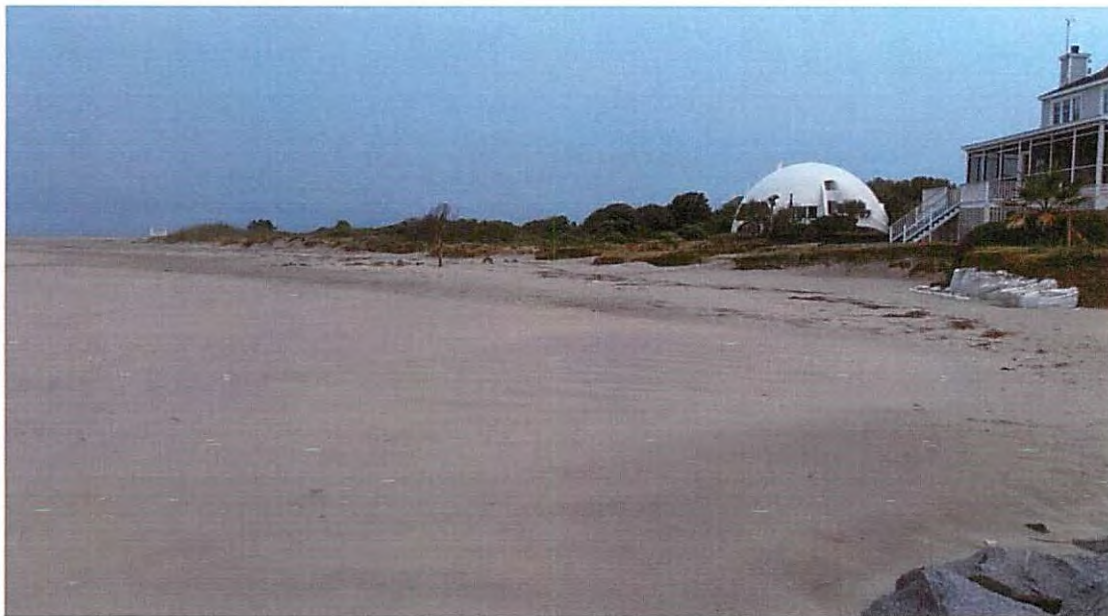
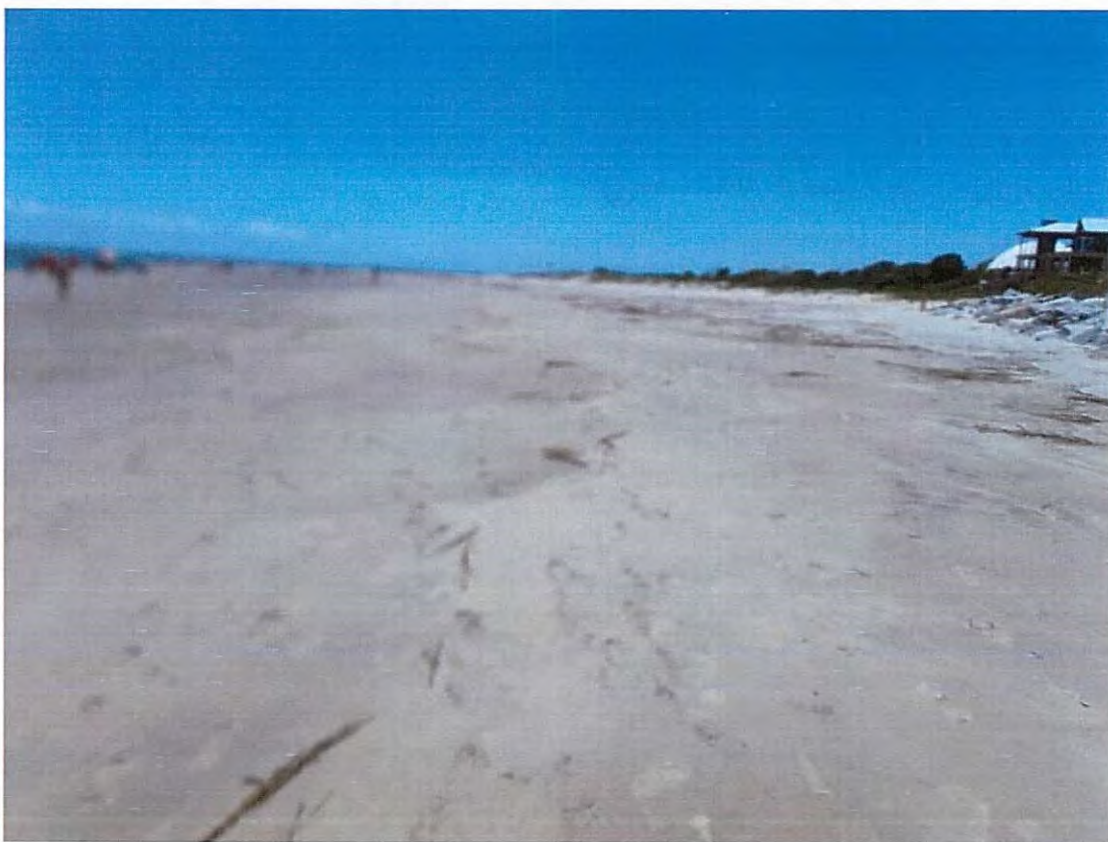
This location marks the transition between the northeast end of the island, which has been stabilized with erosion control structures and the wide, fluctuating beach of the central portion of the island to the southwest (Figure 27).

Figure 27. Ground photo taken at Monument 3083 looking southwest on June 6, 2019 (top) and June 2, 2020 (bottom). Note the increased beach width in 2020 and exposed sand bags.

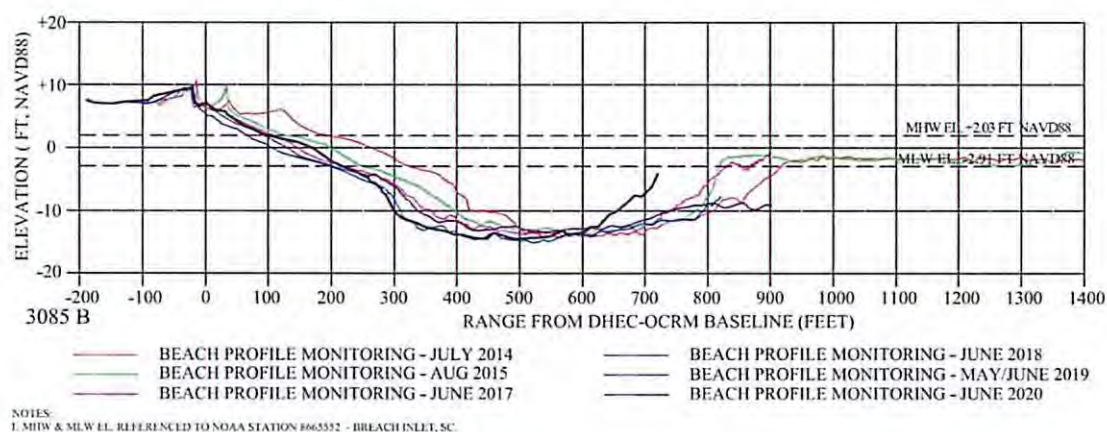
Monument 3085 is located near Station 30. This area had been eroding since the sand bar attachment event in 2014, but some accretion was measured during this monitoring period. Beach profile data indicates evidence of some backbeach recovery between 2019 and 2020 (Figure 28).

According to the 2020 volume calculation, this profile has a unit volume of 111 cy/ft, a slight increase from the 2019 volume.

Figure 28. Beach profile monitoring data from 2014-2020 in cross-section view at Monument 3085.

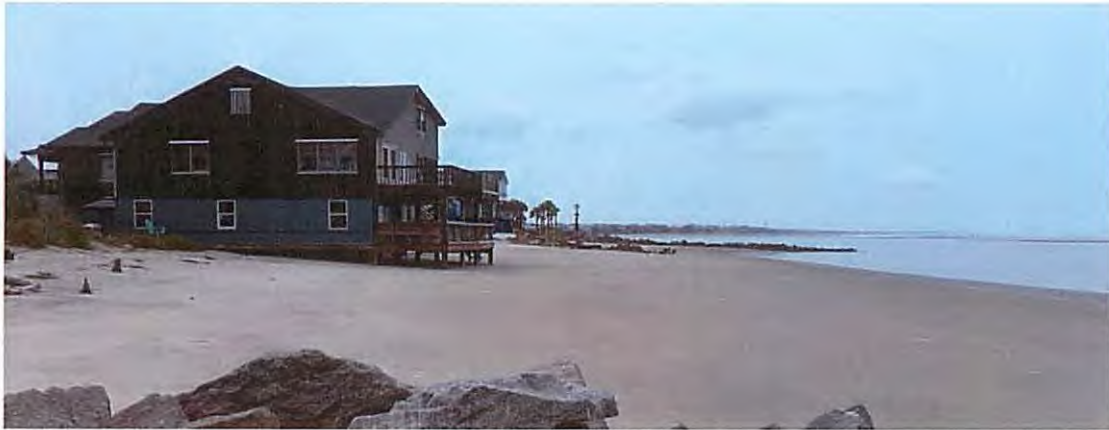
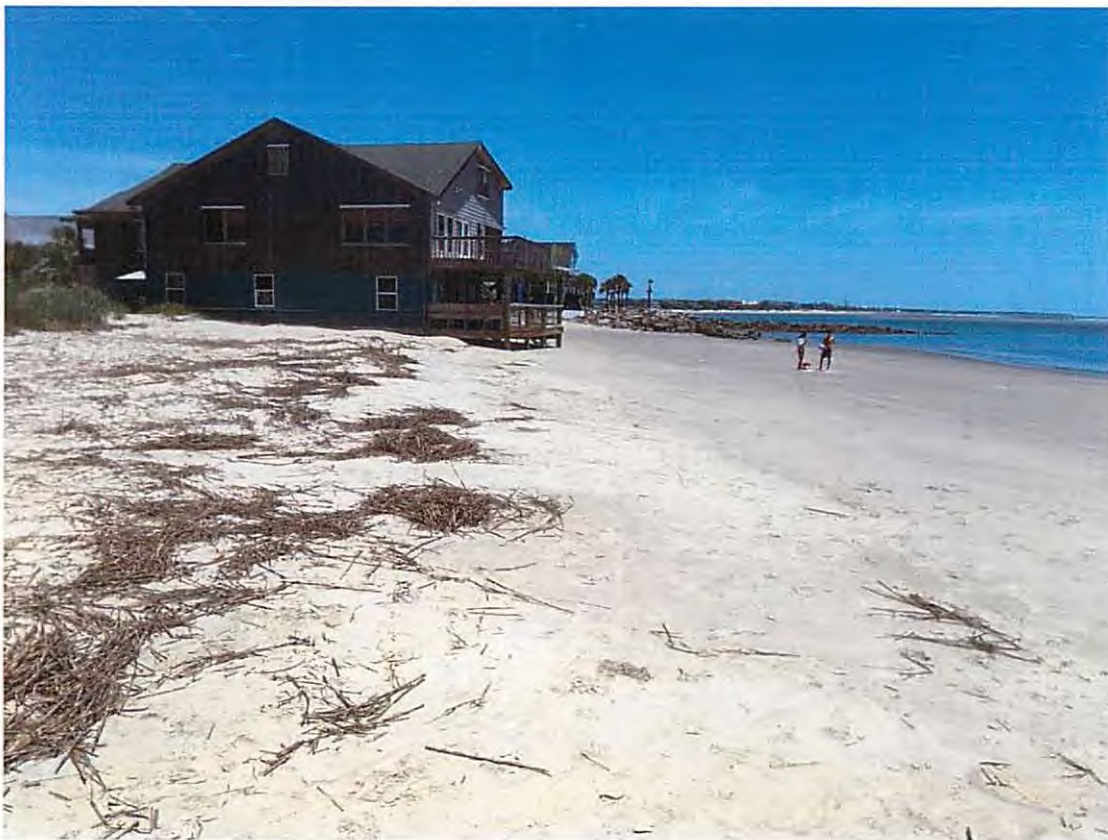
Beach observations indicate that despite some measured recovery, the high tide line remains under the decks of the homes in this area. There is very little dry beach at high tide. Some dune recovery was observed and no dune overtopping has occurred recently.

Figure 29. Ground photo taken at Monument 3085 looking northwest on June 6, 2019 (top) and June 2, 2020 (bottom). Notice the profile deflation under the deck in 2019 and backbeach recovery in 2020.

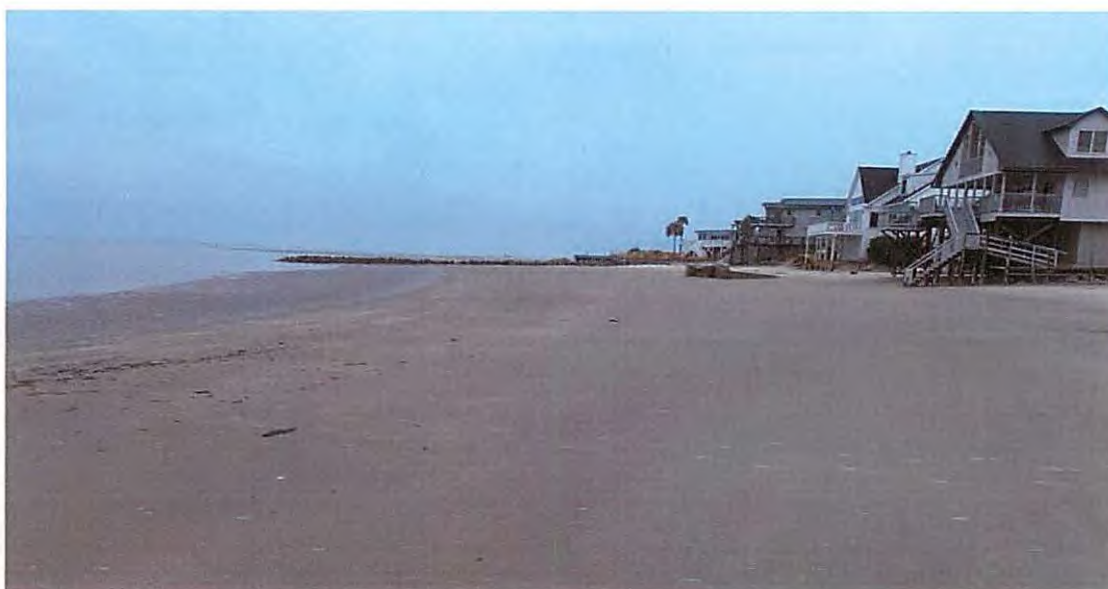
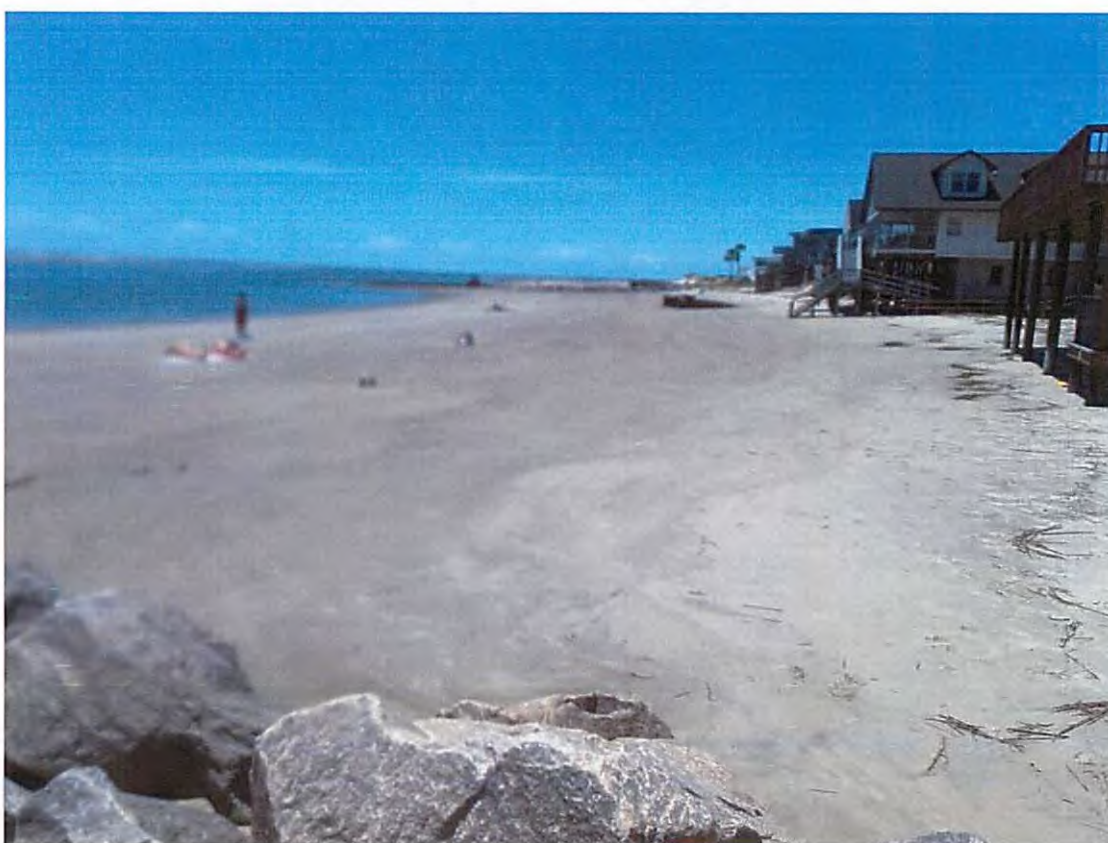
This pocket beach between groins is highly erosional. No dunes are present in front of the houses. Despite the structures, erosion continues to dominate this portion of the island between sandbar attachment events (Figure 29). Erosion has become so severe in this area that a historic cannon structure which has been buried under the beach became exposed on the beachface in 2019 (Figure 30). This profile will be monitored closely.

Figure 30. Ground photo taken at Monument 3085 looking southwest on June 11, 2019 (top) and June 2, 2020 (bottom). Note the exposed cannon structure in 2019 and some back beach recovery in 2020.

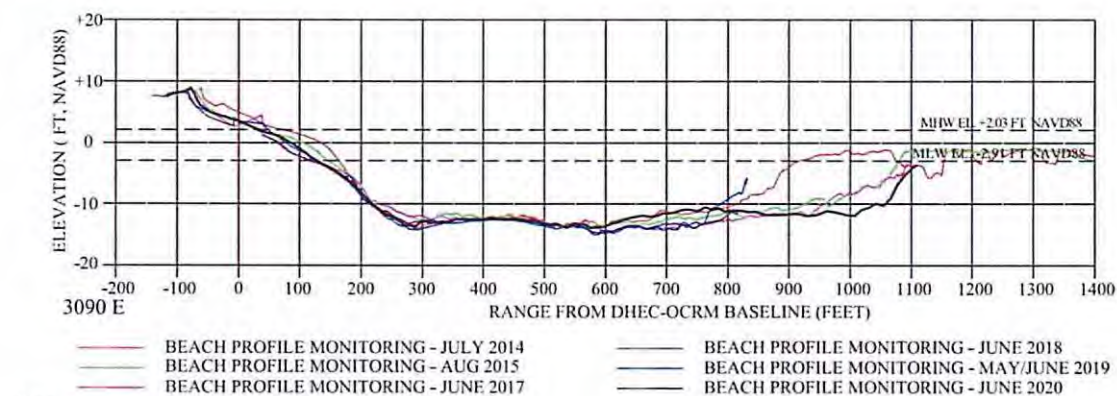
According to the 2020 volume calculation, this profile has a unit volume of 118 cy/ft, nearly the same as 2019.

Figure 31. Beach profile monitoring data from 2014-2020 in cross-section view at Monument 3090.

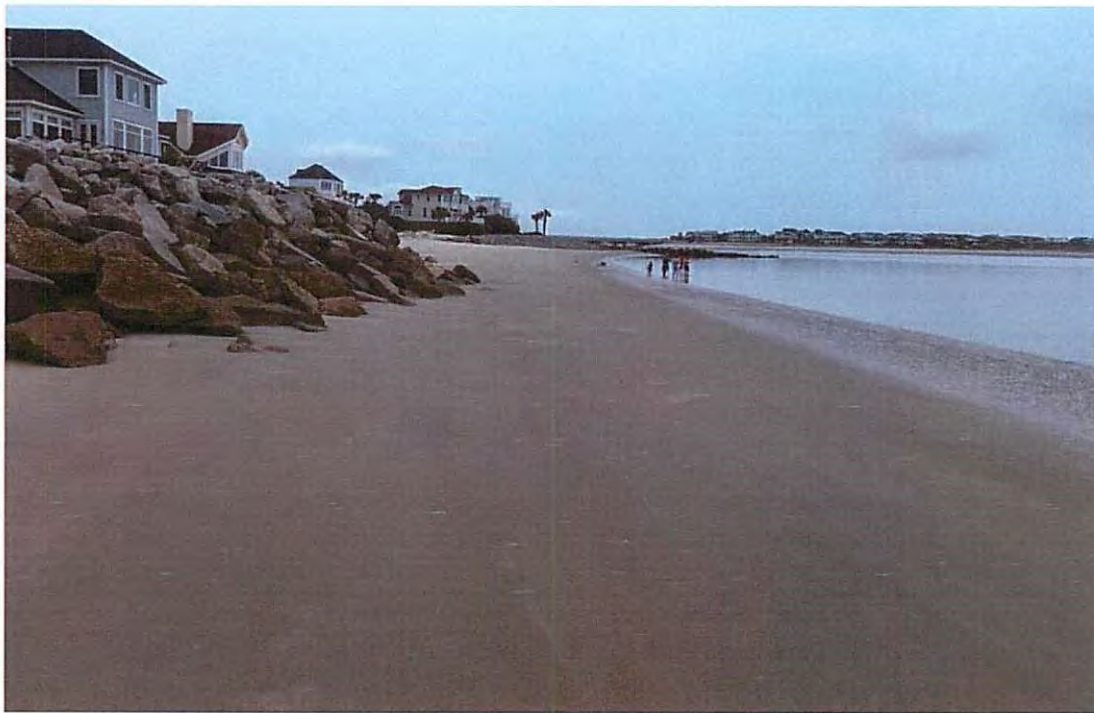
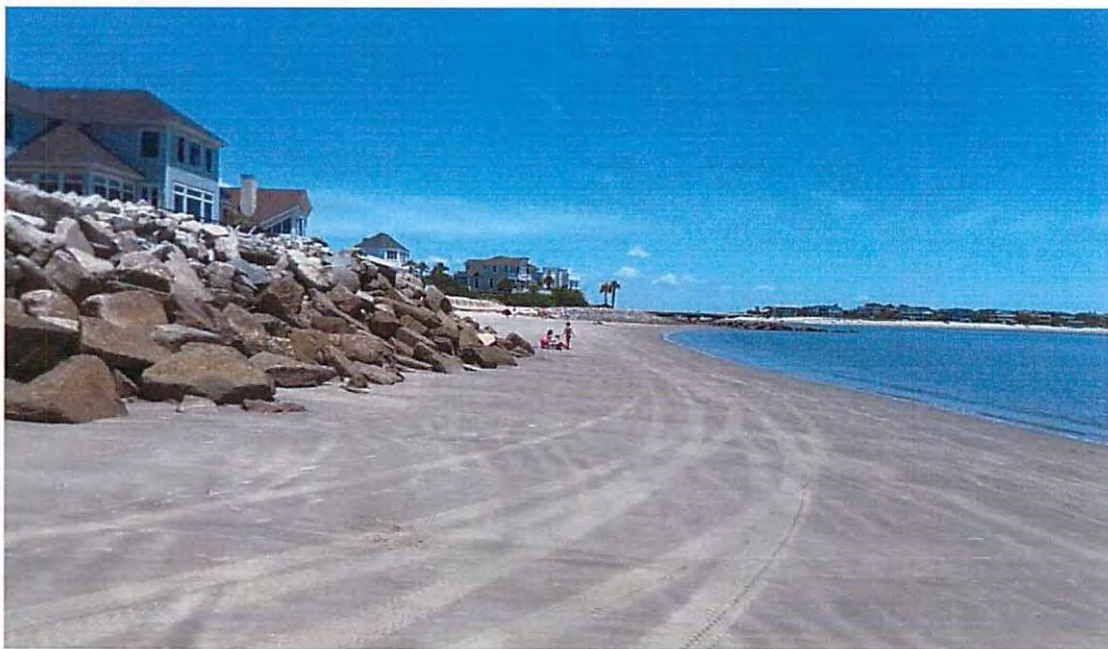
Monument 3090 is located just south of Station 31 on northeastern Sullivan's Island near Breach Inlet. It represents a small (<250 ft long) pocket beach between two groins. The beach is nearly completely armored. The beach profile has exhibited erosion despite the stabilization structures (Figure 31). No dry beach is exposed at high tide and no dunes are present (Figure 32 and Figure 33).

Figure 32. Ground photo taken at Monument 3090 looking north on June 6, 2019 (top) and June 2, 2020 (bottom).

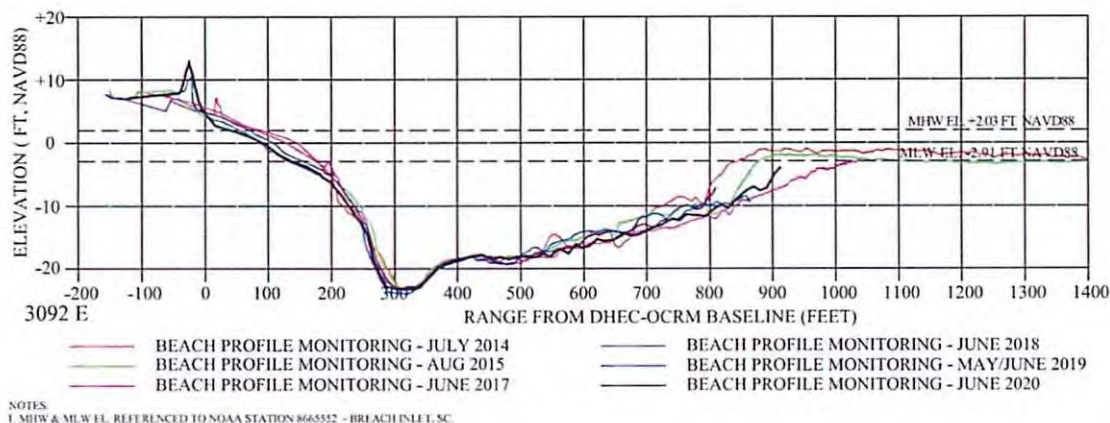
According to the 2020 volume calculation, this profile has a unit volume of 112 cy/ft, nearly the same as in 2019.

Figure 34. Beach profile monitoring data from 2014-2020 in cross-section view at Monument 3092.

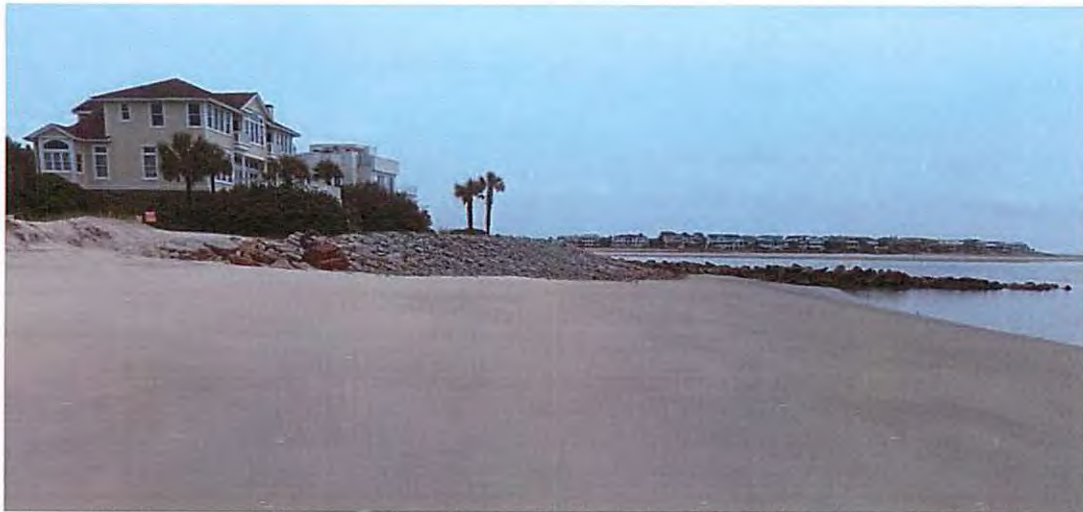
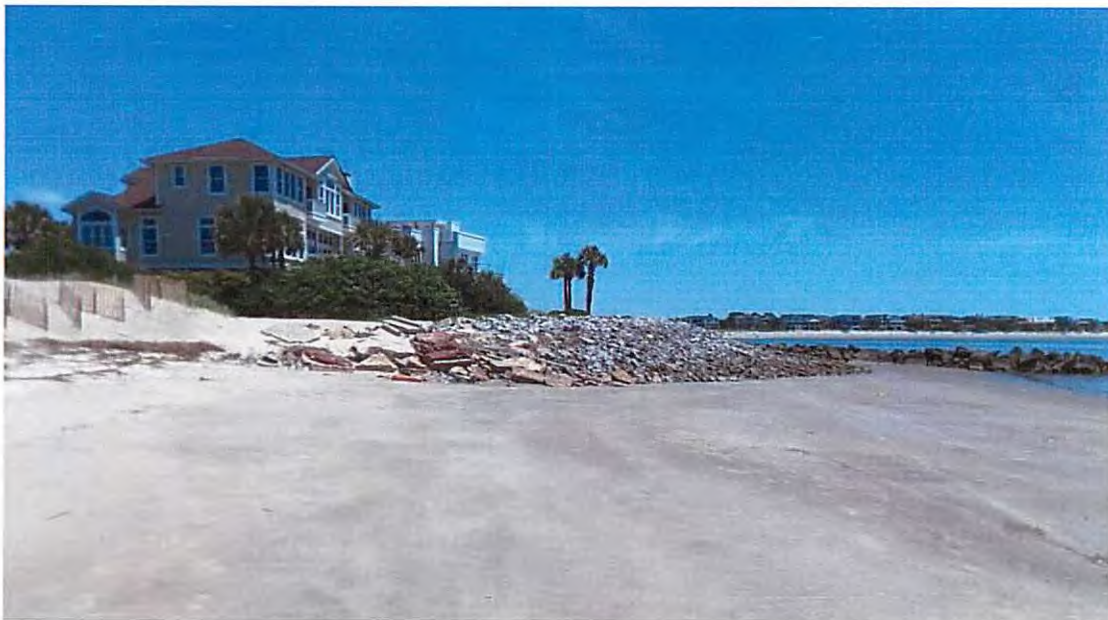
Figure 35. Ground photo taken at Monument 3092 looking north on June 6, 2019 (top) and June 2, 2020 (bottom).

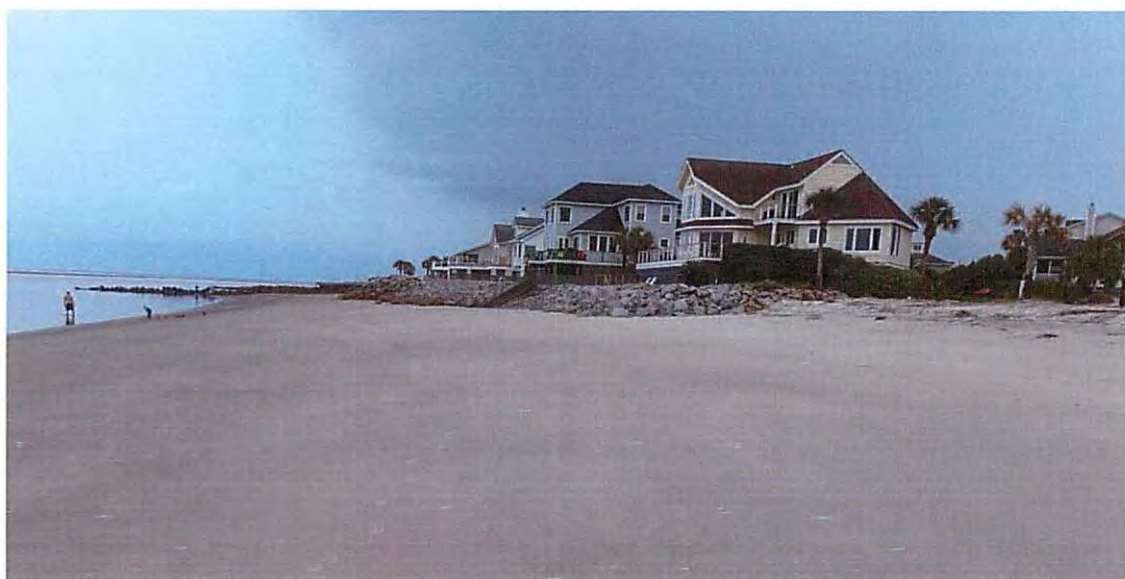
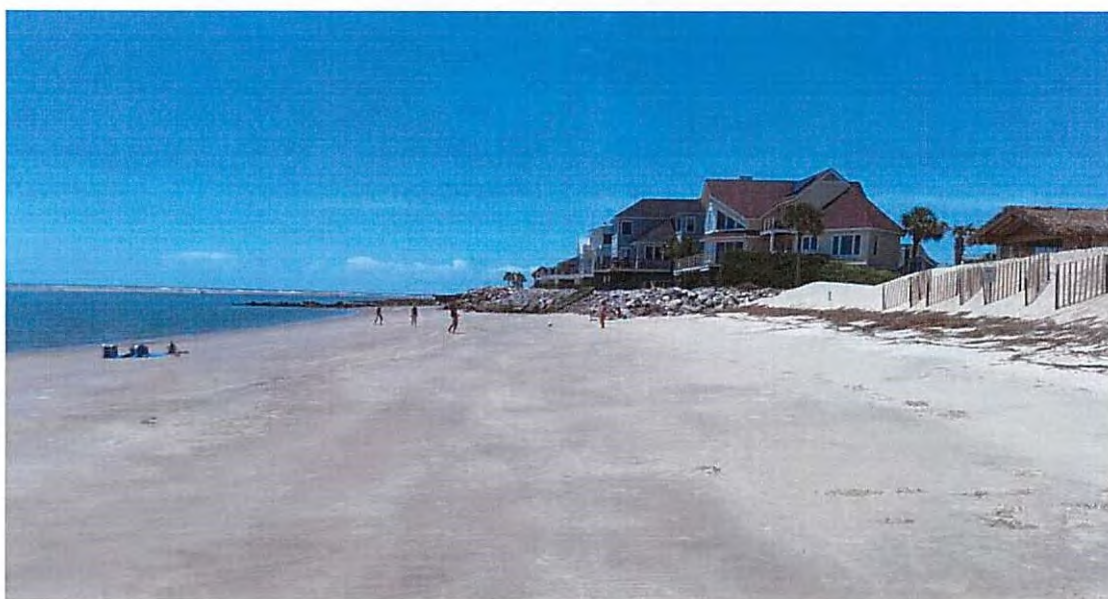
Figure 36. Ground photo taken at Monument 3092 looking south on June 6, 2019 (top) and June 2, 2020 (bottom).

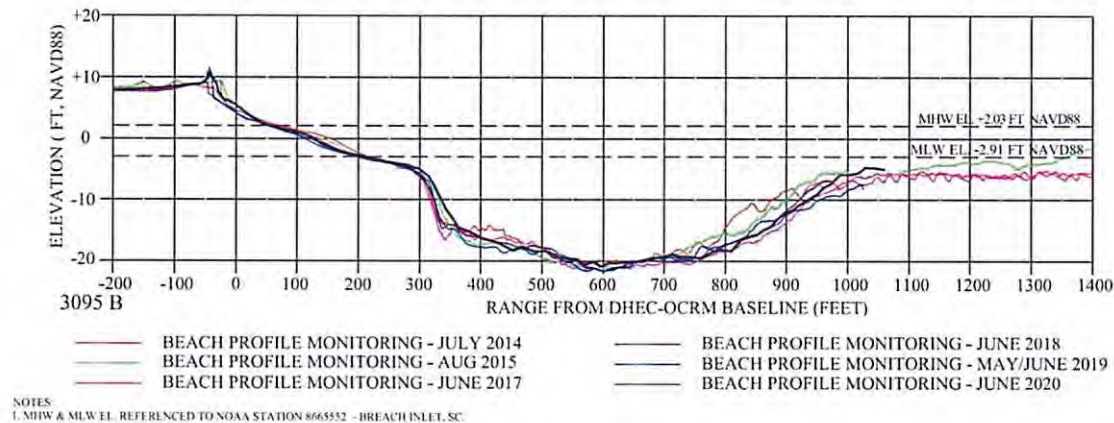
According to the 2020 volume calculation, this profile has a unit volume of 187 cy/ft, about 10 cy/ft greater than 2019.

Figure 37. Beach profile monitoring data from 2014-2020 in cross-section view at Monument 3095.

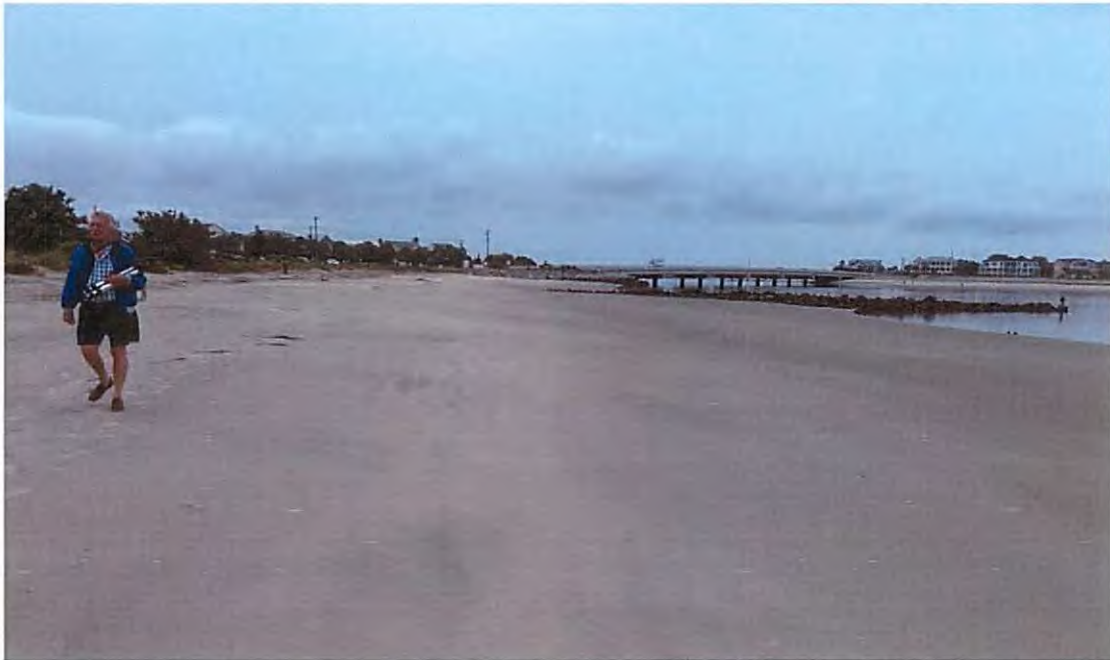
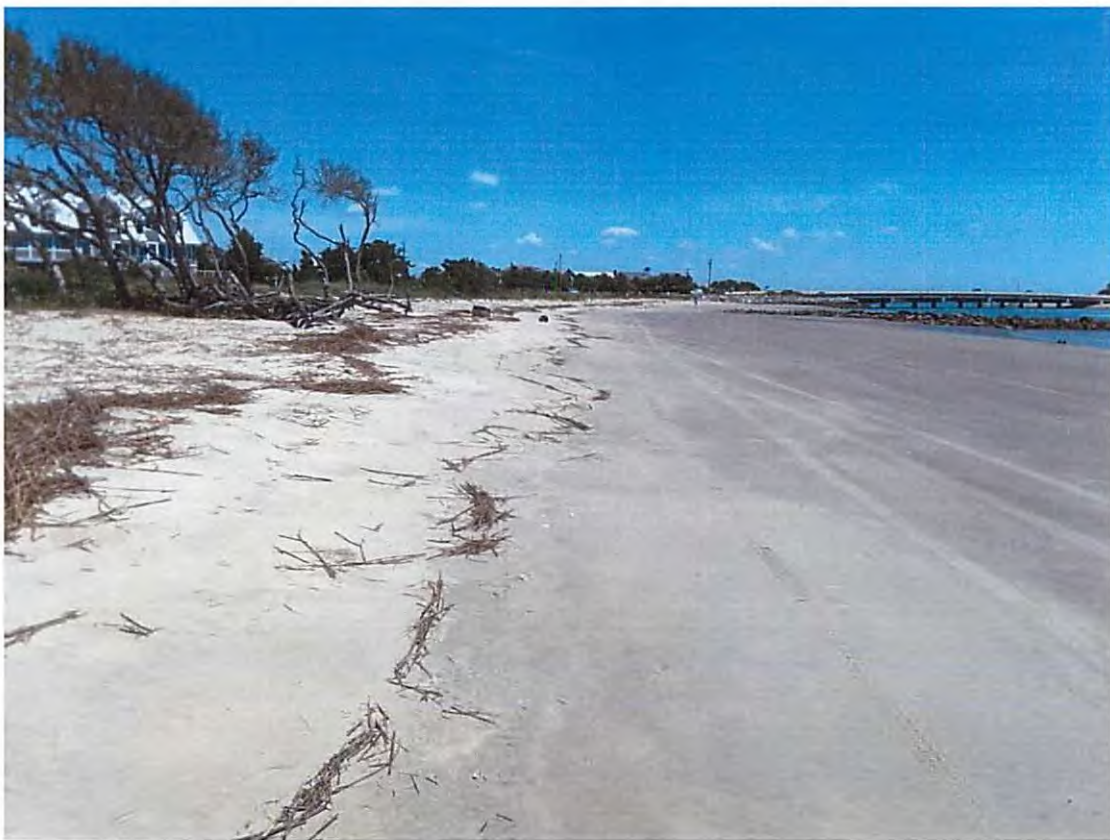
Figure 38. Ground photo taken at Monument 3095 looking north on June 6, 2019 (top) and June 2, 2020 (bottom).

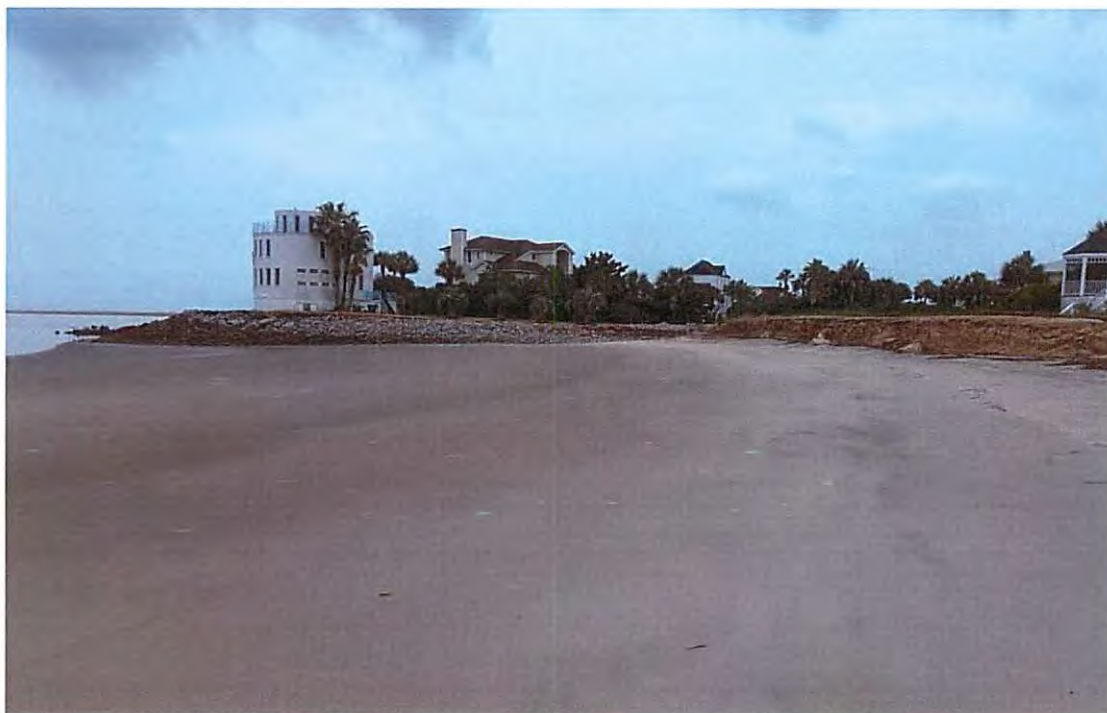
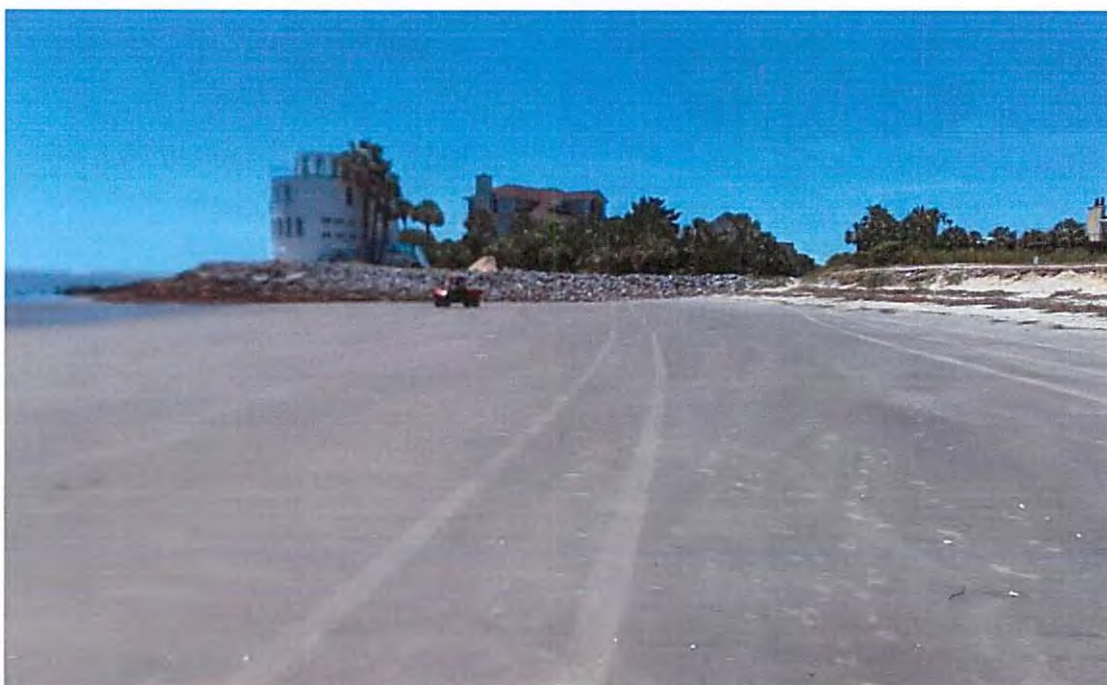
Figure 39. Ground photo taken at Monument 3095 looking south on June 6, 2019 (top) and June 2, 2020 (bottom). Note that the clay bluff has been covered with some sand in 2020.
