2021 Beach Monitoring Survey

TOWN OF SULLIVAN'S ISLAND, SC

Elko Coastal Consulting, Inc. | July 2021

2021 Beach Monitoring Survey:
Town of Sullivan's Island, SC

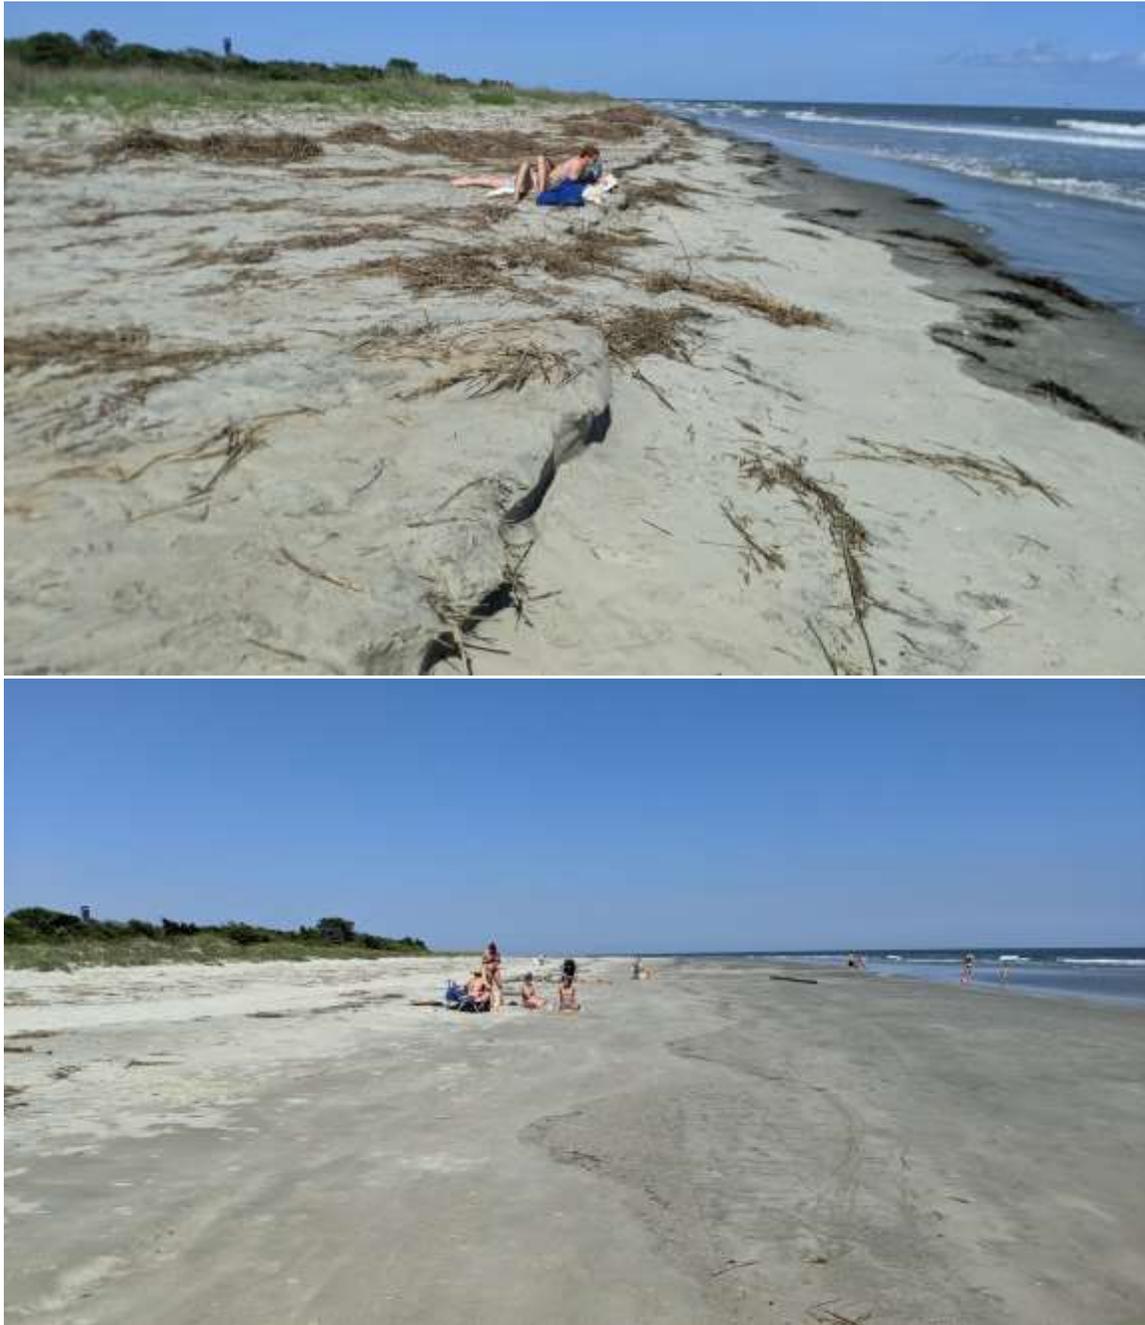
This is the southwesternmost OCRM Monument on Sullivan’s Island, located along the long beach access path at Station 16 with the nature trail. The beach is located on the Charleston Harbor side (“inside”) of the jetty. This profile has experienced significant beach and dune erosion during the last year (Figure 7). Observations indicated that the rack line was at the dune toe, suggesting erosional conditions (Figure 8). Incipient dunes and a wide primary dune that had been growing at this location since 2015 eroded between 2020 and 2021 (Figure 9). According to the 2021 volume calculation, this profile has a unit volume of 743 cy/ft. This is about 50 cy less than the 2020 unit volume.

Figure 8. Ground photo taken at Monument 3010 looking east on June 2, 2020 (top) and June 17, 2021 (bottom). Note the incipient dunes that developed in 2020 had been eroded by 2021.

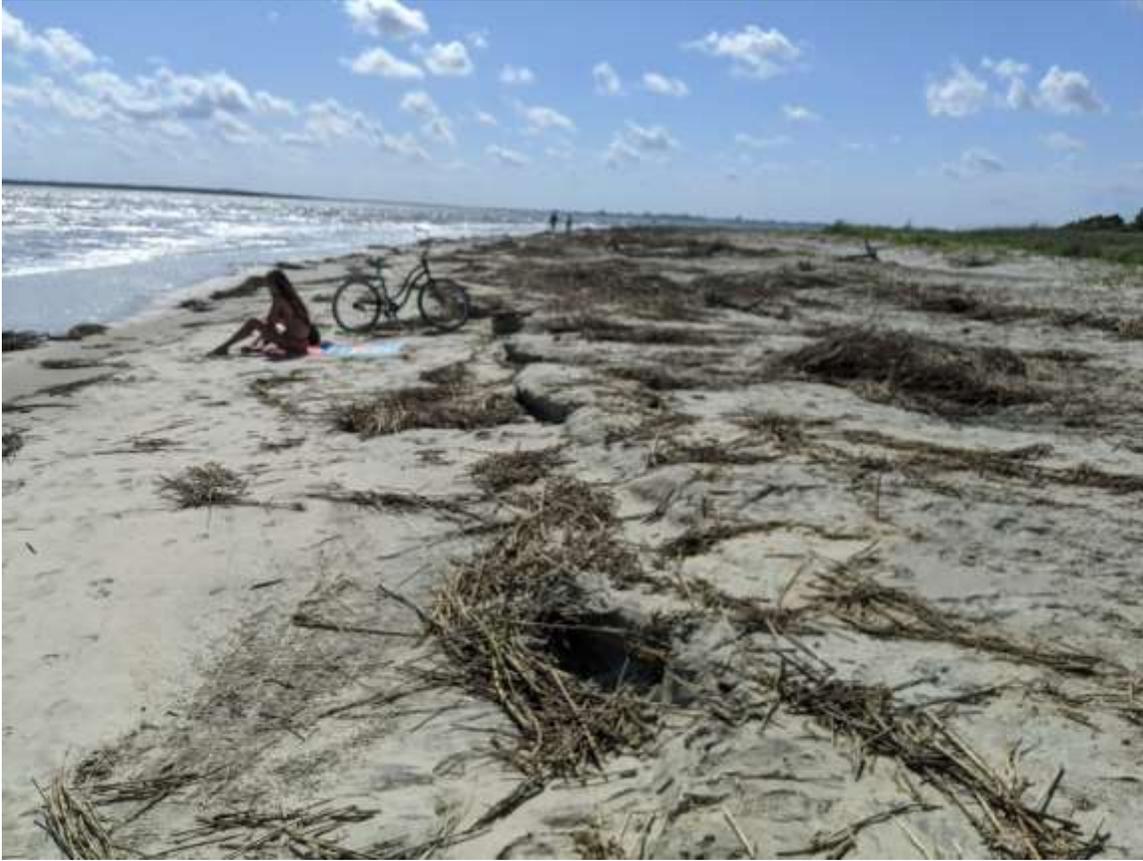
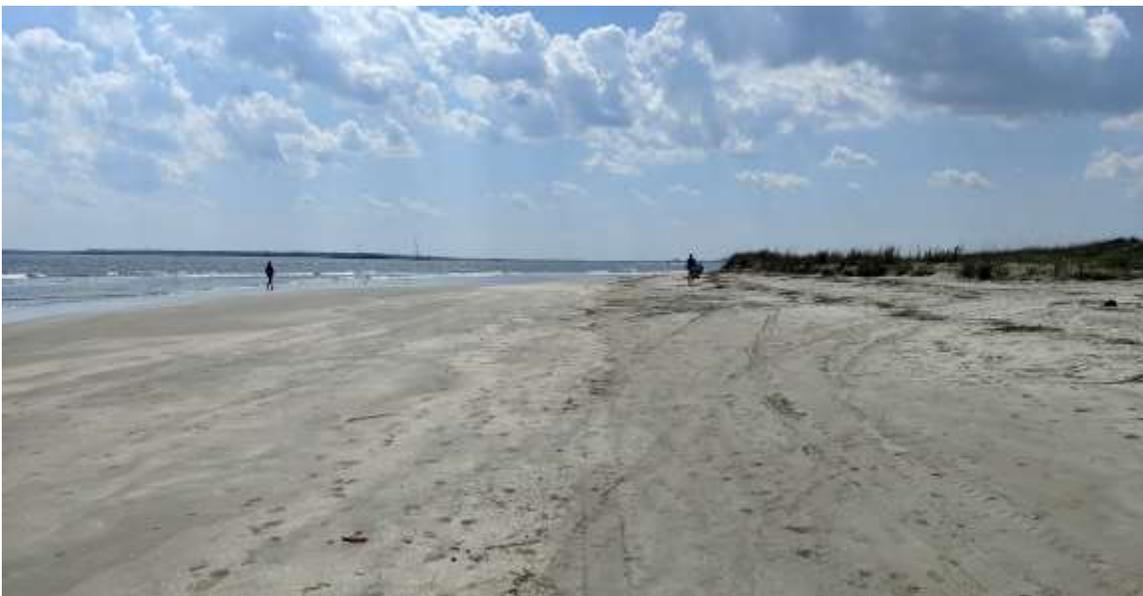
Figure 9. Ground photo taken at Monument 3010 looking west on June 2, 2020 (top) and June 17, 2021 (bottom).

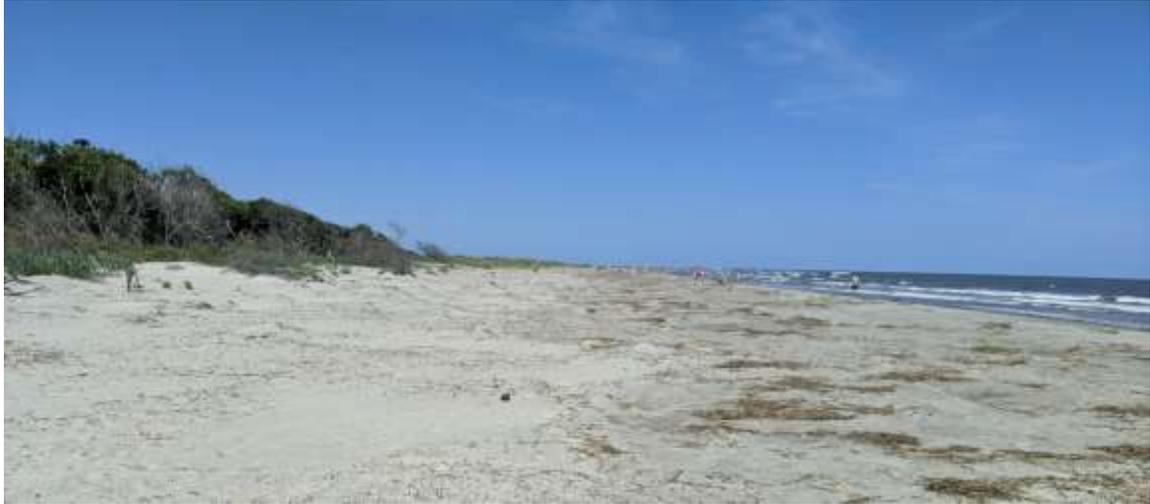
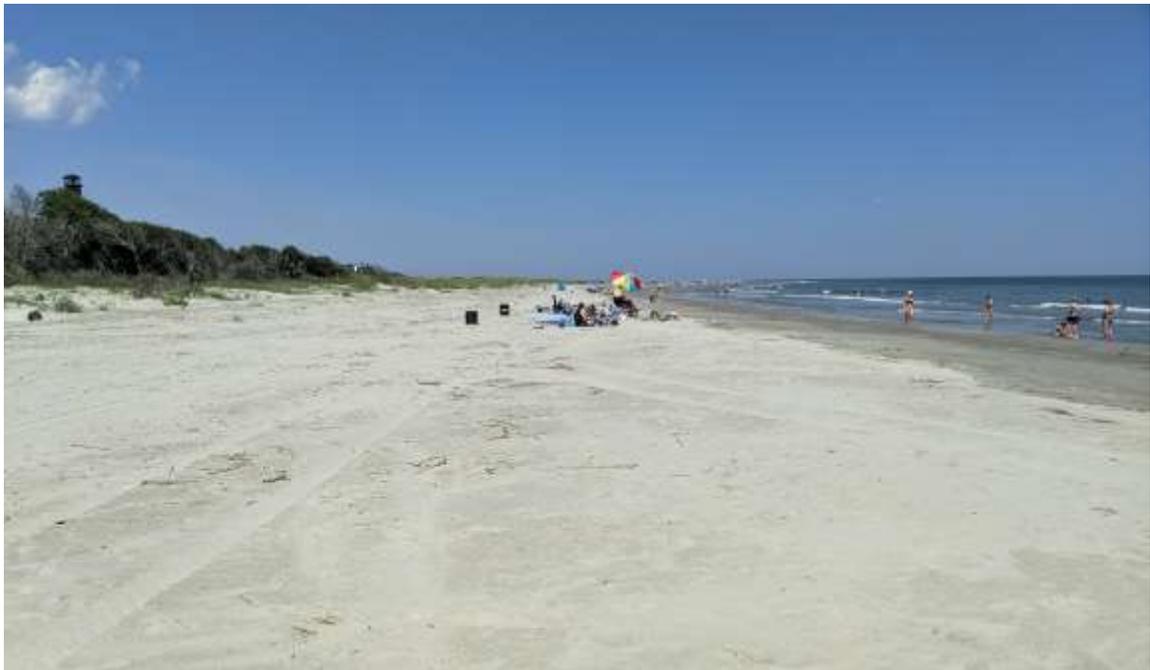
Beach observations confirmed that the recovery that began in 2019 continued in 2021 with vegetation growth and dunes advancing seaward. Dead trees along the dune line were buried with sand. The beach was accreting with at least 100 ft of dry beach at high tide. A sand bar had attached to the updrift beach and the beach berm accreted (Figure 11). Dune recovery continued (Figure 12).

Figure 11. Ground photo taken at Monument 3020 looking northeast on June 2, 2020 (top) and June 17, 2021 (bottom). Notice the evolution of the sand bar attachment on the beach to the northeast.

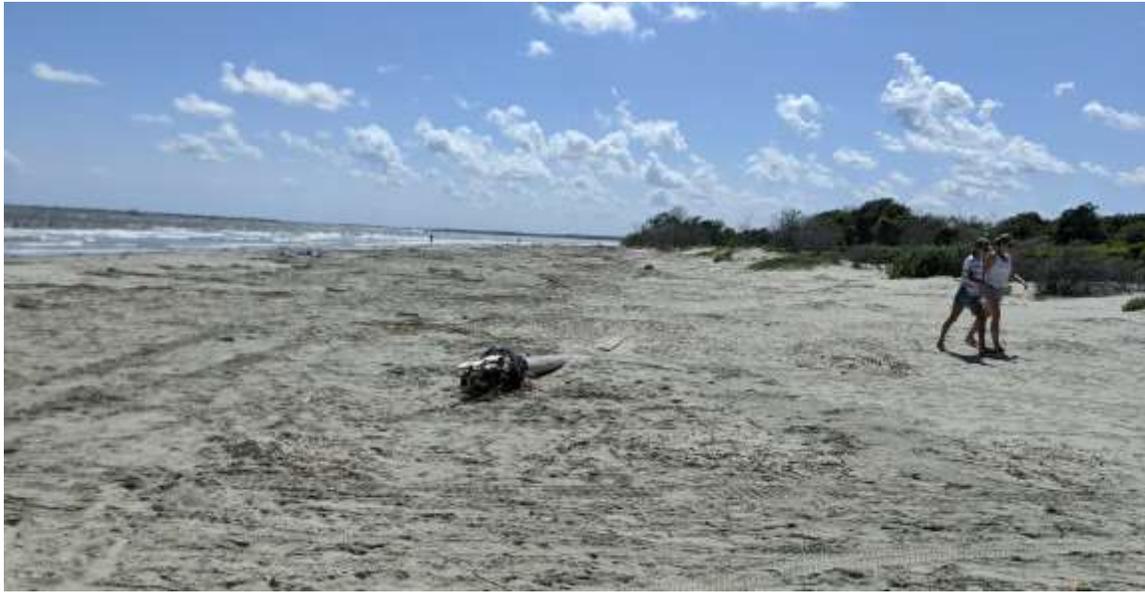
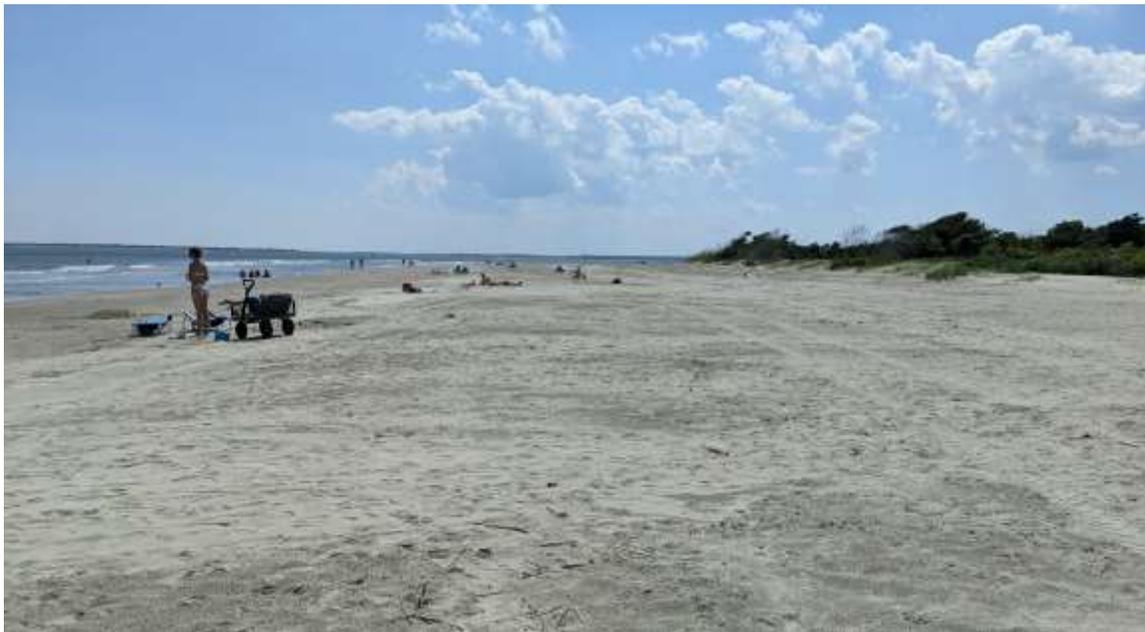
Figure 12. Ground photo taken at Monument 3020 looking southwest June 2, 2020 (top) and June 17, 2021 (bottom).

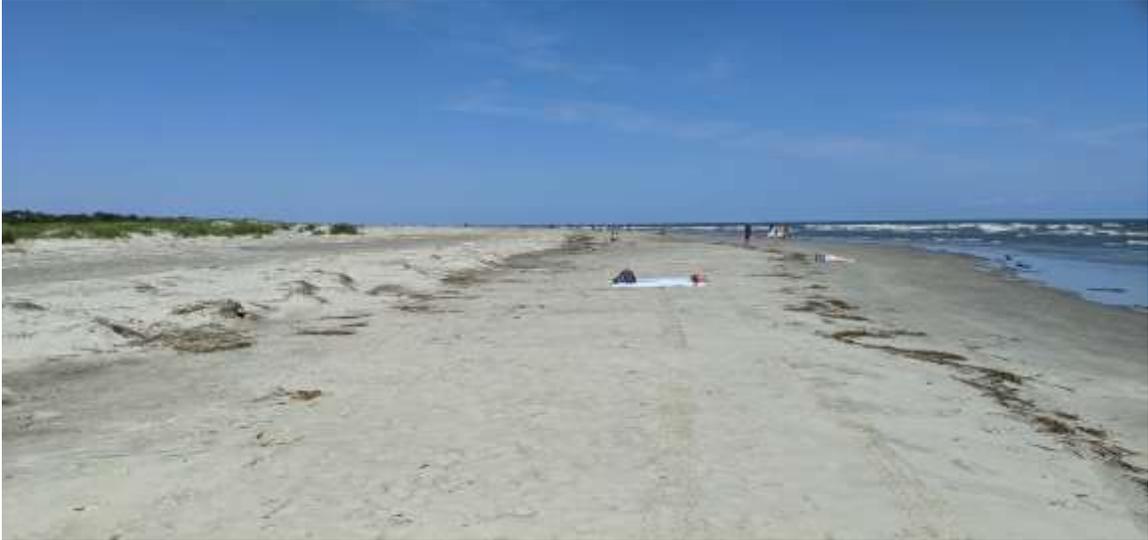
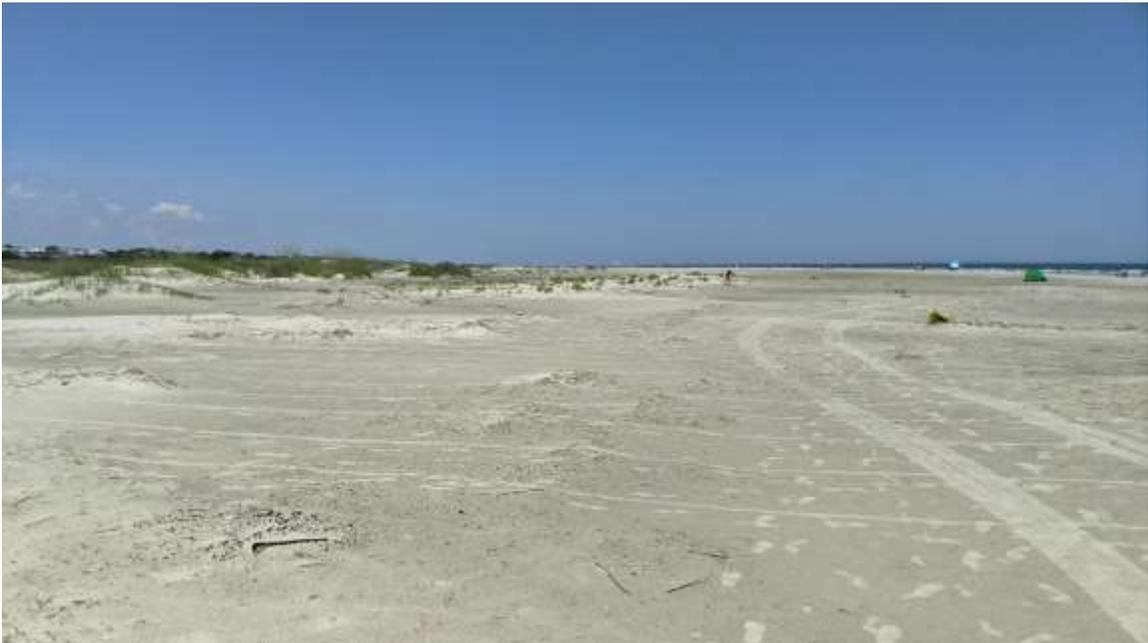
Monument 3035 is located along the long beach access path at Station 19. This area has been the beneficiary of recent sandbar attachment events (Figure 13). The beach has been wide and accreting for the last several years. A new primary dune has formed since 2014. In 2021, beach observations confirmed that a wide backbeach and a wide, high berm (Figure 14 and Figure 15). Evidence of past ponding landward of the berm was observed, which is common at this location.

Figure 14. Ground photo taken at Monument 3035 looking northeast on June 2, 2020 (top) and June 17, 2021 (bottom). Note increased elevation of the berm.

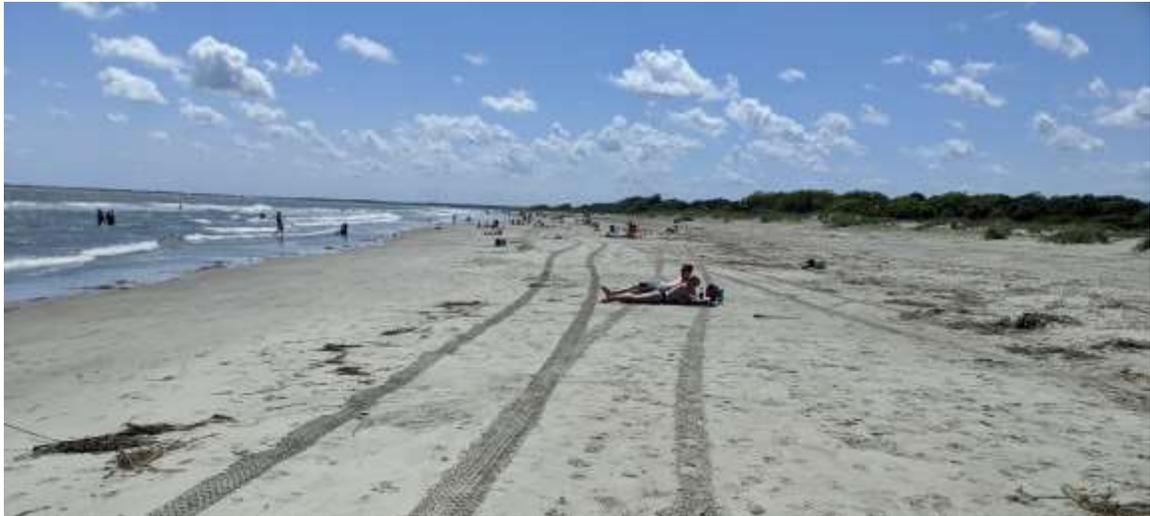
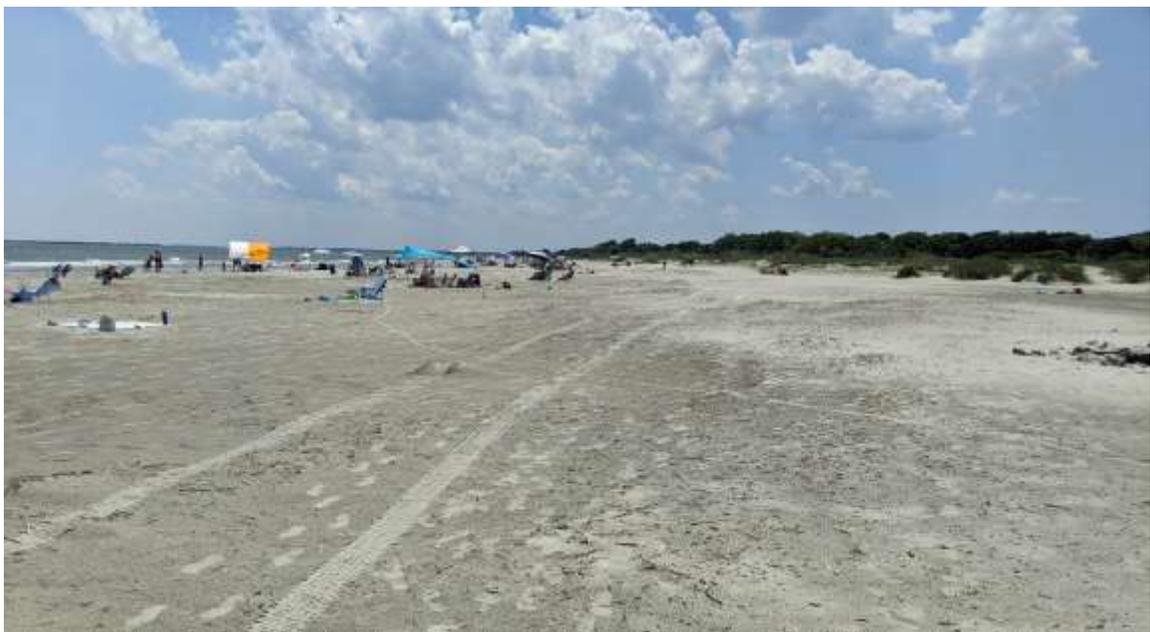
Figure 15. Ground photo taken at Monument 3035 looking southwest on June 2, 2020 (top) and June 17, 2021 (bottom). Note the higher berm elevation.

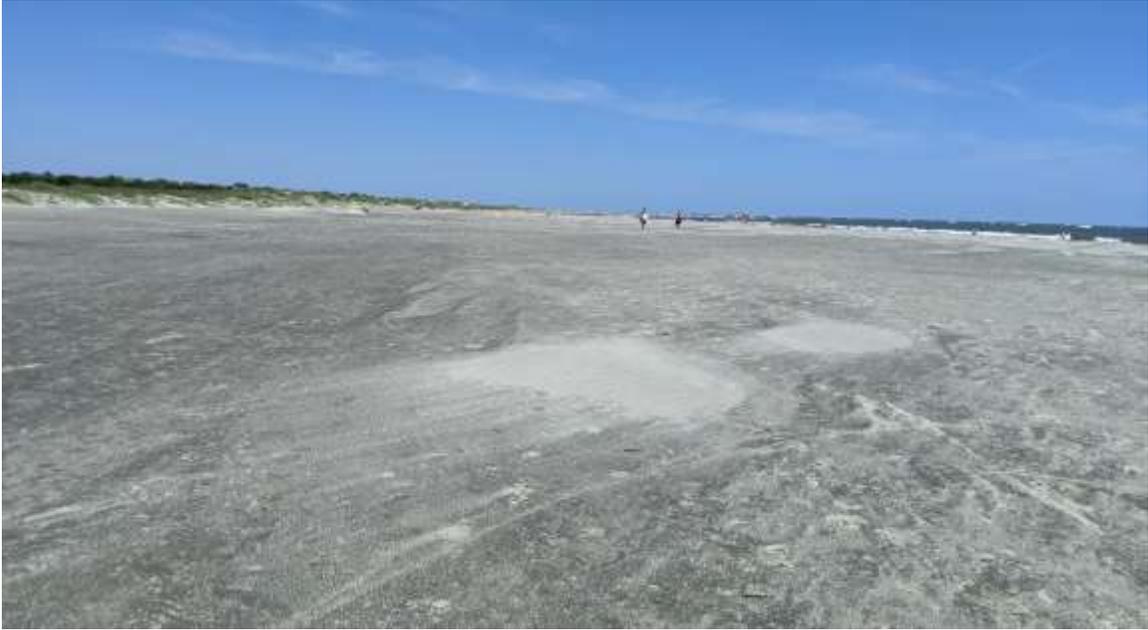
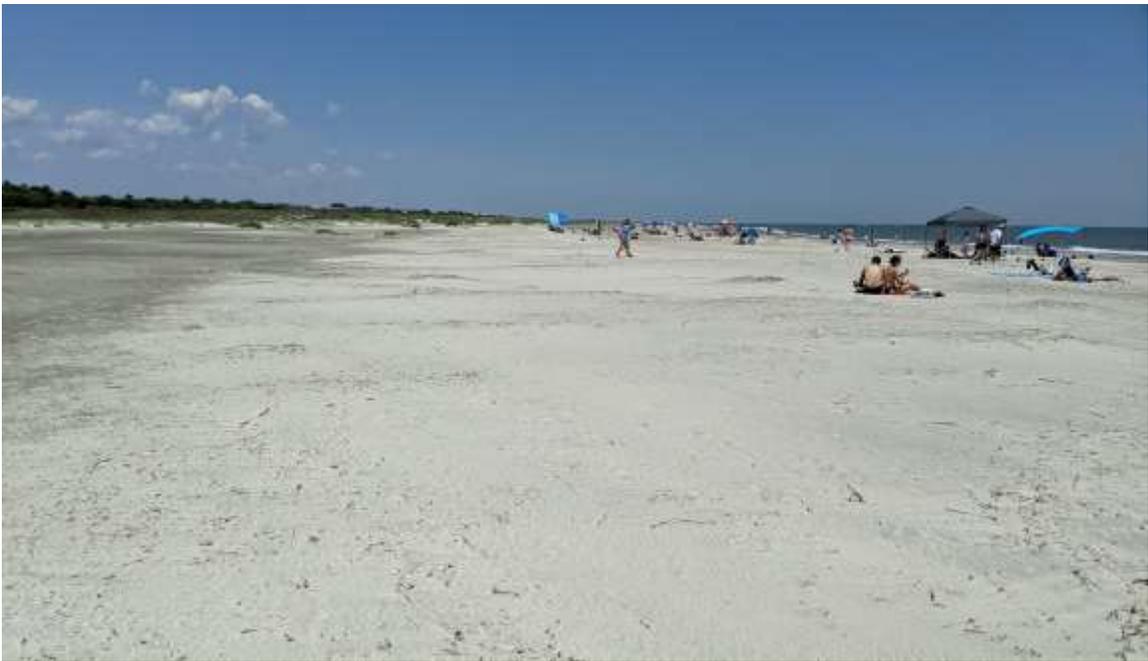
The beach observations confirm that the 2021 beach was over 100 ft wide and accretional. The dunes were healthy with new growth and as with the nearby beach profiles, coppice mounds and incipient dunes that had formed in 2020 had been overtopped and replaced with a sandy berm. Evidence of past backbeach ponding was observed. This is likely a result of King tide events and may be helping to slow seaward aggradation.

Figure 17. Ground photo taken at Monument 3050 looking northeast on June 2, 2020 (top) and June 17, 2021 (bottom).

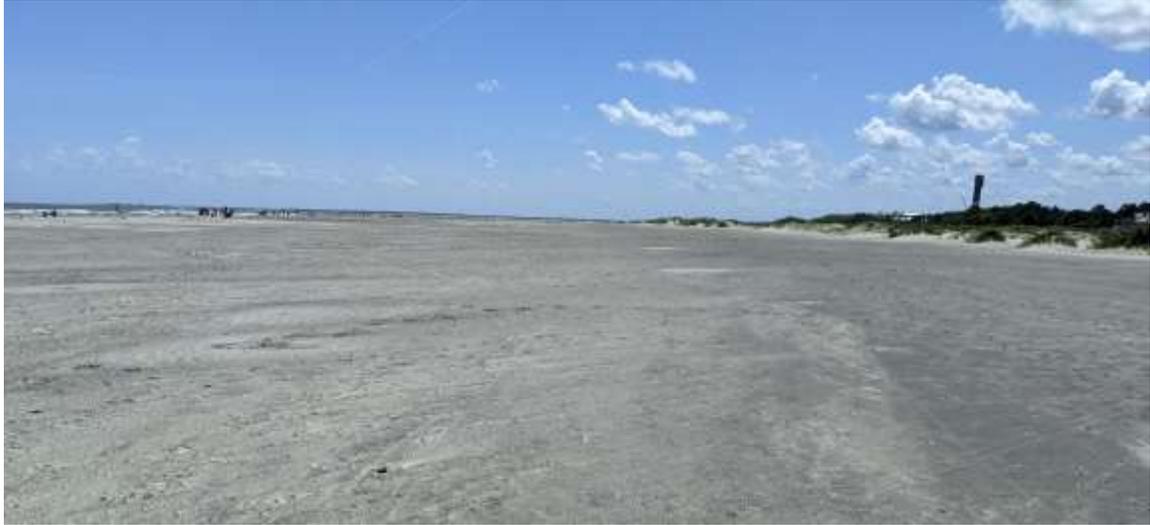
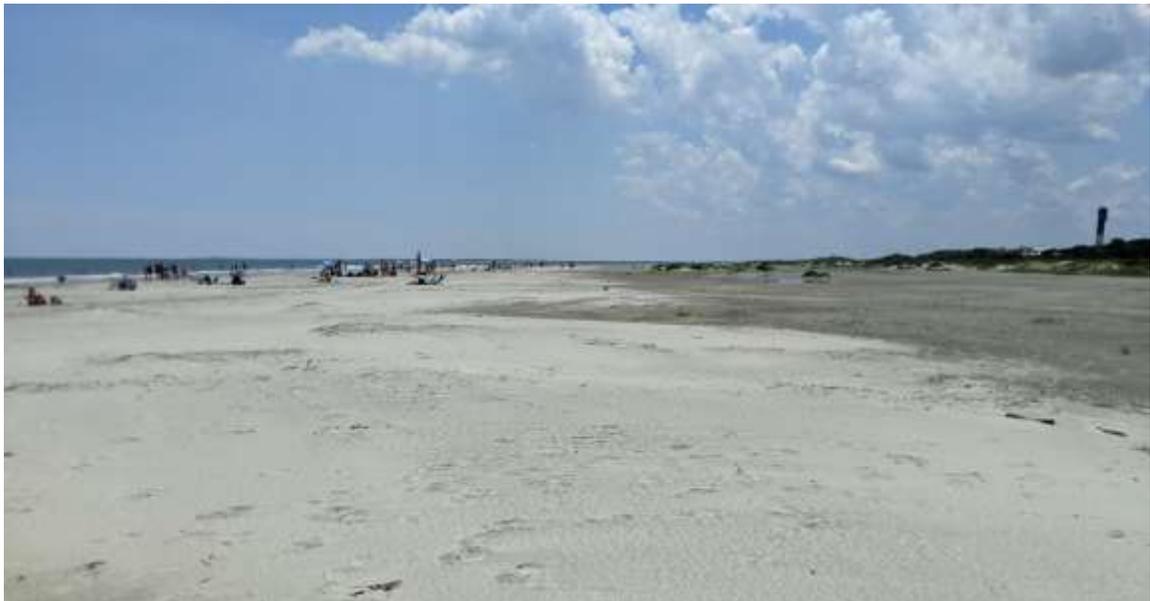
Figure 18. Ground photo taken at Monument 3050 looking southwest on June 2, 2020 (top) and June 17, 2021 (bottom).

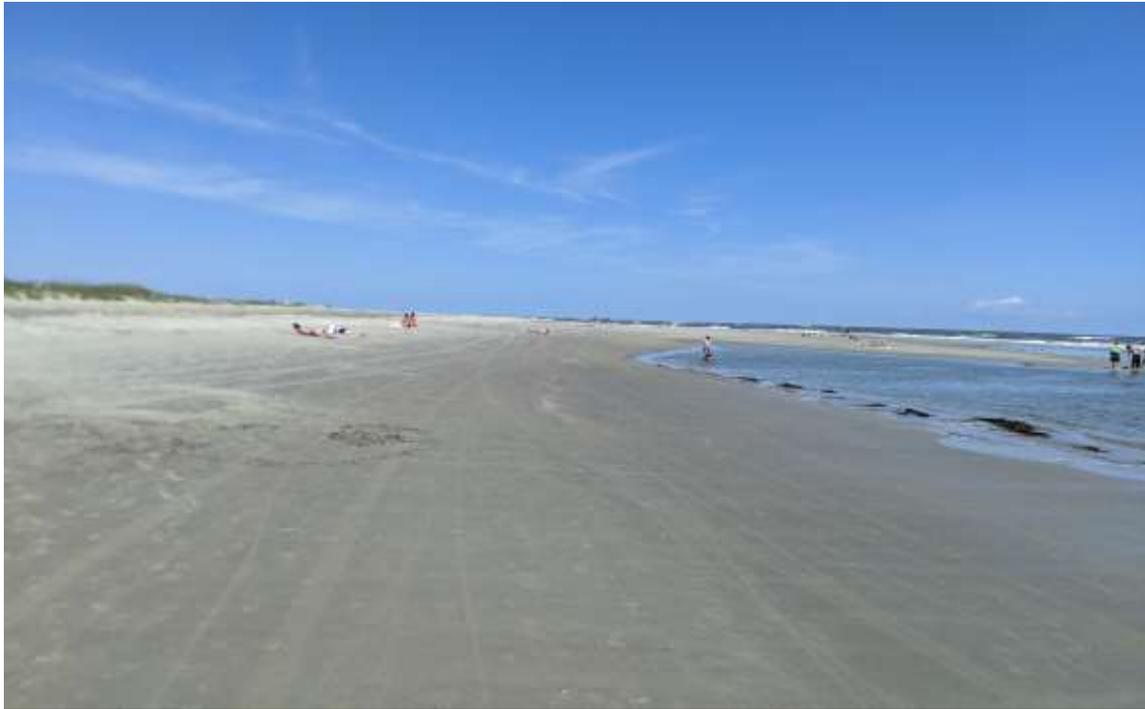
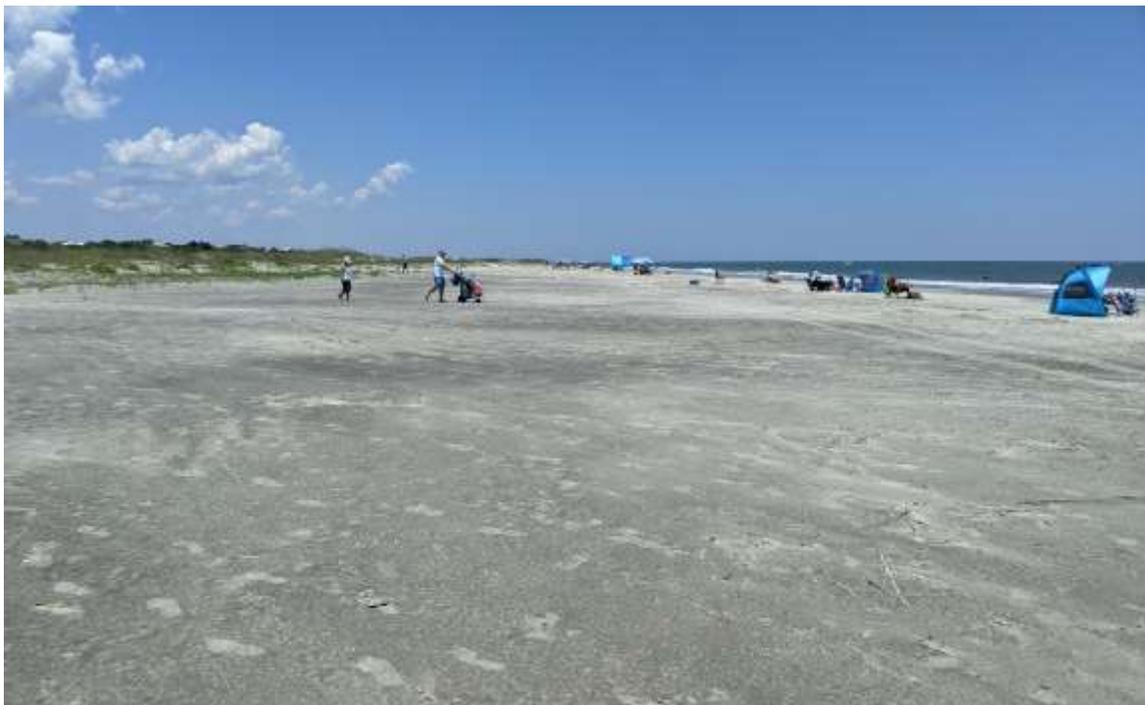
Beach observations confirm that the beach width increased to over 100 ft wide at high tide (Figure 20 and Figure 21). The primary dune was building seaward with new growth and some evidence of overtopping which as suggested previously may be helping to reduce uninhibited seaward growth. According to the 2021 volume calculation, this profile has a unit volume of 425 cy/ft.

Figure 20. Ground photo taken at Monument 3065 looking northeast on June 2, 2020 (top) and June 17, 2021 (bottom). Note the sandbar attachment point in 2020.

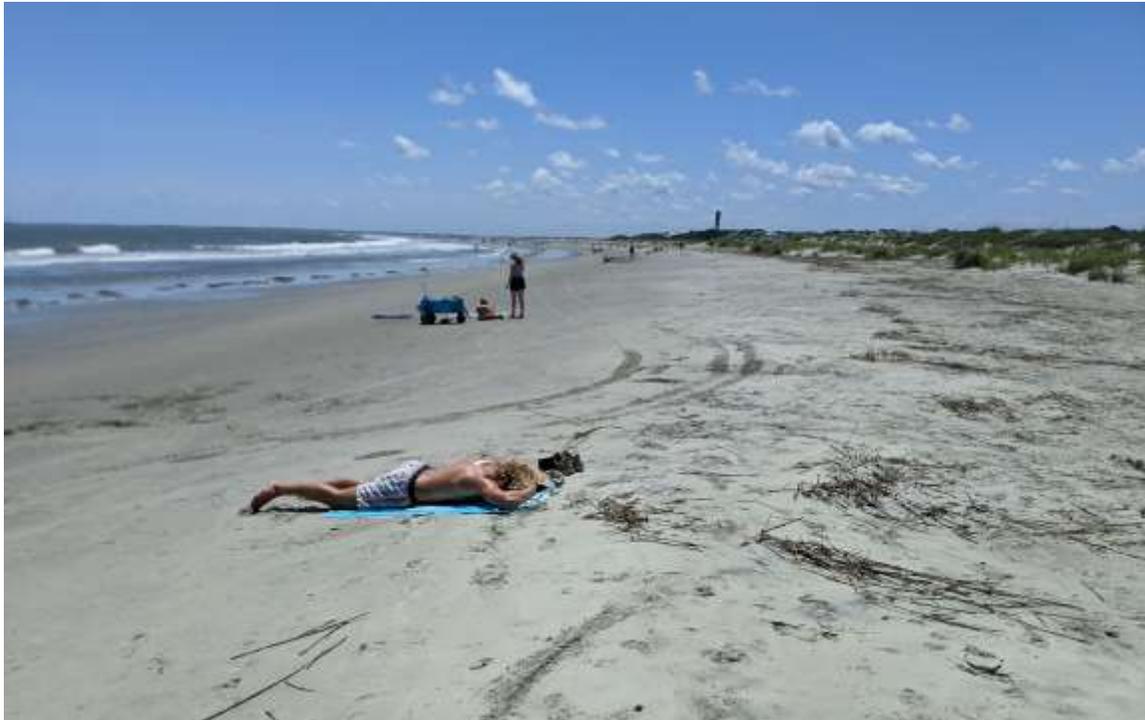
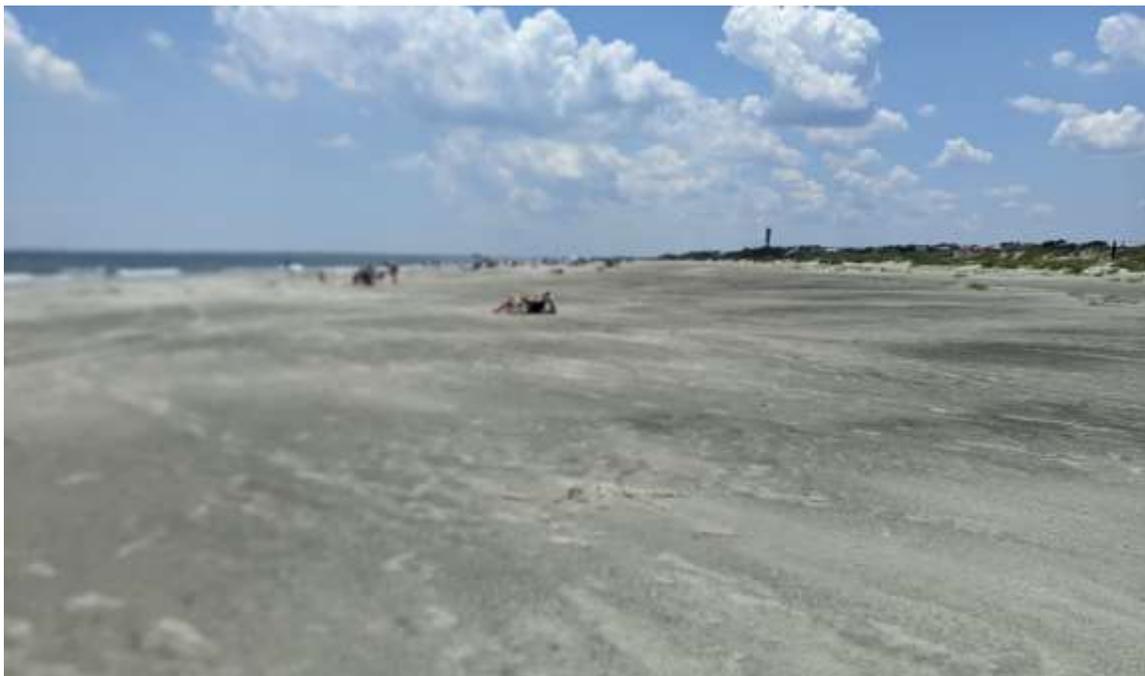
Figure 21. Ground photo taken at Monument 3065 looking southwest on June 2, 2020 (top) and June 17, 2021 (bottom). Note the wide beach in 2021.

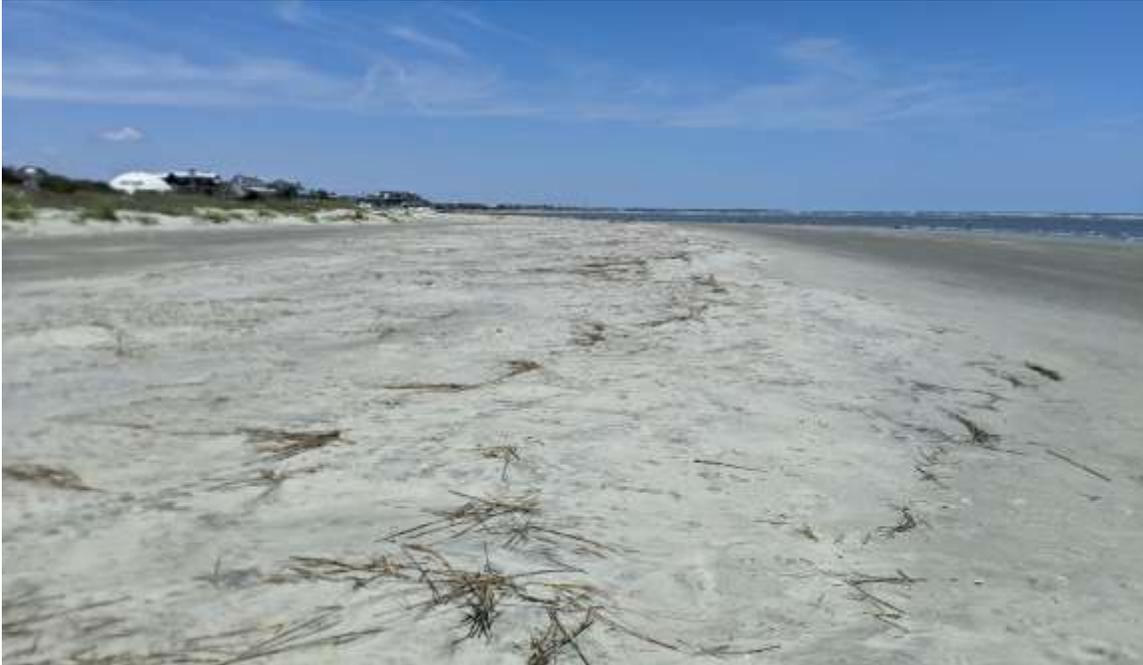
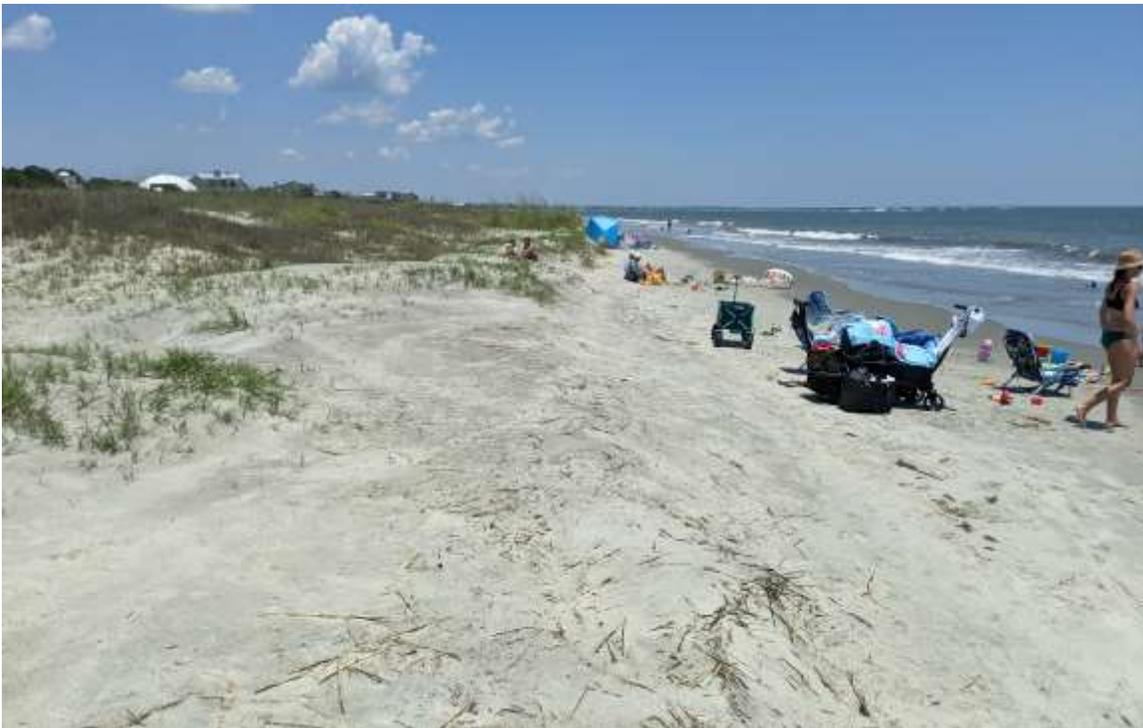
Beach observations confirm that the beach at this location had lost beach width due to sand spreading (Figure 23 and Figure 24). Conditions were erosional with only about 10 feet of dry beach at high tide.

Figure 23. Ground photo taken at Monument 3080 looking northeast on June 2, 2020 (top) and June 17, 2021 (bottom). Note the narrower beach in 2021.

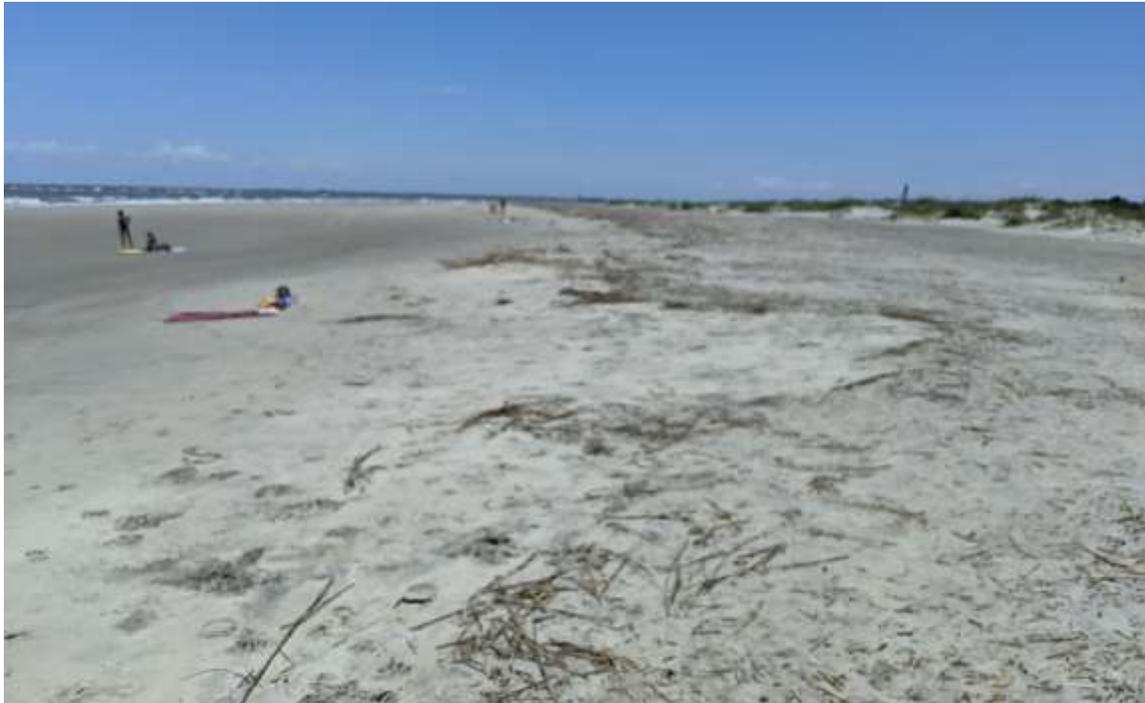
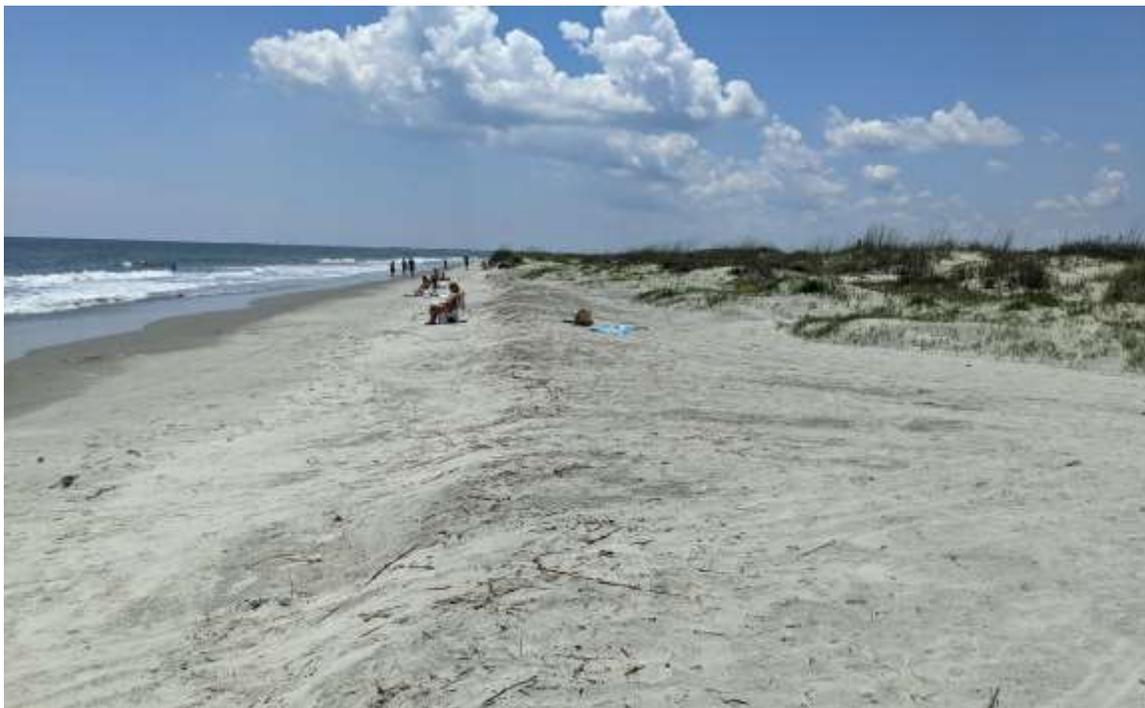
Figure 24. Ground photo taken at Monument 3080 looking southwest on June 2, 2020 (top) and June 17, 2021 (bottom).

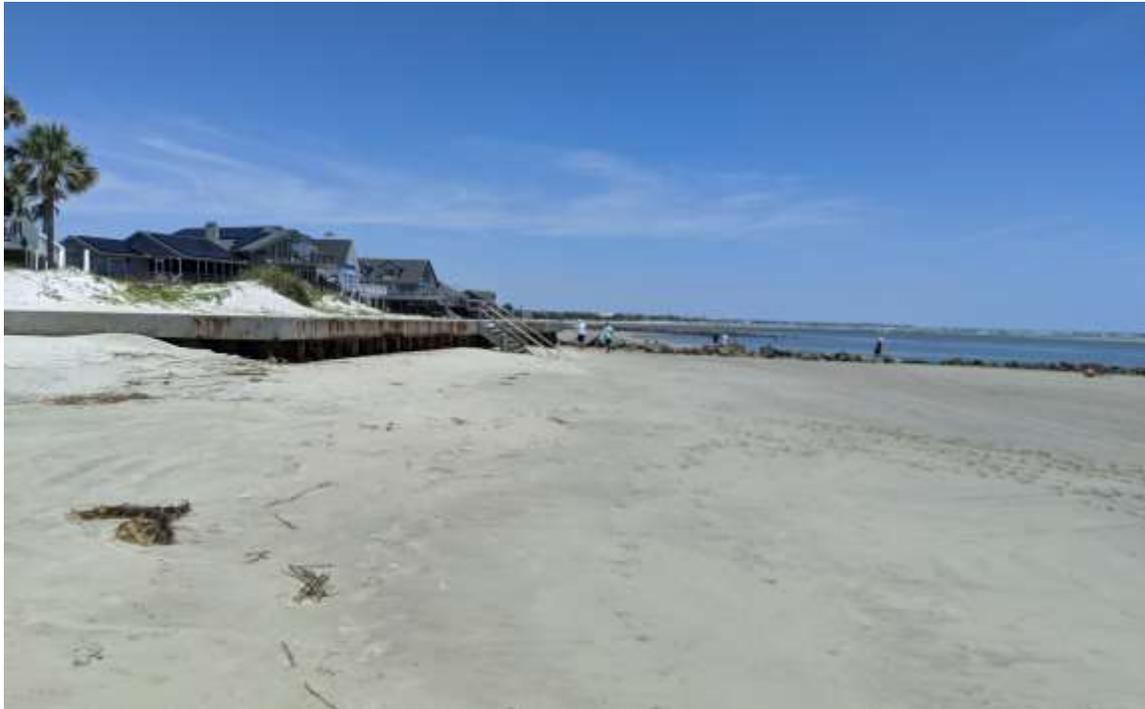
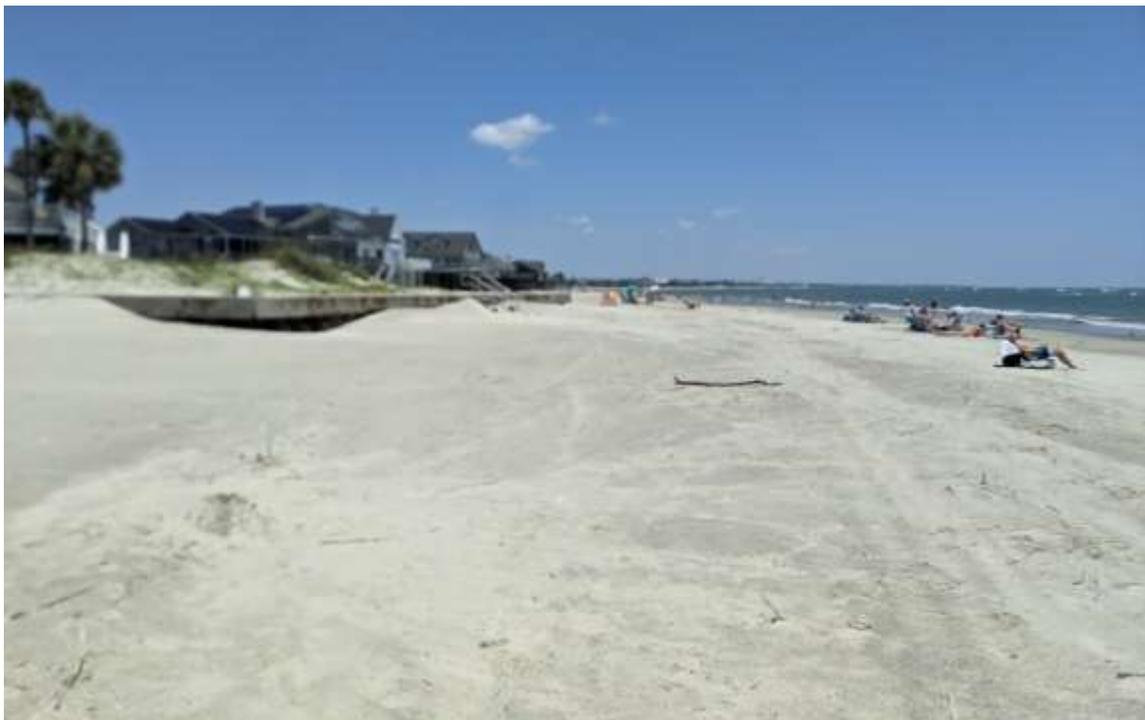
The backbeach accumulated a significant amount of sand covering the previously exposed seawall and sand bags that had been placed and/or exposed at the toe of the dune scarp (Figure 26). Groins and seawalls continue to dominate this portion of the island, but recovery was observed.

Figure 26. Ground photo taken at Monument 3083 looking northwest on June 2, 2020 (top) and June 17, 2021 (bottom). Note the increased beach width in 2021.

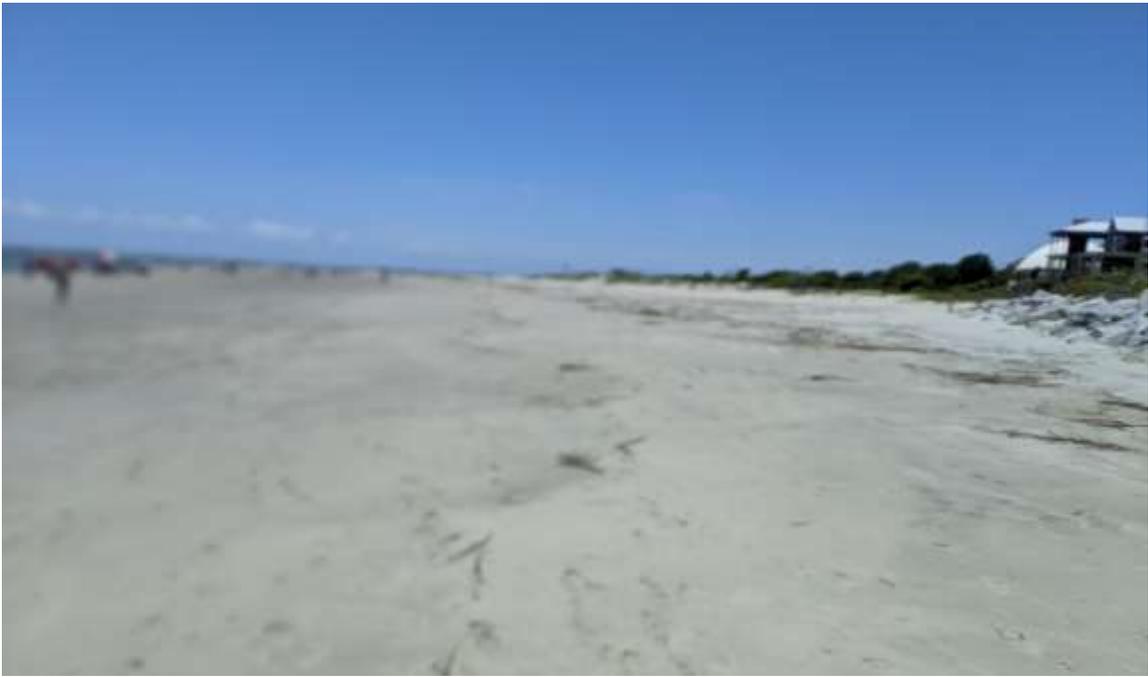
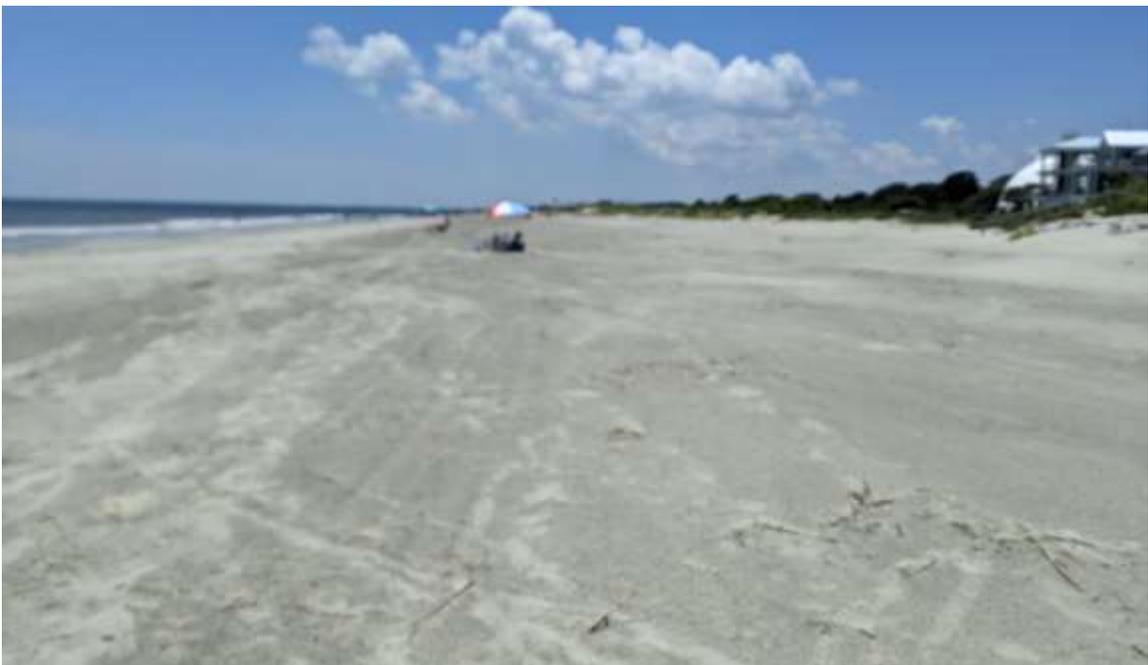
This location marks the transition between the northeast end of the island, which has been stabilized with erosion control structures and the wide, fluctuating beach of the central portion of the island to the southwest (Figure 27).

Figure 27. Ground photo taken at Monument 3083 looking southwest on June 2, 2020 (top) and June 17, 2021 (bottom). Note the exposed sand bags in 2020.
