2021 Beach Monitoring Survey

TOWN OF SULLIVAN'S ISLAND, SC

Elko Coastal Consulting, Inc. | July 2021

2021 Beach Monitoring Survey:
Town of Sullivan's Island, SC

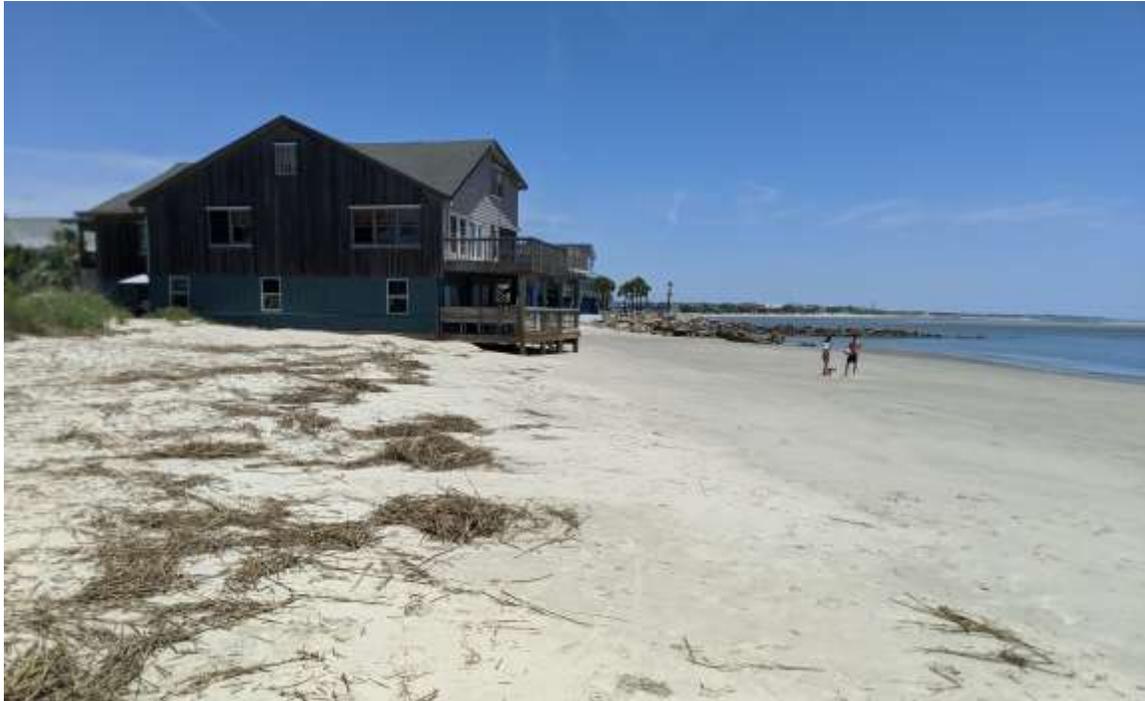
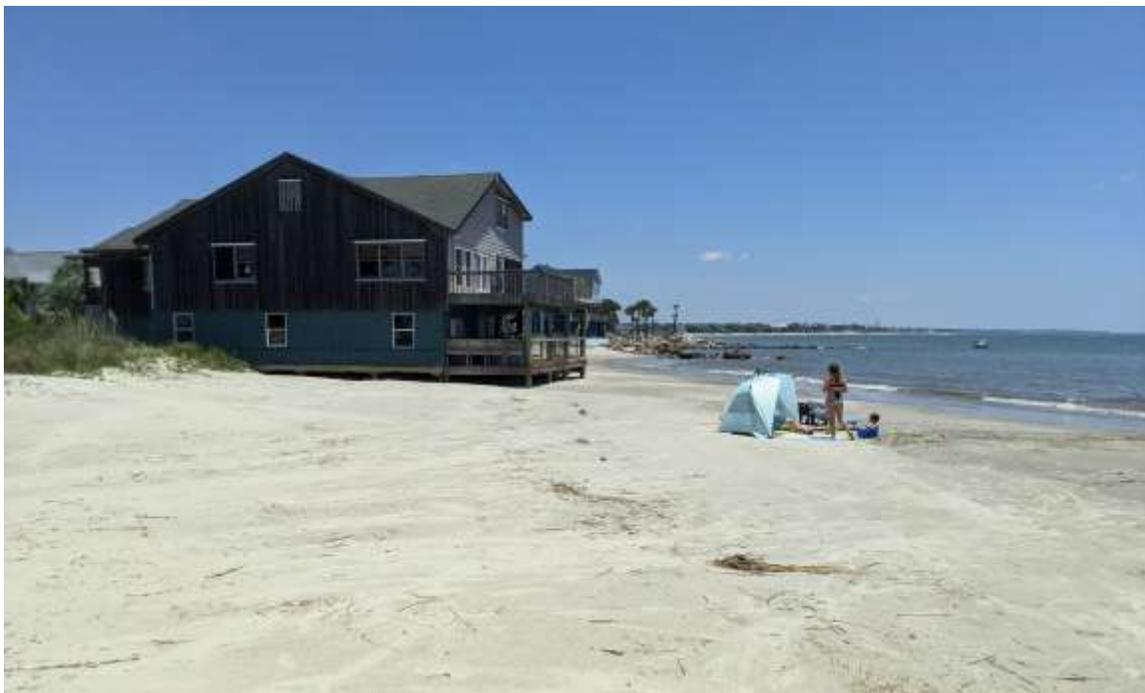
Beach observations indicate some recovery with 40 ft of beach at high tide, as opposed to high water reaching under the decks of the homes in this area in years past. No dune vegetation has developed but sand fencing is helping with some recovery (Figure 29). A historic cannon structure which had been exposed in 2019 was covered with sand in 2021 (Figure 30).

Figure 29. Ground photo taken at Monument 3085 looking northwest on June 2, 2020 (top) and June 17, 2021 (bottom). Notice increased downdrift erosion in 2021.

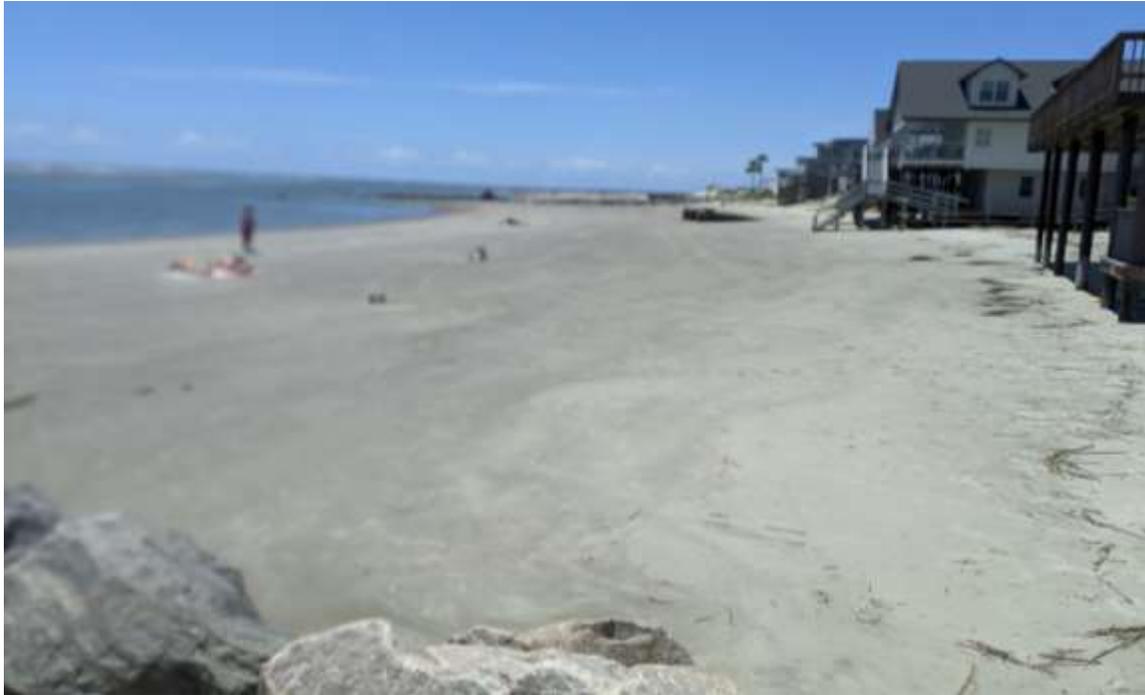
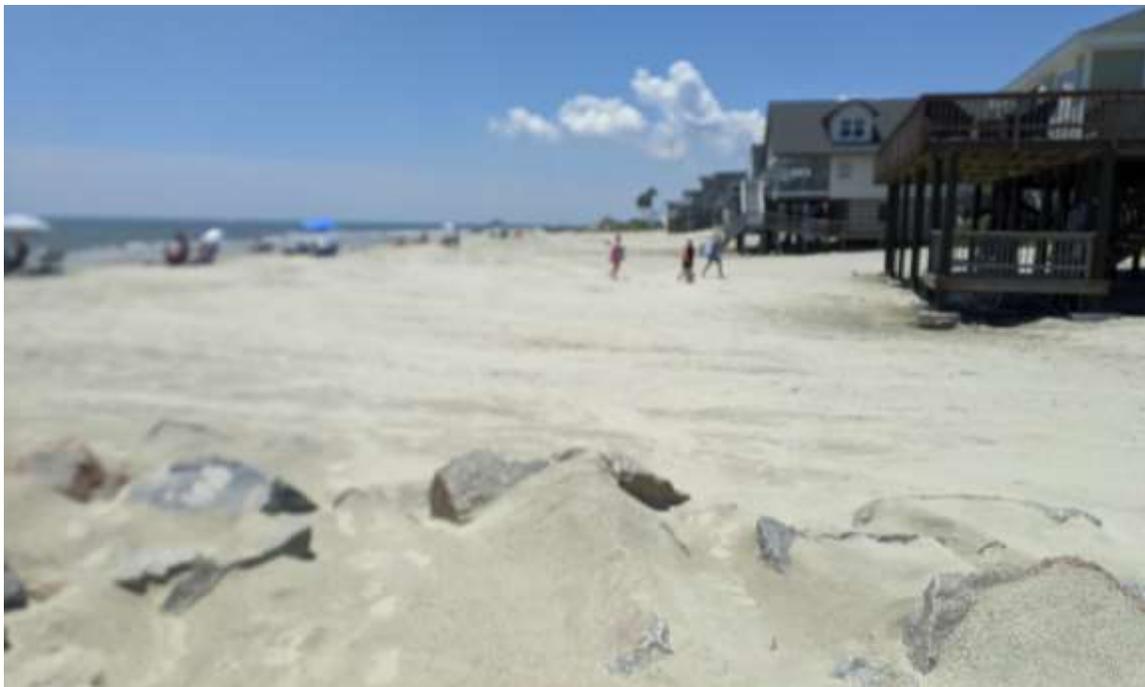
Figure 30. Ground photo taken at Monument 3085 looking southwest on June 2, 2020 (top) and June 17, 2021 (bottom). Note the exposed cannon structure in 2020

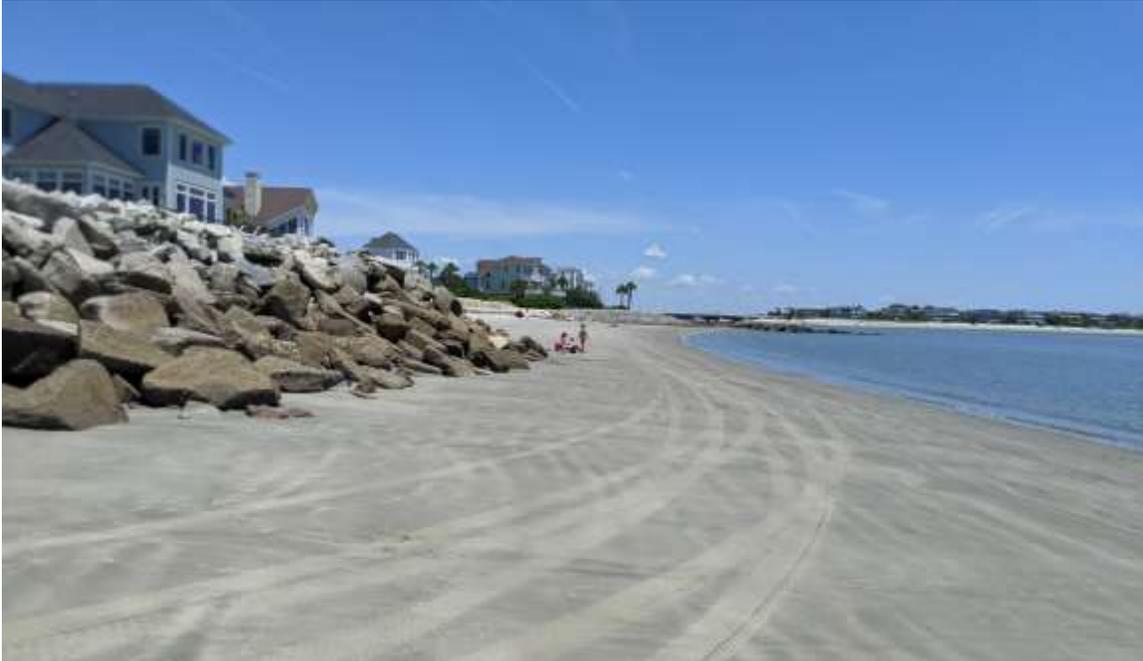
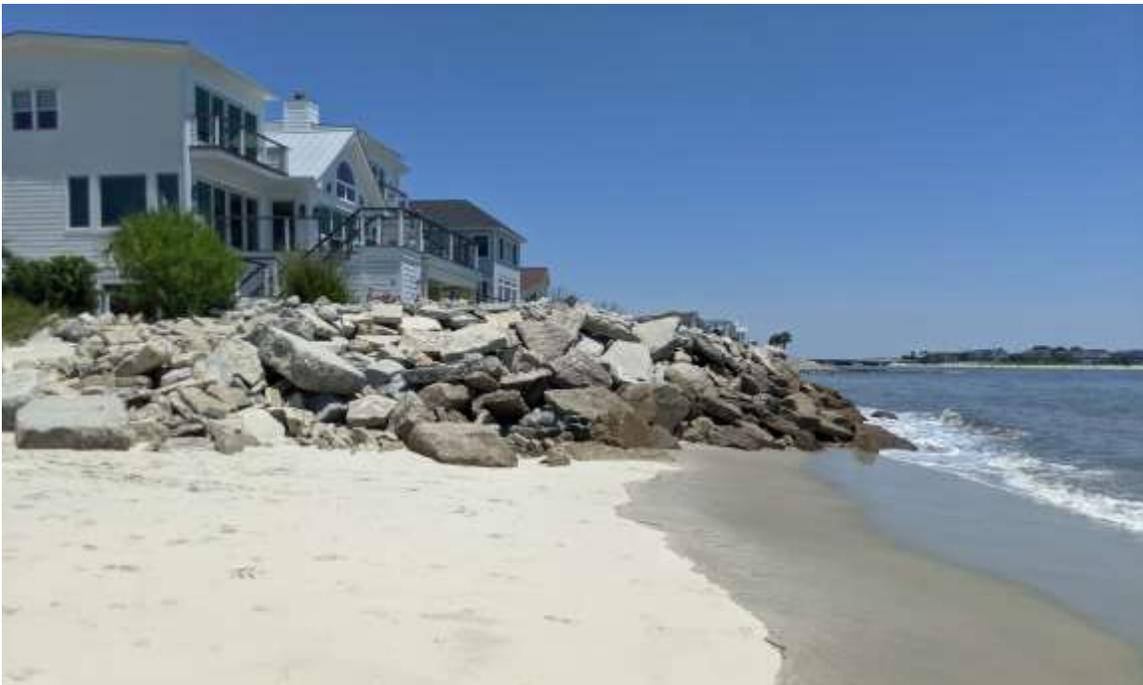
Monument 3090 is located just south of Station 31 on northeastern Sullivan’s Island near Breach Inlet. It represents a small (<250 ft long) pocket beach between two groins. The beach is nearly completely armored. The beach profile has exhibited erosion despite the stabilization structures (Figure 31). No dry beach is exposed at high tide and no dunes are present (Figure 32 and Figure 33).

Beach observations in 2021 confirm these measurements. While some dry sand was present between the road and access path, at the time of the observations there was no dry beach in front of the seawalls.

Figure 32. Ground photo taken at Monument 3090 looking north on June 2, 2020 (top) and June 17, 2021 (bottom). Note increased erosion in 2021.

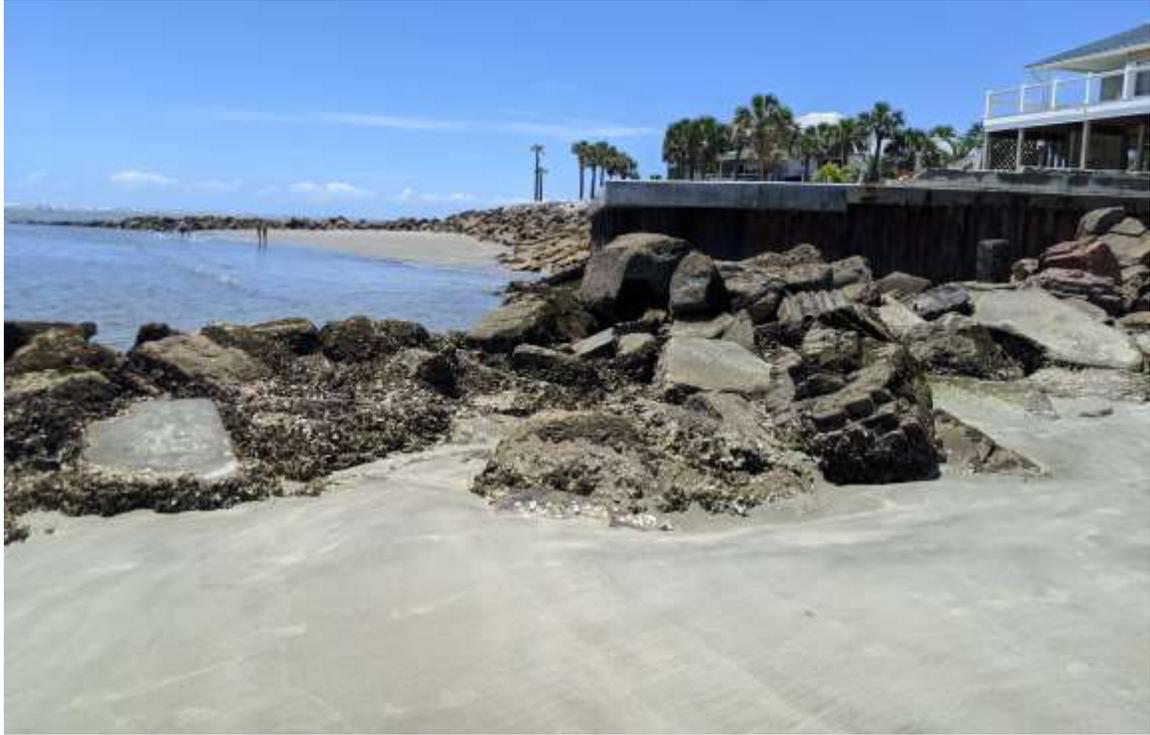
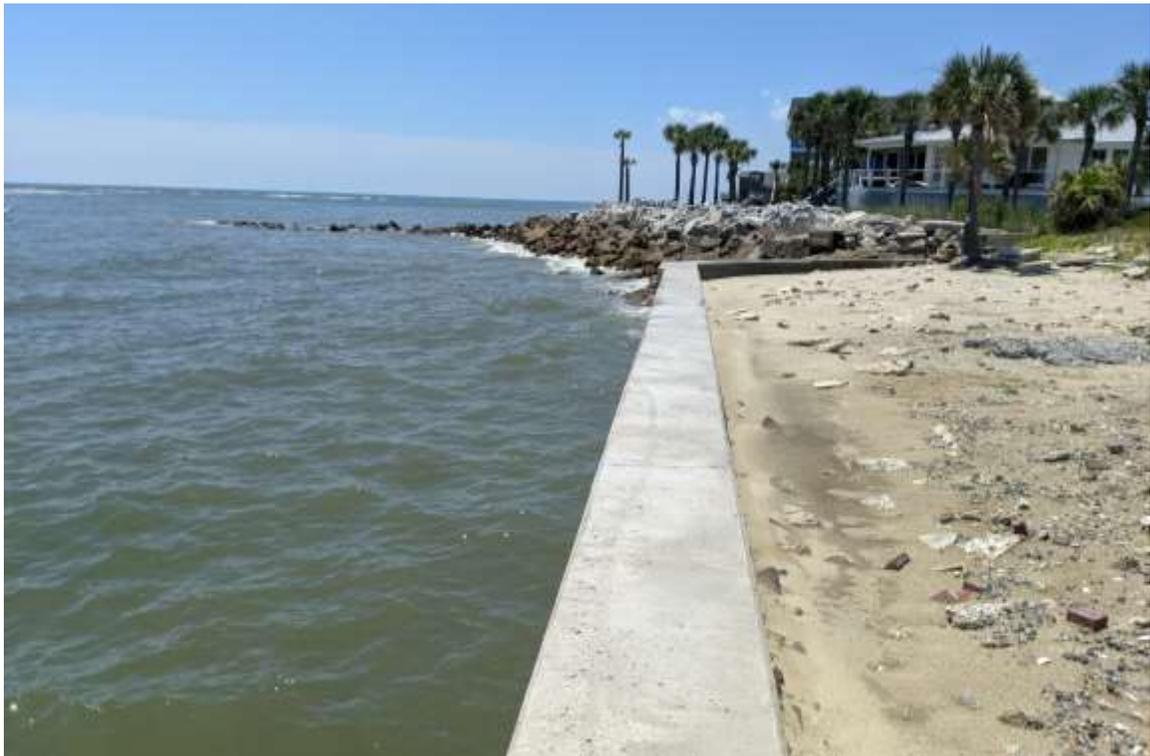
Figure 33. Ground photo taken at Monument 3090 looking southwest on June 2, 2020 (top) and June 17, 2021 (bottom). Note the total lack of dry beach in 2021.

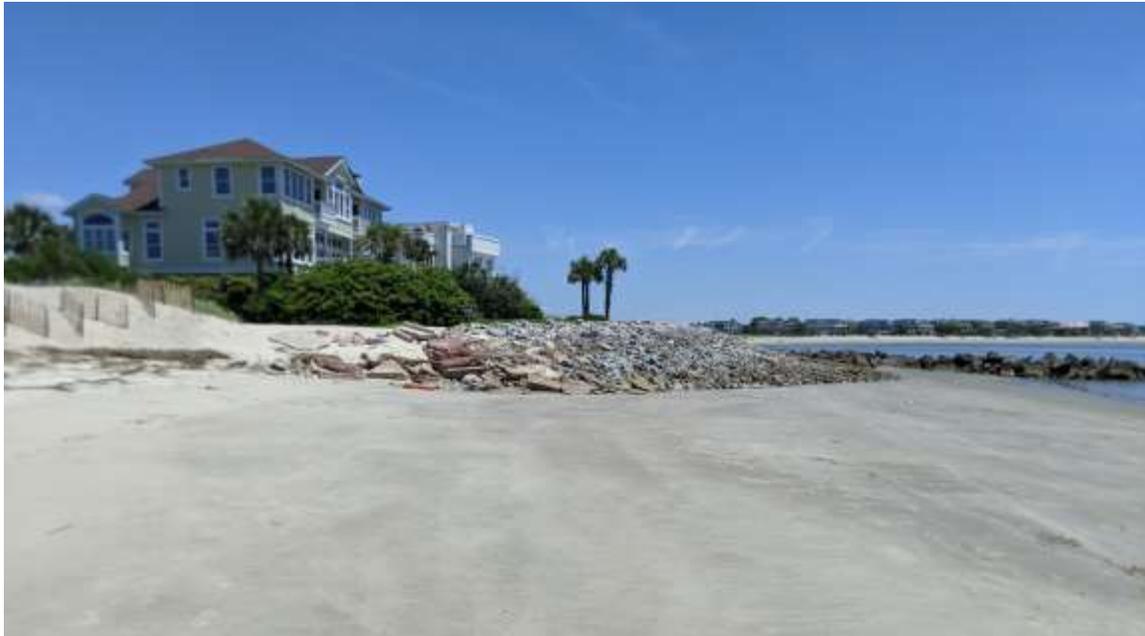
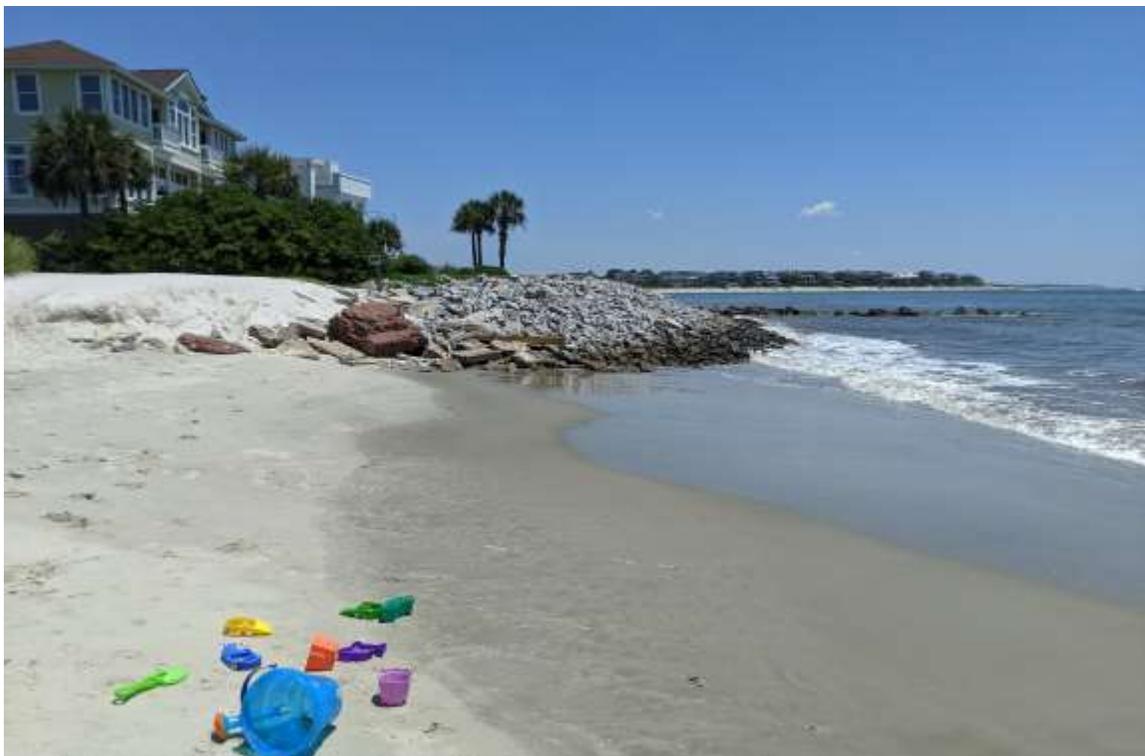
Figure 35. Ground photo taken at Monument 3092 looking north on June 2, 2020 (top) and June 17, 2021 (bottom).

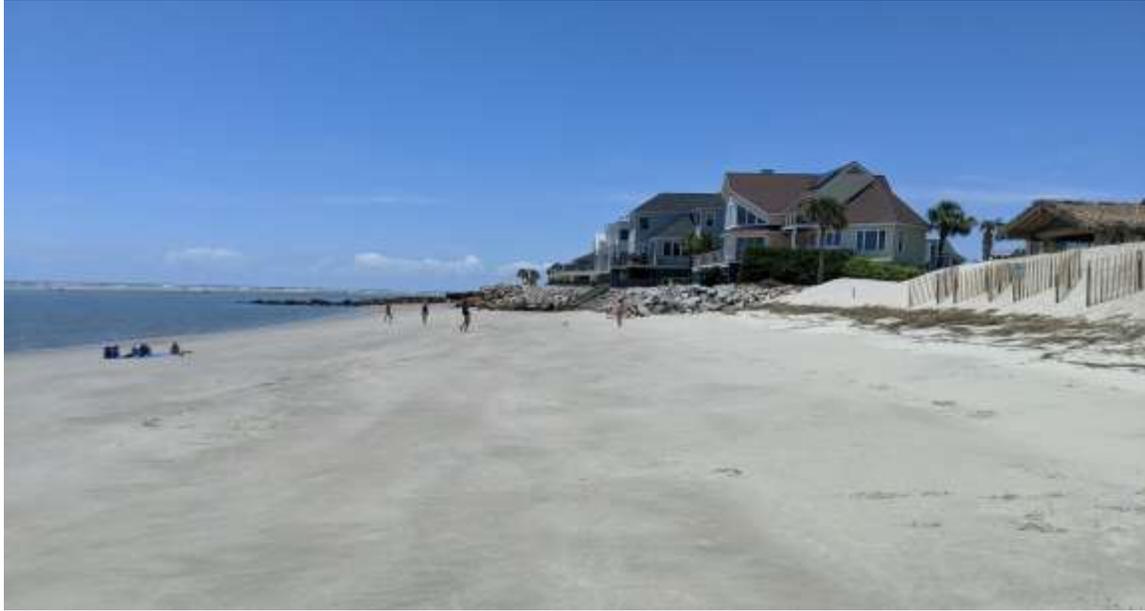
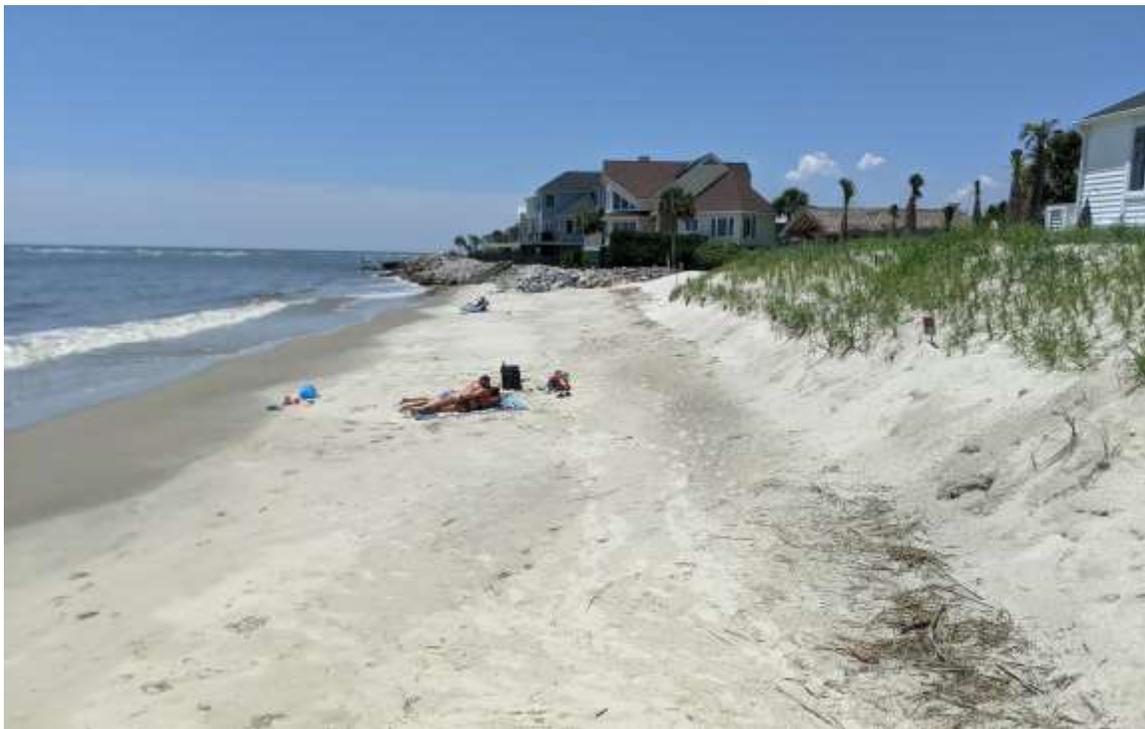
Figure 36. Ground photo taken at Monument 3092 looking south on June 2, 2020 (top) and June 17, 2021 (bottom). Note the dune vegetation in 2021.

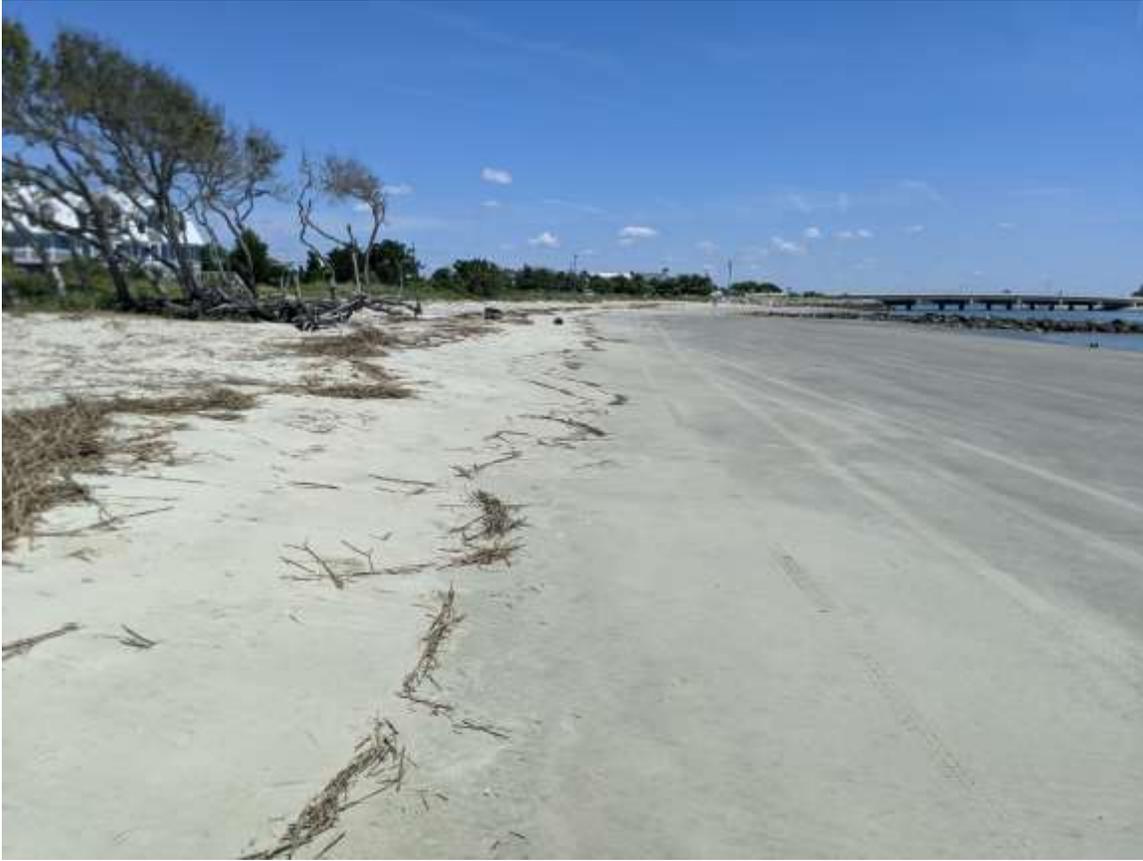
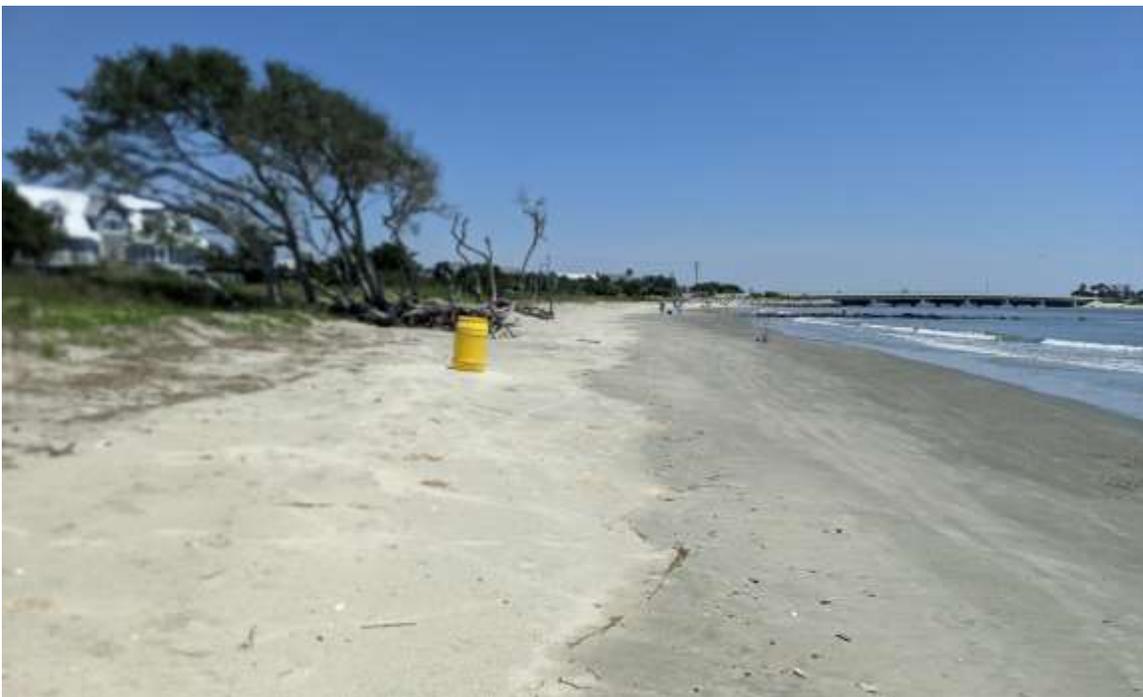
The June 2021 beach observations indicate nearly identical conditions as 2020. Spring high tides were reaching the toe of vegetation and about 10 ft of dry beach existed at high tide (Figure 38 and Figure 39).

Figure 38. Ground photo taken at Monument 3095 looking north on June 2, 2020 (top) and June 17, 2021 (bottom).

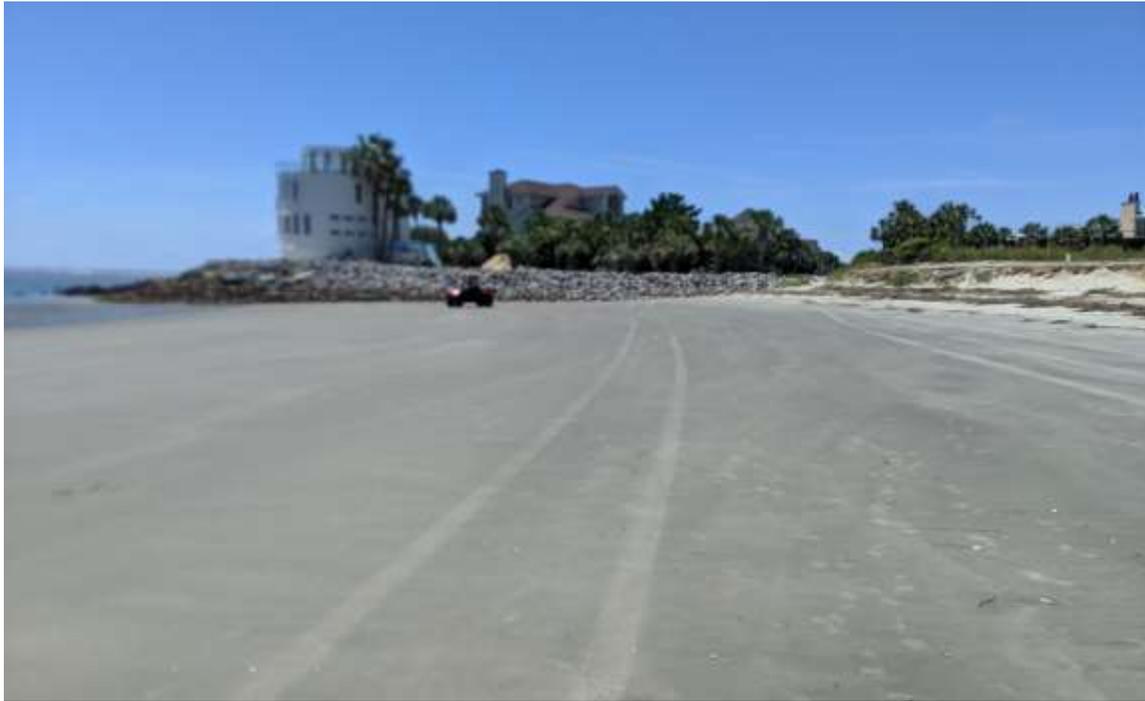
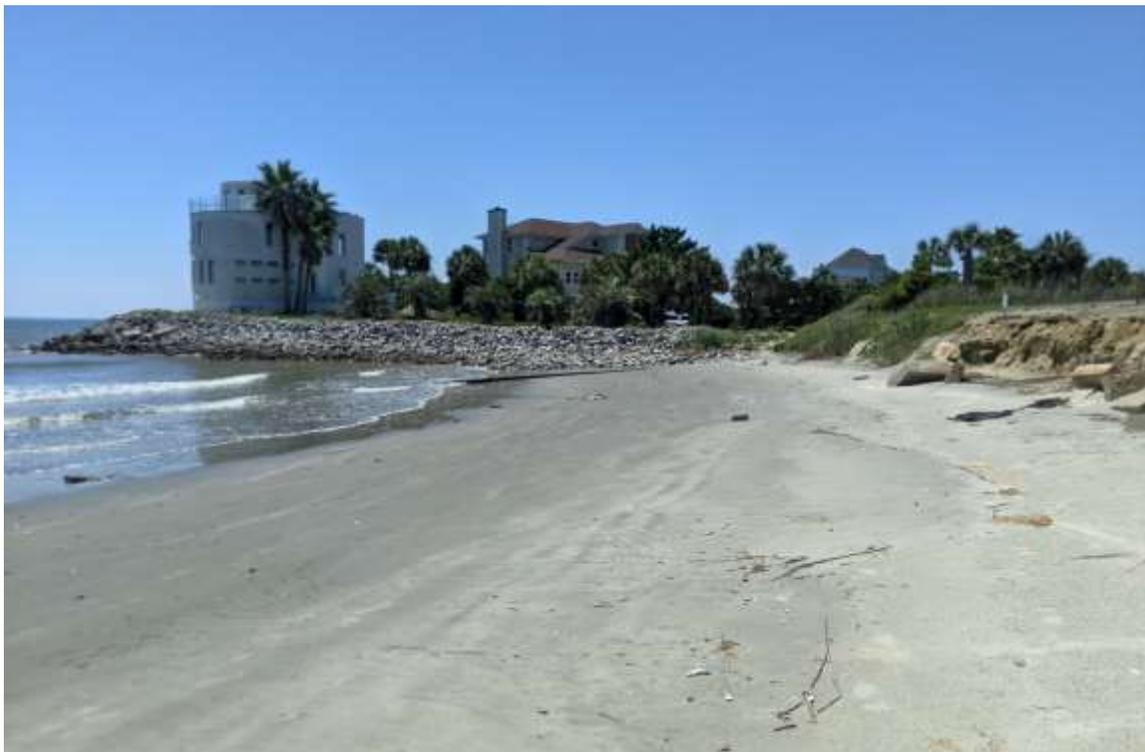
Figure 39. Ground photo taken at Monument 3095 looking south on June 2, 2020 (top) and June 17, 2021 (bottom). Note continued erosion of the clay bluff in 2021.
