South Carolina Inventory of Historic Places
 Survey Field Form/Data Entry Form
 State Historic Preservation Office
 PO Box 11,669, Columbia, SC 29211
 (803) 734-8577

2. HISTORIC NAME(S): Spirit of '76
 3. OTHER NAME: _____
 4. ADDRESS/LOCATION: 2314 Middle St.

HURRICANE HUGO DAMAGE ASSESSMENT INVENTORY
 ADDRESS: 2314 Middle Street

NAME: "Spirit of '76"

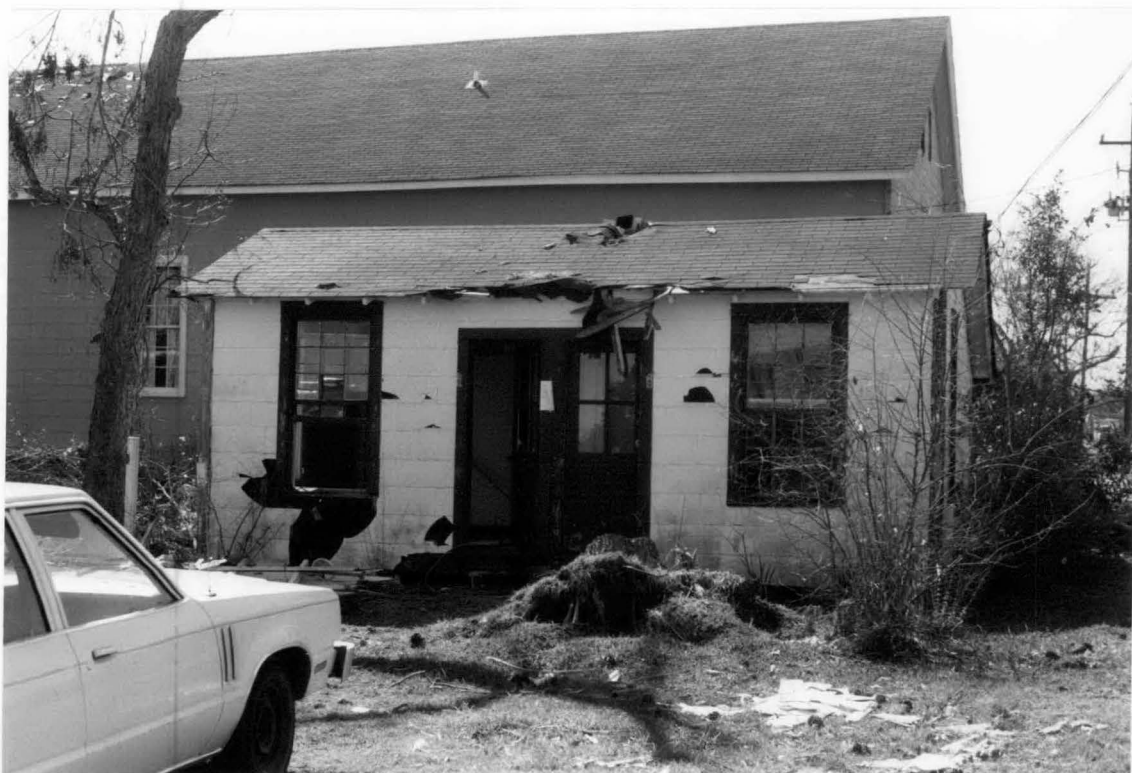
Photo: S7 : 20

FACADE	RIGHT	LEFT	REAR	
A) Structural Damage					* NAD
B) Foundation					* NAD
C) Principal Roof	5%	NAD	NAD	NAD	* Two layers of shingle visible
D) Porch Roof					* NAD
E) Dormers					* NA
F) Chimneys					* NAD
G) Exterior Siding					* screen 100%
H) Porch Trim	*	NA	NA	NA	* panes and sashes are gone
I) Windows	NAD	NAD	10%	20%	* Large hole indicates former location of chimney. Some siding gone.
J) Detail/Trim Work					
K) Other

M) Outbuildings: Chimney to the outbuilding has collapsed on the roof.

Large hole indicates former location of chimney. Some siding gone.

Severe
 Moderate X
 Slight
 None Noted
 Other

- Town permit(12/27/89) rewire
- Town permit(11/16/89) replace siding
- Town Permit(12/1/89)heat pump
- Town Permit(11/30/89)renovation - interior repairs.
