WELCOME TO 2415 MIDDLE

**2415 Middle Street
Sullivan's Island, SC**

The following report concerns an investigation conducted by Glen Heagerty, PE, LLC regarding the structural condition of the above grade foundation elements, floor framing, wall framing, ceiling framing and roof framing for the residential structure @ 2415 Middle St.

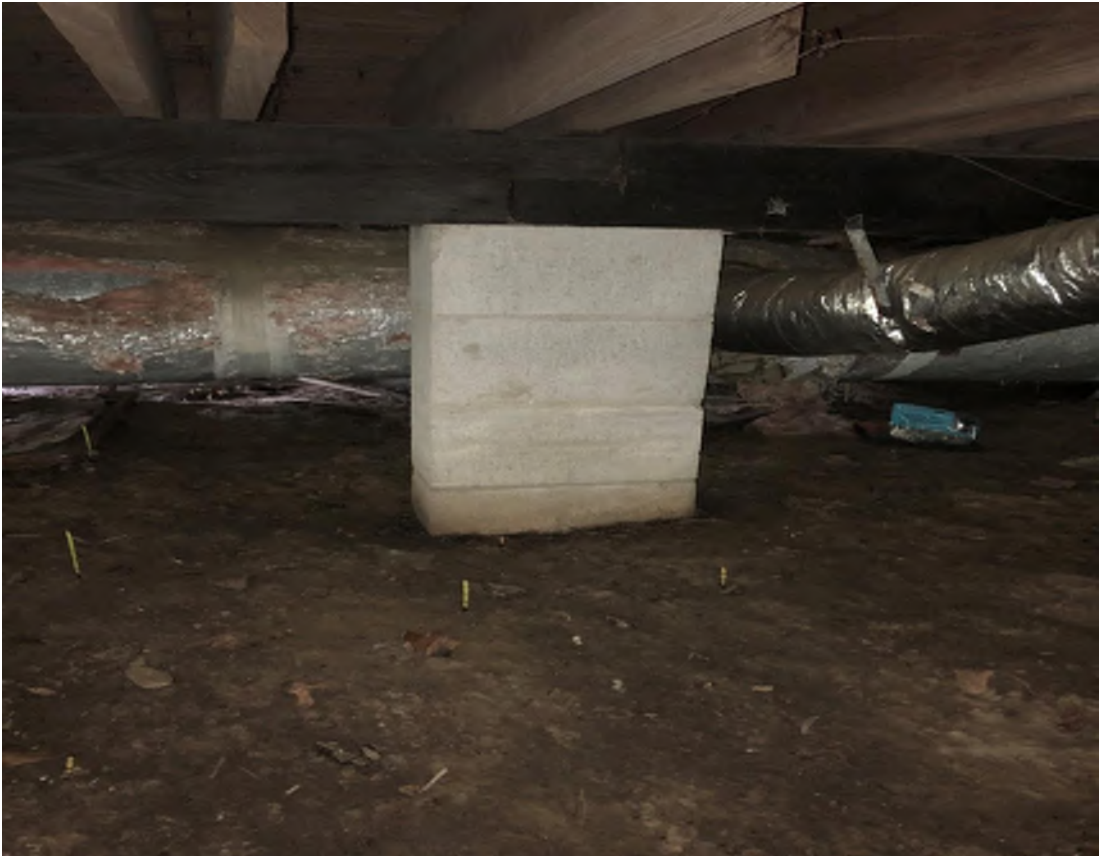
Fig. 1-8 & Fig. 1-9 shows an image of a heavy timber floor girder in good condition. Floor joists are shown in Fig. 1-10, which appear to be in good condition. Moving on to the interior of the house, the first floor floors are sloping, as shown in Fig. 1-11. The slope is due to uneven pier heights and soil settlement. The walls on the right hand side of the kitchen are leaning outwardly as shown in Fig. 1-12. The right hand exterior wall of Fig. 1-13 shows a lean/ bowing outwardly of roughly 5 degrees. Fig. 1-14 shows the 1st floor ceiling sloping from left to right in the picture. The 2nd floor has sloping floors throughout, as shown in Fig. 1-15. The uneven foundation and the right hand wall bowing outwardly is causing the 2nd floor to slope.

Fig. 1-9. Timber girder appears to be in good condition.

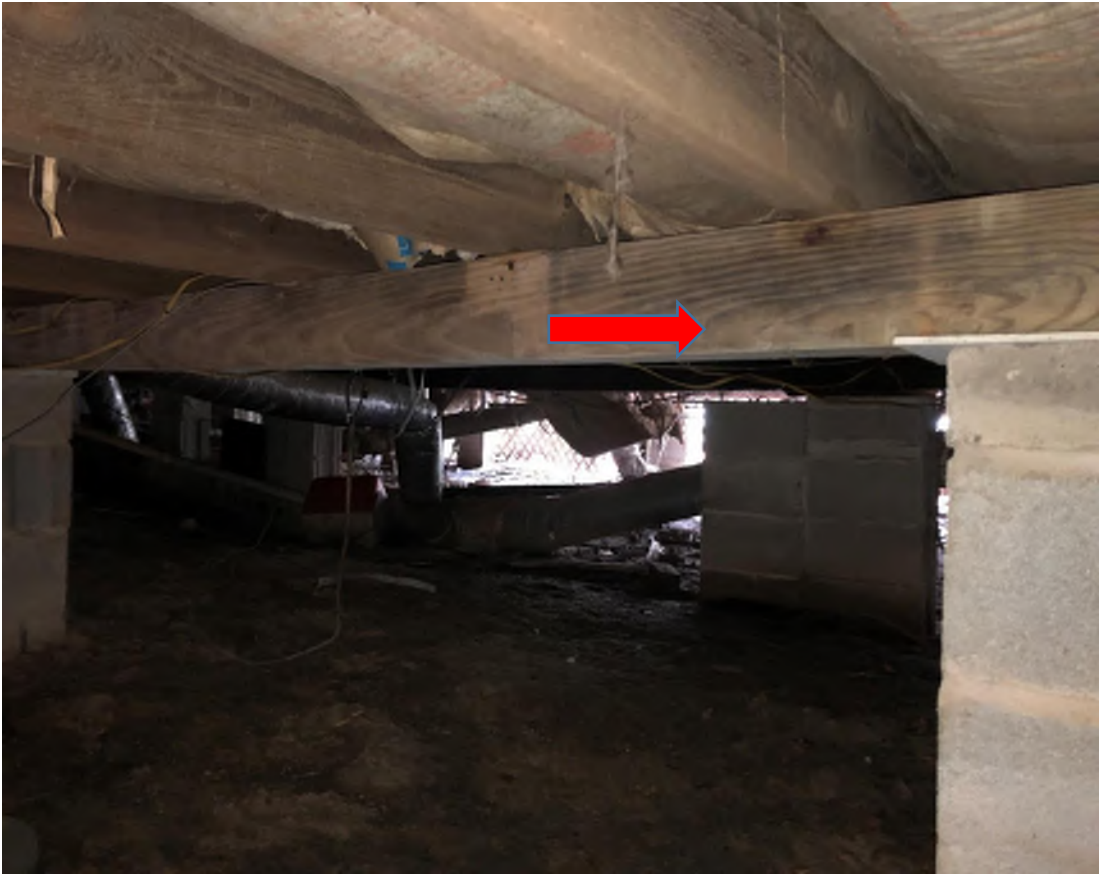
Fig. 1-10. Floor joists appear to be in good condition.

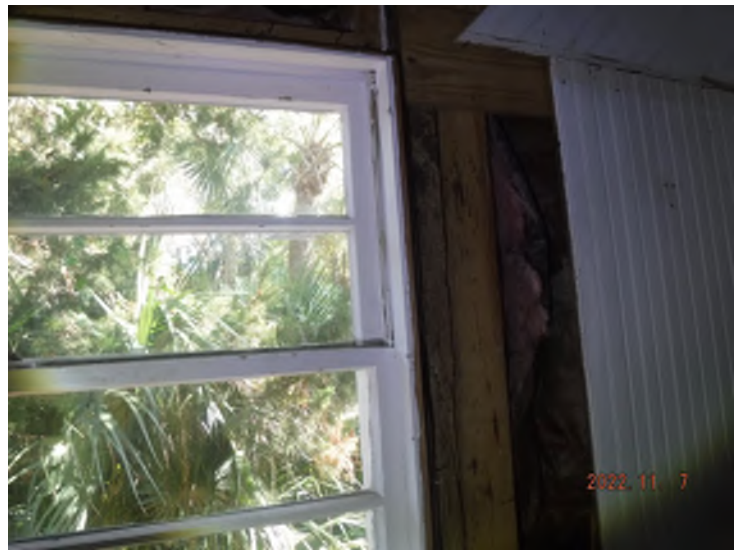
Evidence of previous subterranean termite activity and damage.

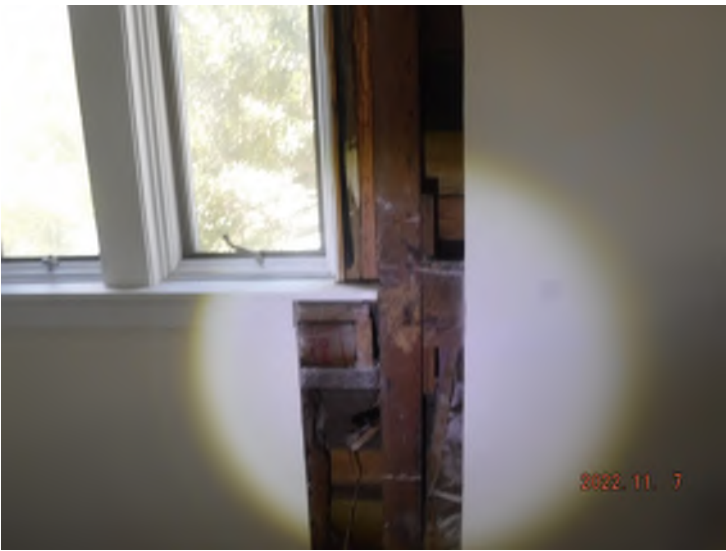
Evidence of previous subterranean termite activity and damage.

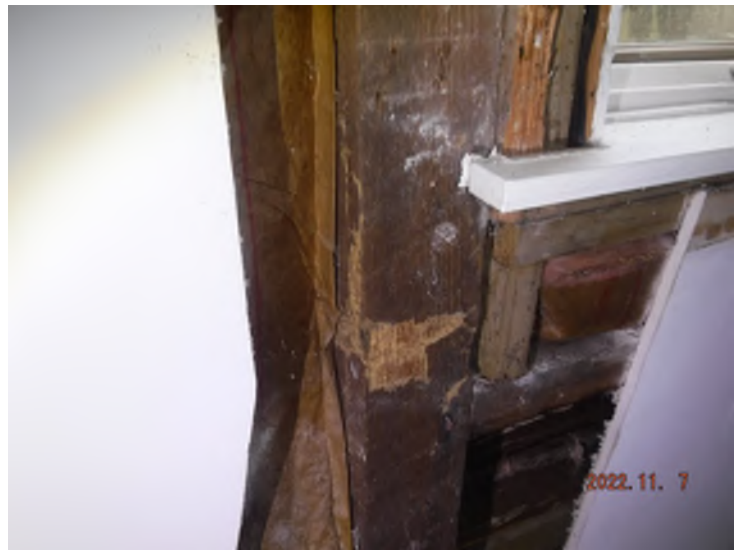
Evidence of previous subterranean termite activity and damage.

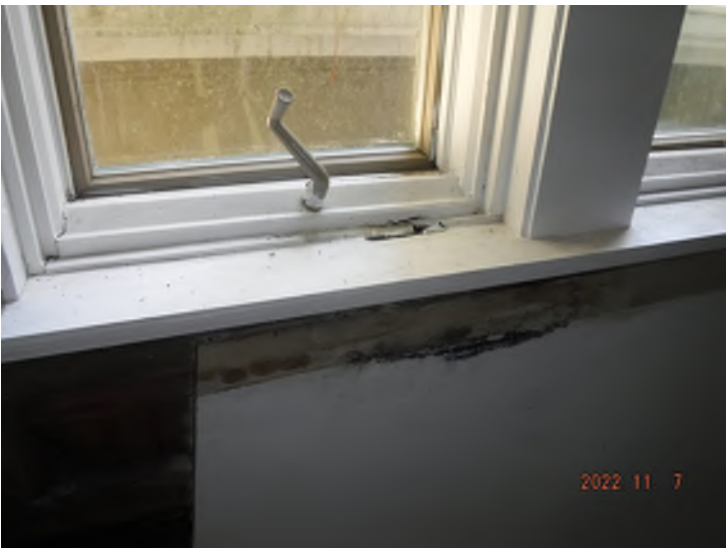
Rot/moisture damage to window.

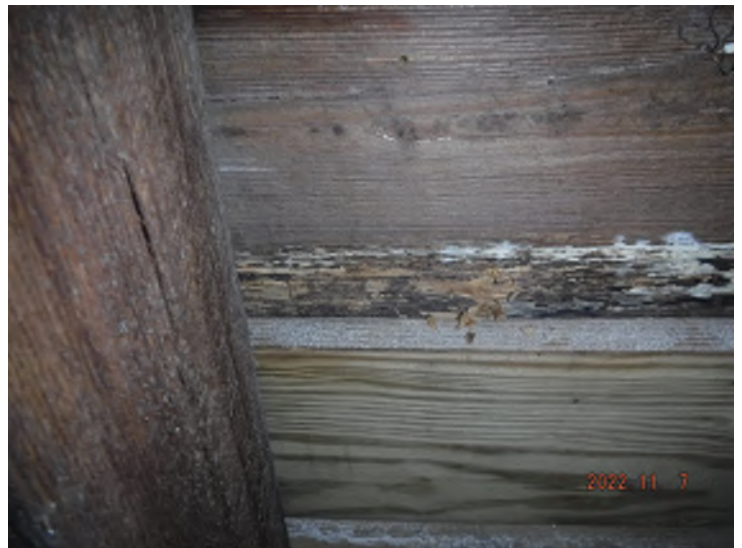
Rot/moisture damage to siding.

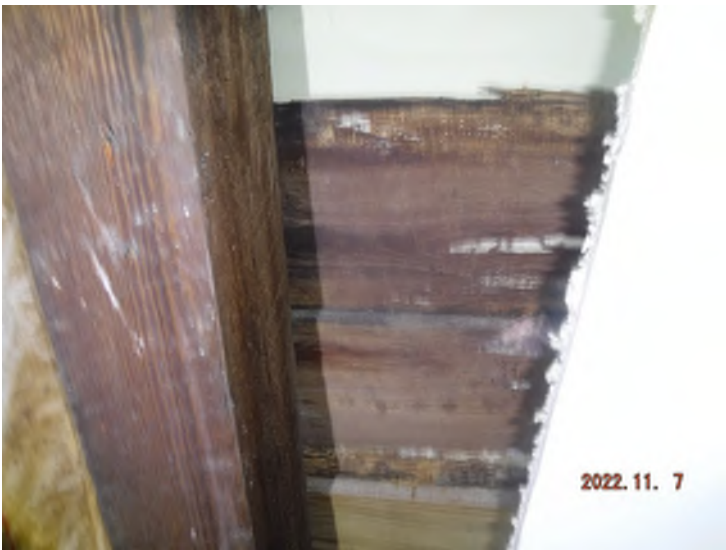
Rot/moisture damage to siding.

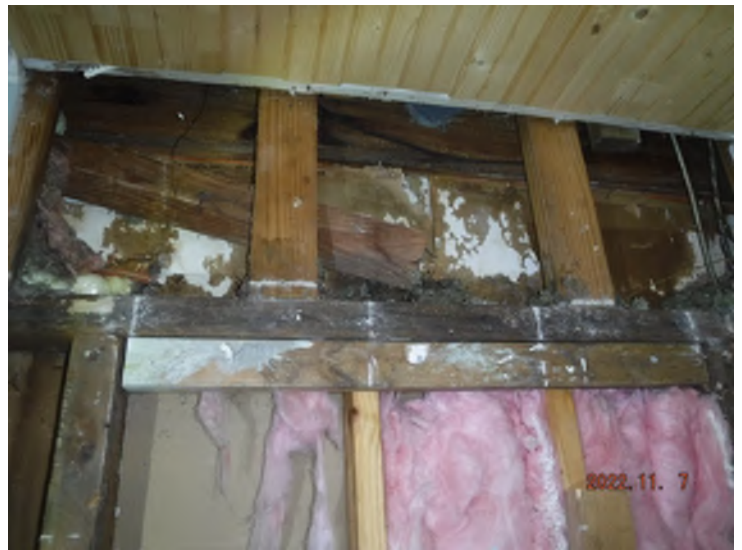
Rot/moisture damage.

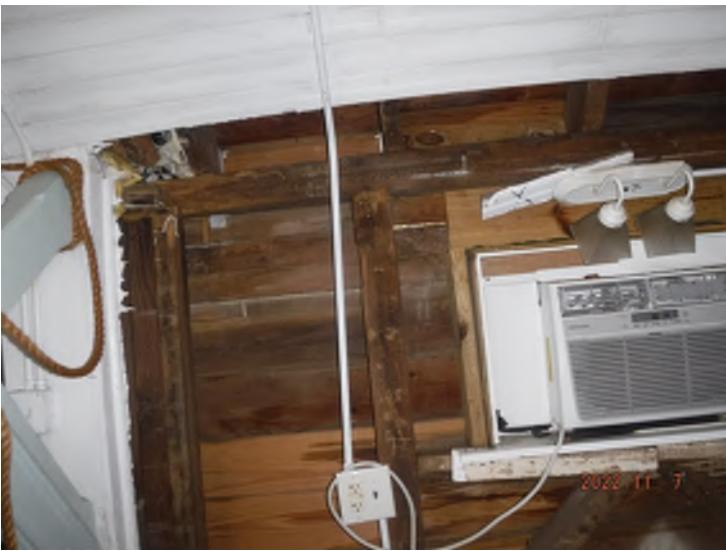
Evidence of previous subterranean termite activity and damage.

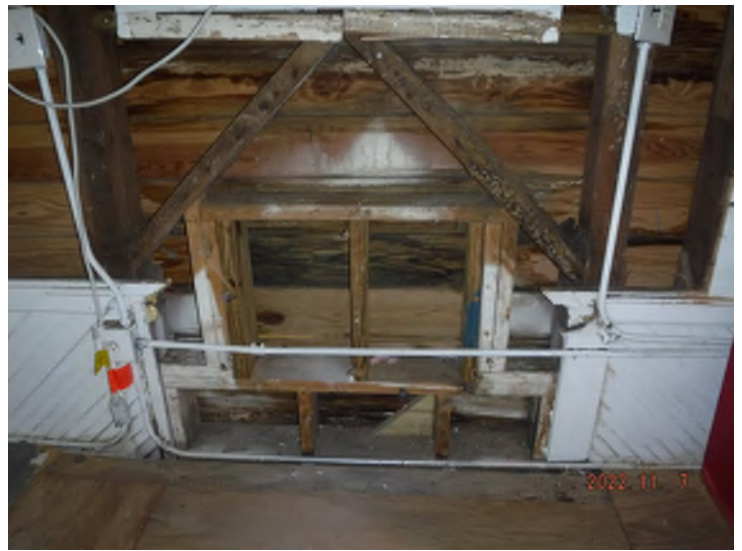
Rot/moisture damage.

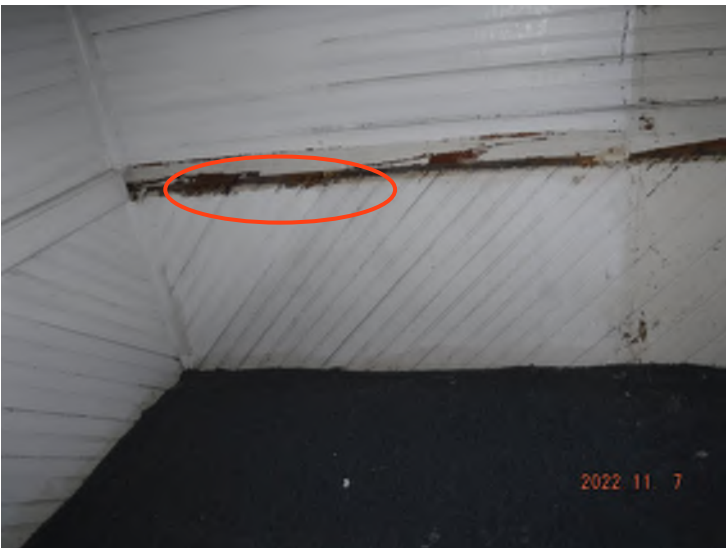
Evidence of previous subterranean termite activity and damage.

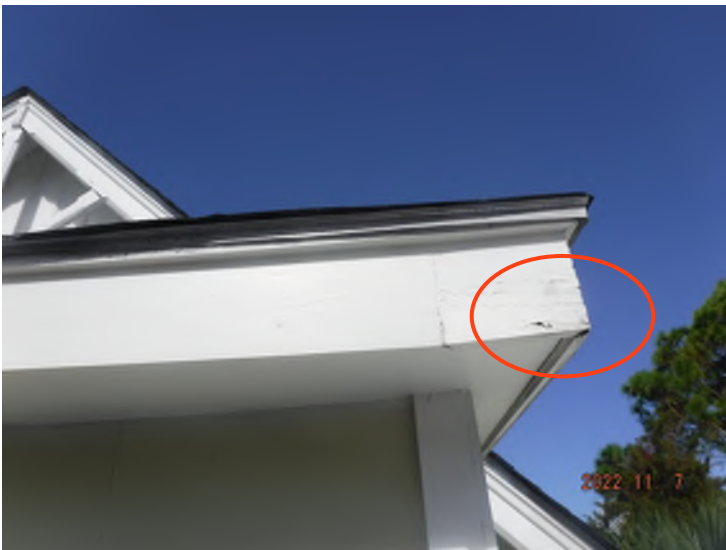
Rot/moisture damage to fascia.

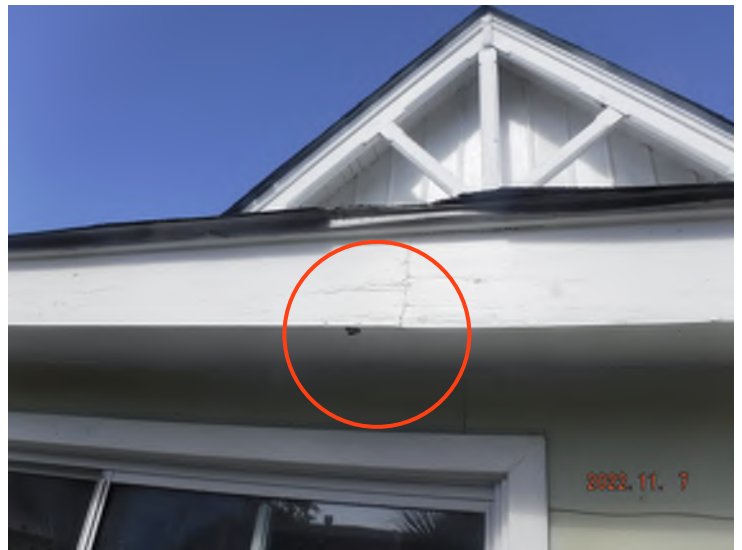
Rot/moisture damage to fascia.

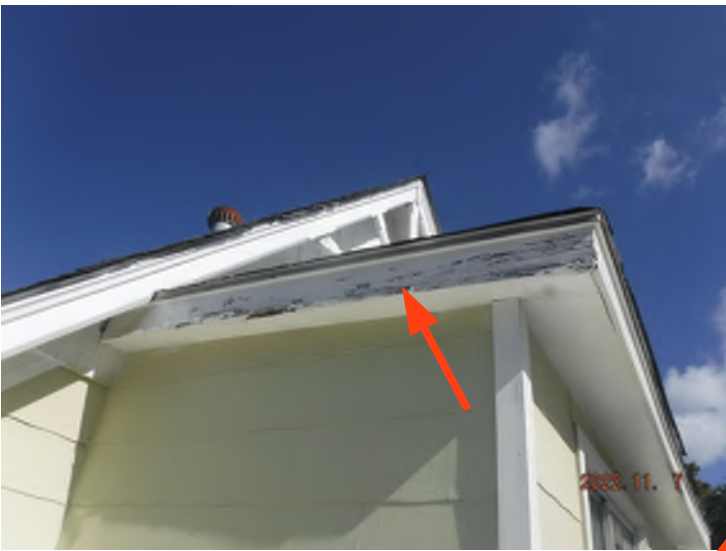
Rot/moisture damage to fascia.

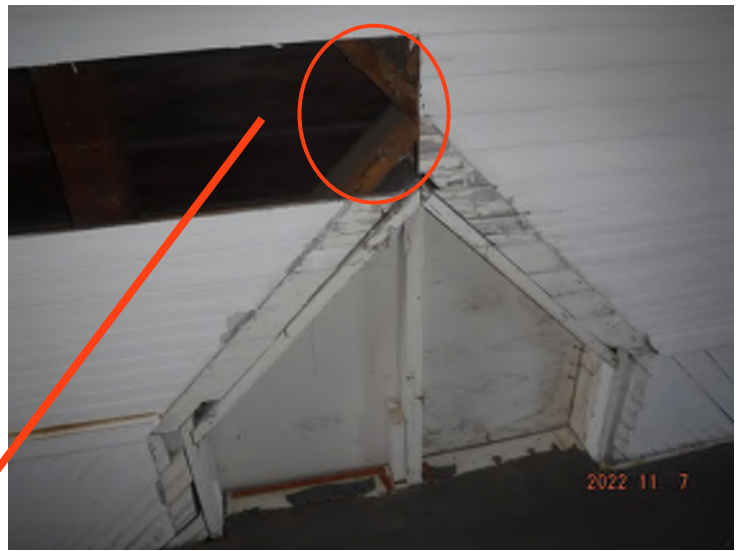
Evidence of previous subterranean termite activity and damage.

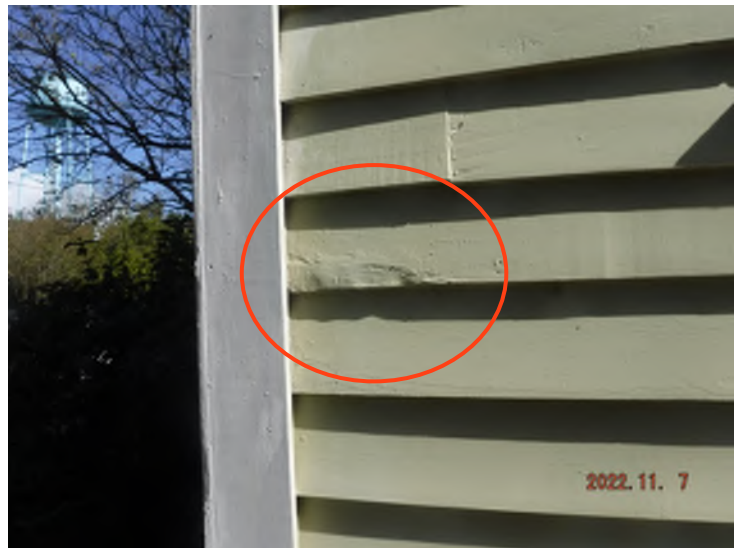
Rot/moisture damage to siding.

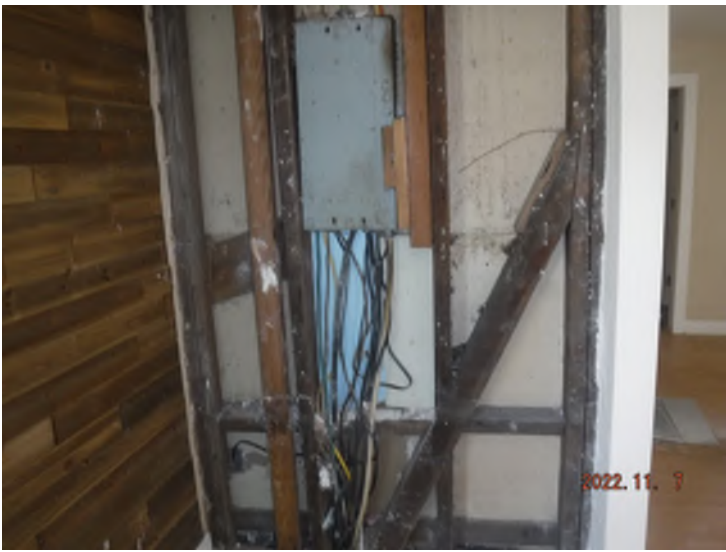
Rot/moisture damage.

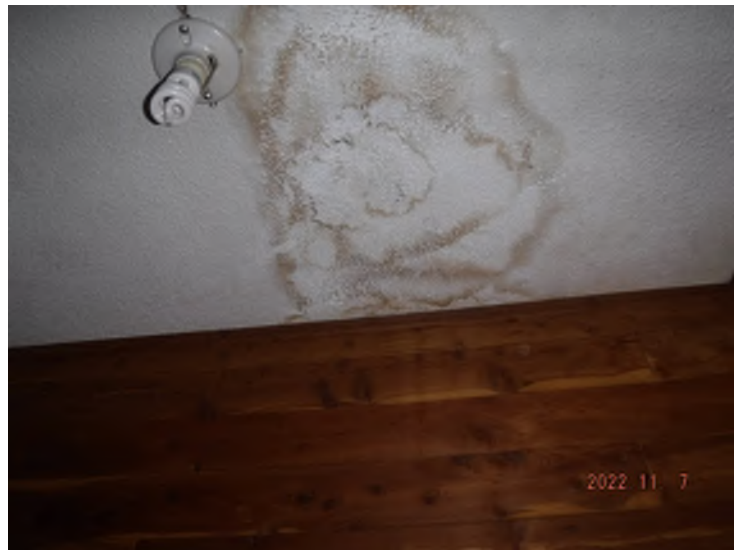
Moisture stains on ceiling

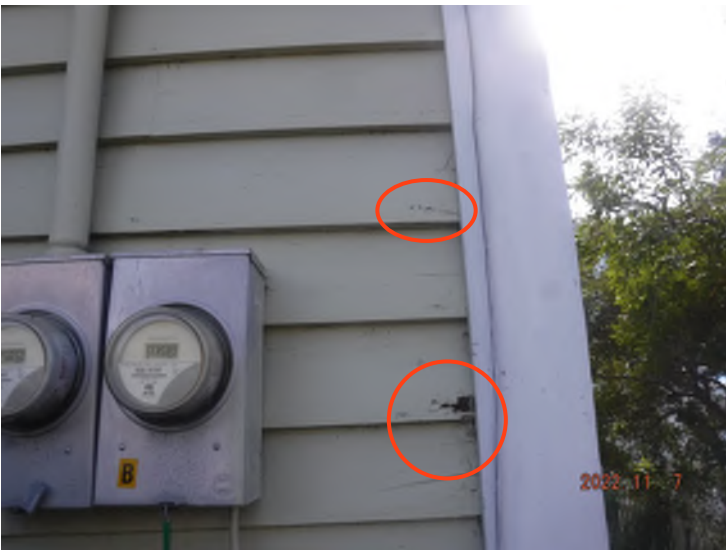
Rot/moisture damage and previous subterranean termite activity damage to siding.

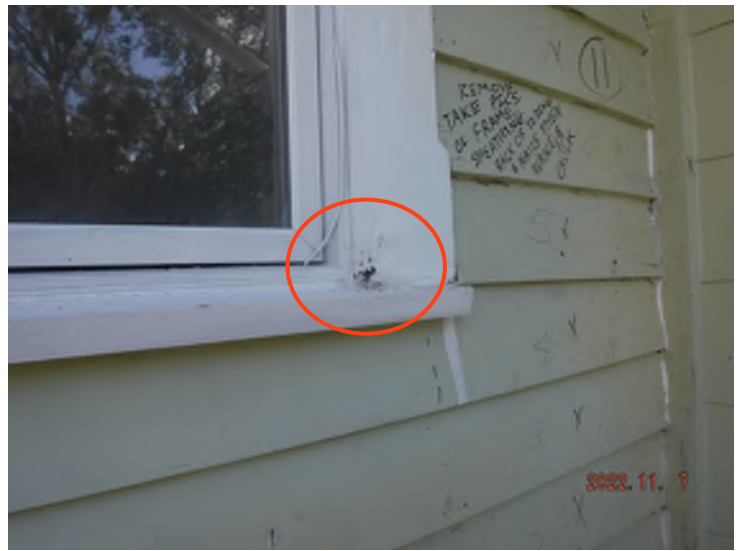
Rot/moisture damage to window trim.

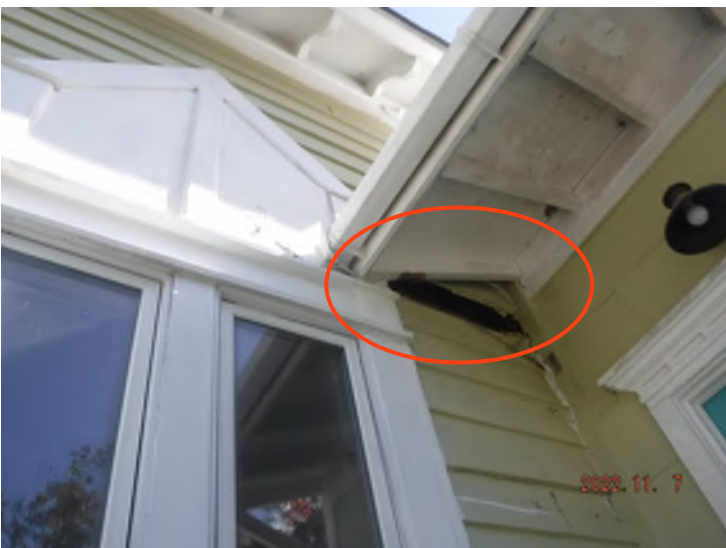
It appears to be rot/moisture damage

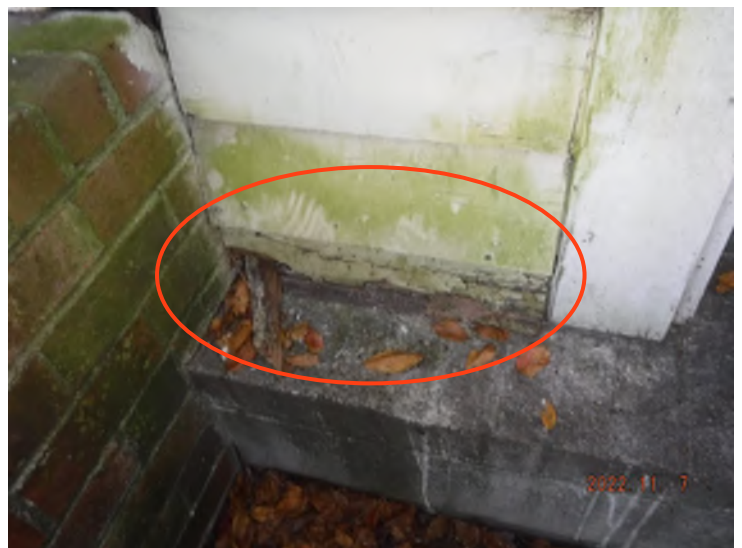
Rot/moisture damage to siding.

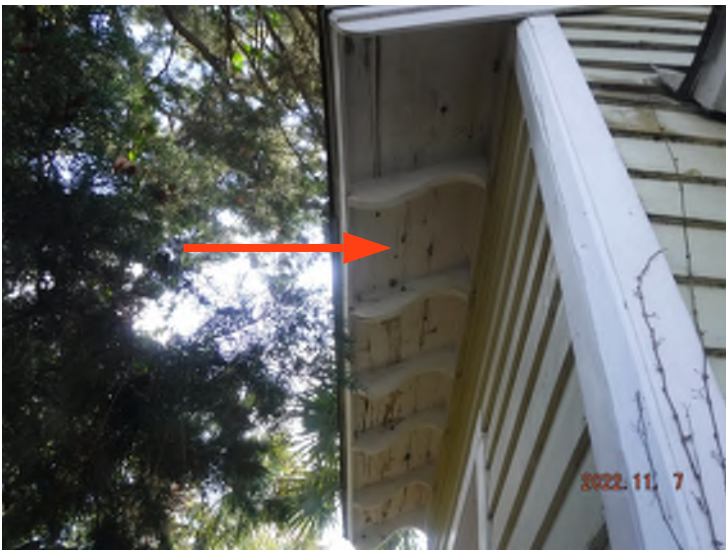
Rot/moisture damage to overhang.

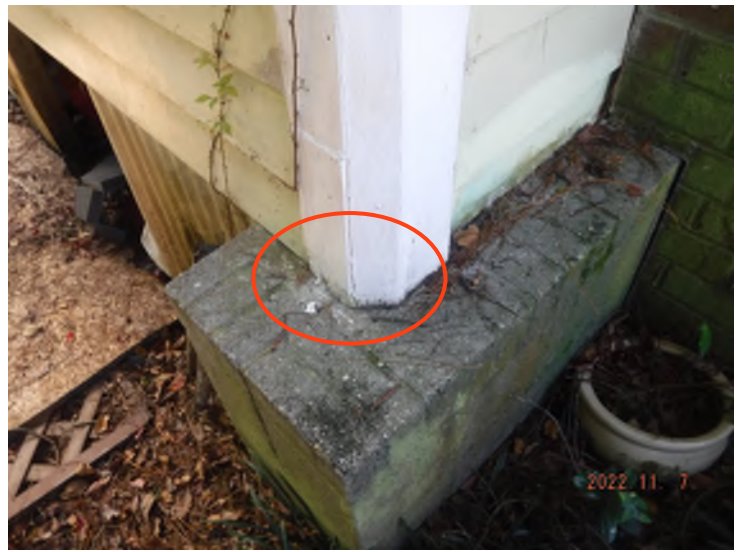
Rot/moisture damage to trim.

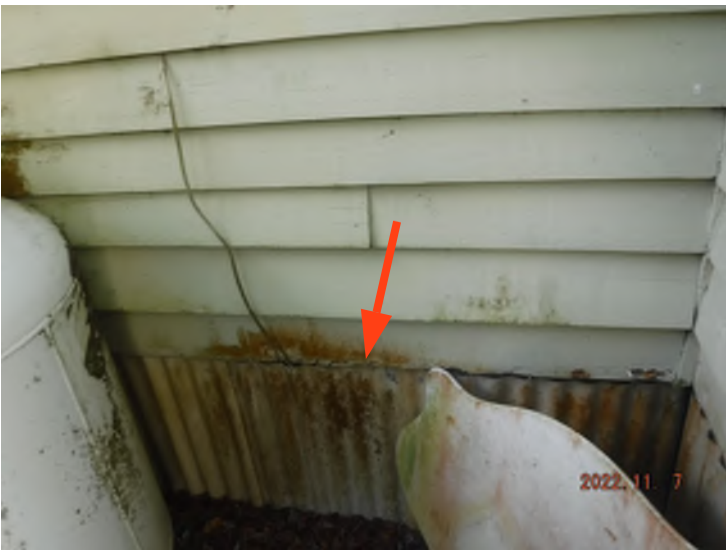
Rot/moisture damage to siding.

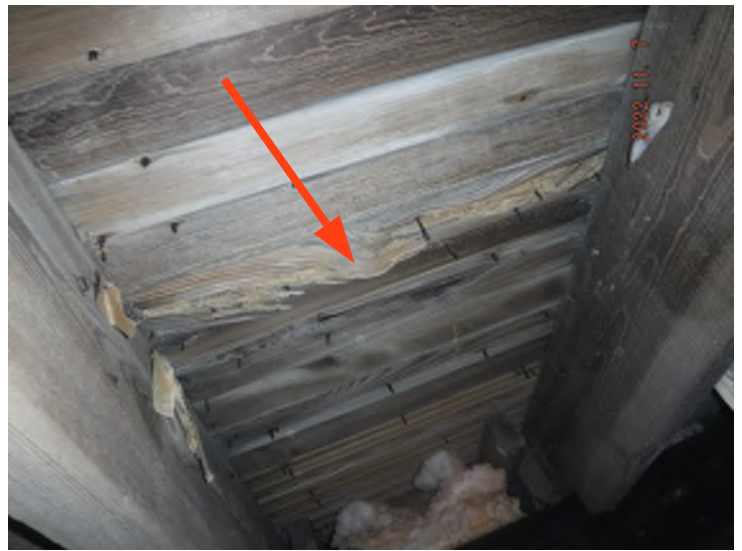
Previous subterranean termite activity and damage in the crawlspace.

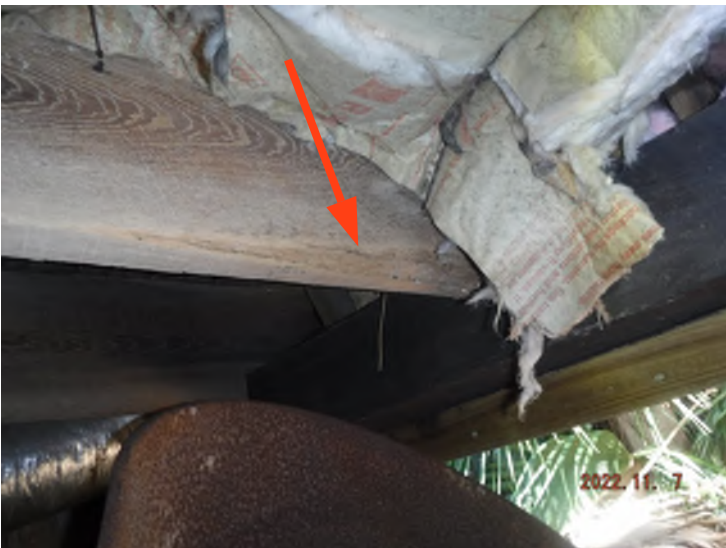
Previous powder post beetle activity and damage in the crawlspace.

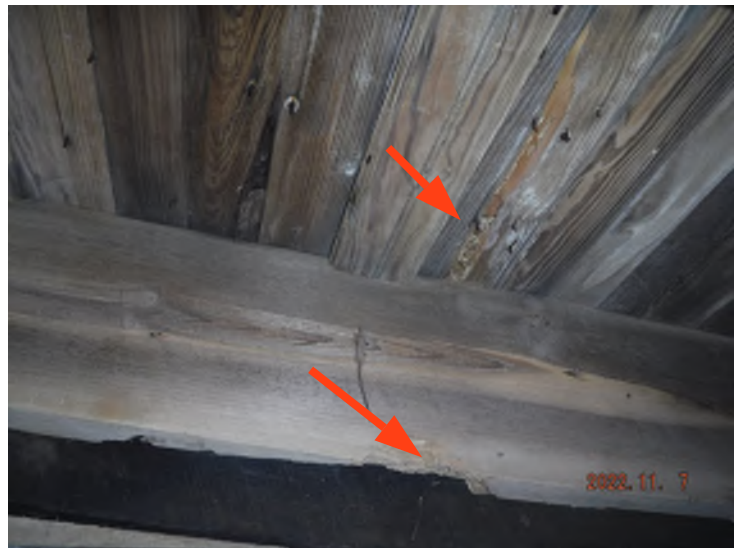
Previous subterranean termite and powder post beetle activity and damage in the crawlspace.

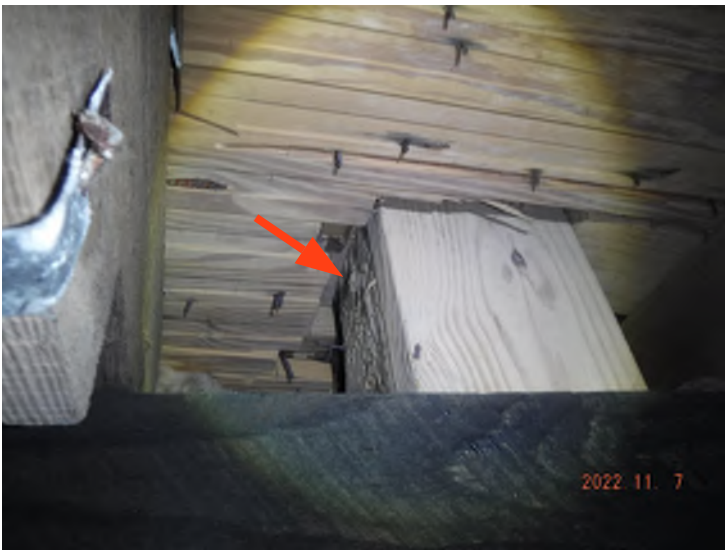
Previous subterranean termite activity and damage in the crawlspace.

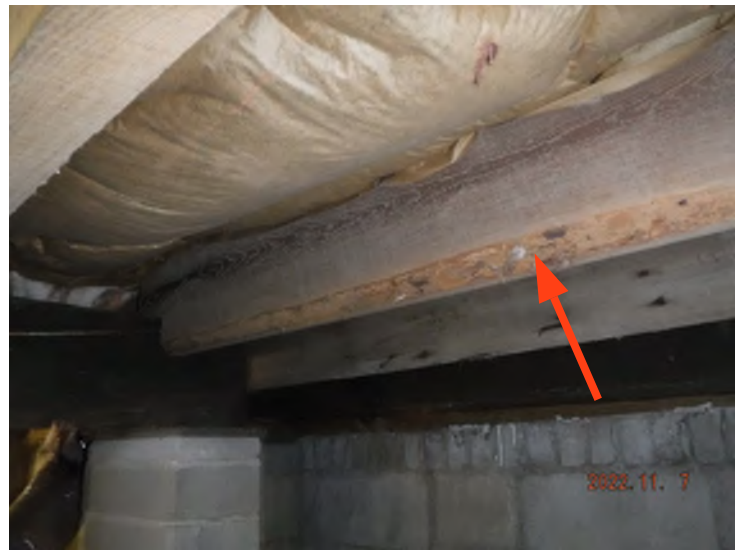
Previous powder post beetle activity and damage in the crawlspace.

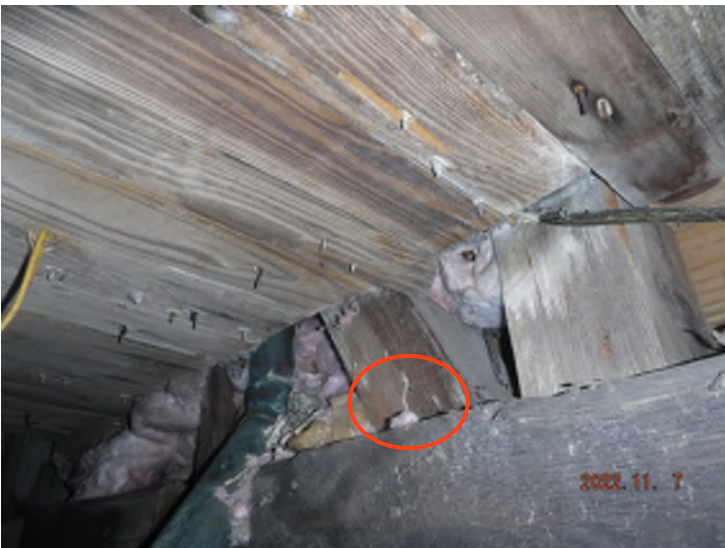
Previous subterranean termite activity and damage in the crawlspace.

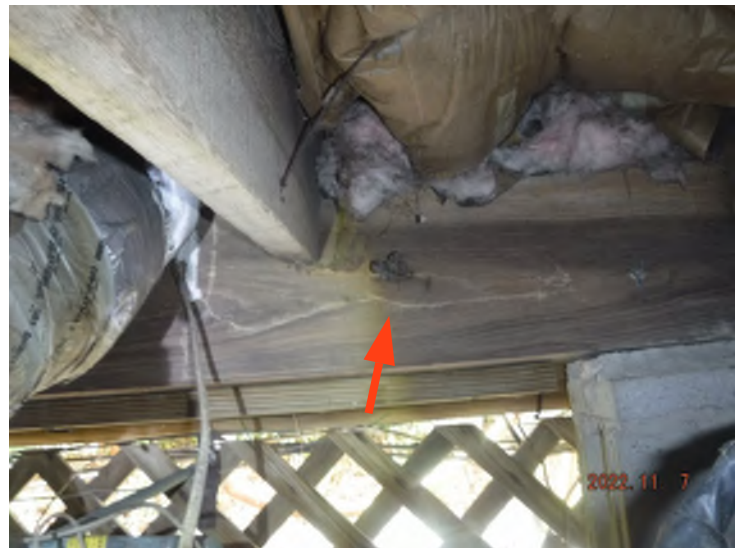
Previous subterranean termite activity and damage in the crawlspace.

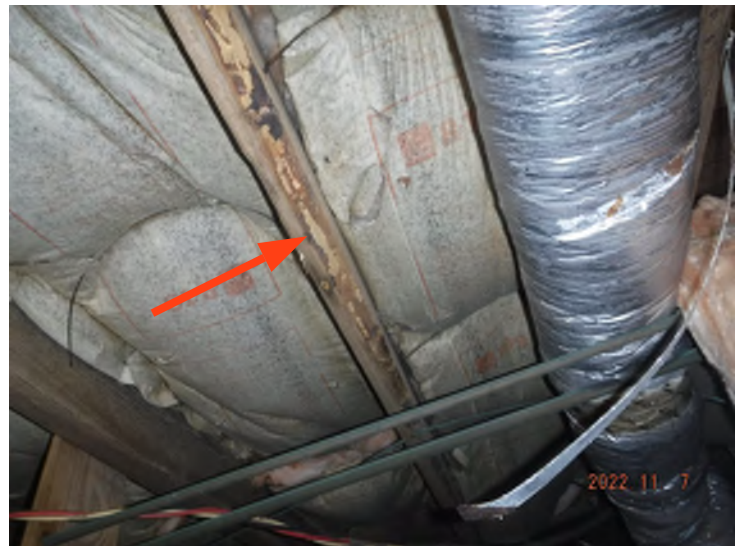
Previous old house borer beetle activity and damage in the crawlspace.

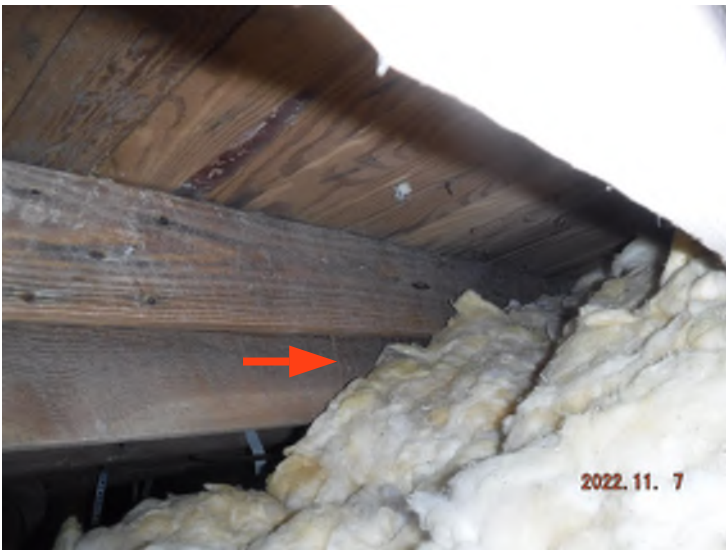
Previous subterranean termite activity and damage in the crawlspace.

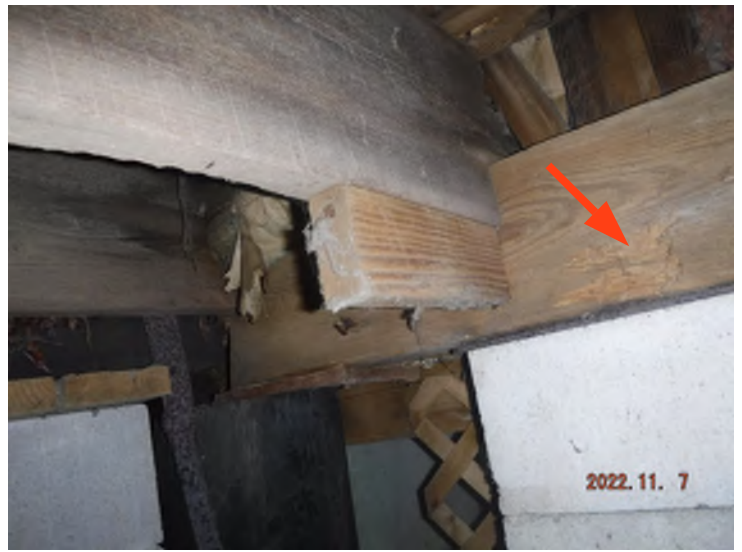
Previous powder post beetle activity and damage in the crawlspace.

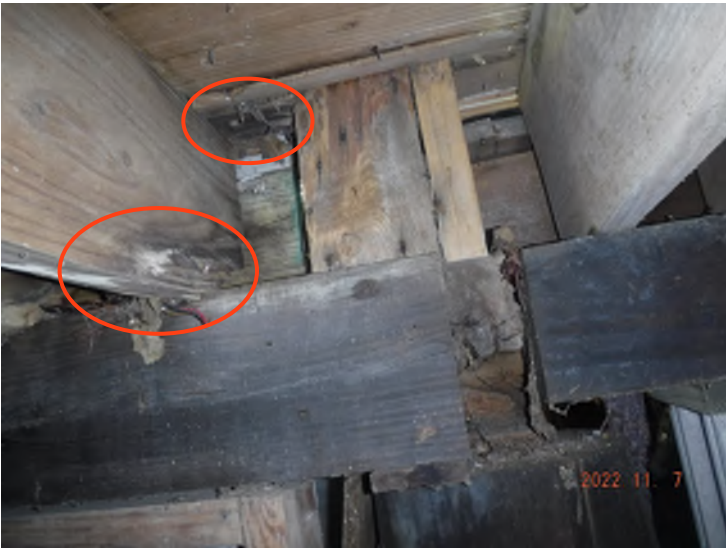
Rot/moisture damage

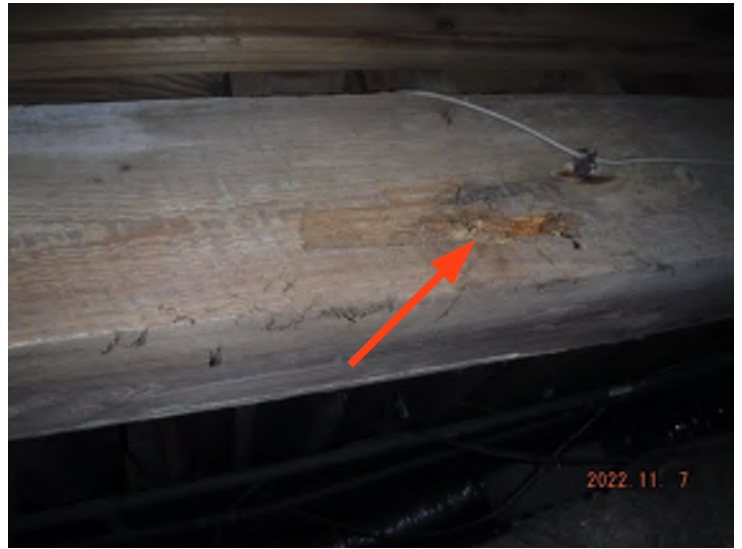
Previous powder post beetle activity and damage in the crawlspace.

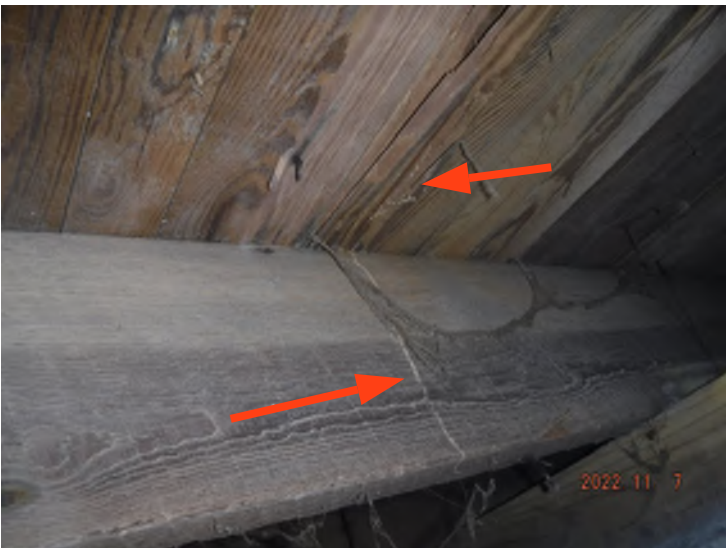
Previous subterranean termite activity and damage in the crawlspace.

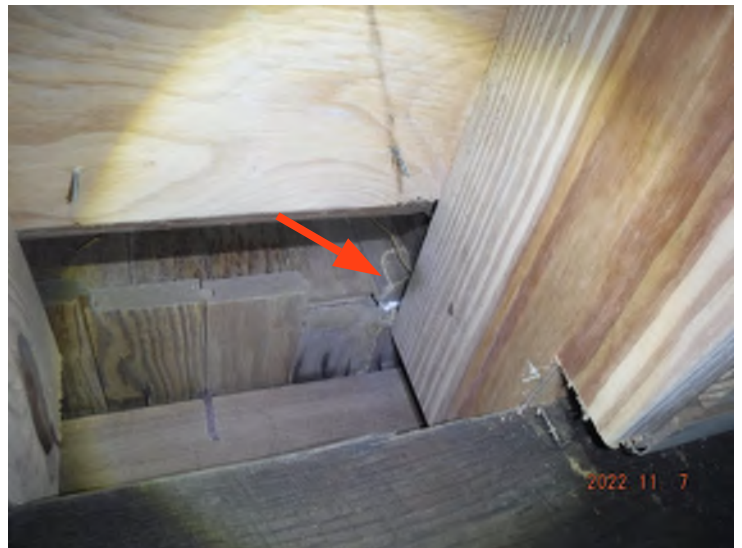
Previous subterranean termite activity and damage in the crawlspace.

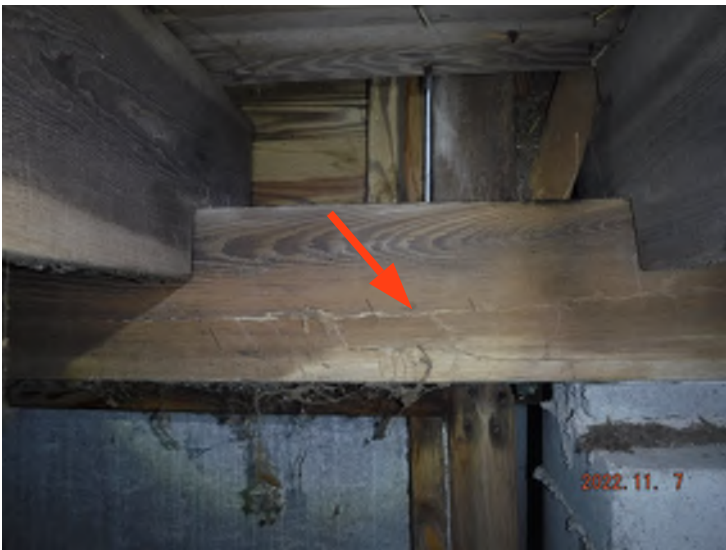
Previous subterranean termite activity and damage in the crawlspace.

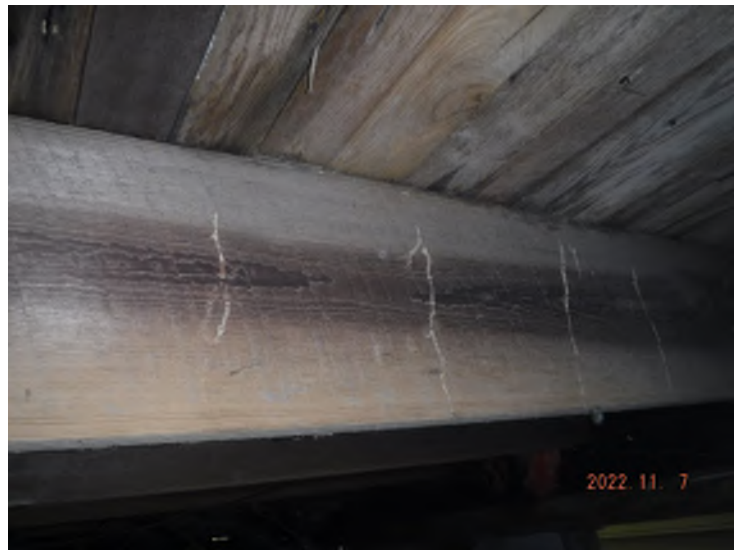
Previous subterranean termite activity and damage in the crawlspace.

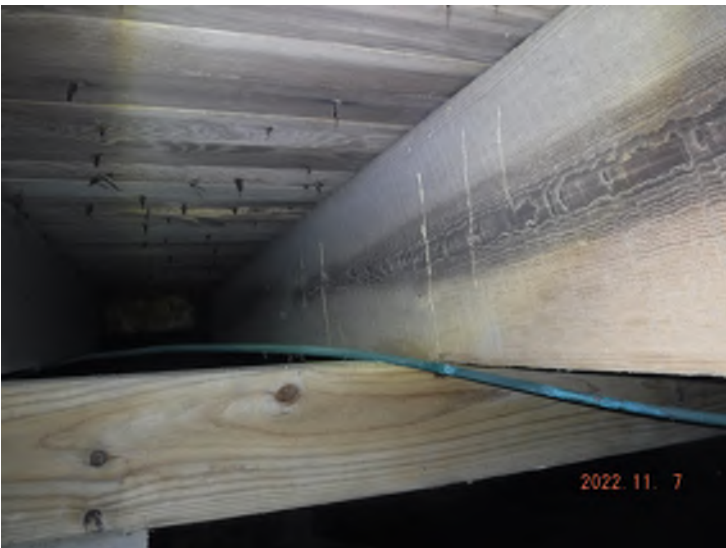
Previous subterranean termite activity and damage in the crawlspace.

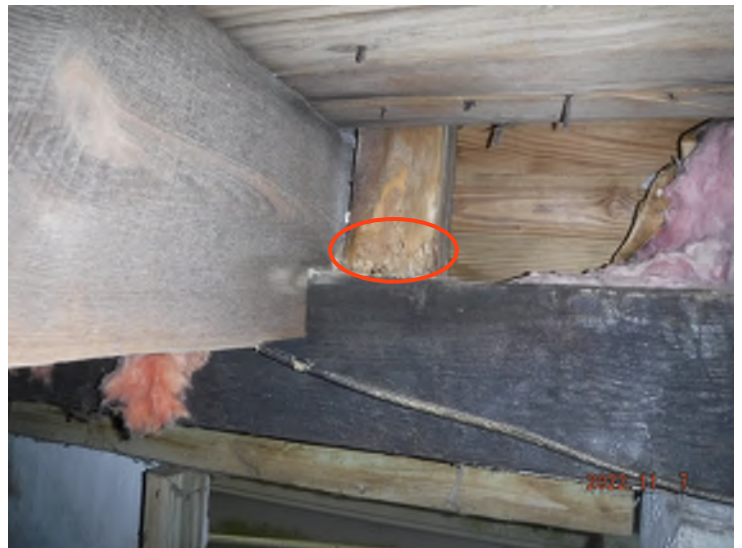
Previous subterranean termite and powder post beetle activity and damage in the crawlspace.

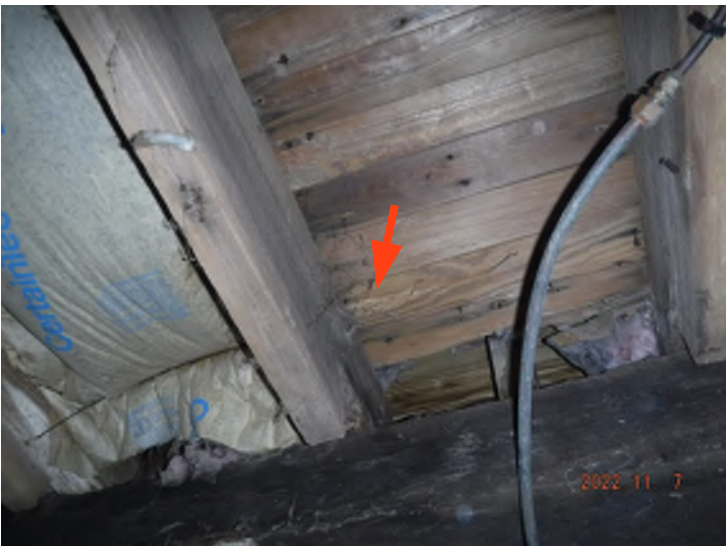
Previous subterranean termite activity and damage in the crawlspace.

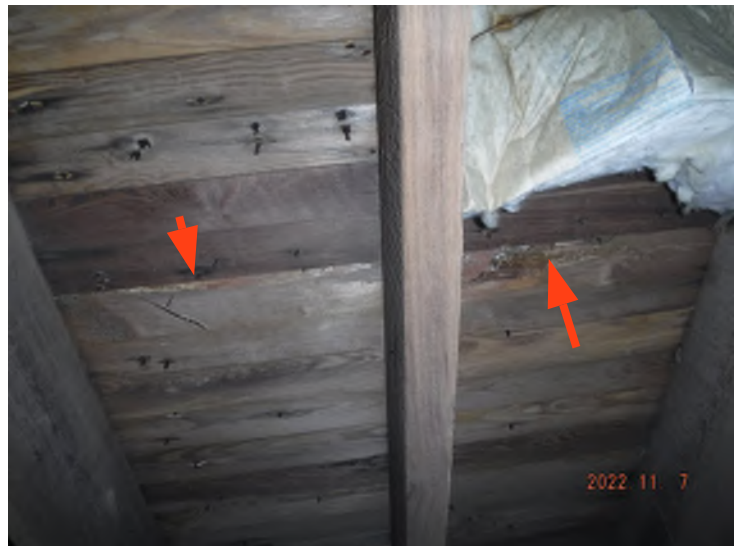
Previous powder post beetle activity and damage in the crawlspace.

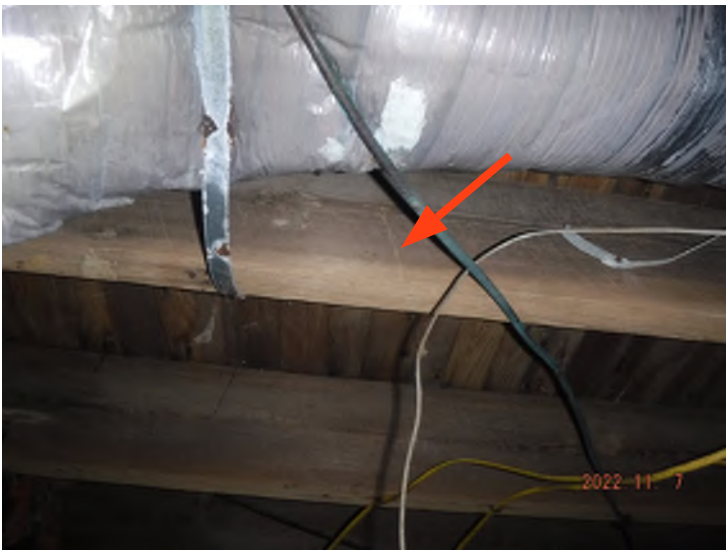
Previous subterranean termite activity and damage in the crawlspace.

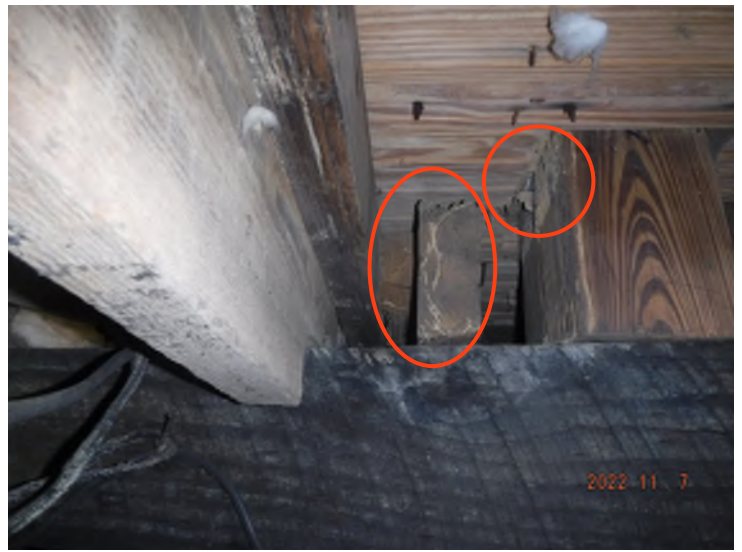
Previous subterranean termite activity and damage in the crawlspace.

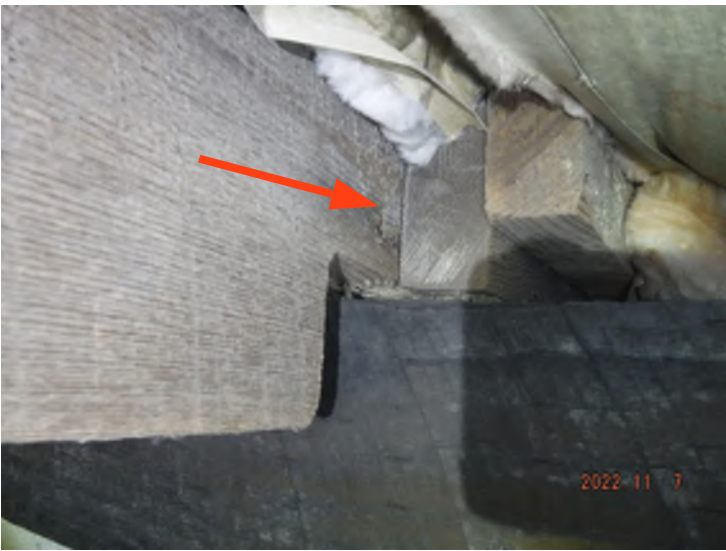
Previous subterranean termite activity and damage in the crawlspace.

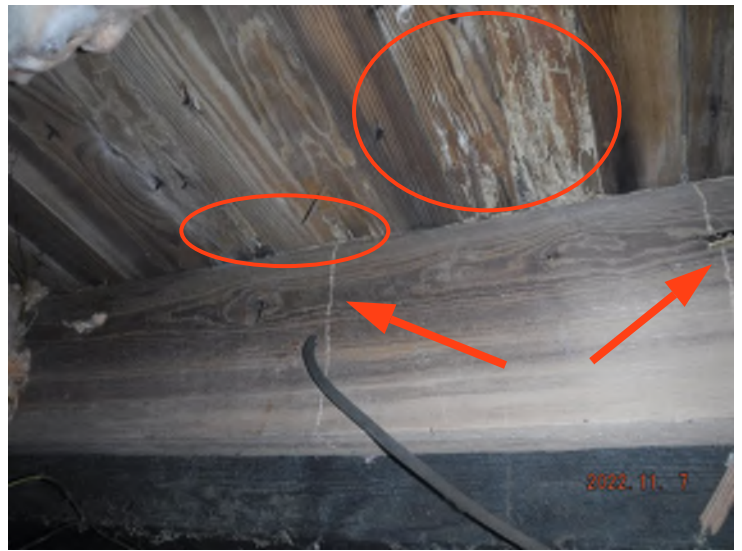
Previous subterranean termite activity and damage in the crawlspace.
