# 2019 Beach Monitoring Survey

TOWN OF SULLIVAN'S ISLAND, SC

Elko Coastal Consulting, Inc. | July 2019

Technical Report

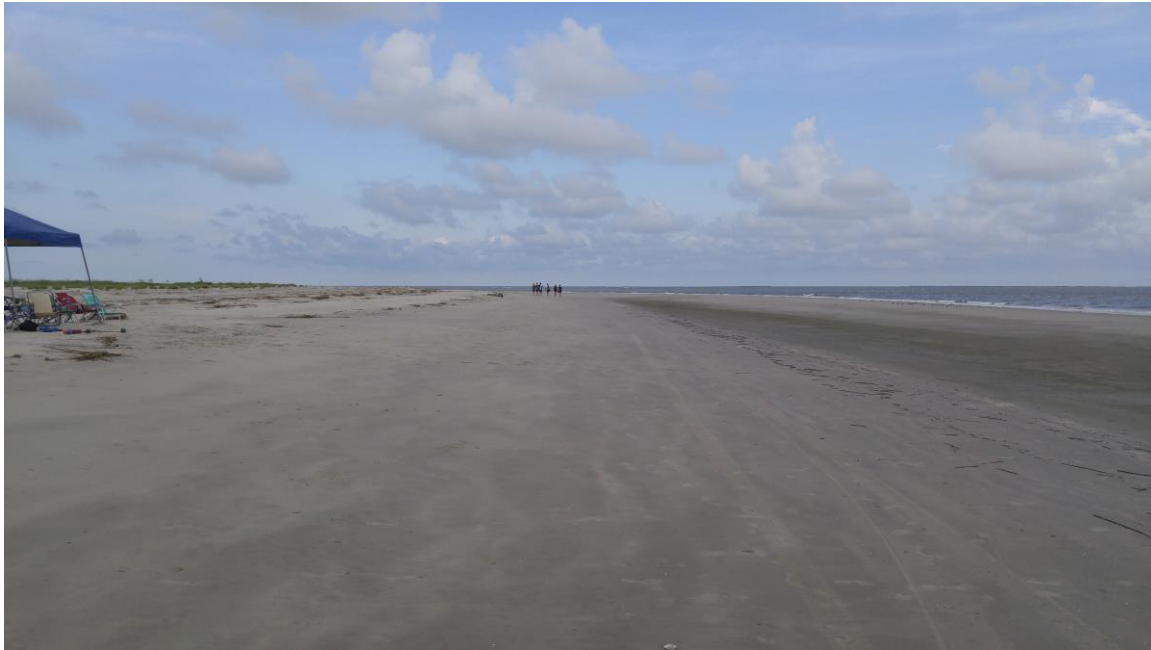
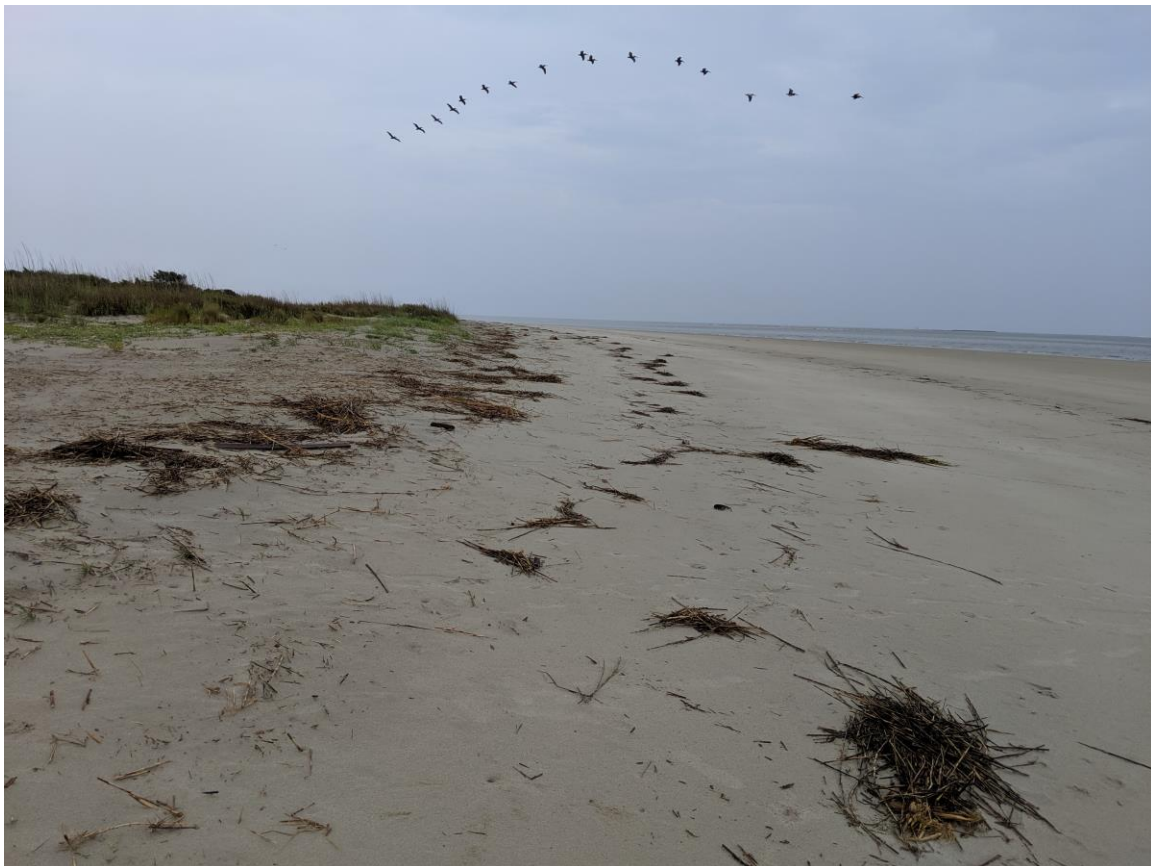
Compared to the 2016 conditions, the dunes are higher and accreting seaward with incipient dune vegetation observed to the northeast (Figure 8). Minor dune scarping was observed to the southwest (Figure 9). According to the 2019 volume calculation, this profile has a unit volume of 793 cy/ft.

*Figure 8. Ground photo taken at Monument 3010 looking east on August 4, 2016 (top) and June 6, 2019 (bottom). Note the narrower beach but higher elevation of the backbeach and dune in 2019.*

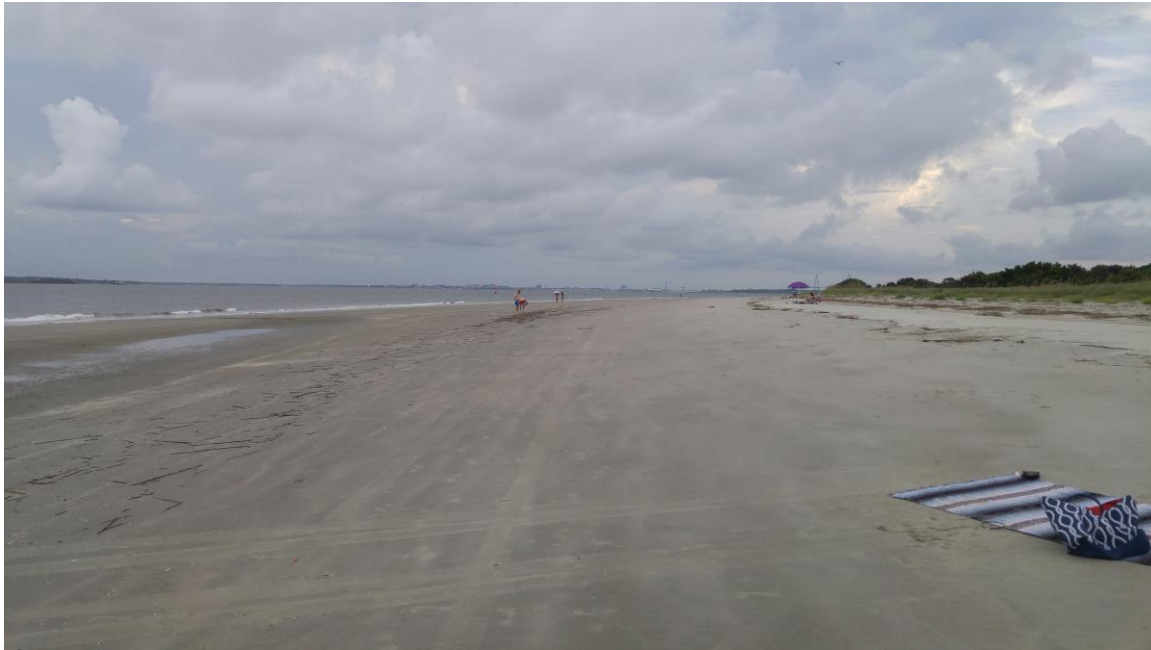
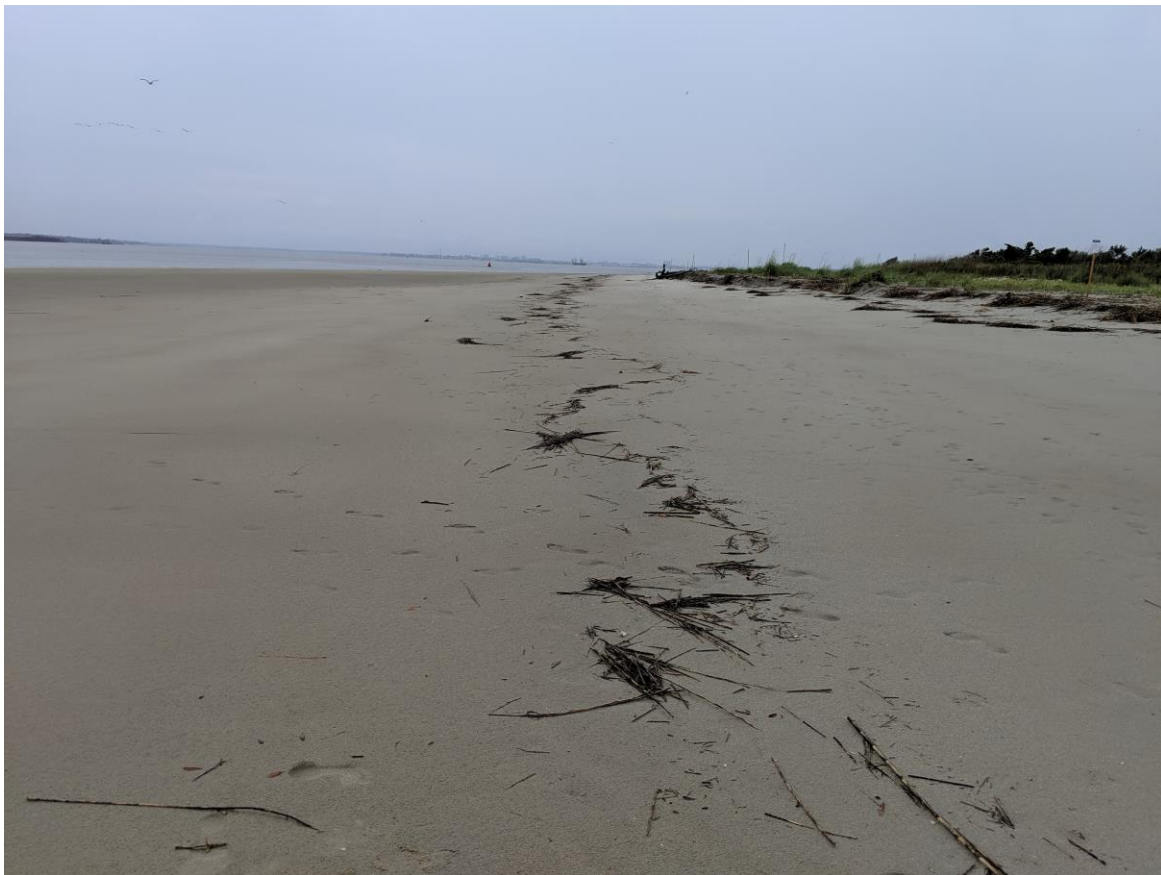
*Figure 9. Ground photo taken at Monument 3010 looking west on August 4, 2016 (top) and June 6, 2019 (bottom). Note the higher elevation of the backbeach and dune in 2019.*

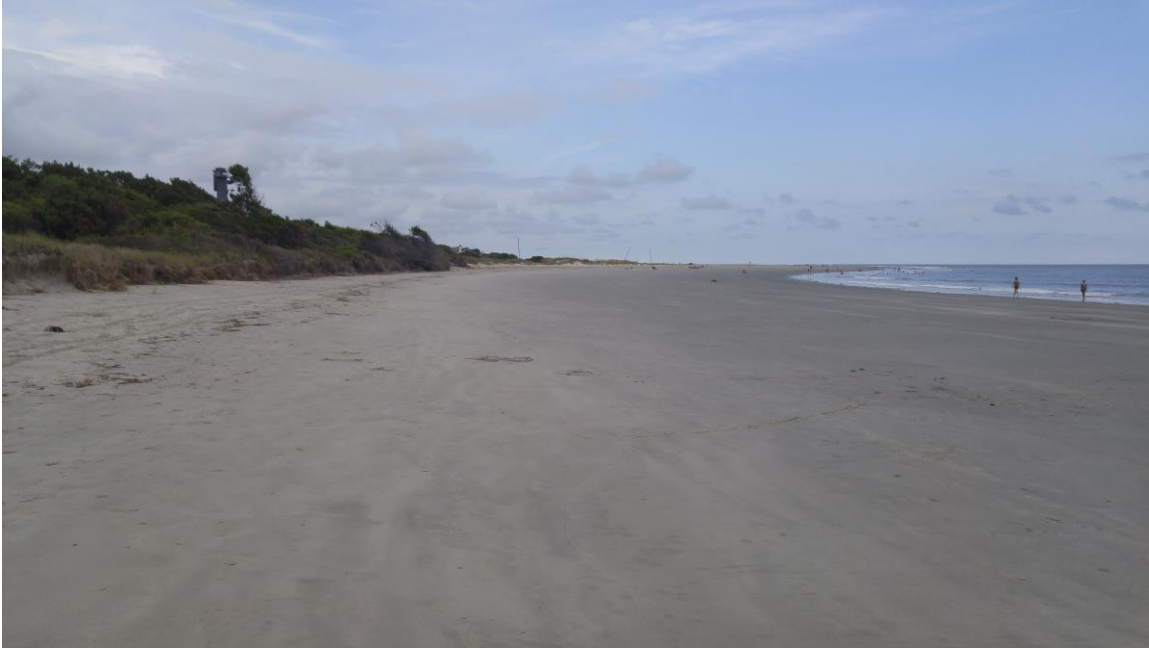
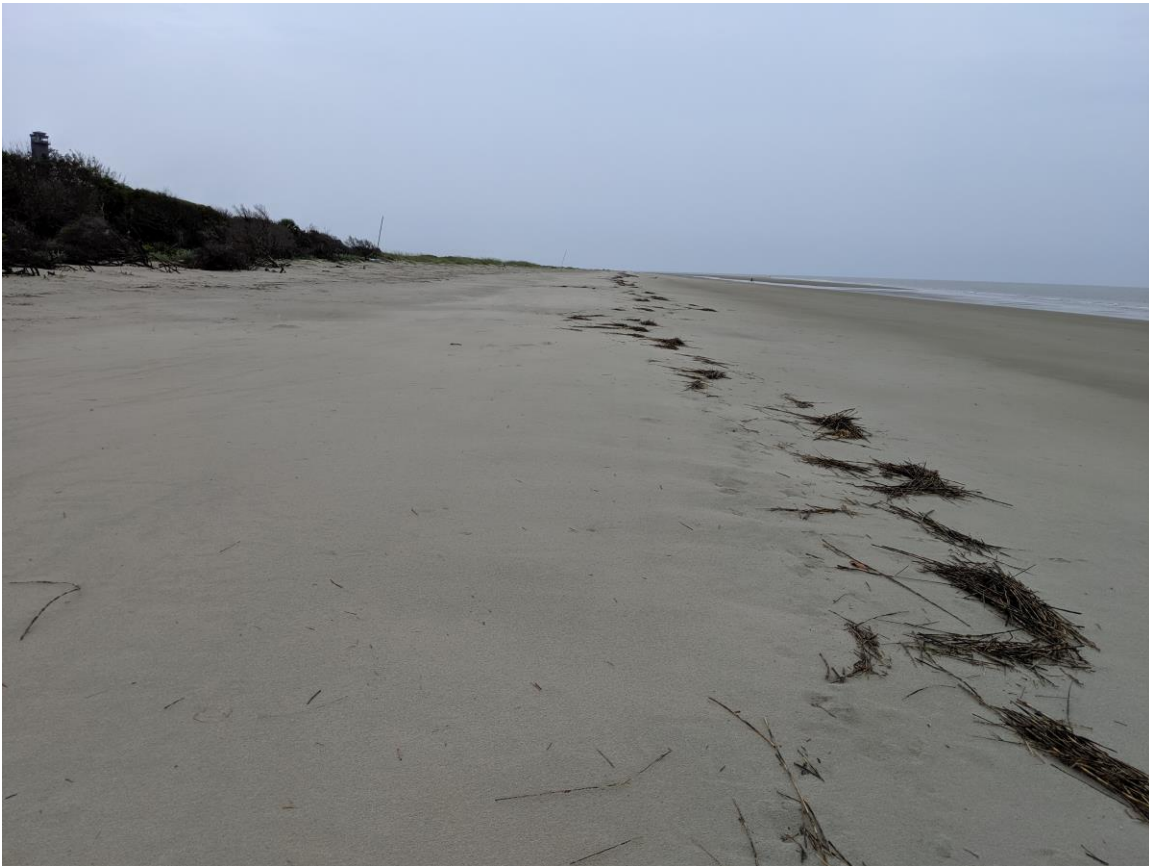
A sand bar had attached to the updrift beach (Figure 11) in 2016. Considerable ongoing dune erosion was evident to the southwest in 2016, but the dunes have recently been recovering (Figure 12).

*Figure 11. Ground photo taken at Monument 3020 looking northeast on August 4, 2016 (top) and June 6, 2019 (bottom). Notice the evolution of the sand bar attachment on the beach to the northeast.*

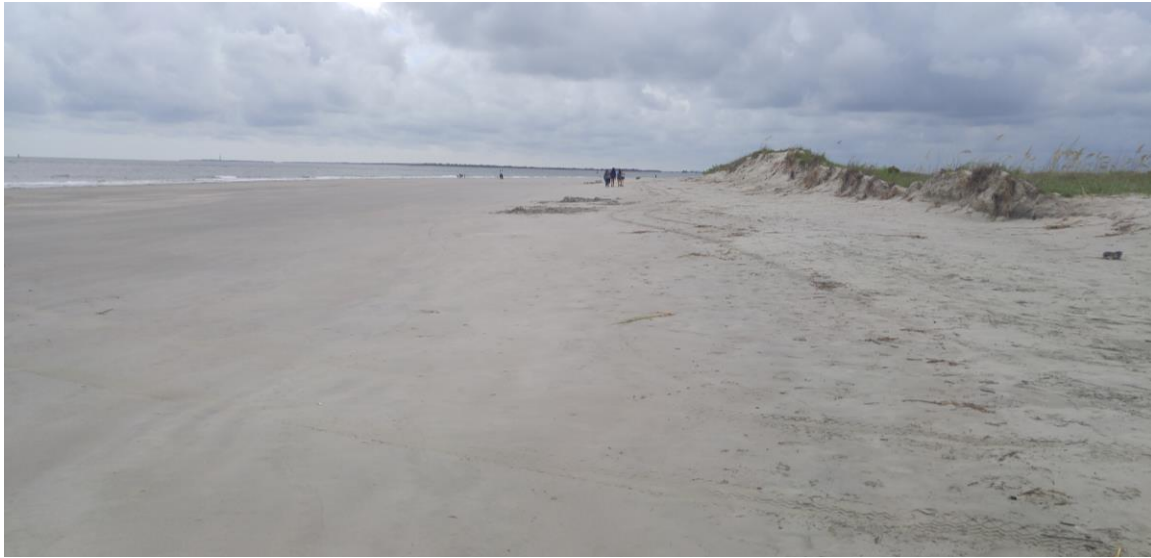
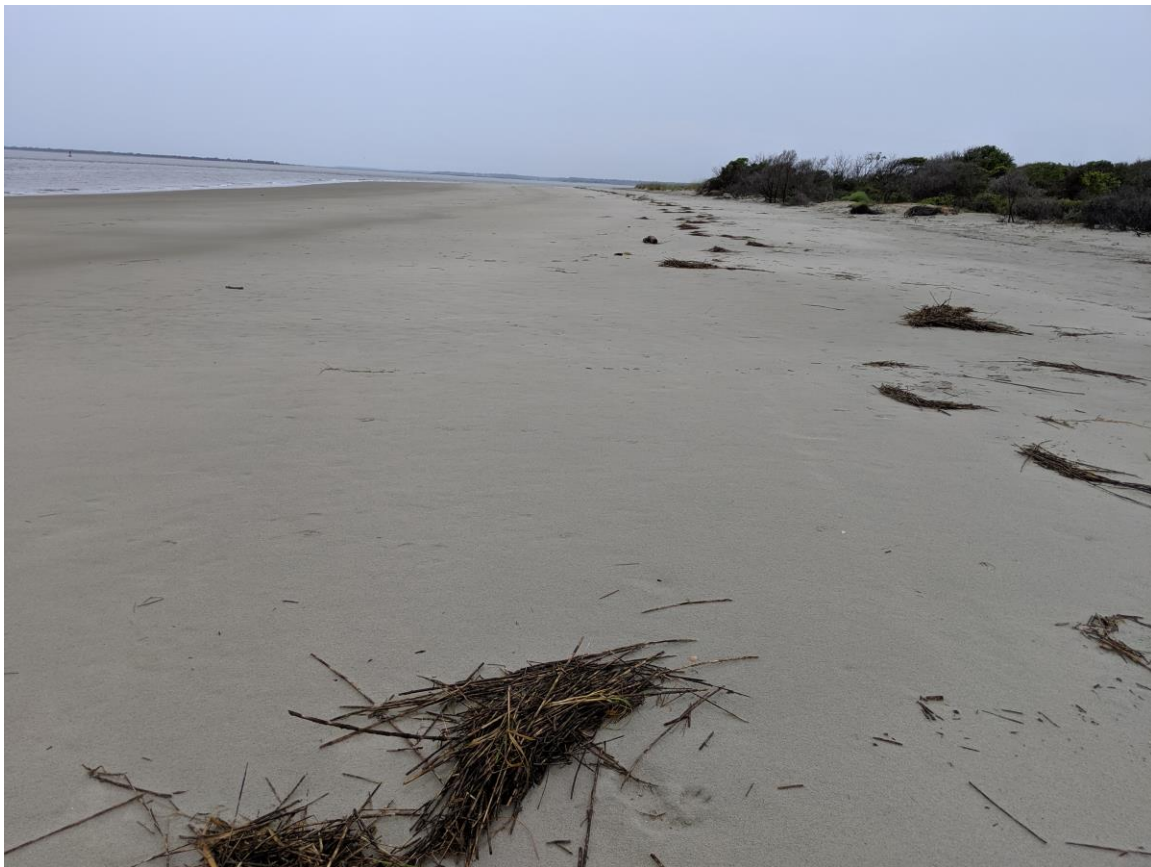
*Figure 12. Ground photo taken at Monument 3020 looking southwest on August 4, 2016 (top) and June 6, 2019 (bottom). Note the recovery of dune vegetation to the southwest in 2019.*

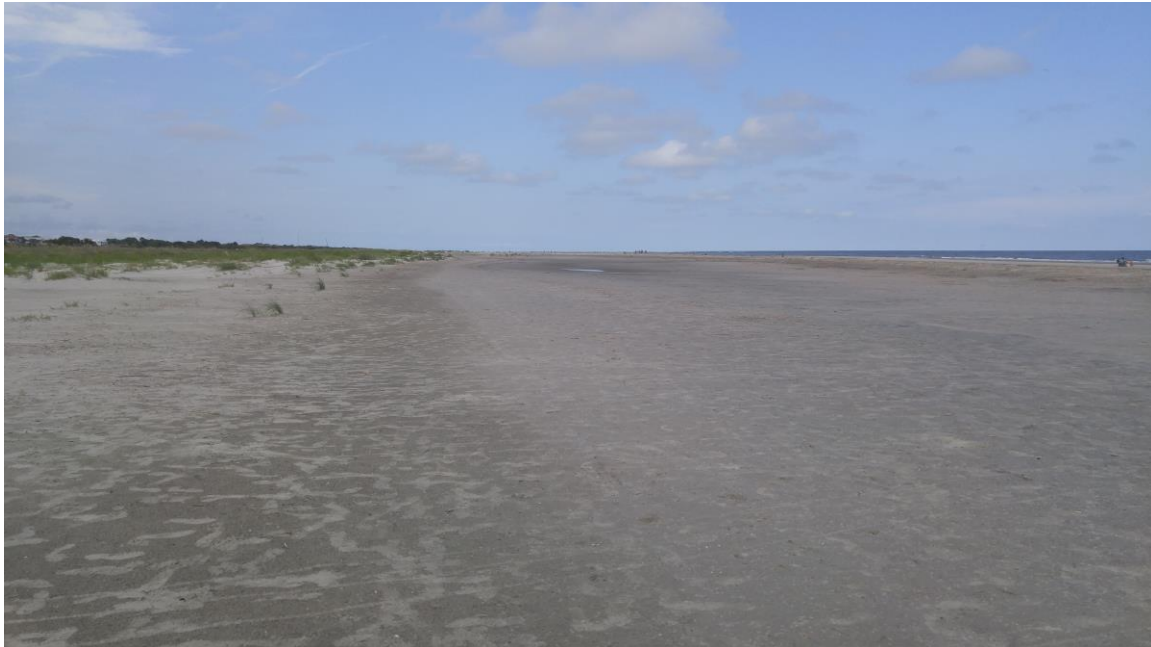
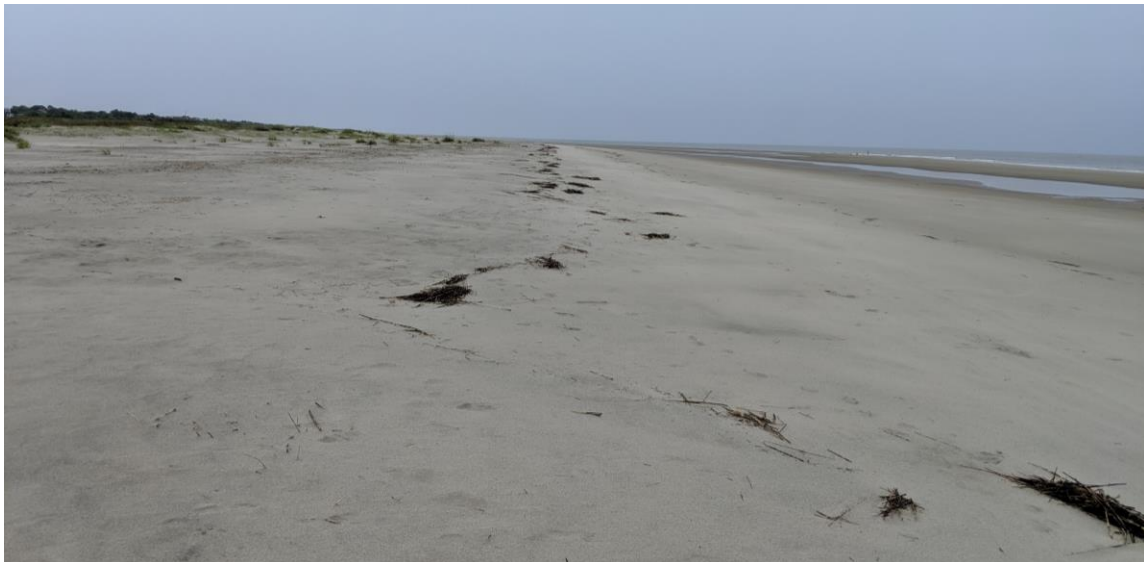
*Figure 14. Ground photo taken at Monument 3035 looking northeast on August 4, 2016 (top) and June 6, 2019 (bottom). Note the abundance of incipient dunes, reduced ponding, and over change in slope.*

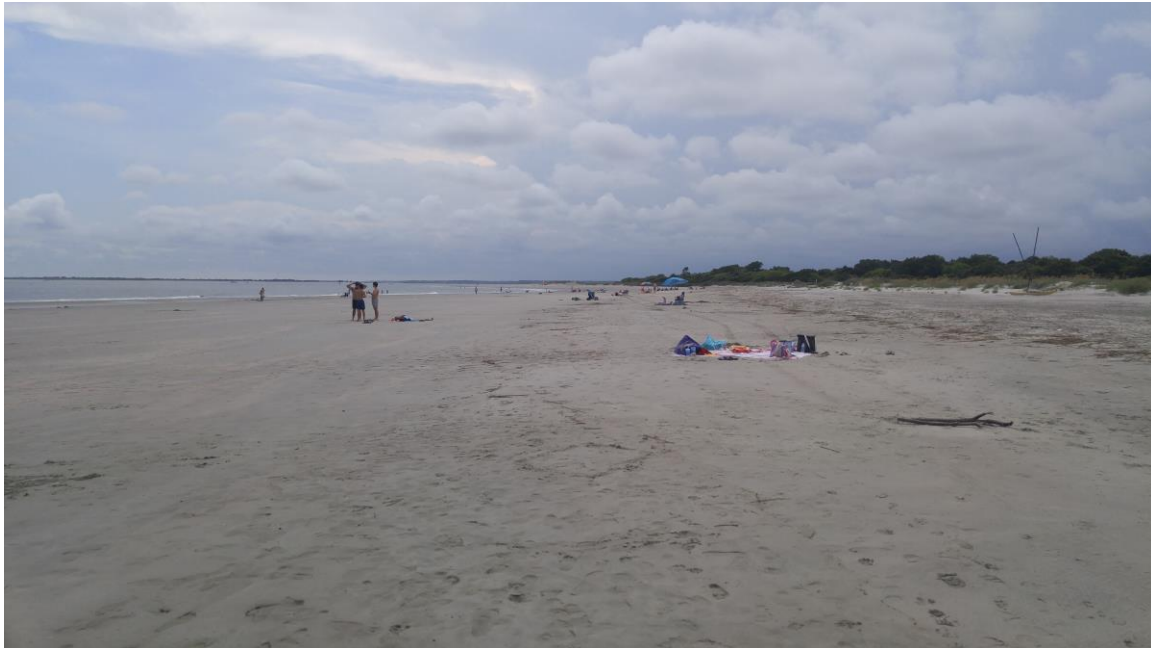
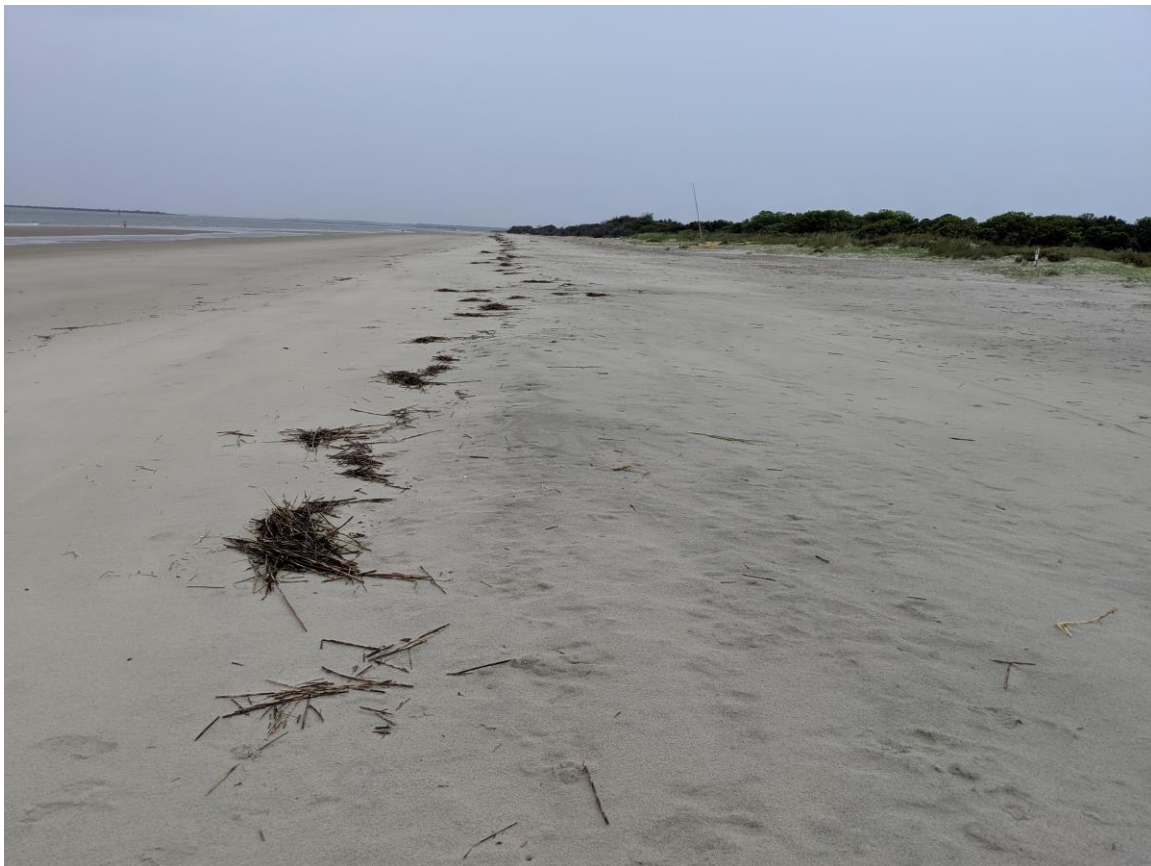
*Figure 15. Ground photo taken at Monument 3035 looking southwest on August 4, 2016 (top) and June 11, 2019 (bottom). Note the higher berm elevation.*

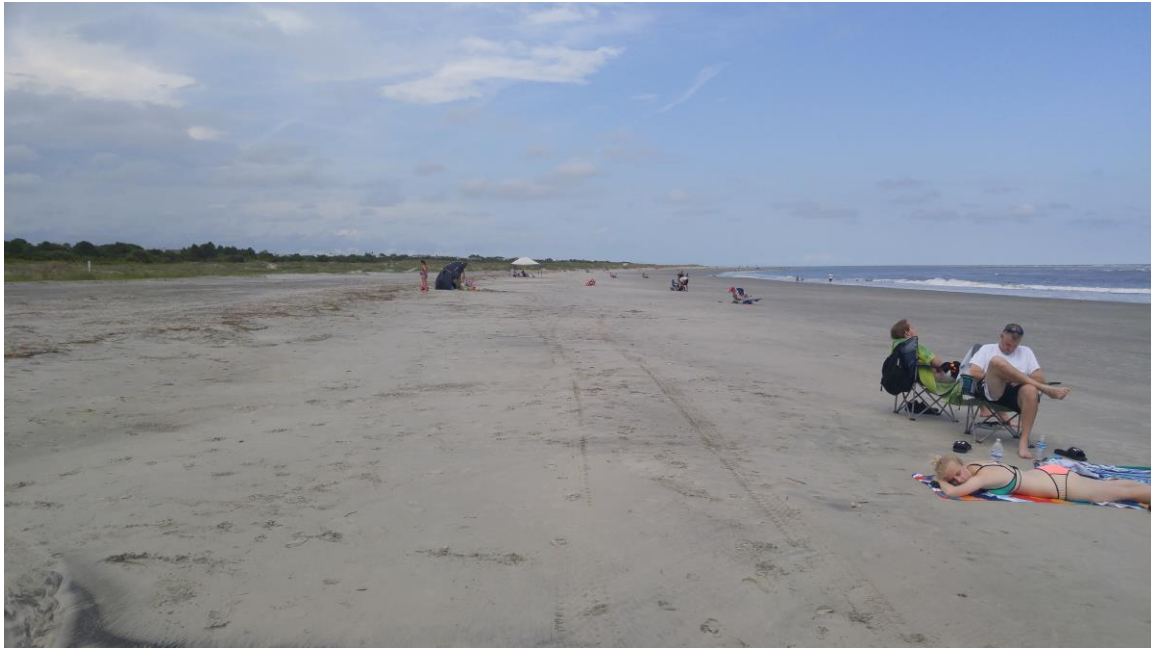
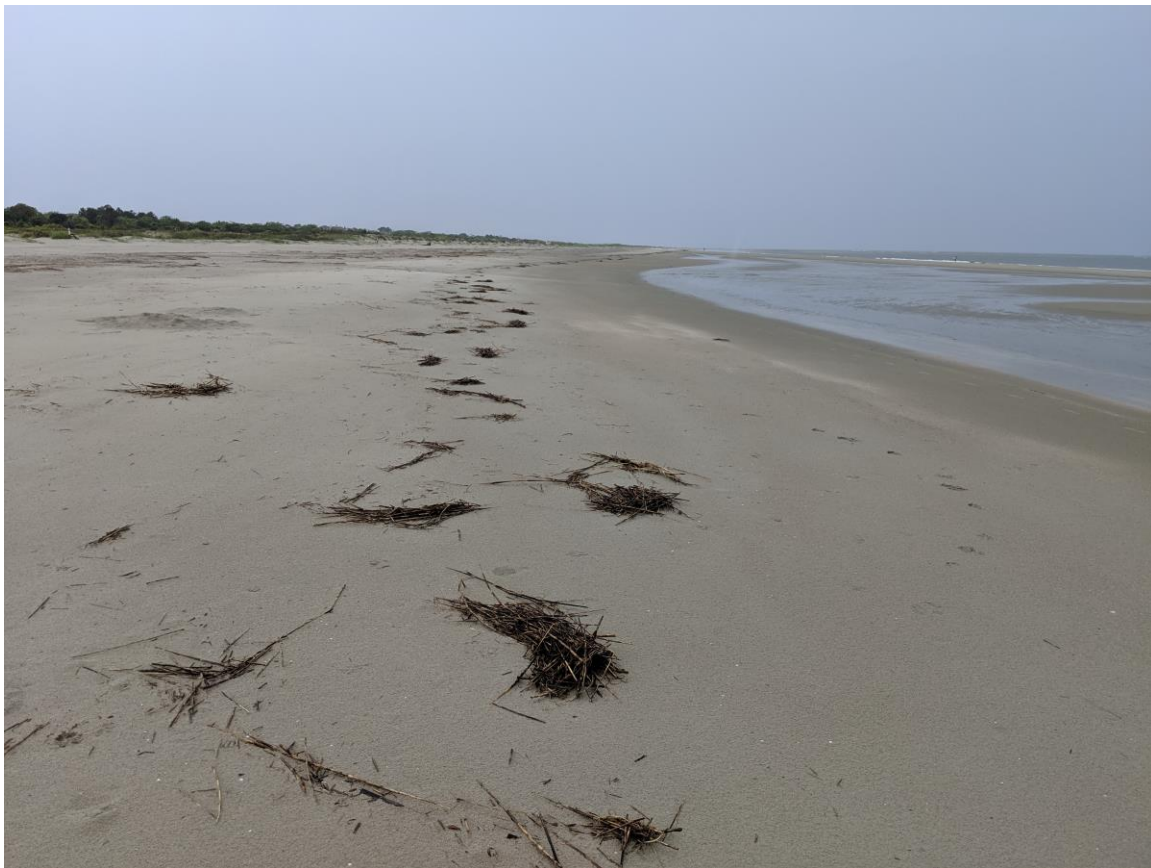
*Figure 17. Ground photo taken at Monument 3050 looking northeast on August 4, 2016 (top) and June 6, 2019 (bottom). Note the sandbar attachment in 2019.*

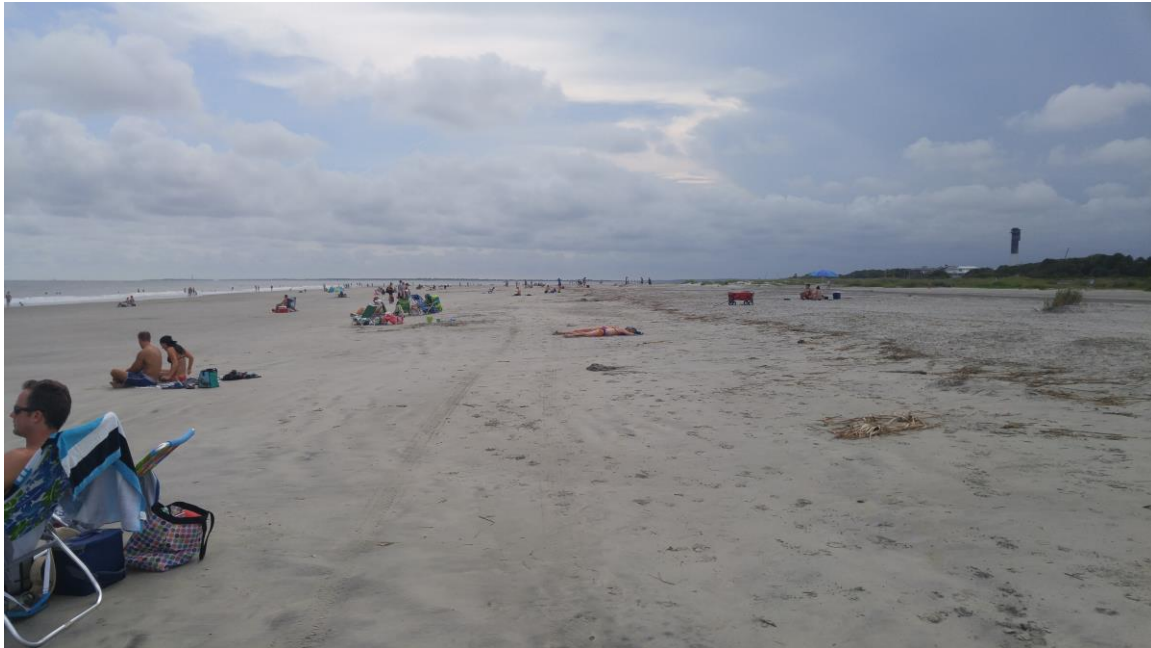
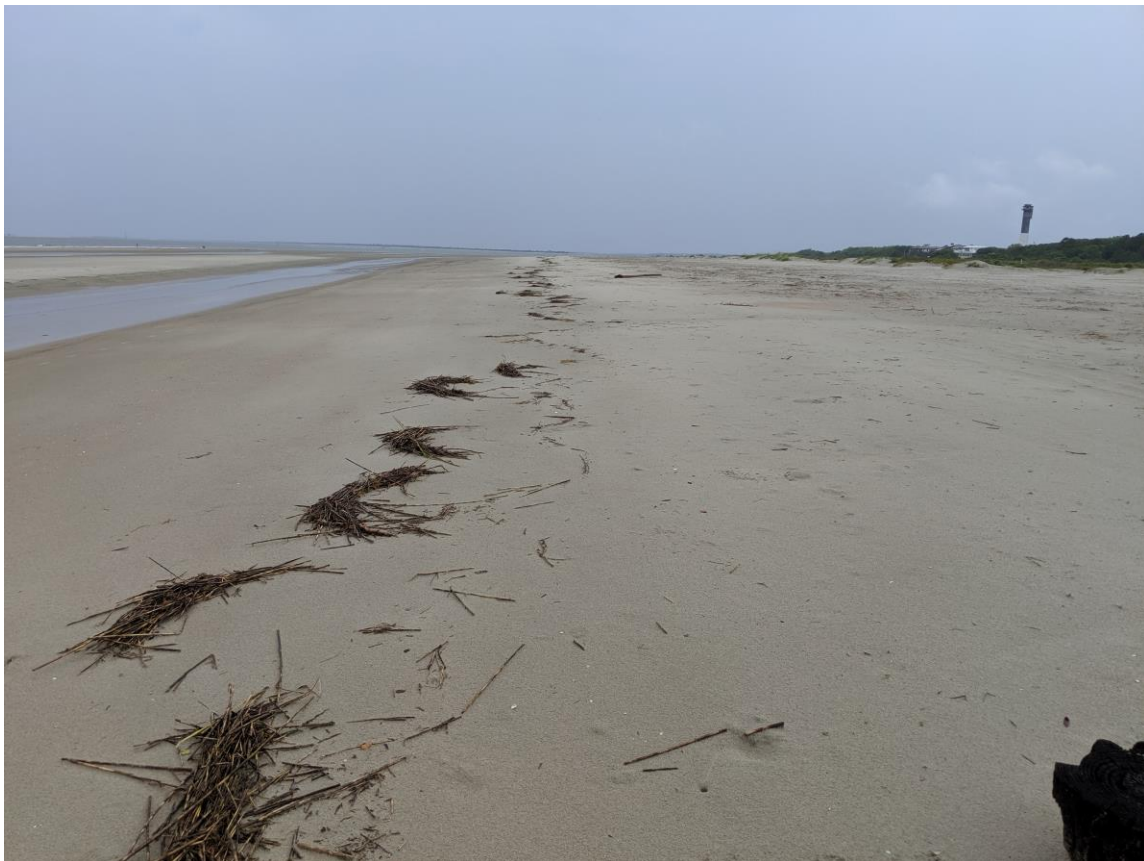
*Figure 18. Ground photo taken at Monument 3050 looking southwest on August 4, 2016 (top) and June 6, 2019 (bottom). Note the sandbar attachment in 2019.*

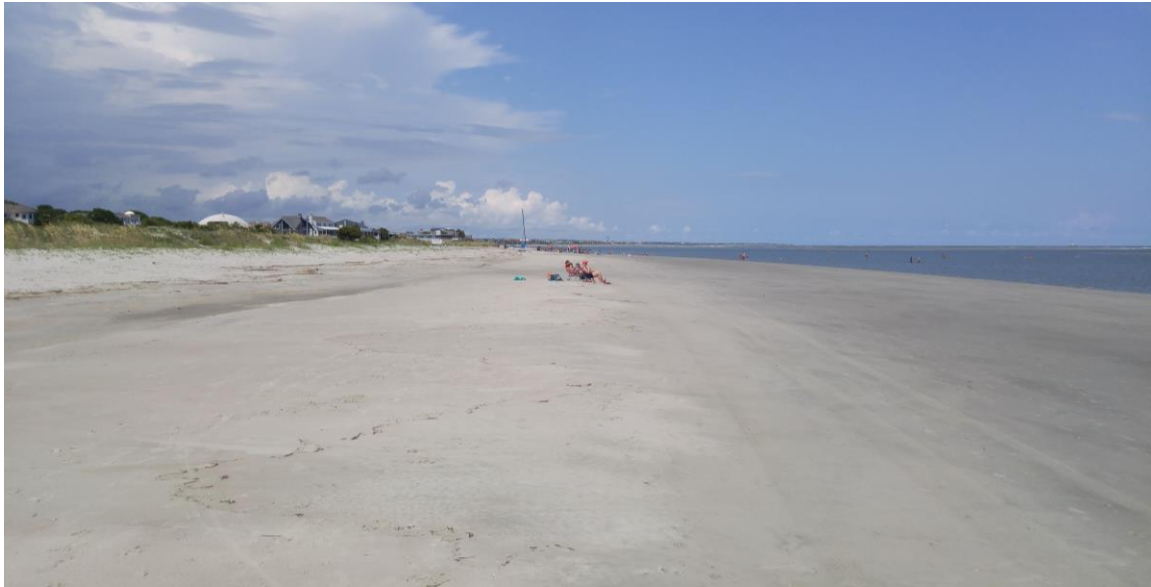
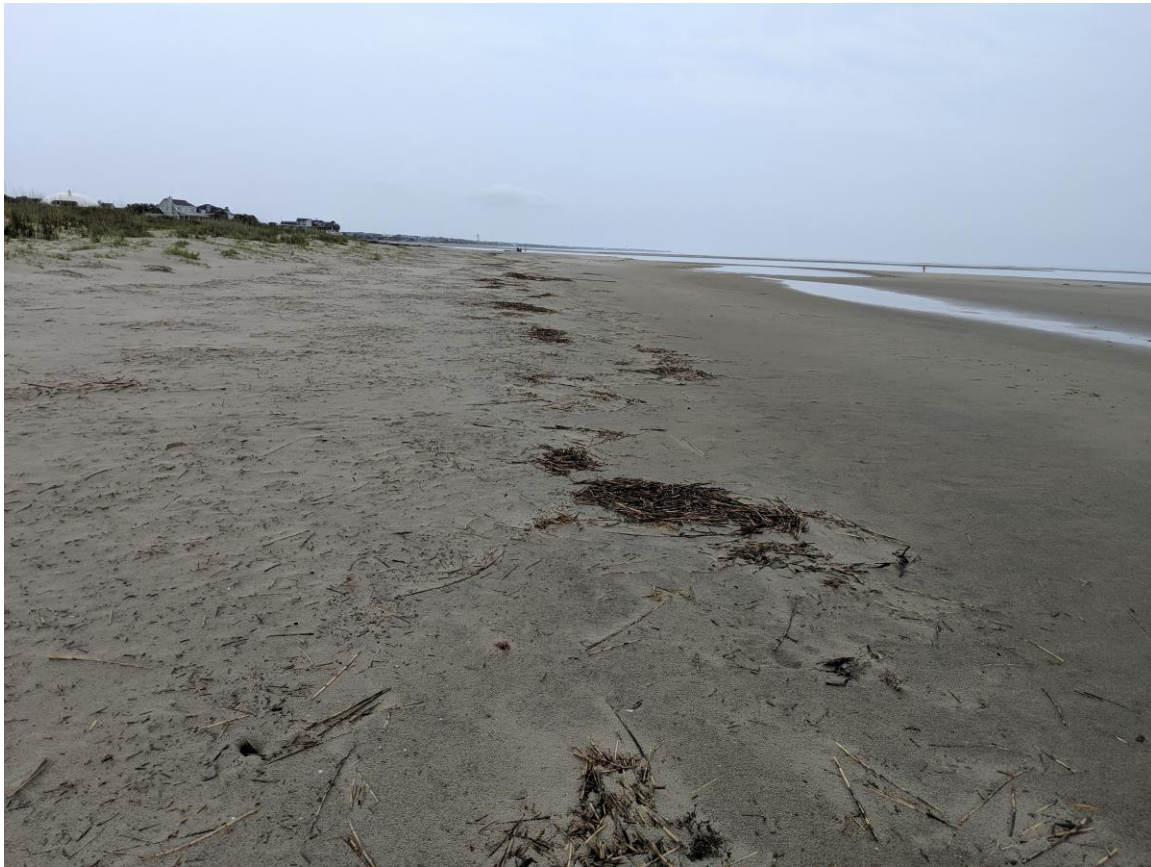
The beach at this location displayed classic signs of accretion with a large ridge and runnel (attaching sand bar) and wide healthy dunes (Figure 23 and Figure 24). Dune vegetation is healthy and flourishing with a high foredune. Spring high tide is about 30 ft from the toe of vegetation.

*Figure 23. Ground photo taken at Monument 3080 looking northeast on August 4, 2016 (top) and June 11, 2019 (bottom). Note the sand bar attachment in 2019.*

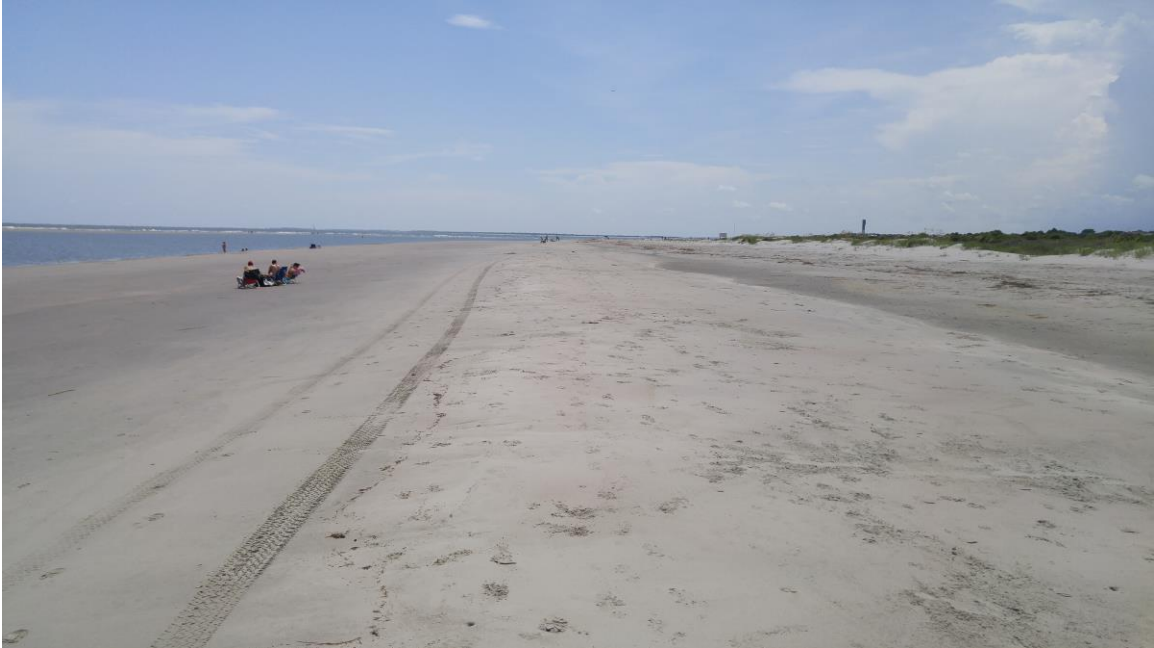
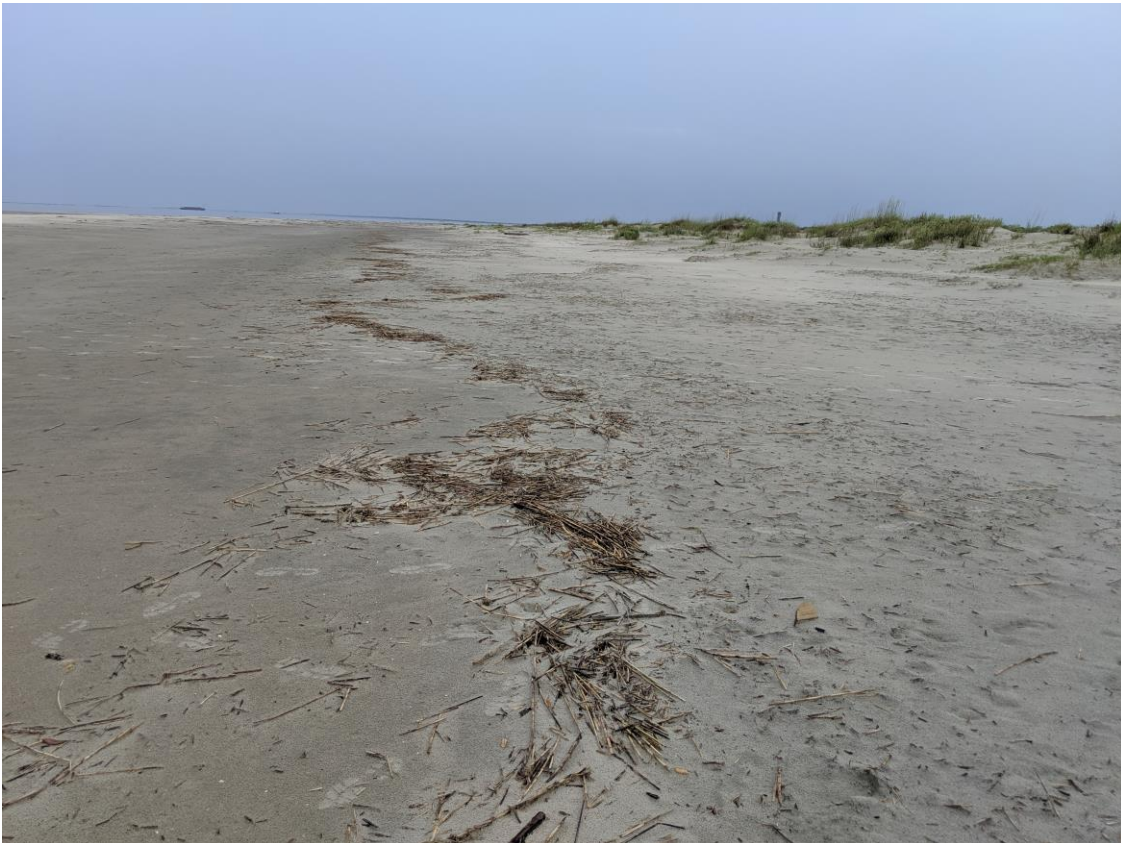
*Figure 24. Ground photo taken at Monument 3080 looking southwest on August 4, 2016 (top) and June 6, 2019 (bottom).*

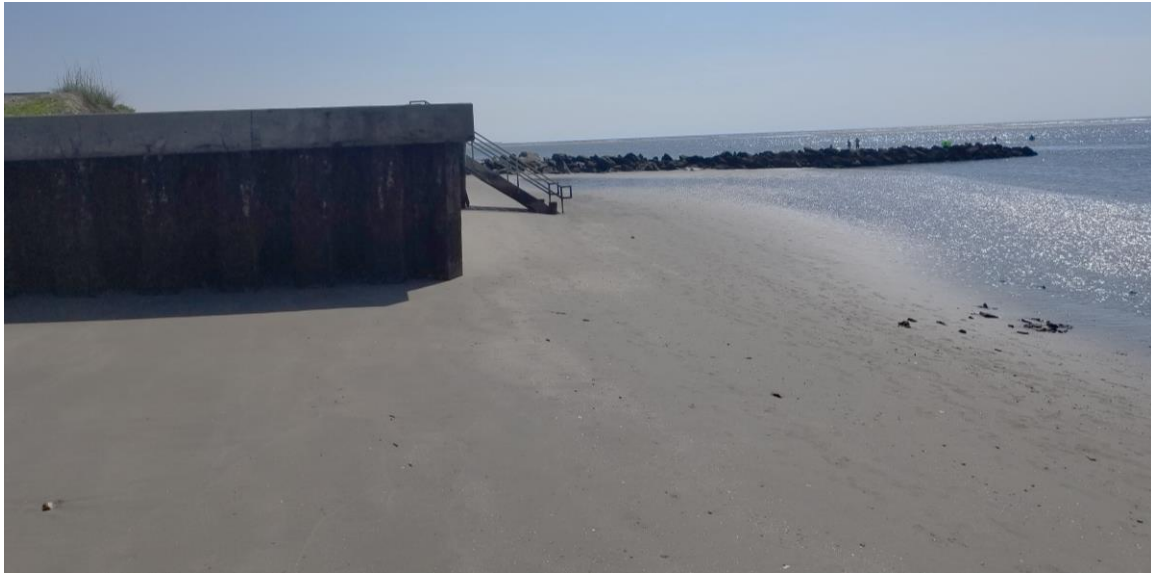
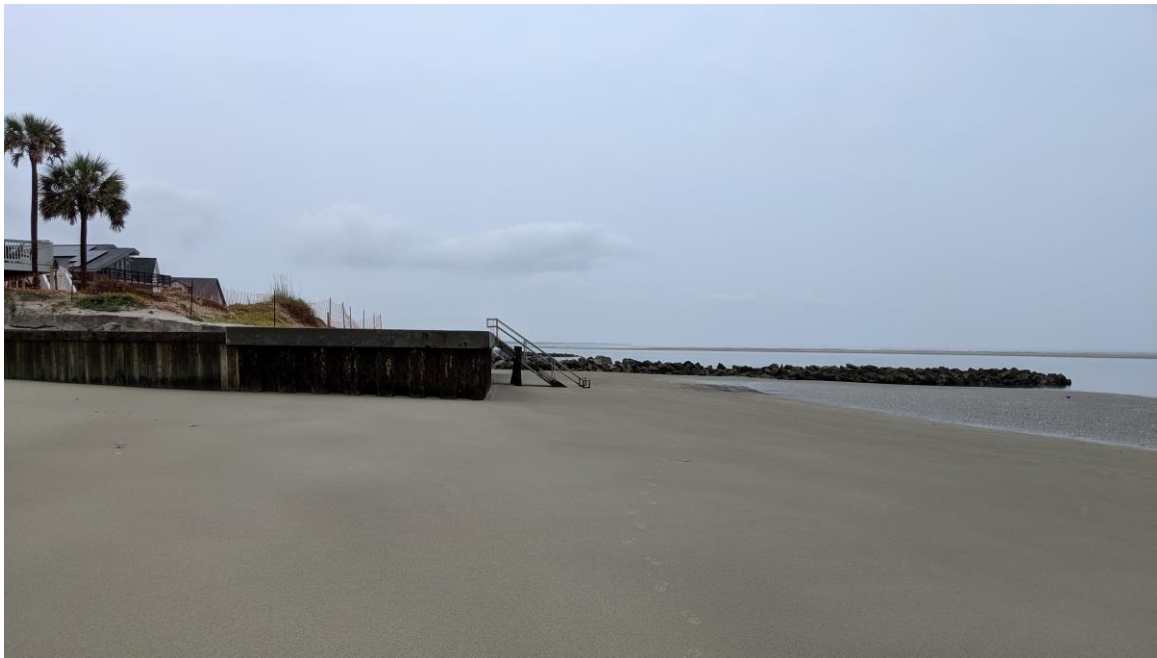
This location marks the transition between the northeast end of the island, which has been stabilized with erosion control structures (Figure 26) and the wide, fluctuating beach of the central portion of the island to the southwest (Figure 27).

*Figure 26. Ground photo taken at Monument 3083 looking seaward on June 11, 2018 (top) and looking northwest on June 6, 2019 (bottom).*

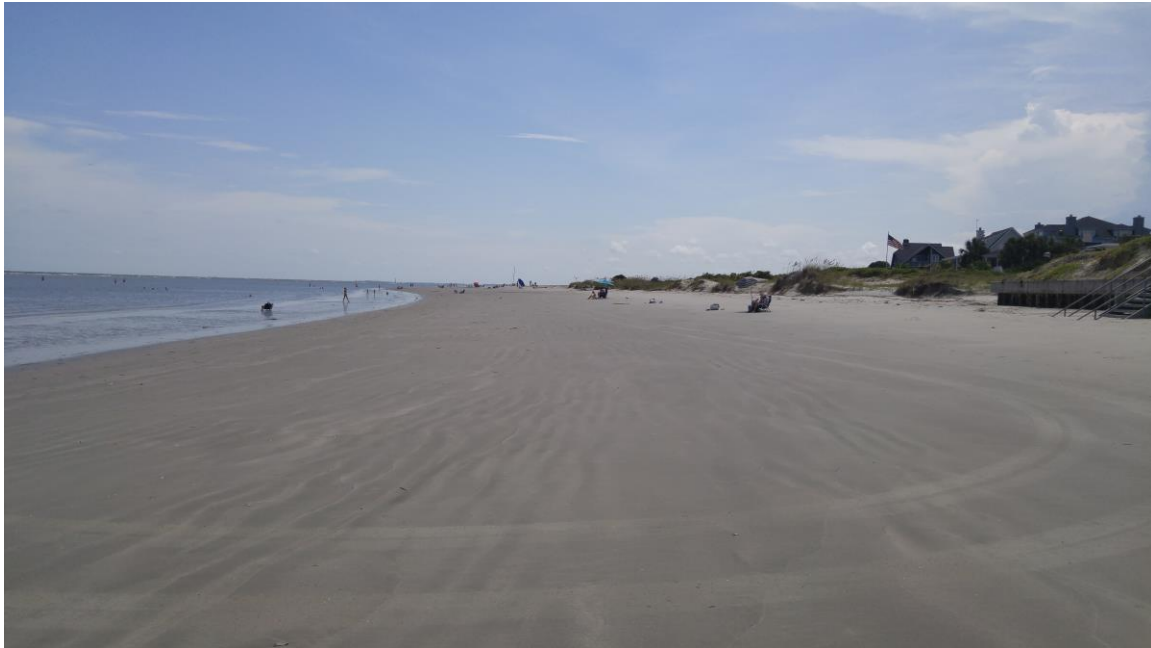
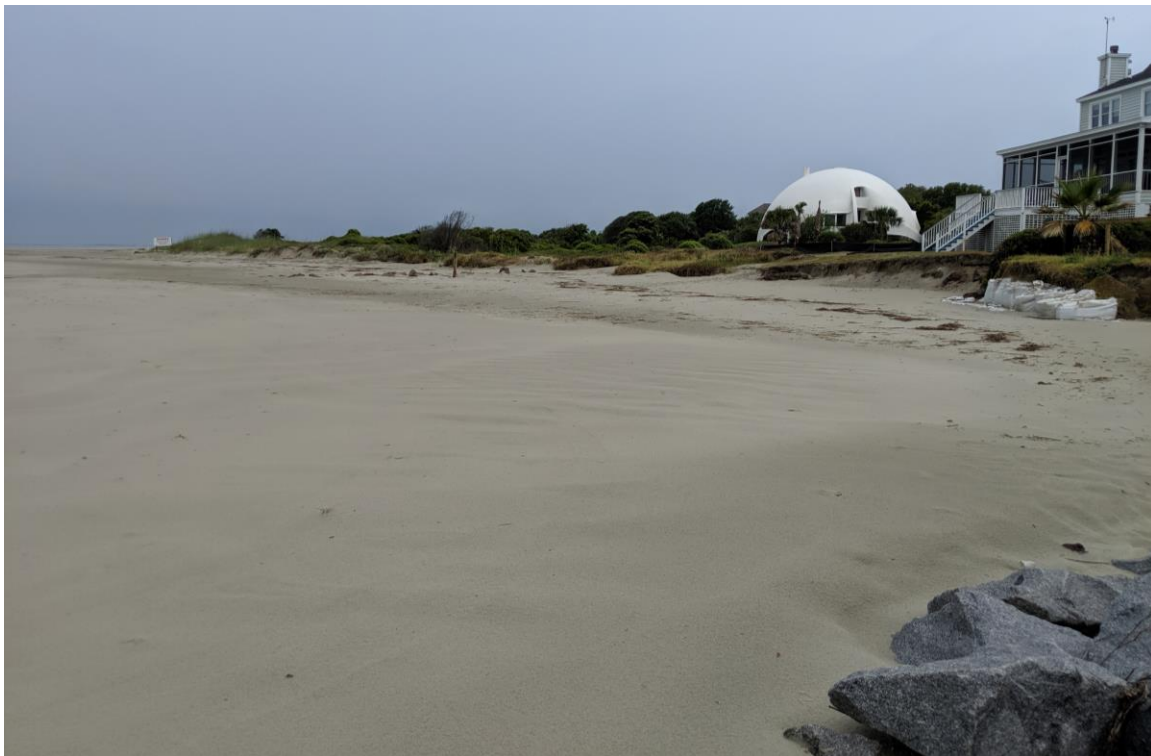
*Figure 27. Ground photo taken at Monument 3083 looking southwest on August 4, 2016 (top) and on June 6, 2019 (bottom). The entire dry beach in the 2016 photo had eroded by 2019.*

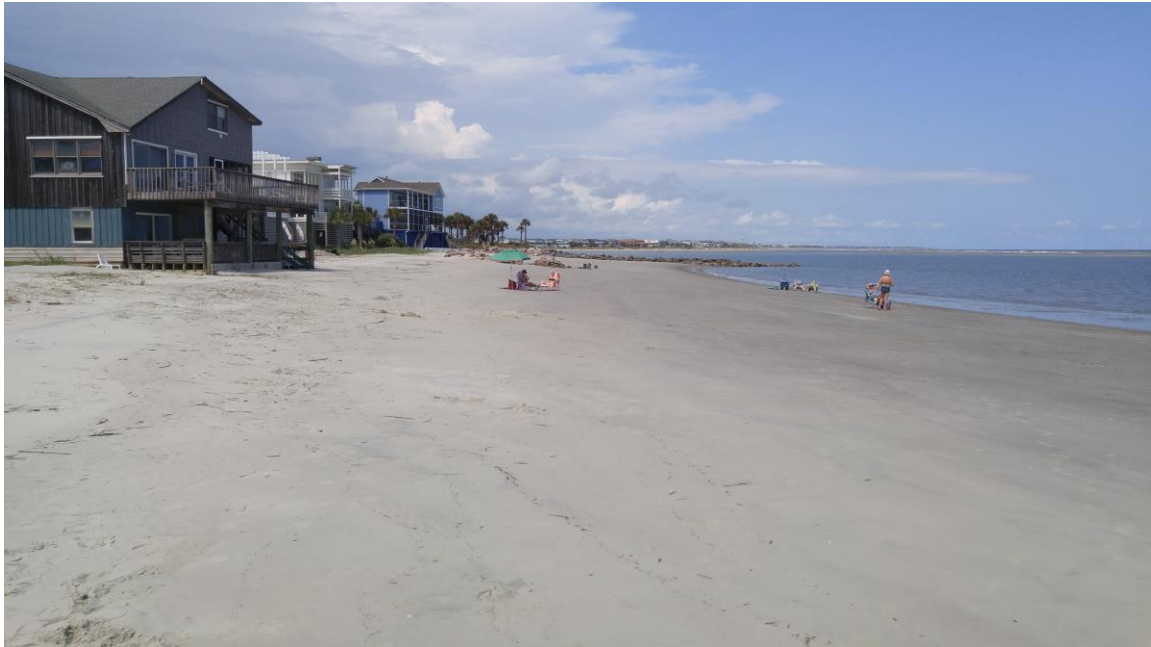
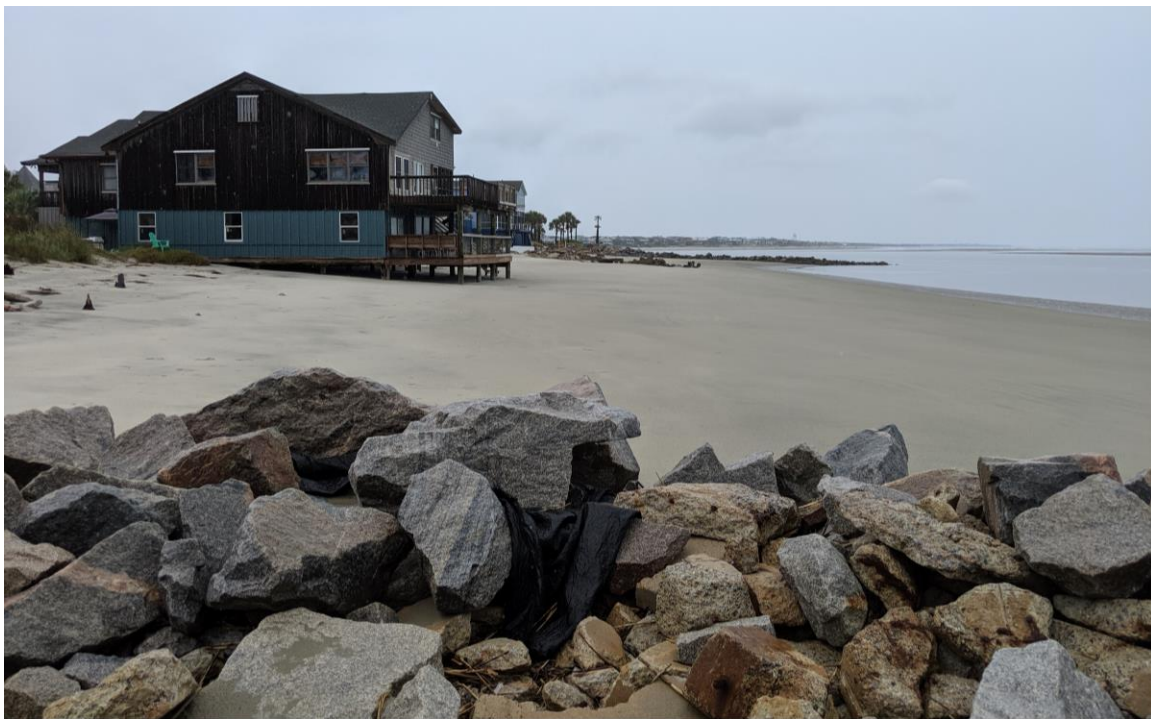
*Figure 29. Ground photo taken at Monument 3085 looking northwest on August 4, 2016 (top) and June 6, 2019 (bottom). Notice the profile deflation under the deck in 2019.*
