# 2019 Beach Monitoring Survey

TOWN OF SULLIVAN'S ISLAND, SC

Elko Coastal Consulting, Inc. | July 2019

Technical Report

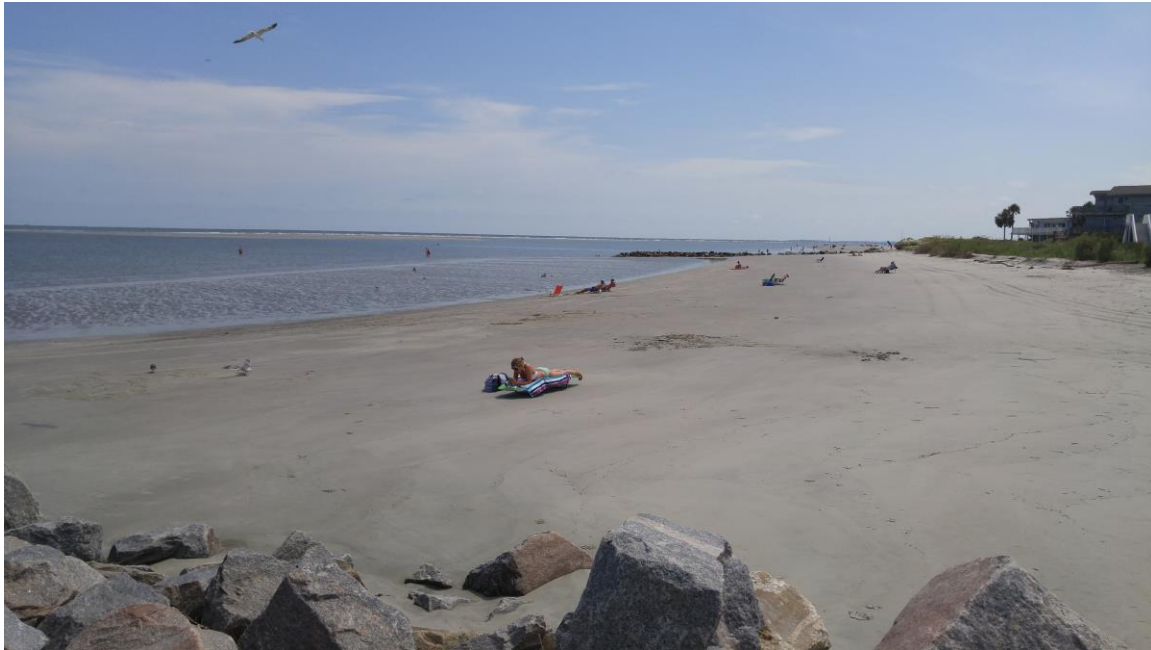
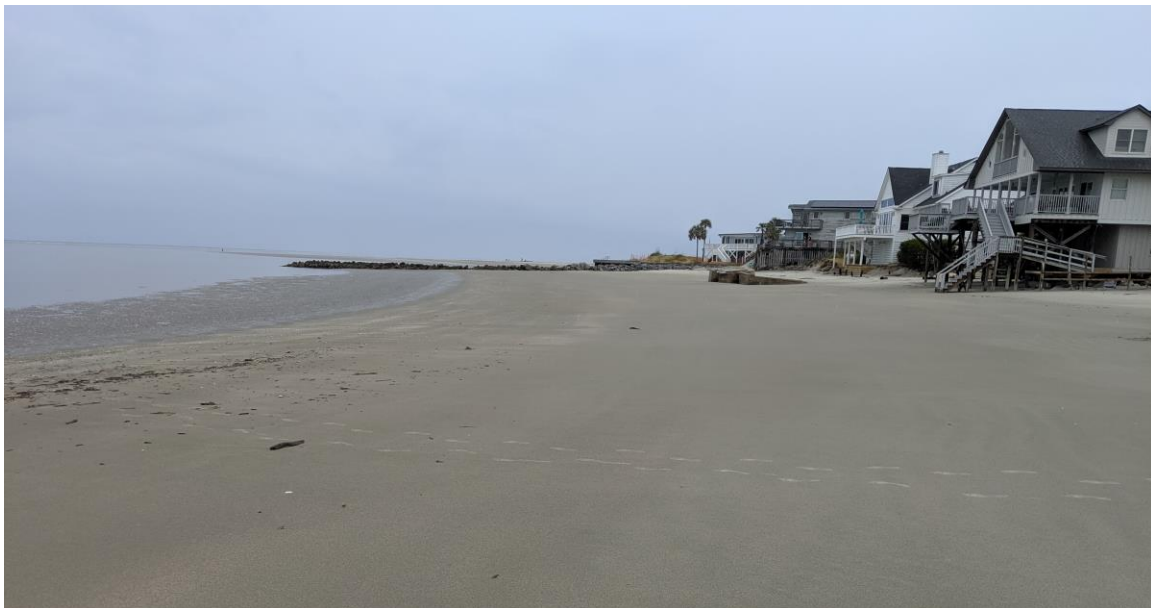
This pocket beach between groins is highly erosional. No dunes are present in front of the houses. Despite the structures, erosion continues to dominate this portion of the island between sandbar attachment events (Figure 29). Erosion has become so severe in this area that a historic cannon structure which has been buried under the beach became exposed on the beachface this year (Figure 30). This profile will be monitored closely.

*Figure 30. Ground photo taken at Monument 3085 looking southwest on August 4, 2016 (top) and June 11, 2019 (bottom). Note the exposed cannon structure and loss of dunes in the background in 2019.*

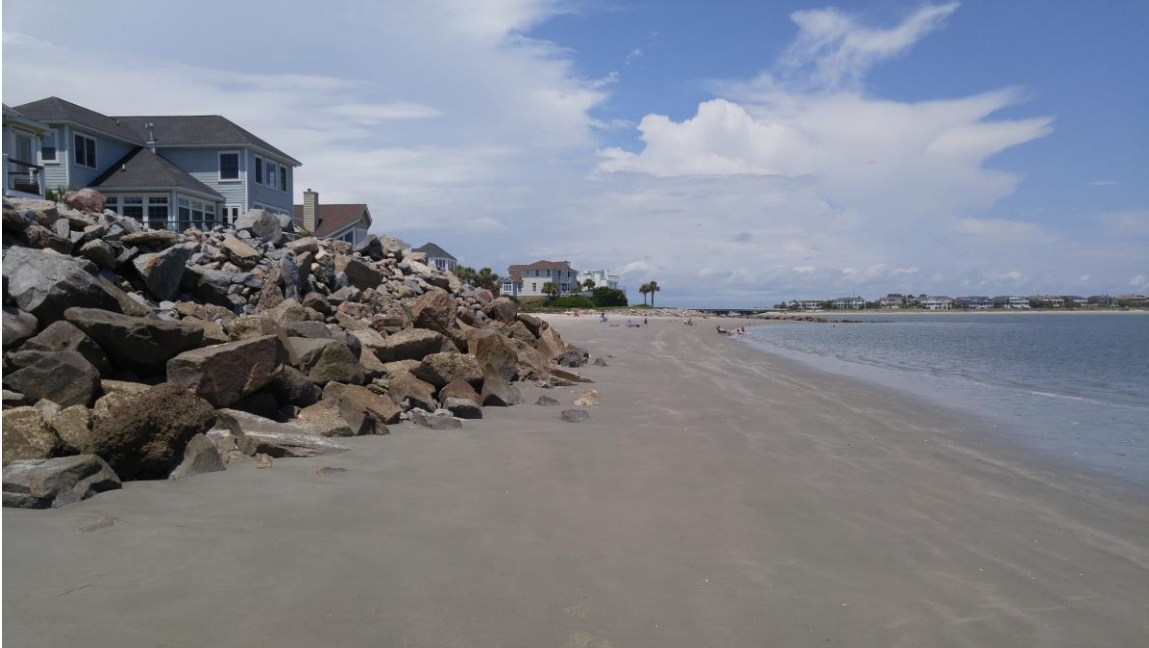
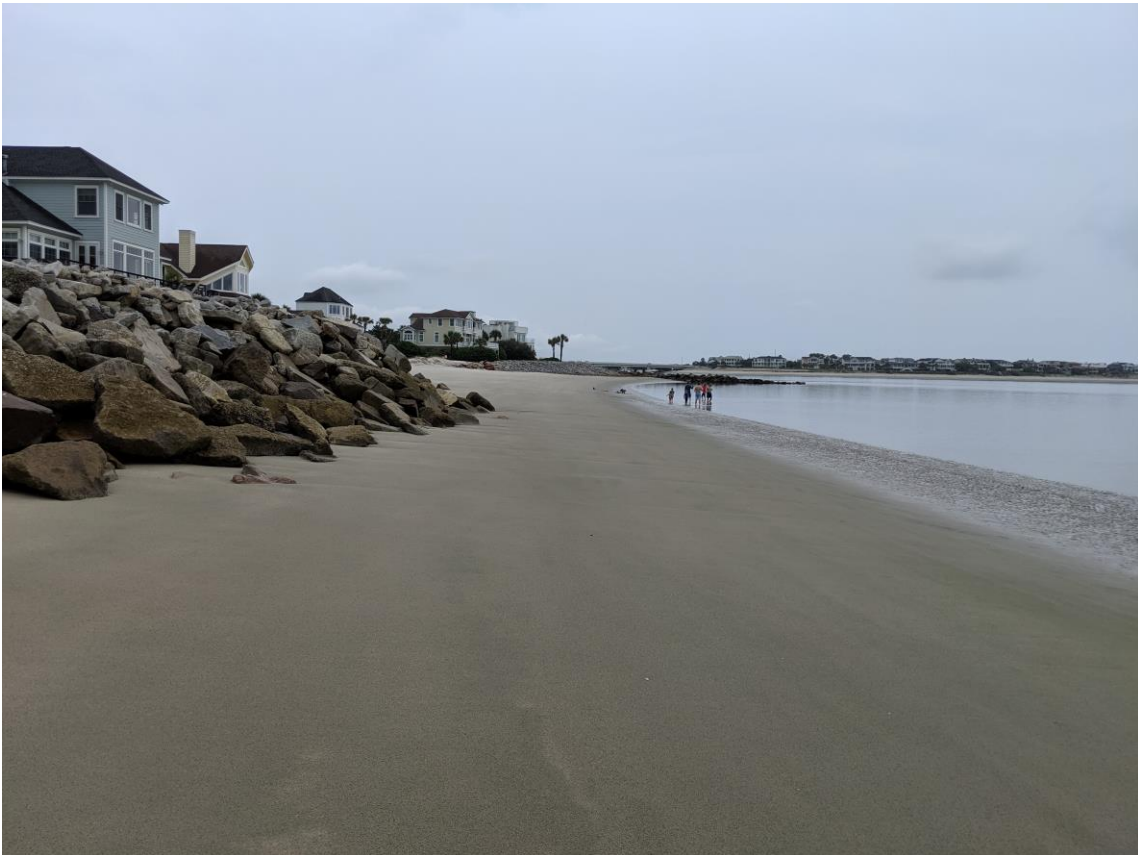
Monument 3090 is located just south of Station 31 on northeastern Sullivan's Island near Breach Inlet. It represents a small (<250 ft long) pocket beach between two groins. The beach is nearly completely armored. The beach profile has exhibited erosion despite the stabilization structures (Figure 31). No dry beach is exposed at high tide and no dunes are present. Upland erosion continued in 2019 with the high tide reaching nearly up to the road between the seawalls (Figure 32 and Figure 33).

*Figure 32. Ground photo taken at Monument 3090 looking north on August 4, 2016 (top) and June 6, 2019 (bottom).*

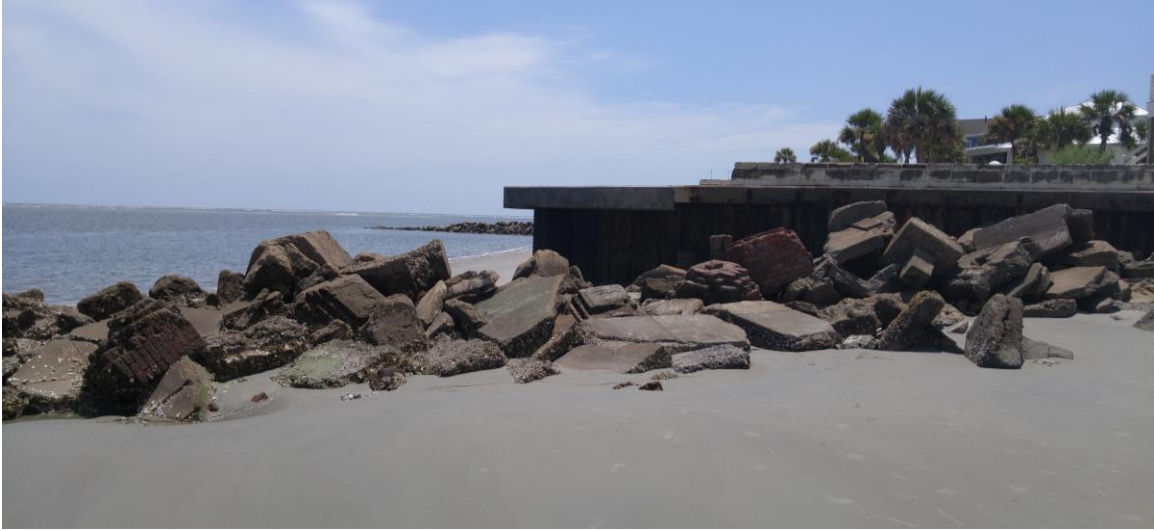
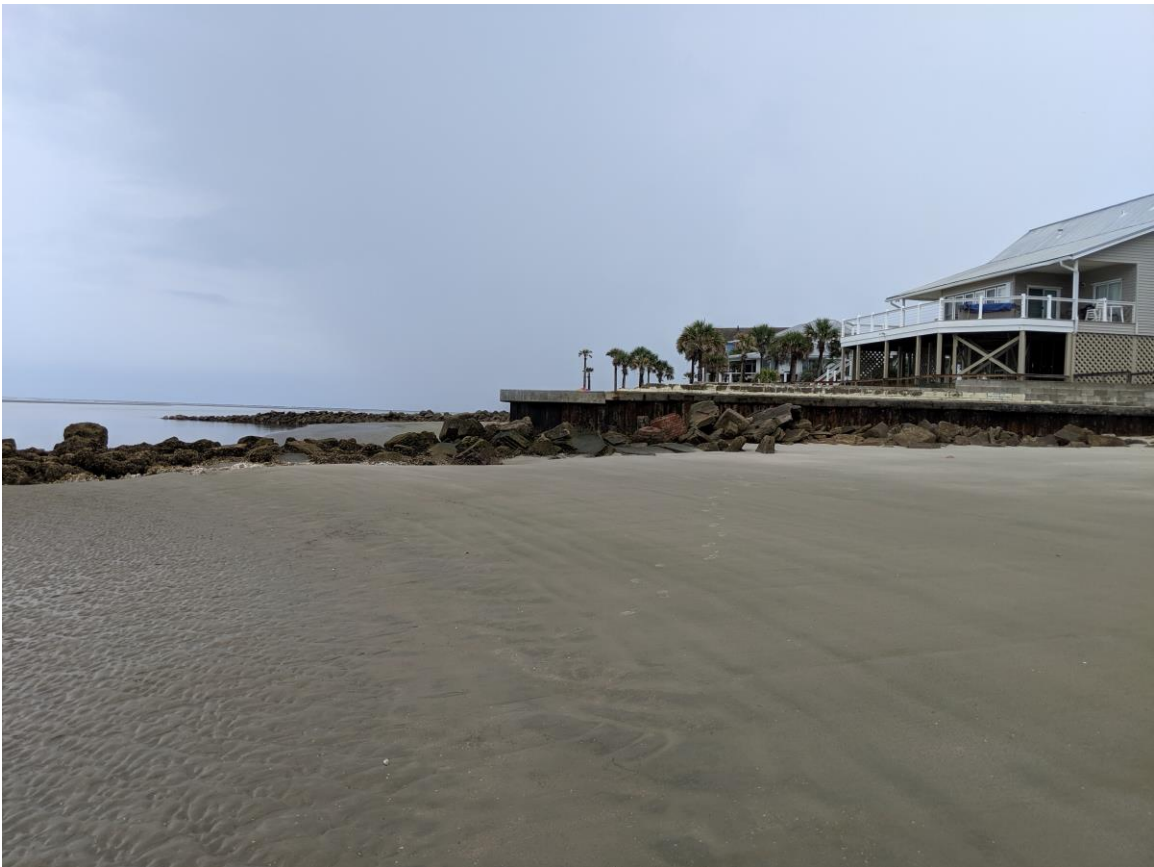
*Figure 33. Ground photo taken at Monument 3090 looking southwest on August 4, 2016 (top) and June 6, 2019 (bottom).*

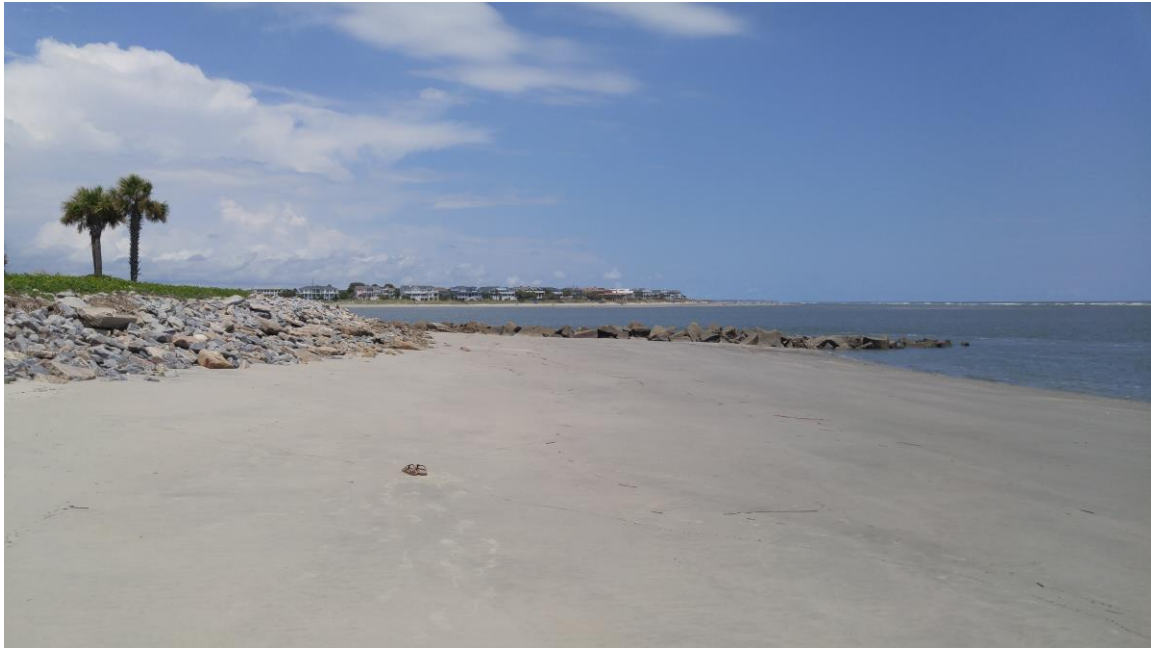
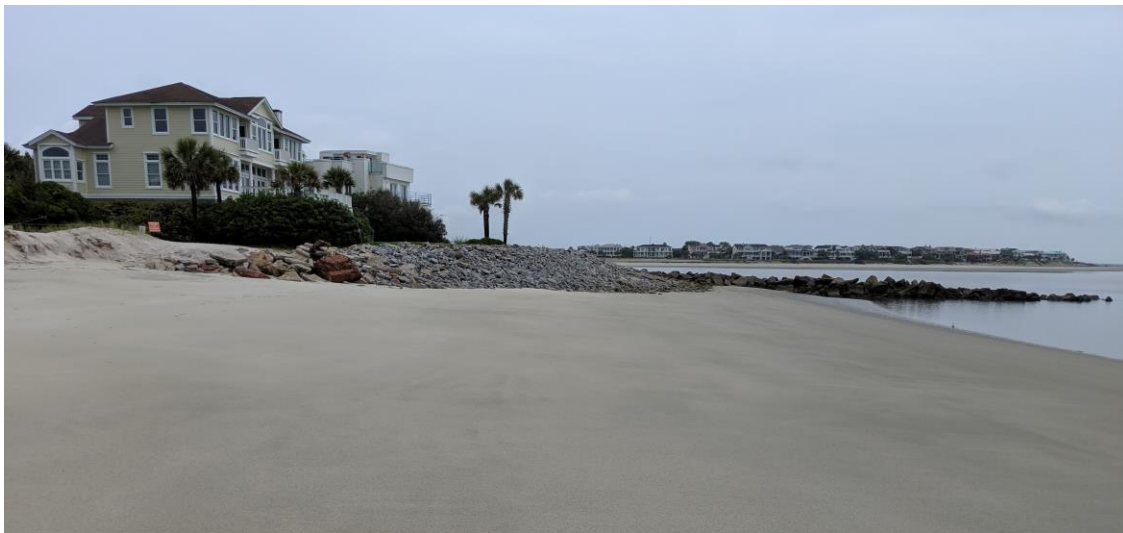
Monument 3092 is located south of Station 32 on northeastern Sullivan's Island near Breach Inlet. This profile line represents a section of the island that has been armored with erosion control structures; however, erosion continues (Figure 34). In 2019, no high tide beach existed despite a recent small-scale beach and dune restoration project installed by one of the homeowners here. The structures have somewhat stabilized this portion of the beach, but erosion continues (Figure 35 and Figure 36).

*Figure 35. Ground photo taken at Monument 3092 looking north on August 4, 2016 (top) and June 6, 2019 (bottom).*

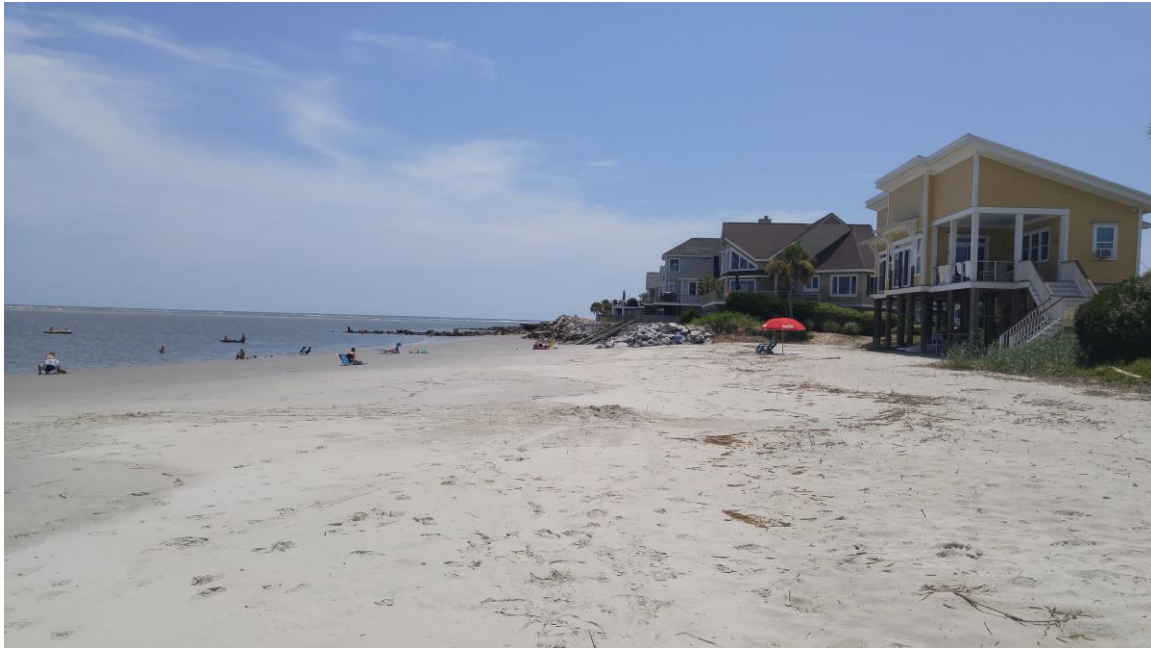
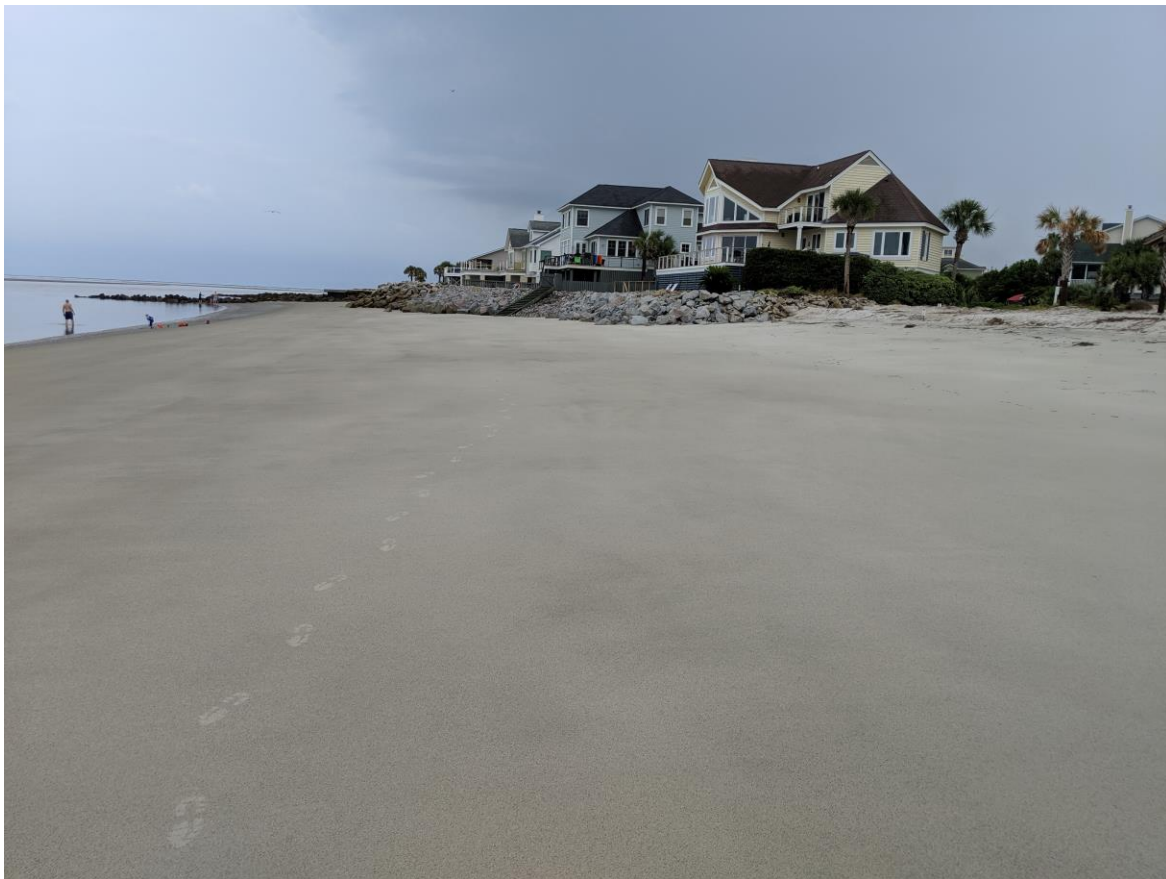
*Figure 36. Ground photo taken at Monument 3092 looking south on August 4, 2016 (top) and June 6, 2019 (bottom). The yellow house in the foreground of the 2016 photo was removed in 2017. Note the beach deflation in the background, exposing the riprap wall.*

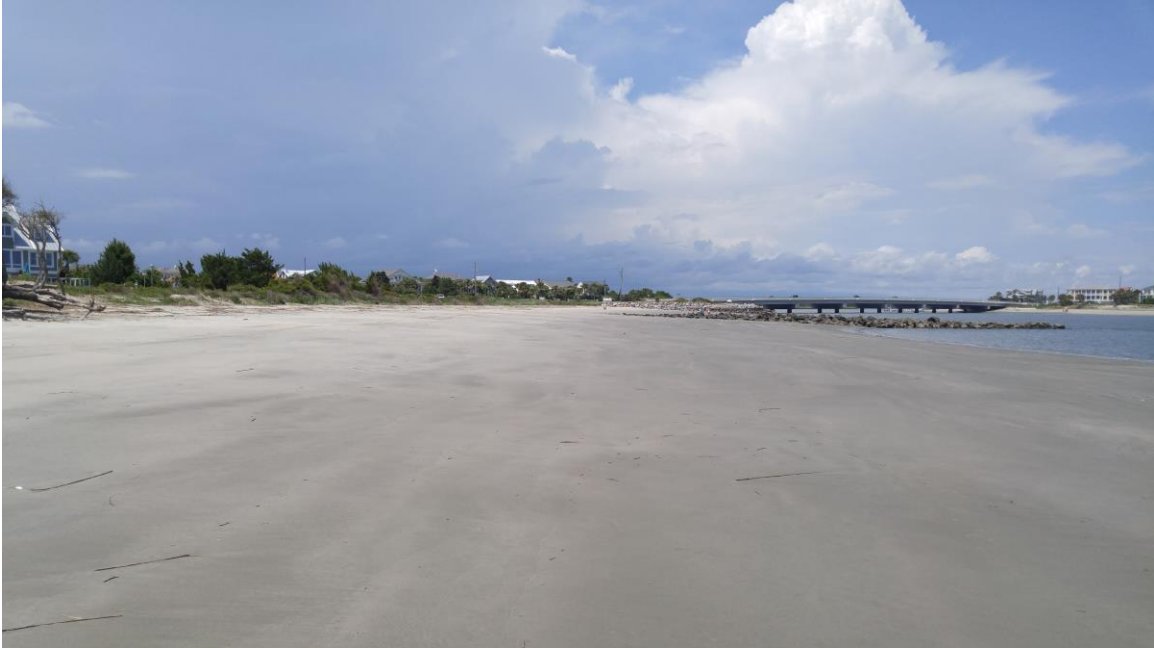
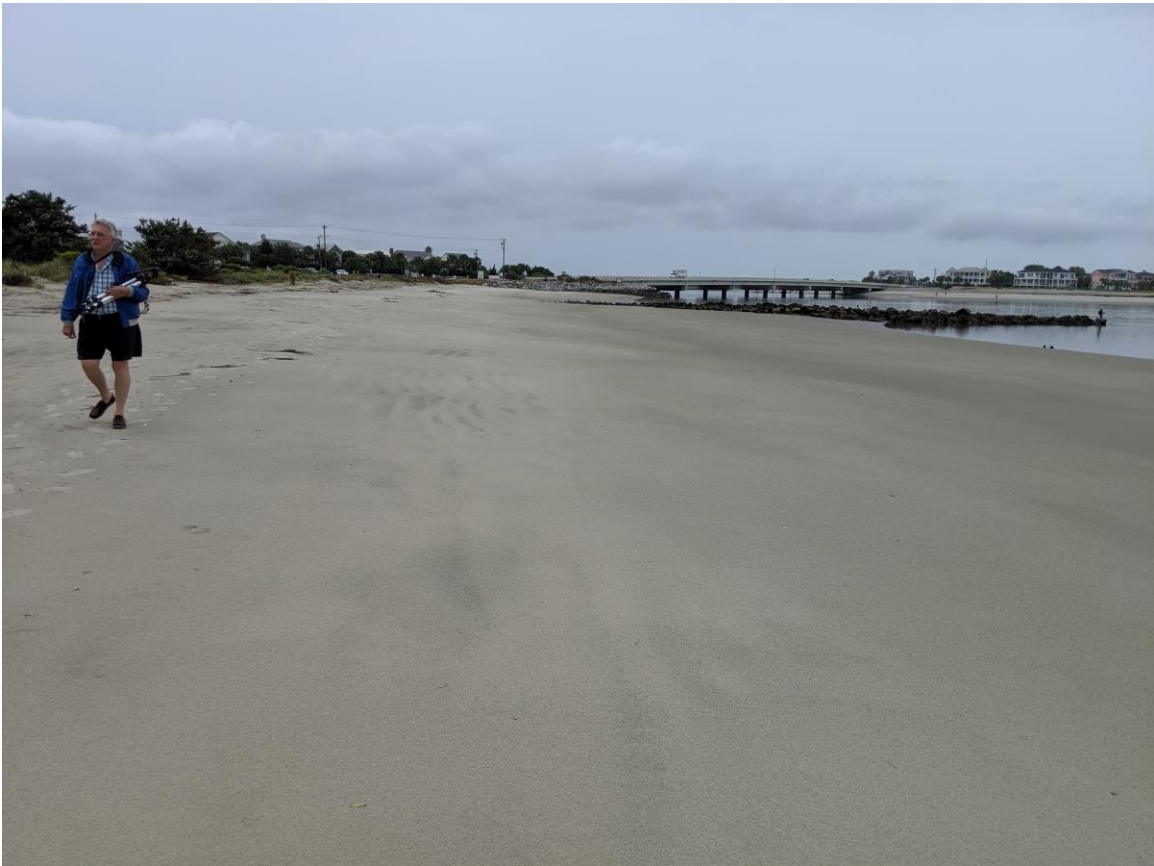
Monument 3095 is located on Station 32 at the northeastern tip of Sullivan's Island on Breach Inlet. It represents a cusped beach anchored by erosion control structures (groins). The beach profile has exhibited little change over time due to the stabilization structures (Figure 37) with the exception of continuous upland erosion and beach face deflation. In June 2019, the upland "bluff" on the southwest side of the pocket beach had retreated significantly. The spring high tides are reaching the toe of vegetation and no high tide beach exists (Figure 38 and Figure 39).

*Figure 38. Ground photo taken at Monument 3095 looking north on August 4, 2016 (top) and June 6, 2019 (bottom).*

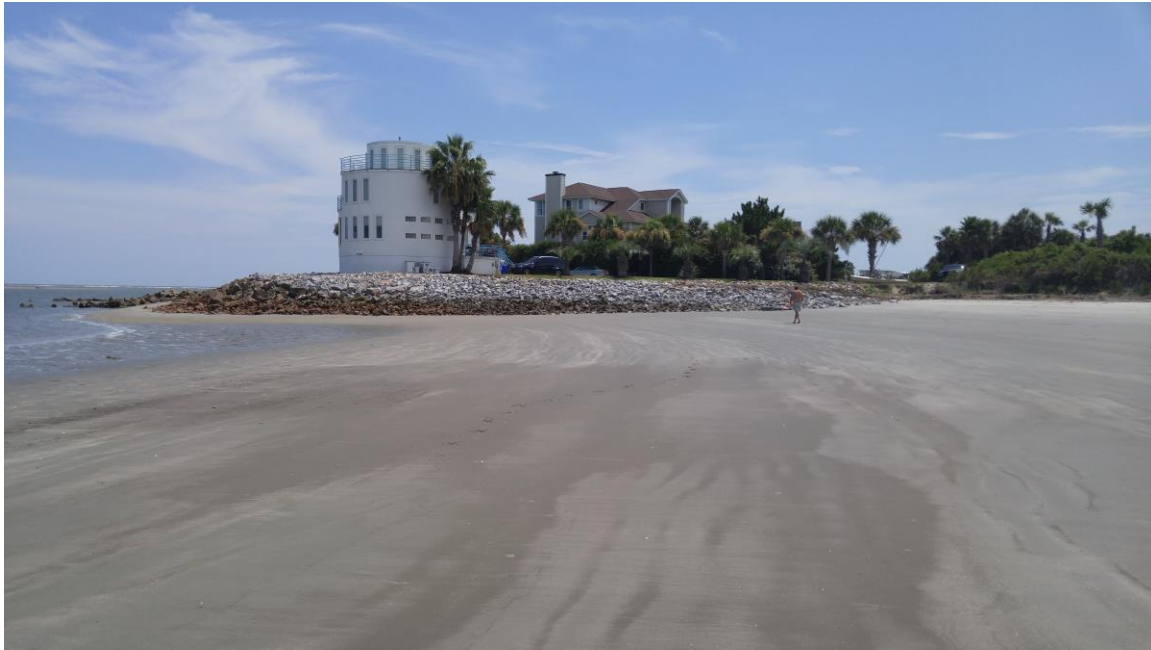
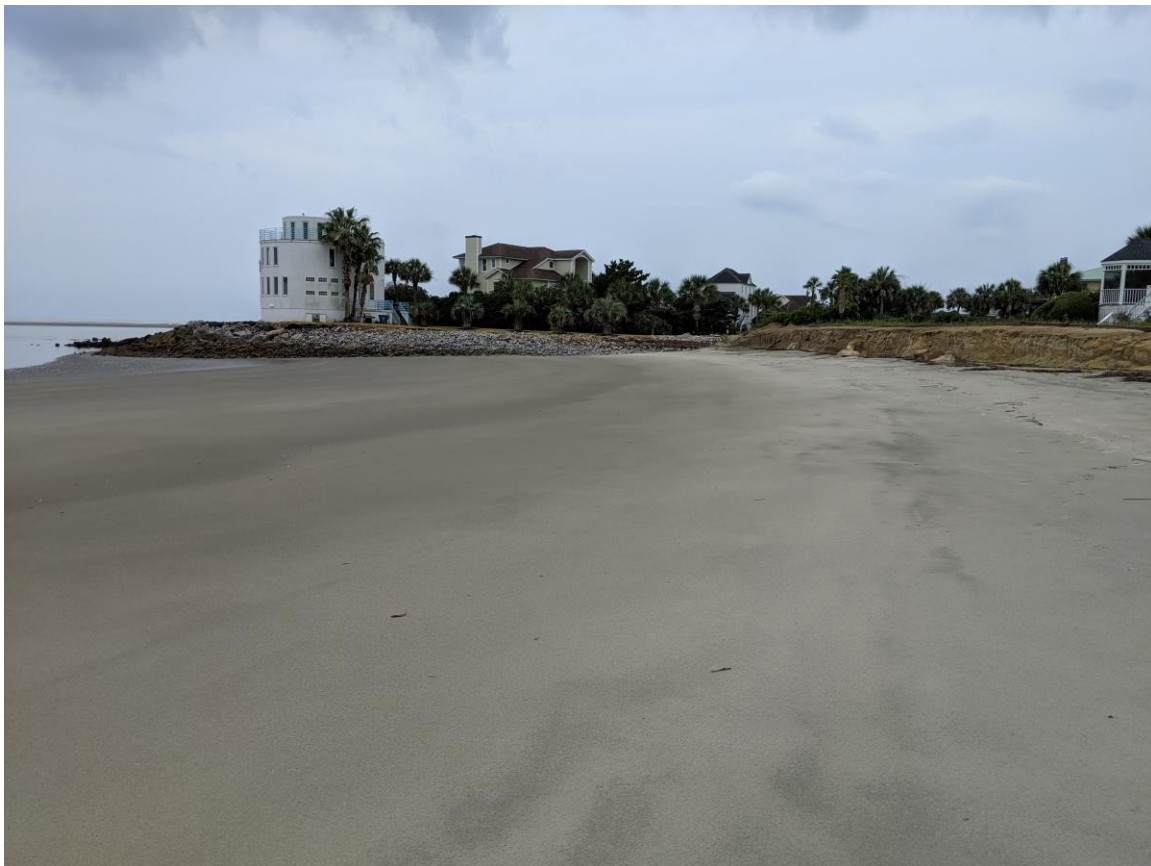
*Figure 39. Ground photo taken at Monument 3095 looking south on August 4, 2016 (top) and June 6, 2019 (bottom).*
