# TOWN OF SULLIVAN'S ISLAND, SC

Elko Coastal Consulting, Inc. | July 2017

# 2017 Beach Monitoring Survey: Town of Sullivan's Island, SC

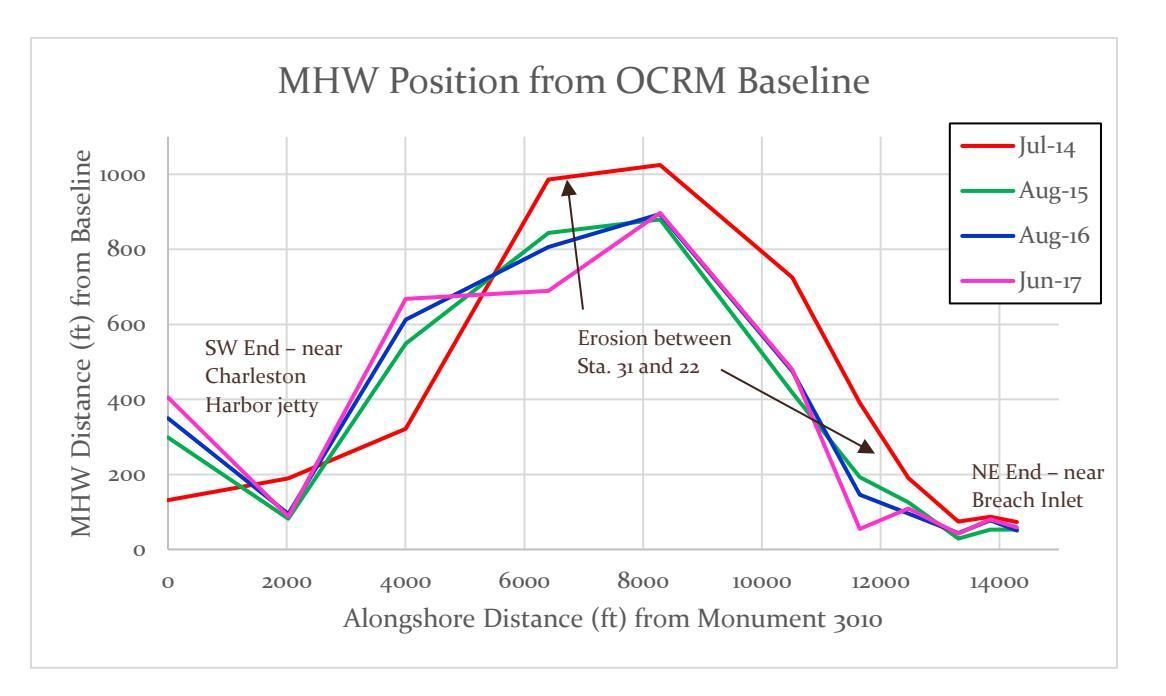
The northeast end of the island, between Monuments 3090 and 3095 and adjacent to Breach Inlet, was flagged in last year's report. It is under continual erosional pressure due to the southwesterly migration of Breach Inlet, but has been stabilized by erosion control structures. Little shoreline change occurred along this northeastern end during the study period; however, the small distance between the shoreline and the OCRM baseline suggests erosional pressure and the need for continued monitoring. There is little storm damage protection at this location.

The shoreline between Station 31 and 22 (OCRM Monuments 3050 and 3085) was also flagged in last year's report because the shoreline position moved landward an average of 180

Figure 5). This dramatic shoreline retreat has stopped and shoreline positions have stabilized at most of the monuments in this section with two previously mentioned exceptions.

*Figure 5. Annotated MHW Position graph illustrating the change in shoreline position from 2014 to 2017, as well as the distance between the shoreline and baseline.*

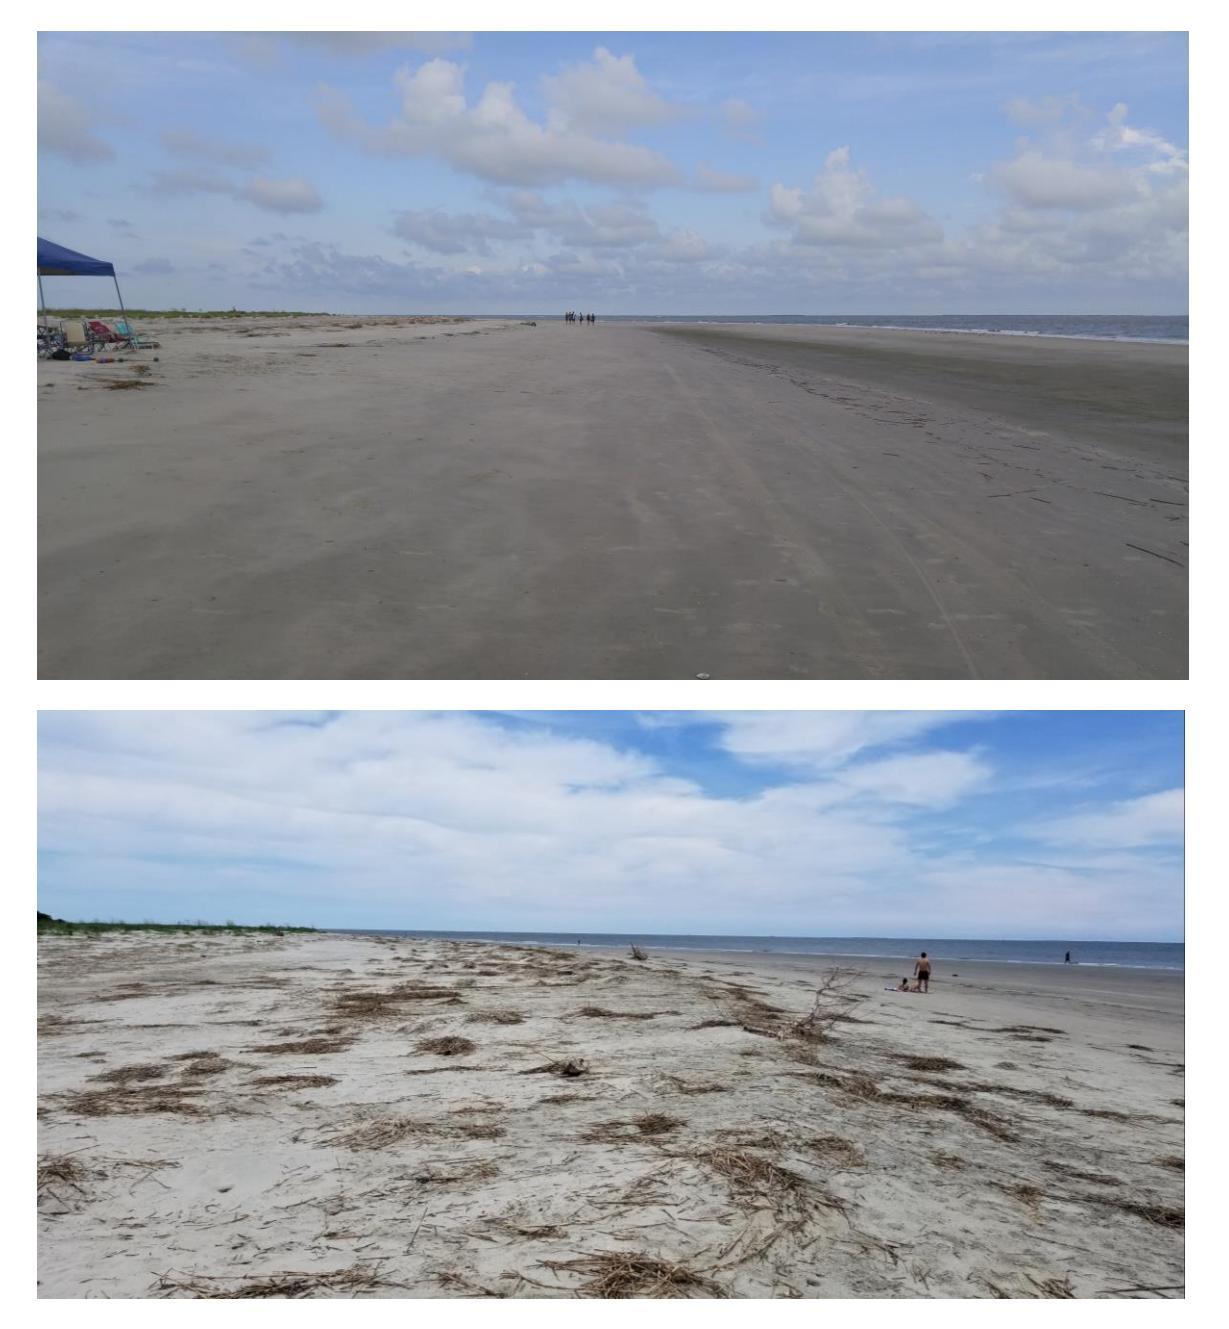
Incipient dunes were abundant at this location. The dry beach between the high tide line and the incipient dunes was wide and low with evidence of repeated recent overtopping in the form of multiple rack lines (Figure 8 and Figure 9).

Figure 8. Ground photo taken at Monument 3010 looking east on August 4, 2016 (top) and June 12, 2017 (bottom). Note the higher elevation of the berm in 2017.

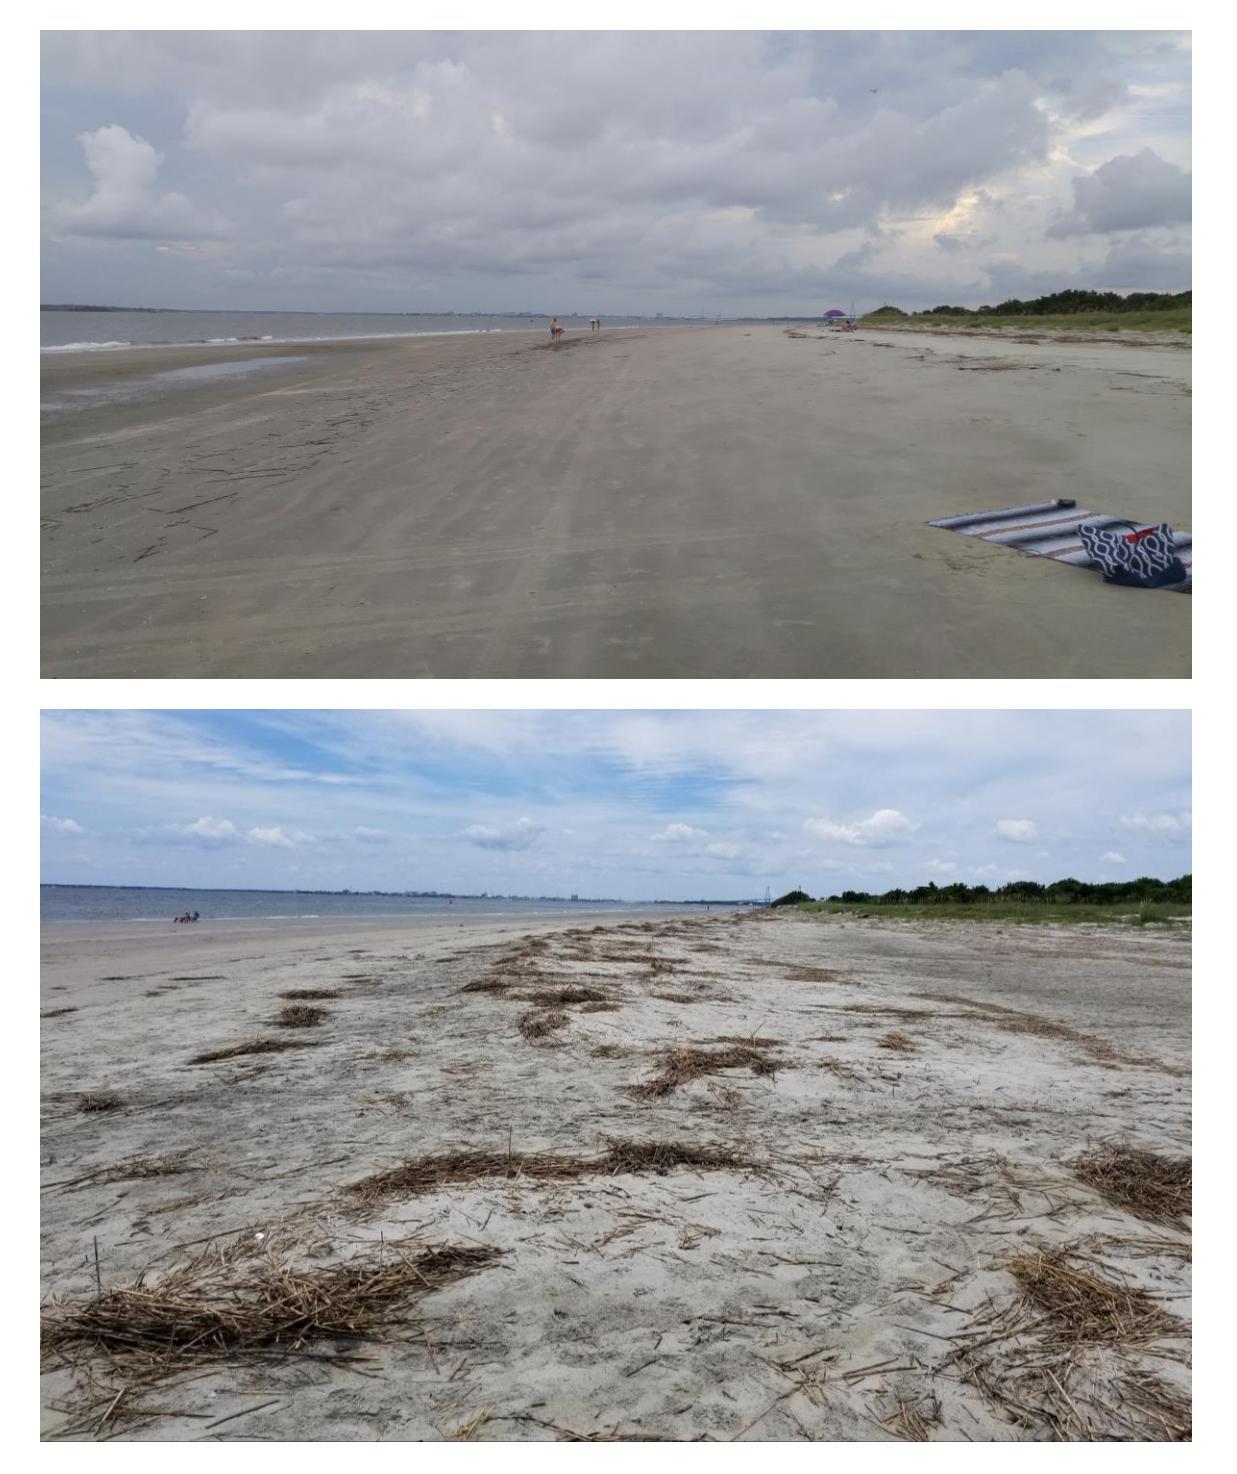
Figure 9. Ground photo taken at Monument 3010 looking west on August 4, 2016 (top) and June 12, 2017 (bottom). Note the higher elevation of the berm in 2017.

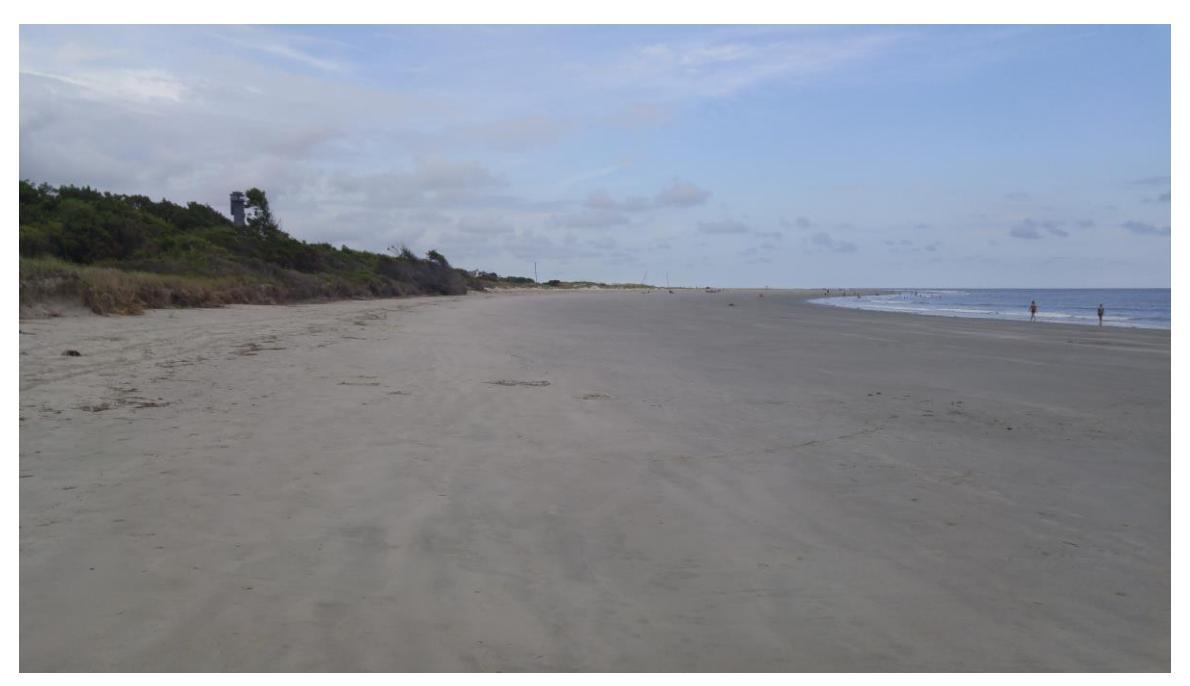
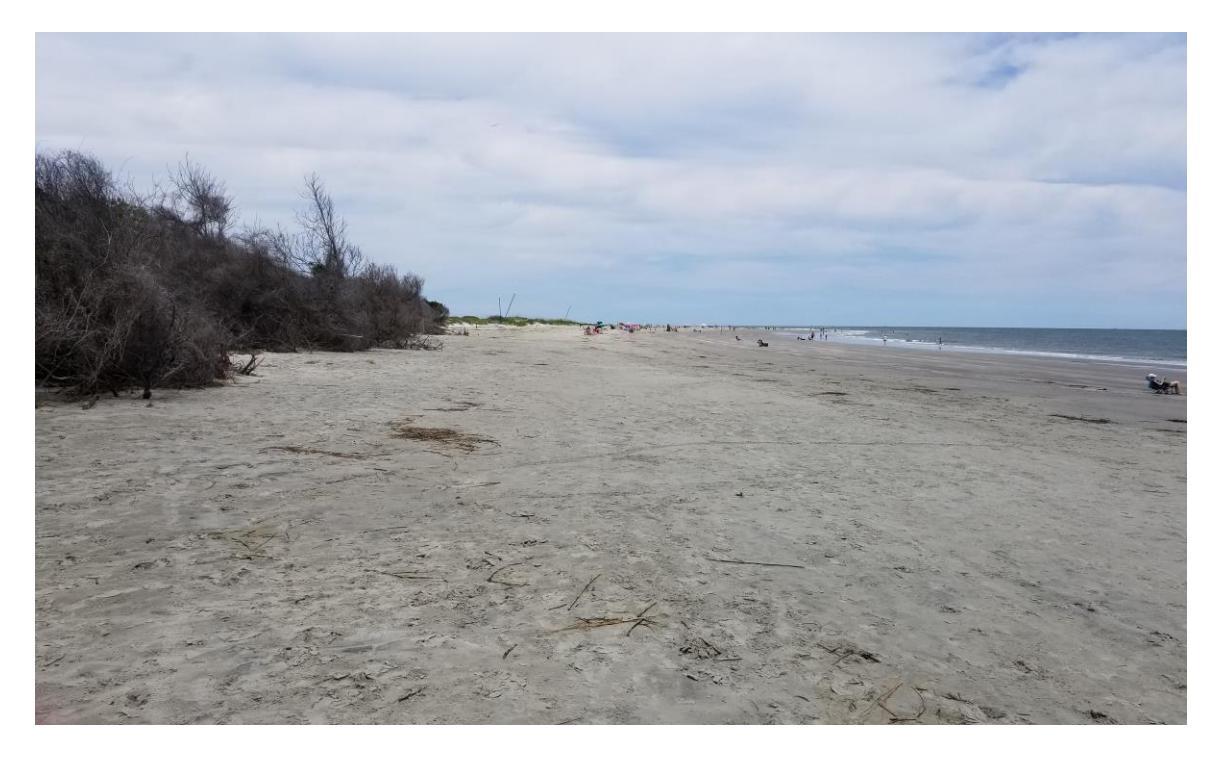
Monument 3020 is located along the long beach access path at the Sand Dunes Club. As in 2016, the beach at Monument 3020 exhibited erosional conditions in contrast to the beach conditions at the two adjacent monuments in June 2017. All dune vegetation here has been removed and the toe of vegetation location is occupied by dead trees. Evidence of a high storm tide also exists extending landward into the adjacent maritime forest, likely due to Hurricane Matthew. Matthew's storm surge likely eroded the frontal dune that existed in 2016 (Figure 10). More recently, there is some evidence of recovery with storm high tides not reaching the (dead) vegetation, but rather stopping about 30 ft seaward.

Figure 11. Ground photo taken at Monument 3020 looking northeast on August 4, 2016 (top) and June 12, 2017 (bottom).

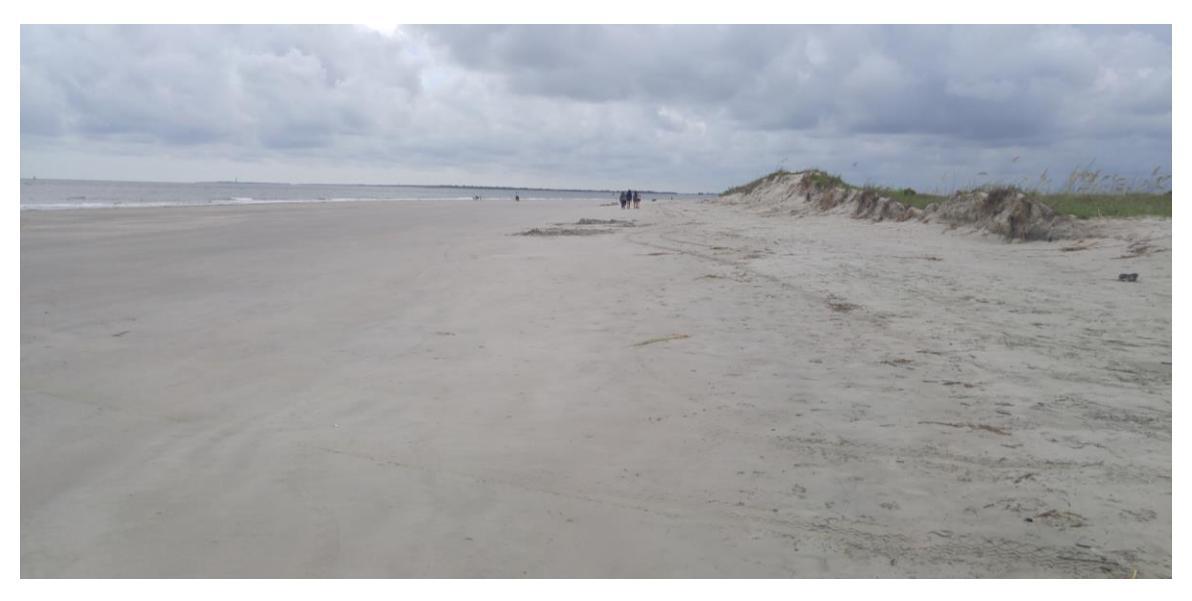
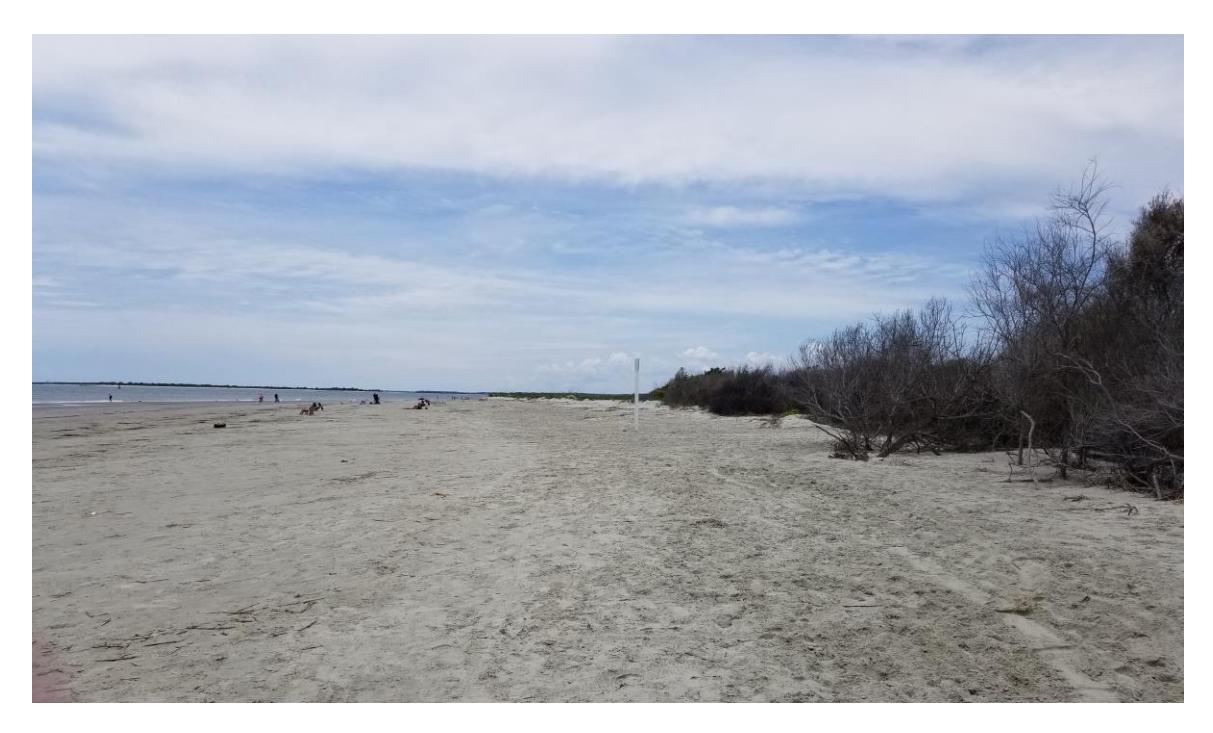
Hurricane Matthew was not solely responsible for the condition of the beach at this location. Significant erosion has taken place here since 2014 that included loss of a large dune and submerged nearshore sand body (Figure 10). Now, sediment in the offshore sandbar is accumulating and the bar is migrating onshore. A sand bar was attaching to the updrift beach (Figure 11) in 2017. Both may eventually supply sediment to this location. Considerable ongoing dune erosion was evident to the southwest in 2016, but some recovery was evident in 2017

*Figure 12. Ground photo taken at Monument 3020 looking southwest on August 4, 2016 (top) and June 12, 2017 (bottom). Note the recovery of dune vegetation to the southwest in 2017.*

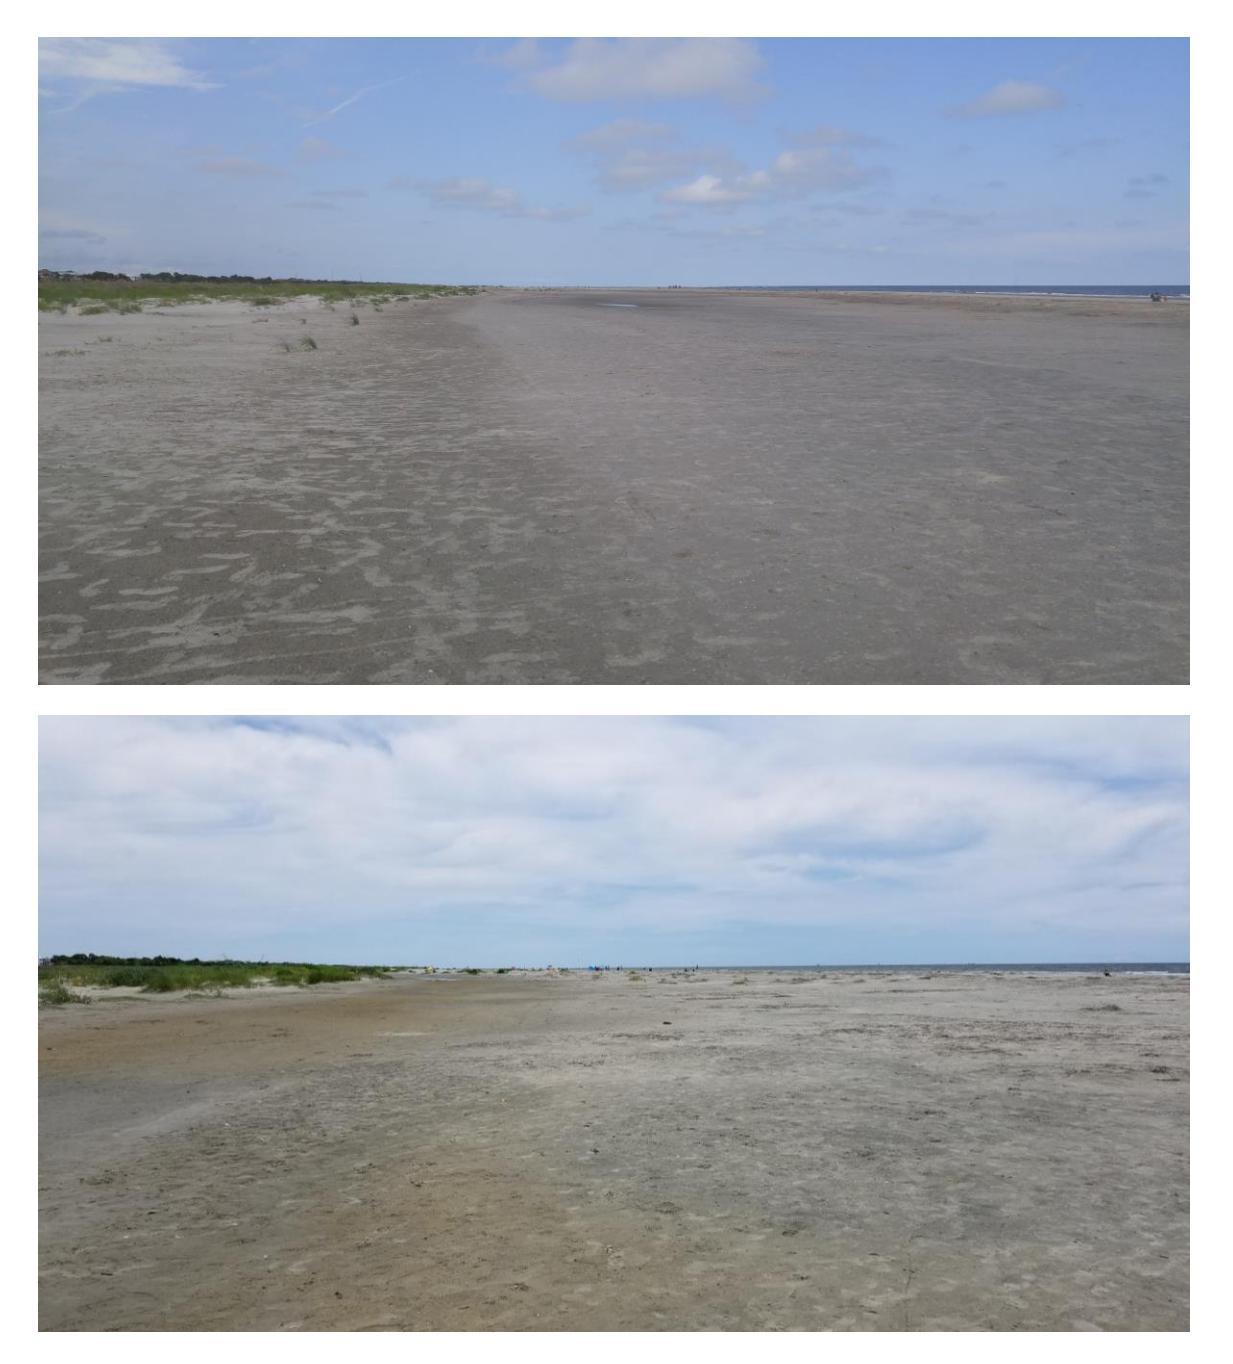
Monument 3035 is located along the long beach access path at Station 19. This area has been the beneficiary of the 2014 sandbar attachment event (Figure 13). The beach was wide and accreting in August 2016 and June 2017 with about 120 ft of dry beach between the vegetation line and the high tide line (Figure 14 and Figure 15). Continued accretion has occurred between 2016 and 2017 with the growth of the incipient dunes (Figure 15). Ponding was observed during both years in the backbeach (Figure 14), which is common on very wide, accreting beaches.

Figure 14. Ground photo taken at Monument 3035 looking northeast on August 4, 2016 (top) and June 12, 2017 (bottom). Note the ponding on the backbeach.

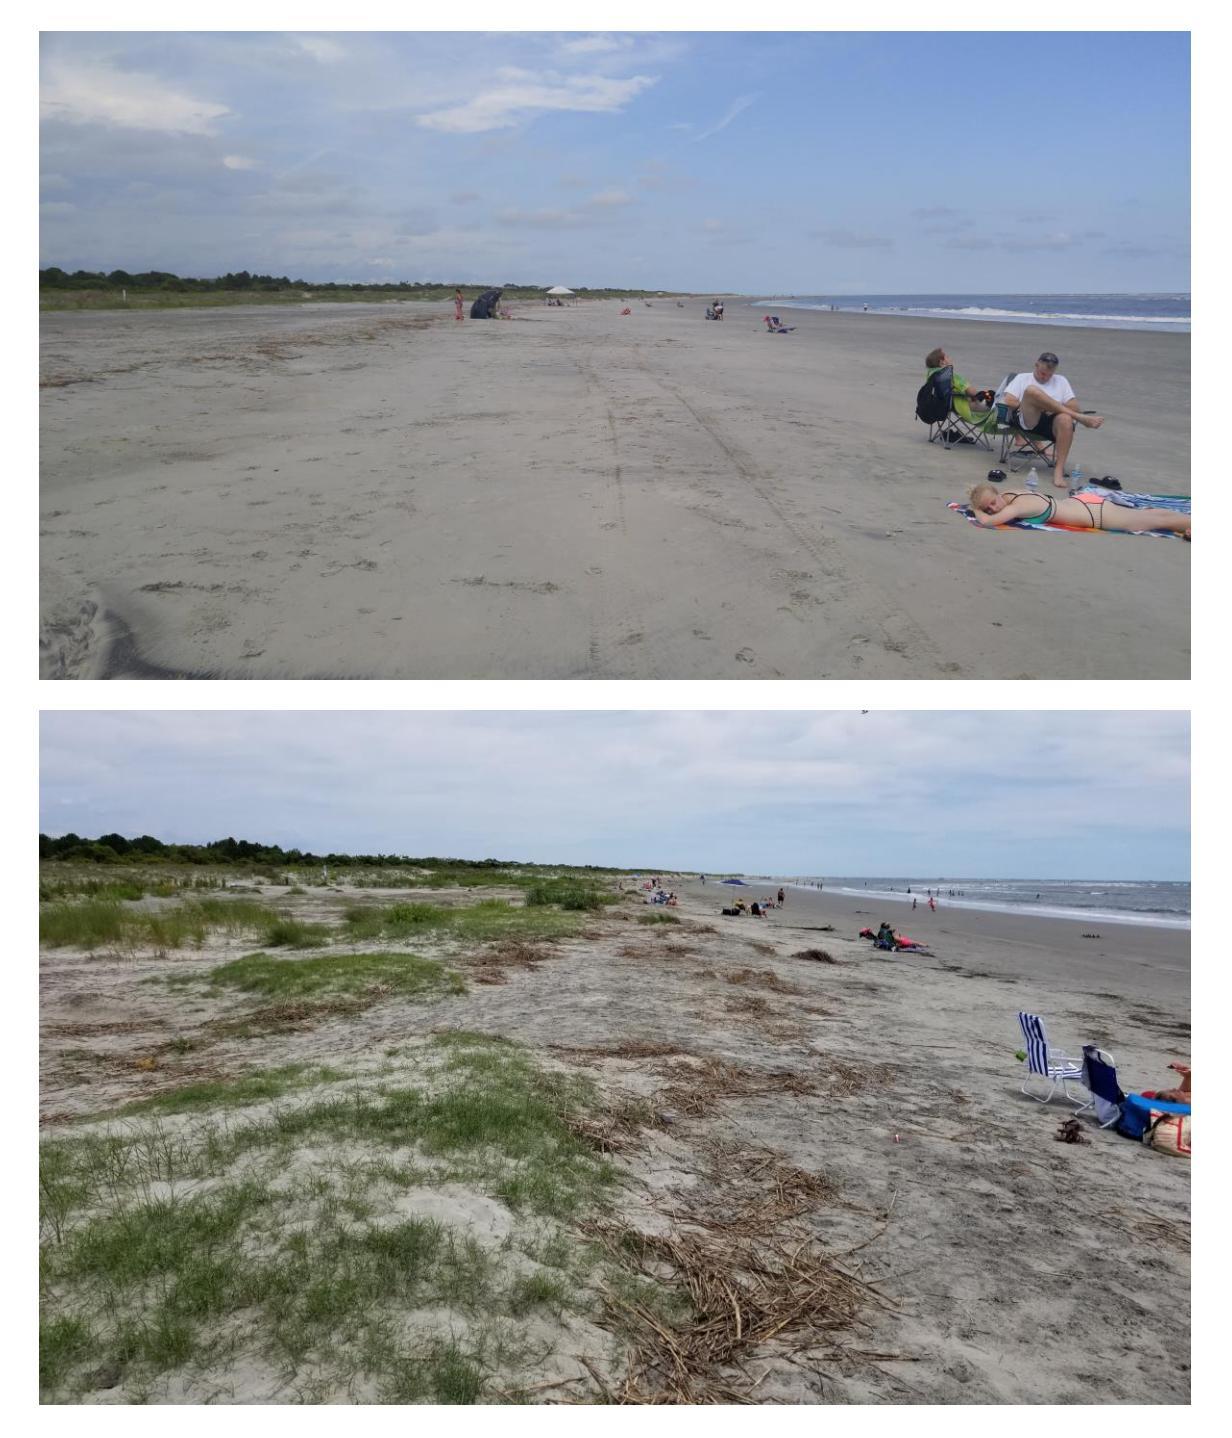
Monument 3050 is located along the long beach access path at Station 22 in the center of the island. Beach profile data indicate the recent sand bar attachment event that occurred here in 2014 (Figure 16). Over the last four years, sediment from this attachment bar has welded to the shoreface and resulted in the 2017 beach which includes a higher primary dune and a slightly reduced berm width. In 2017, a substantial amount of accretion was evident along the berm and backbeach with evidence of multiple storm events (rack lines) intermixed with incipient dune formation.

*Figure 17. Ground photo taken at Monument 3050 looking northeast on August 4, 2016 (top) and June 12, 2017 (bottom). Note the accretion and incipient dune formation along the backbeach in 2017.*

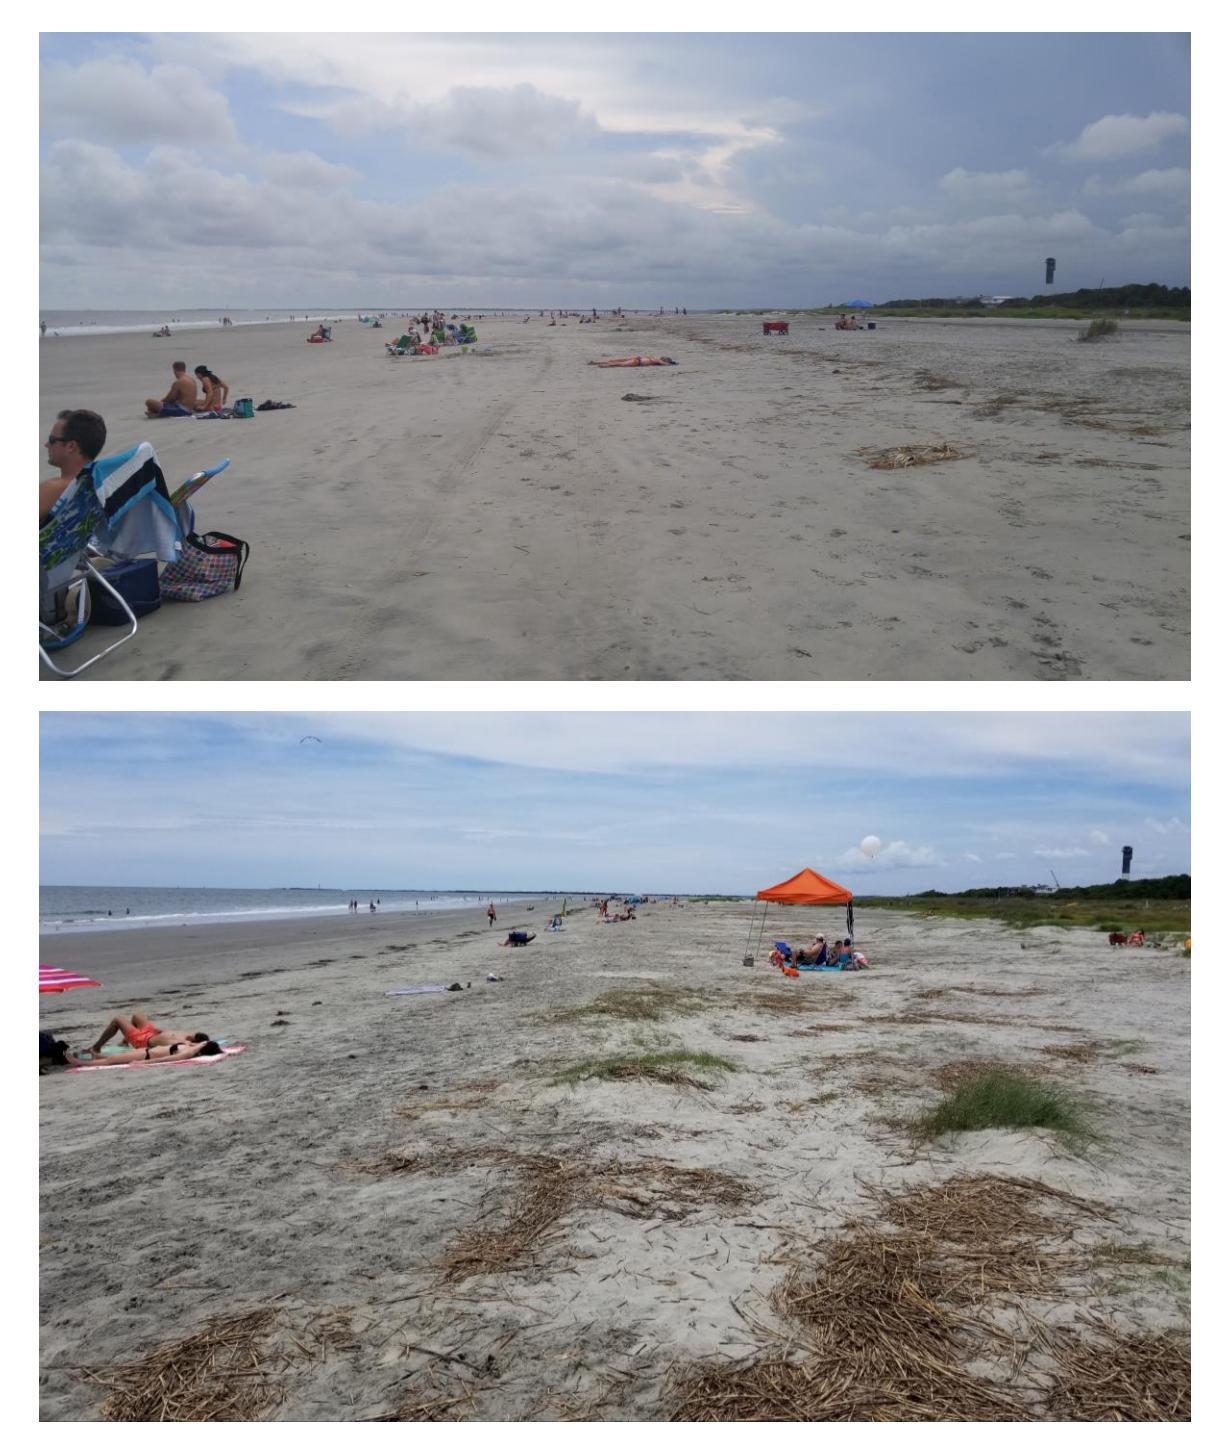
*Figure 18. Ground photo taken at Monument 3050 looking southwest on August 4, 2016 (top) and June 12, 2017 (bottom). Note the accretion and incipient dune formation along the backbeach in 2017.*

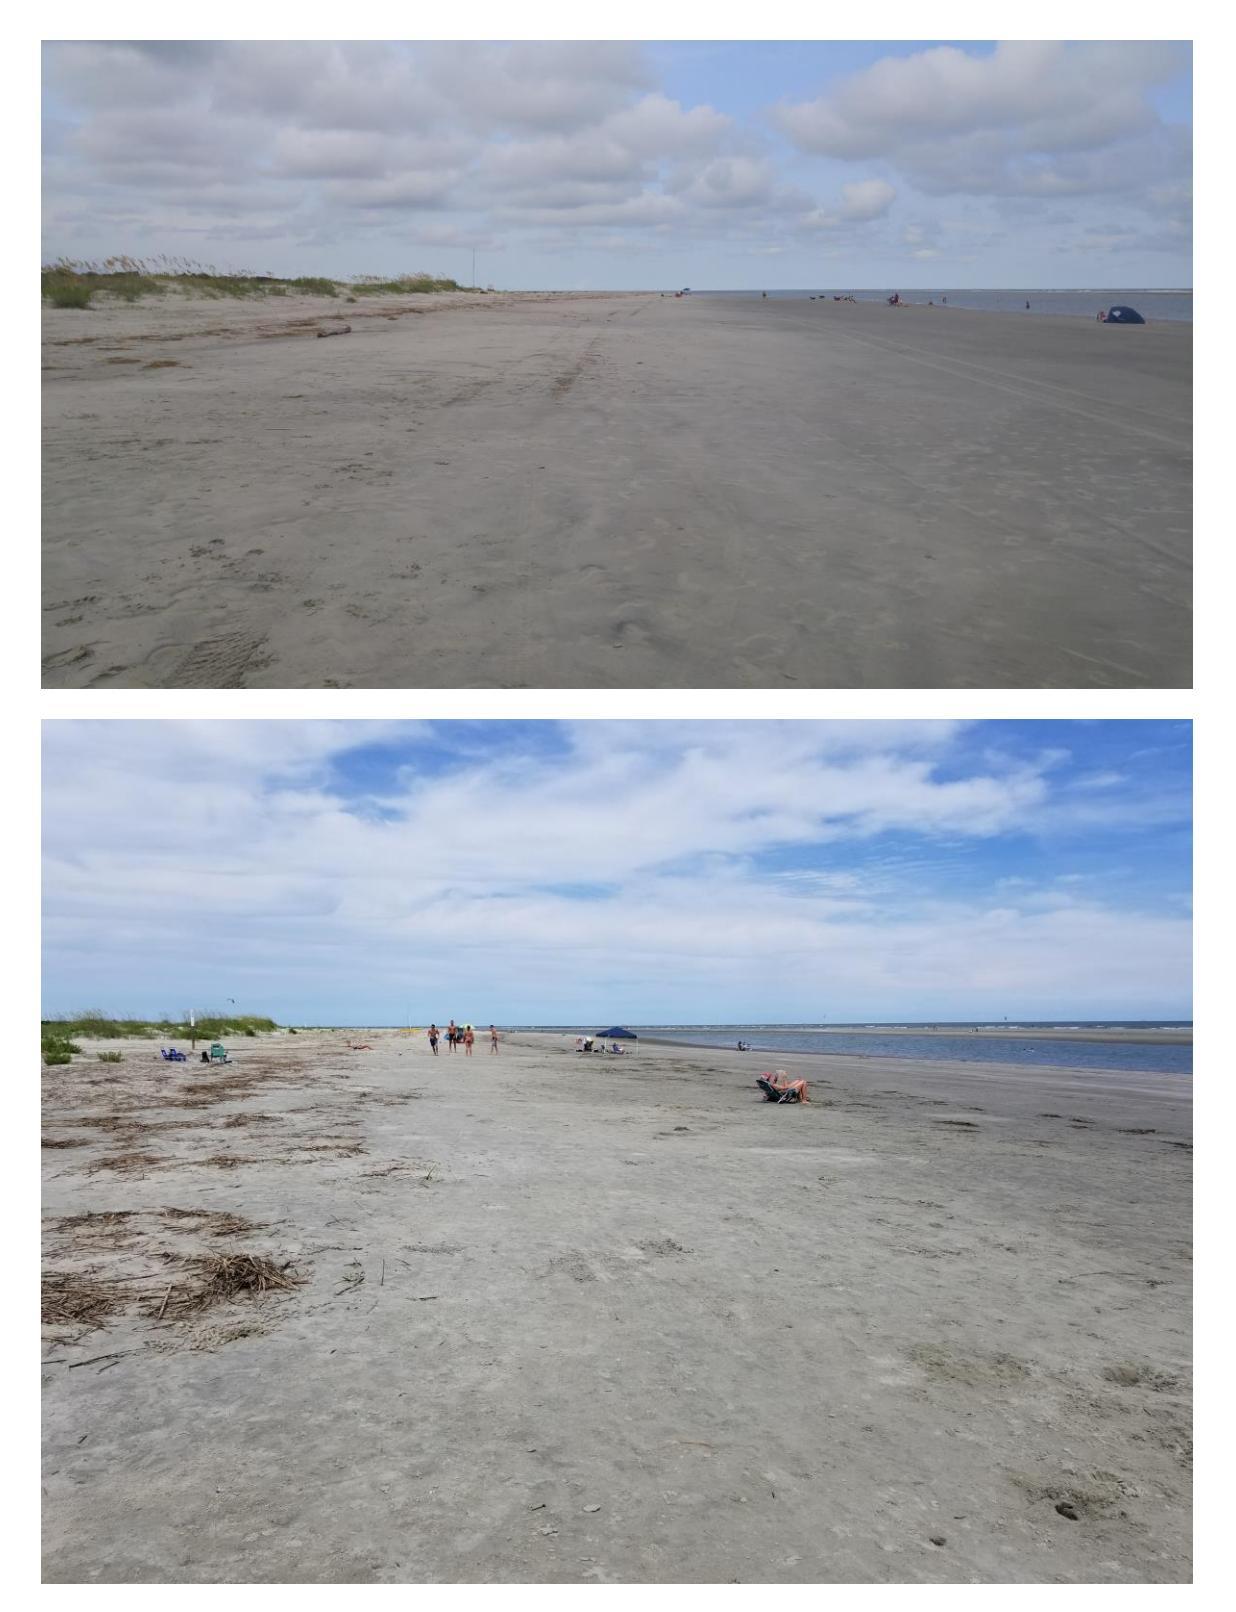
This is the sandbar attachment point. In June 2017, another sandbar was attaching to the beach profile. Prior to the attachment of this sandbar, past beach profile data indicated substantial beachface erosion following the 2014 attachment event (Figure 19). In 2017, incipient dunes were forming and accretional conditions were dominant. The recent storm rack line was 15 ft from the toe of vegetation with some evidence of previous dune erosion. The dry beach is 50 ft wide at high tide. exhibits a wide, gently sloping low tide terrace and a robust dune system (Figure 20 and Figure 21).

Figure 20. Ground photo taken at Monument 3065 looking northeast on August 4, 2016 (top) and June 12, 2017 (bottom).

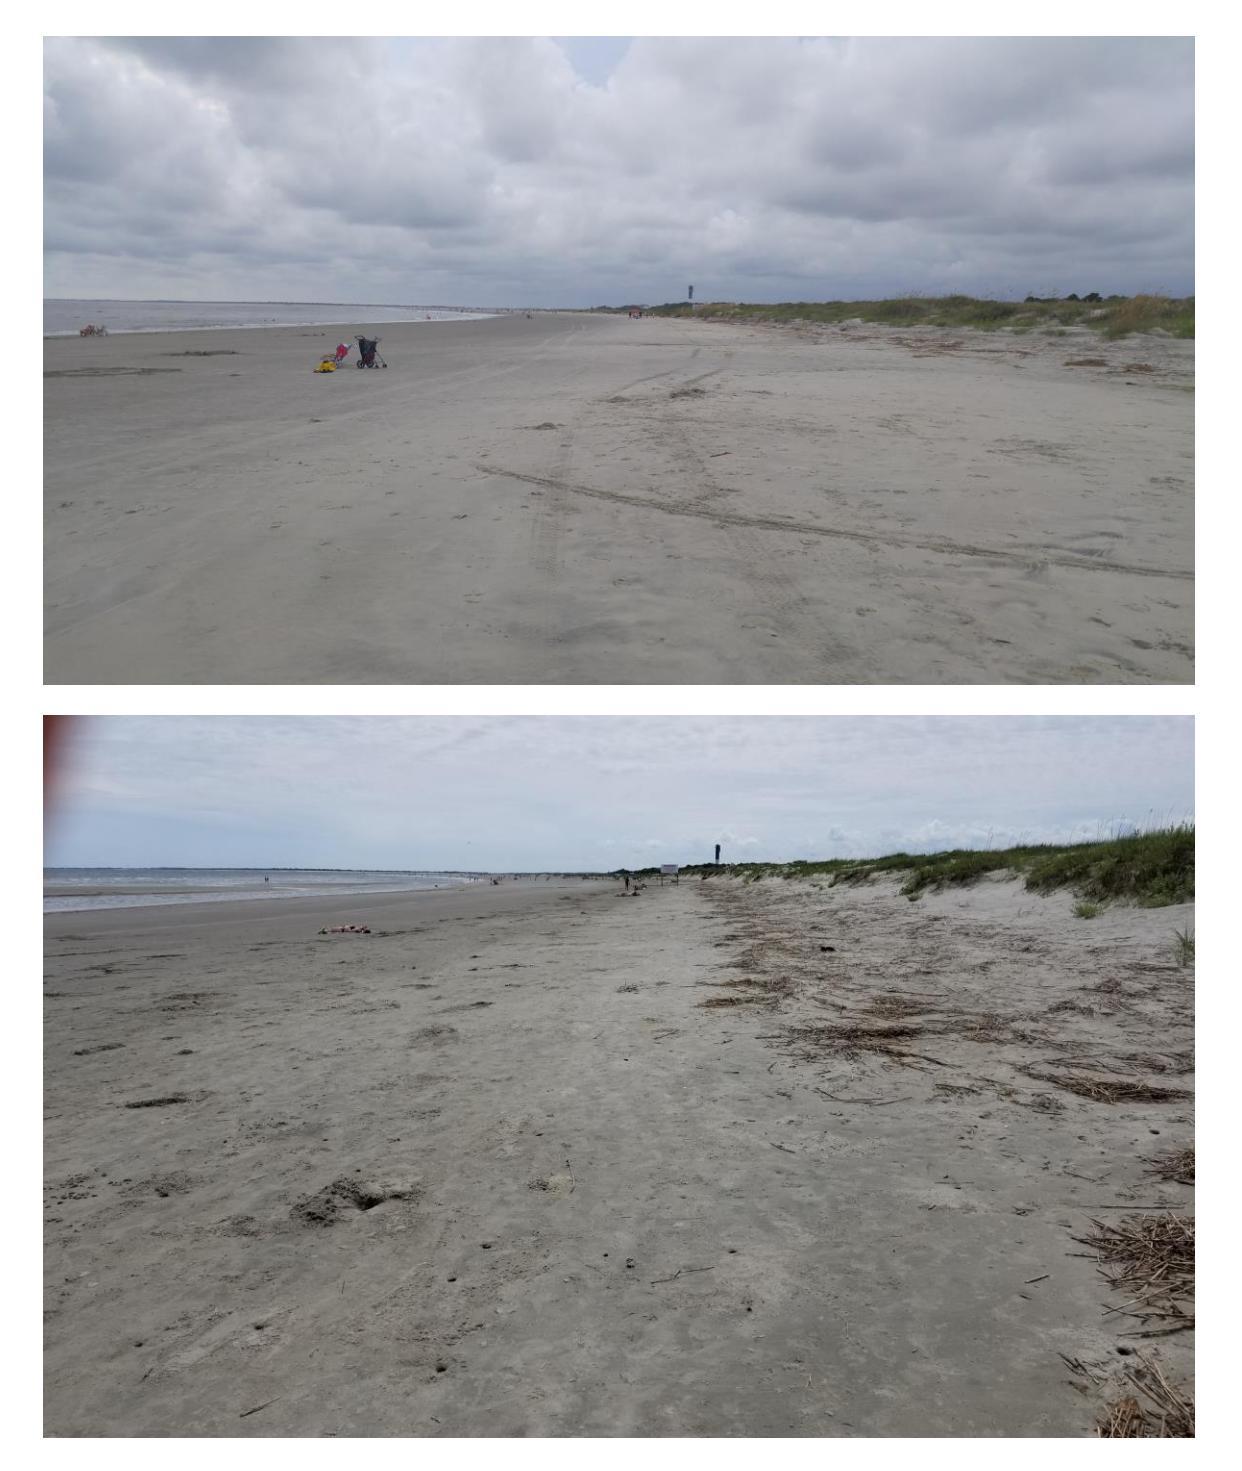
Figure 21. Ground photo taken at Monument 3065 looking southwest on August 4, 2016 (top) and June 12, 2017 (bottom).

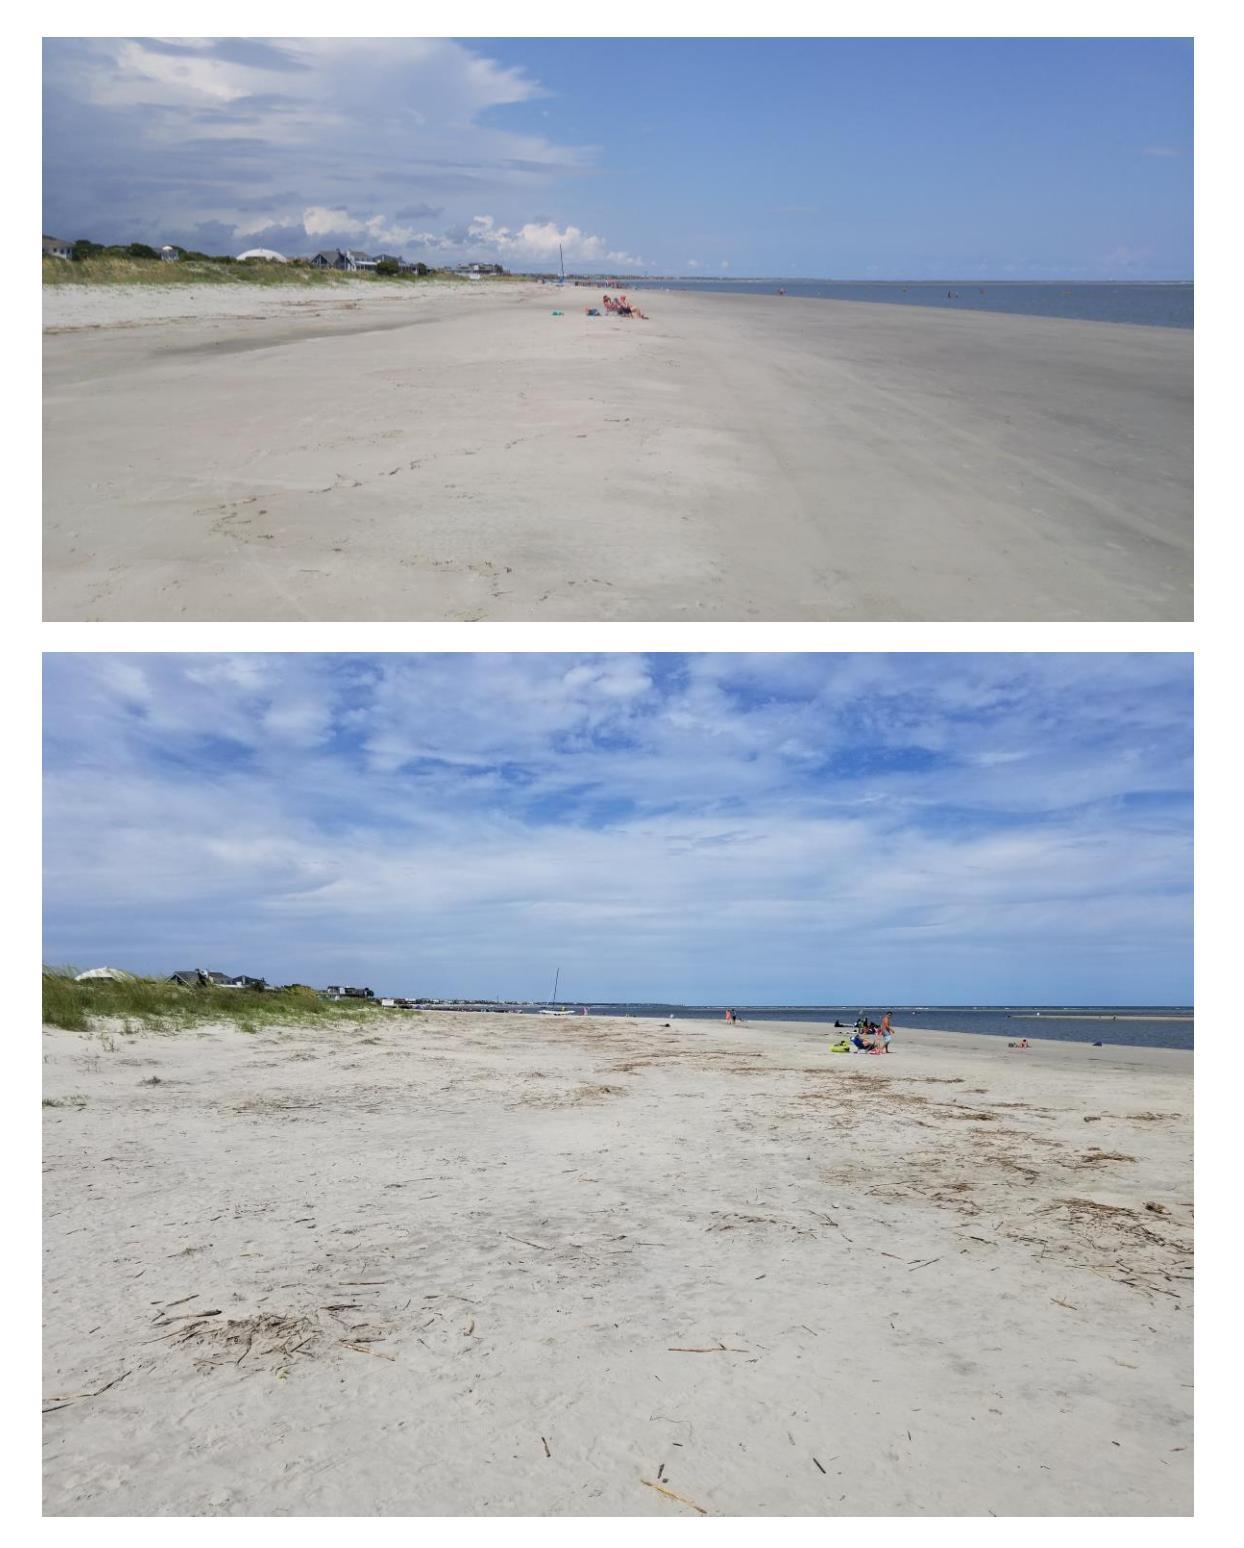
Beach profile data indicate a sand bar attachment event in 2014 (Figure 22). The sand bar was farther offshore at this location than at profile 3065 in 2017. The beach at this location displayed classic signs of accretion with no dune erosion in 2016 and 2017 (Figure 23 and Figure 24). The high tide dry beach is 75 ft wide and the dune vegetation is healthy and flourishing. Backbeach ponding was no longer present in 2017.

Figure 23. Ground photo taken at Monument 3080 looking northeast on August 4, 2016 (top) and June 12, 2017 (bottom). Note the backbeach accretion in 2017.

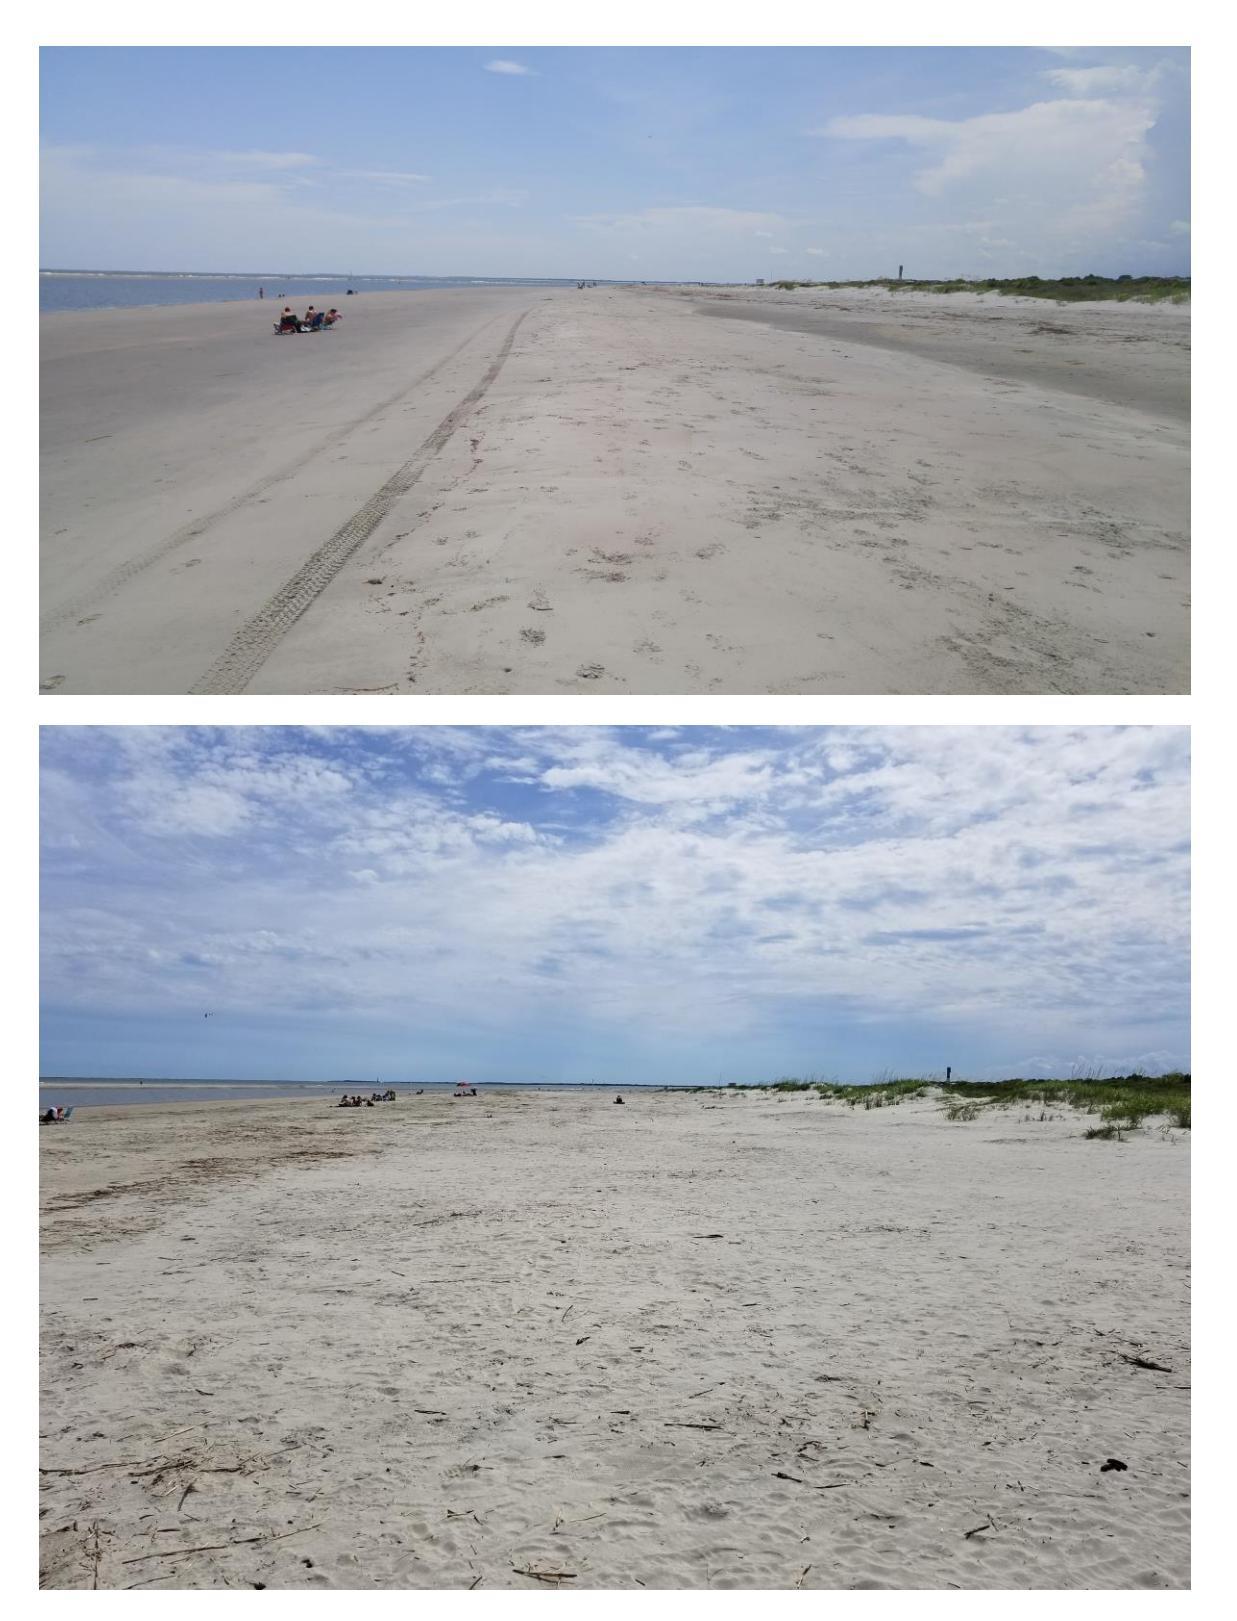
Figure 24. Ground photo taken at Monument 3080 looking southwest on August 4, 2016 (top) and June 12, 2017 (bottom). Note the backbeach accretion in 2017.
