# TOWN OF SULLIVAN'S ISLAND, SC

Elko Coastal Consulting, Inc. | July 2017

# 2017 Beach Monitoring Survey: Town of Sullivan's Island, SC

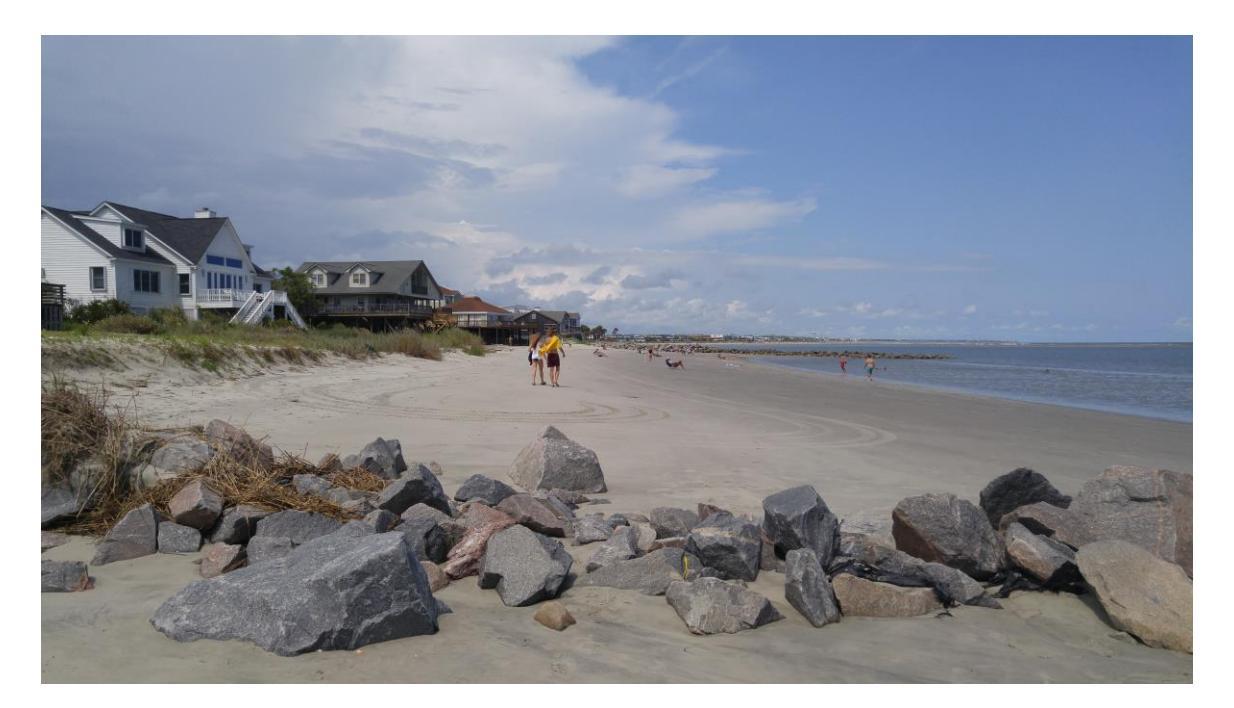
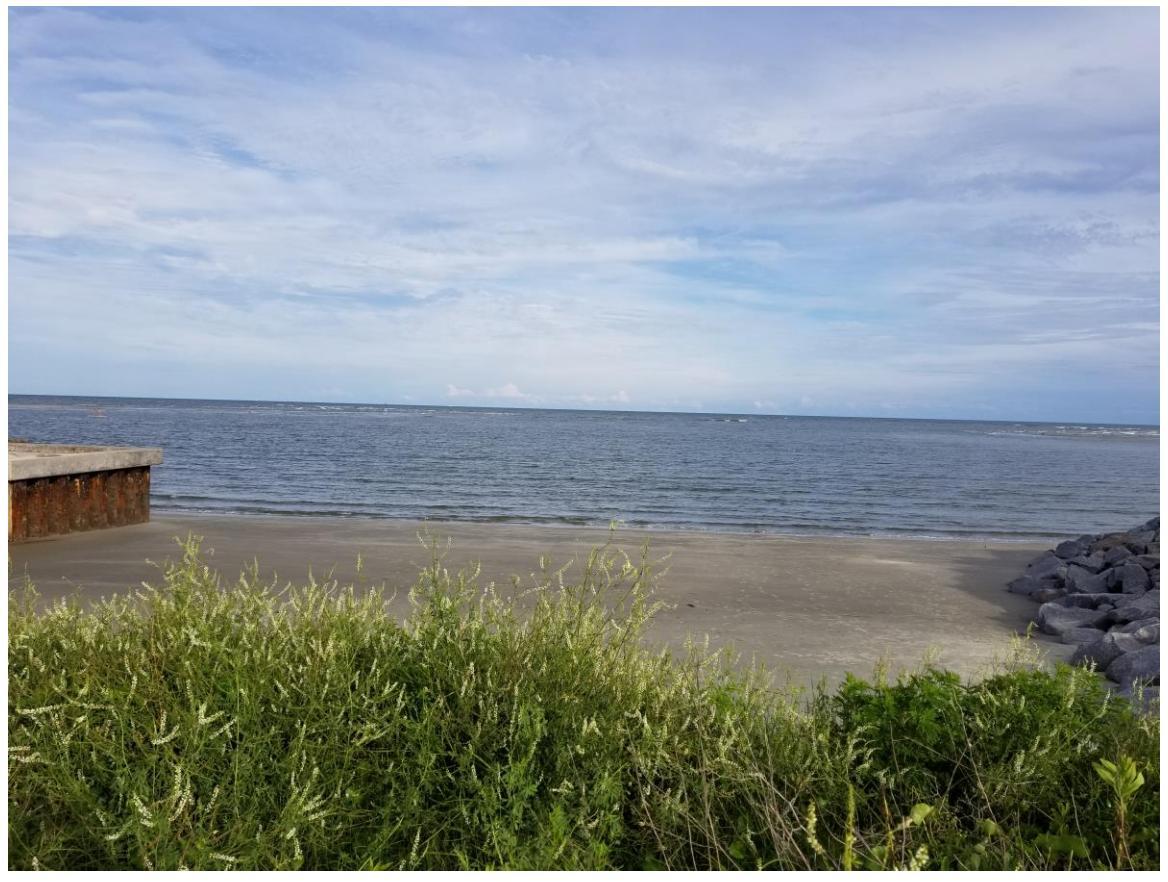
Monument 3083 is located near Station 28 ½. This area of the island has experienced considerable erosion since the last sand bar attachment event in 2014 (Figure 25), including the loss of three rows of low sand dunes. This is the typical beach response after a sand bar attachment event, as the sand migrates downdrift. Interestingly, the sand bar that attached to the shoreface just to the southwest did not benefit this beach profile. Some of the sand may spread to this location over the next year. This profile will be closely monitored.

This location marks the transition between the northeast end of the island, which has been stabilized with erosion control structures (Figure 26) and the wide, fluctuating beach of the central portion of the island to the southwest (Figure 27). There is little to no dry beach at high tide to the northeast

Figure 26. Ground photo taken at Monument 3083 looking northwest on August 4, 2016 (top) and looking seaward on June 12, 2017 (bottom).

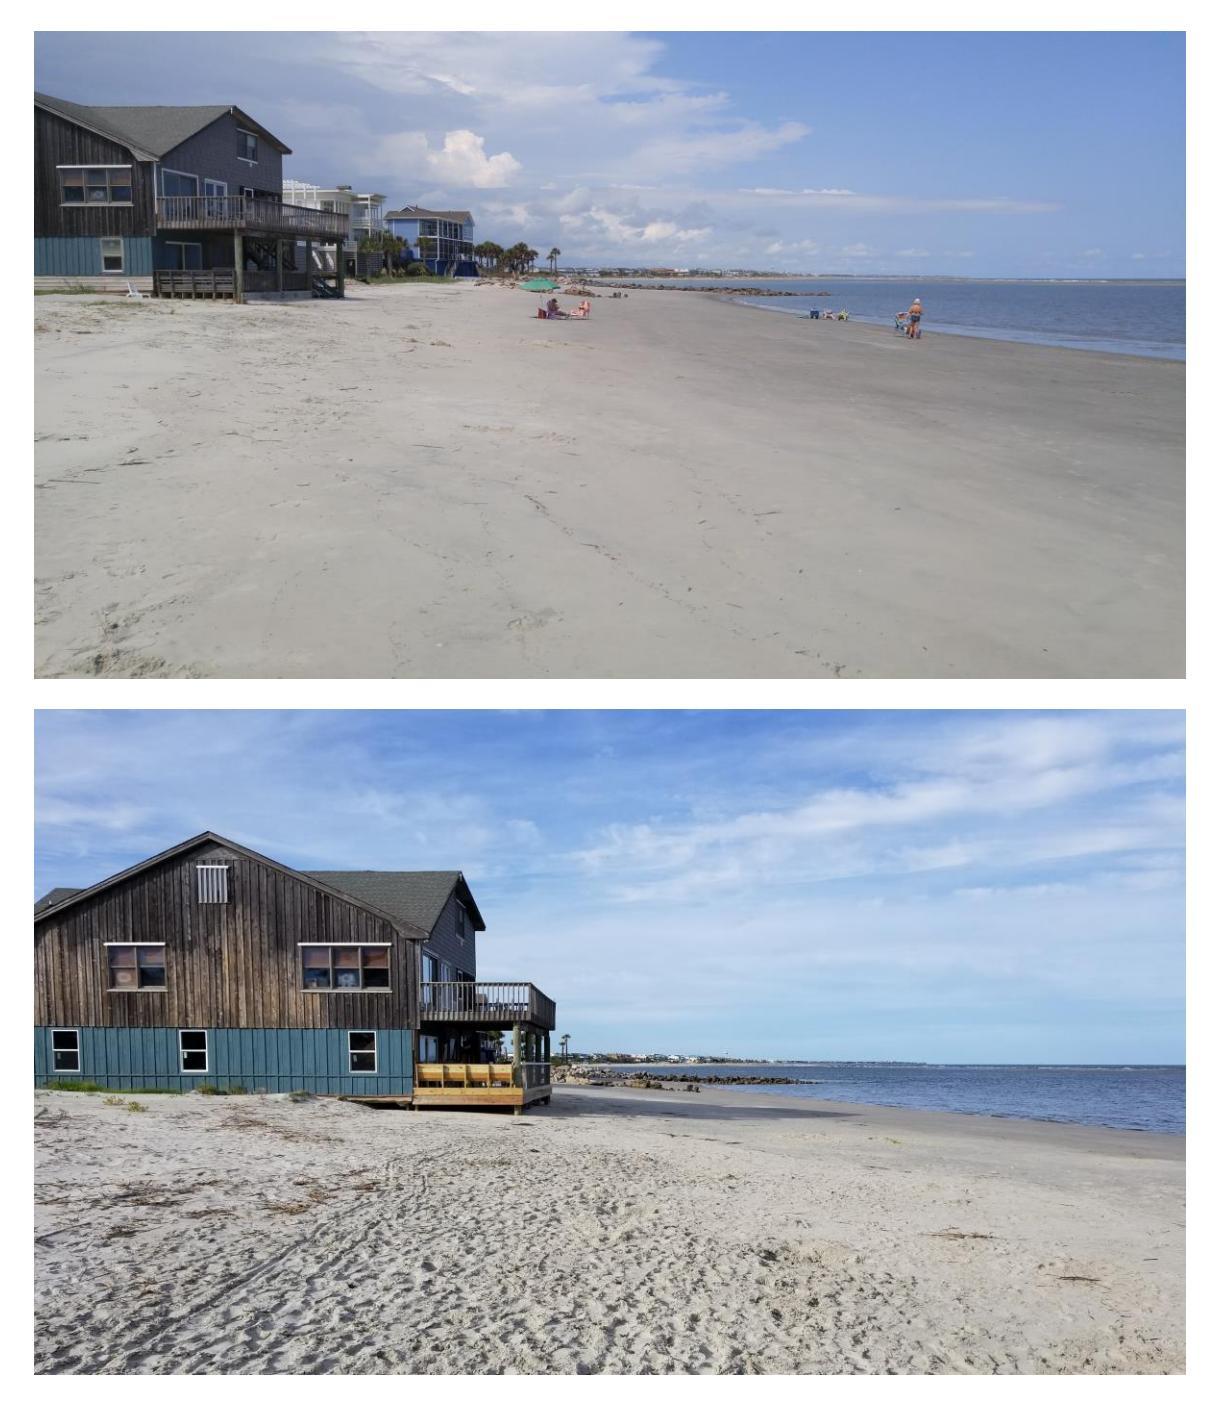
This pocket beach between groins is stable to erosional. The high tide rack line was under the houses in 2017. No dunes are present in front of the houses. Despite the lack of dry beach at high tide, the structures appear to have stabilized this portion of the island (Figure 29 and Figure 30).

Figure 29. Ground photo taken at Monument 3085 looking northwest on August 4, 2016 (top) and June 12, 2017 (bottom). Notice the profile deflation under the deck in 2017.

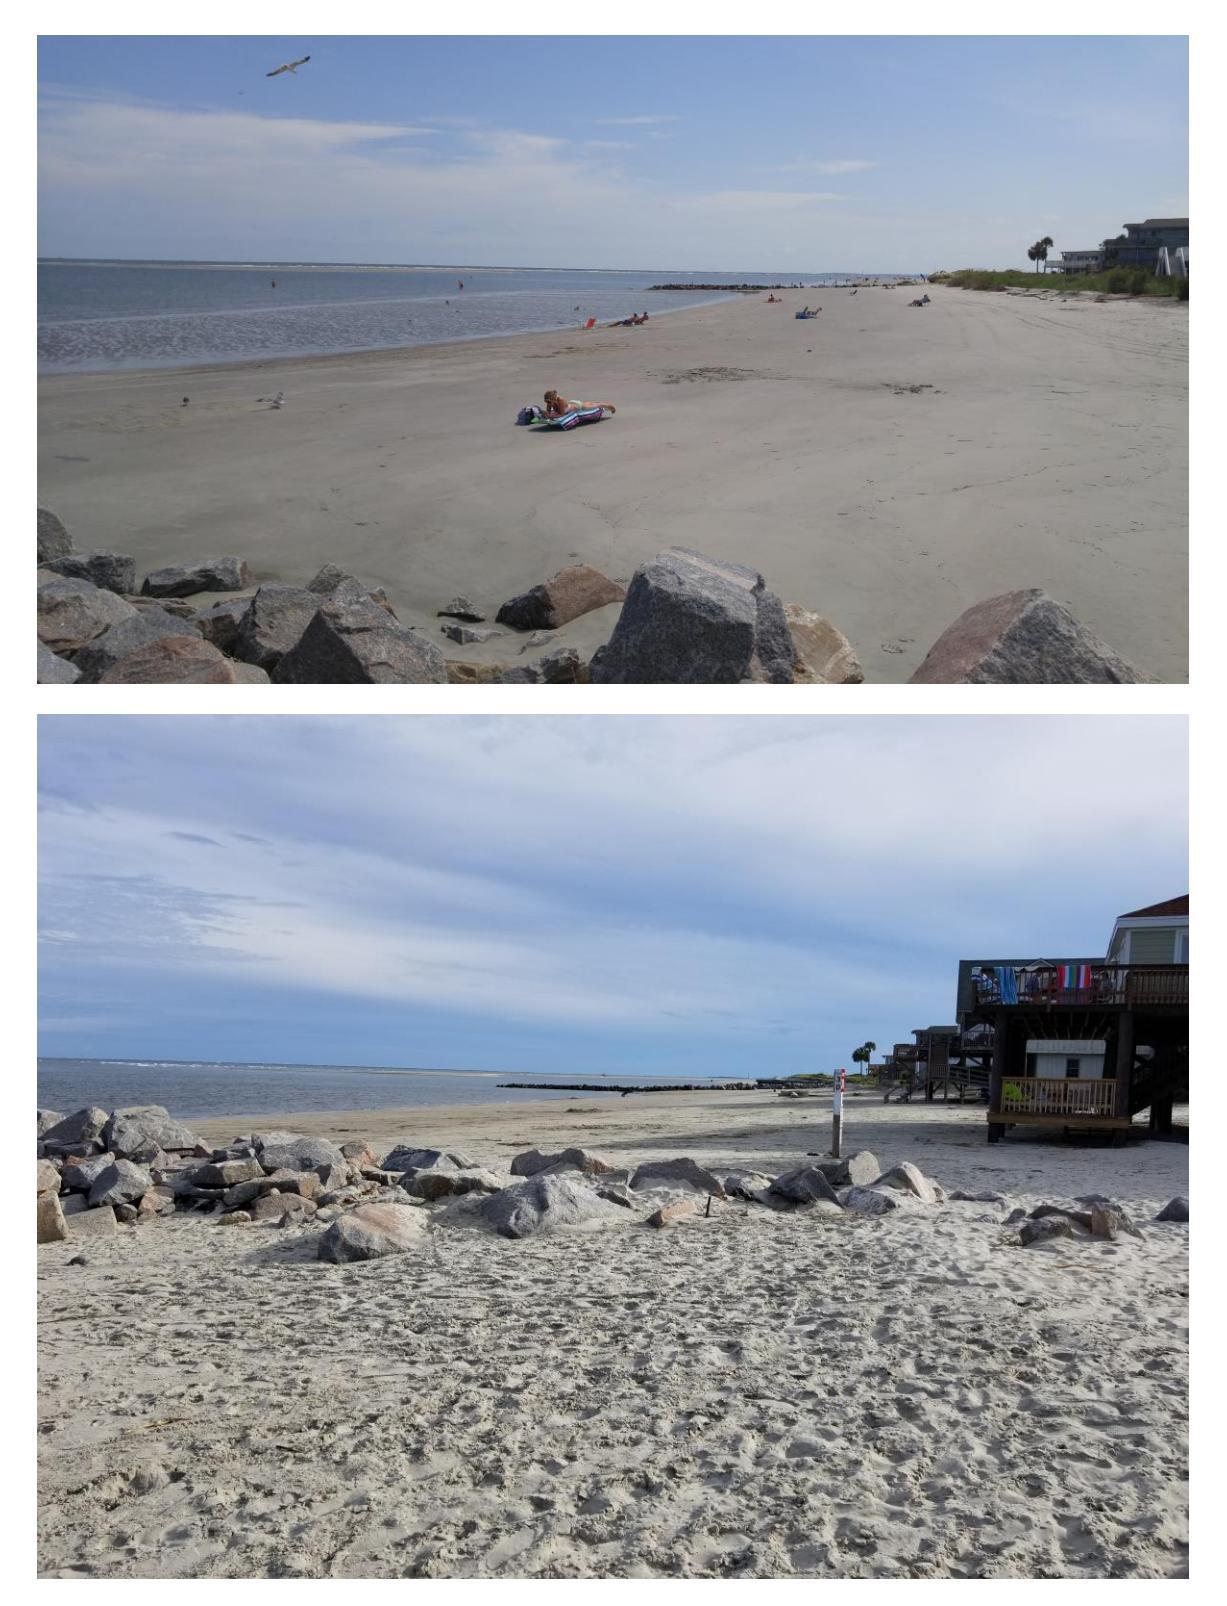
Figure 30. Ground photo taken at Monument 3085 looking southwest on August 4, 2016 (top) and June 12, 2017 (bottom).

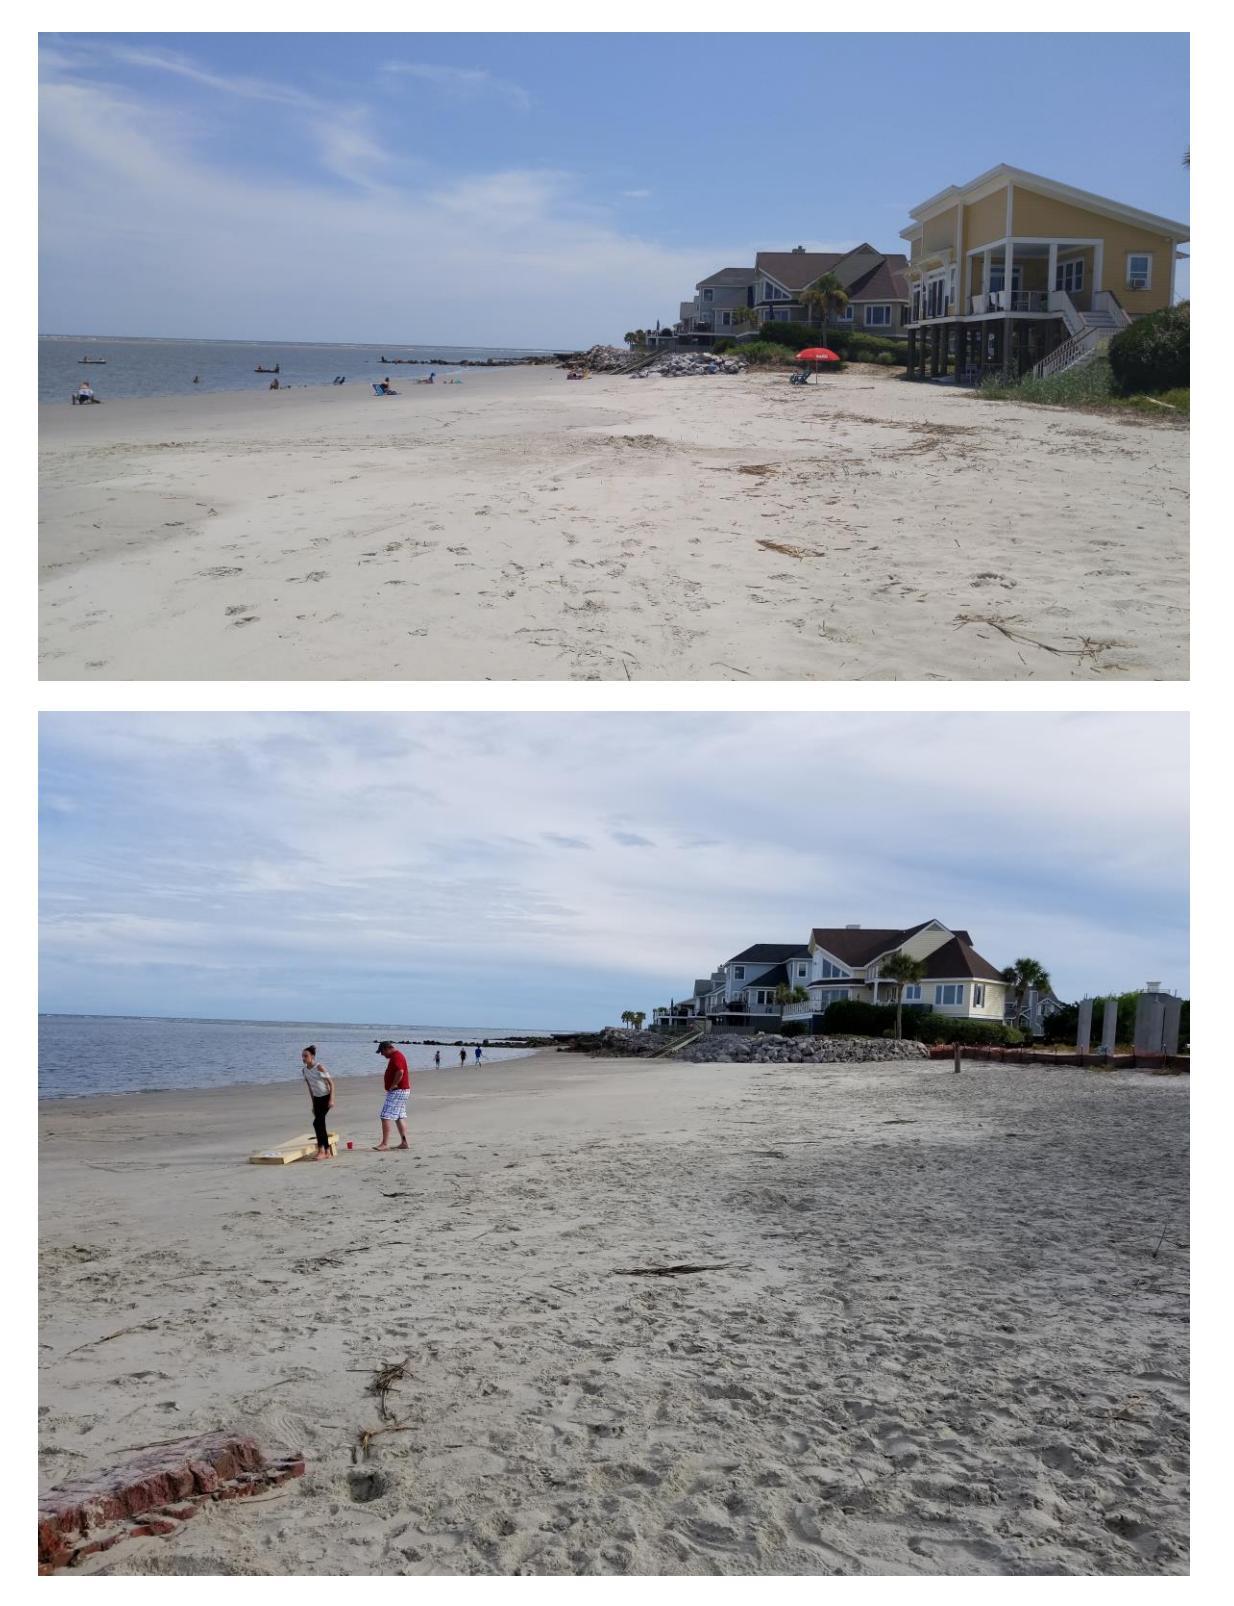
Monument 3092 is located north of Station 31 on northeastern Sullivan's Island near Breach Inlet. This profile line represents a section of the island that has been stabilized with erosion control structures. The beach profile has exhibited little change due to the stabilization structures (Figure 34). In 2016, no erosion was evident; however, little to no dry beach is exposed at high tide. In 2017, a 50-ft-wide high tide beach existed indicating some minor accretion. The structures have stabilized this portion of the beach (Figure 35 and Figure 36).

Figure 36. Ground photo taken at Monument 3092 looking south on August 4, 2016 (top) and June 12, 2017 (bottom). The yellow house in the foreground of the 2016 photo was removed in 2017.
