# TOWN OF SULLIVAN'S ISLAND

# TREE COMMISSION

# TREE COMMISSION STAFF REPORT

# 2114 JASPER BOULEVARD

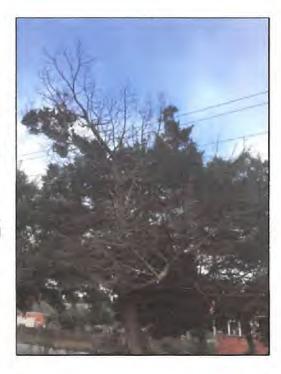
#### 21" Red Cedar (Juniperus virginiana):

As stated in the Ordinance, Red Cedars are protected on the island and bear special consideration. This specimen is suffering from several issues that have compromised its health to the point of decline and creating a potential hazard. The tree has encountered heavy pruning due to its proximity to the overhead powerlines, damage from a previous lightning strike, as well as extensive damage from the more recent adjacent structure fire.

The primary growth leader appears to have been removed during past pruning activities and the secondary leader has now been killed due to the fire. It appears that more than half of the canopy has died as a result of the fire. This has created a very unbalanced canopy, with the only remaining live material on the south side of the tree facing Jasper Blvd. This uneven canopy creates an unbalanced and weakened structure which could be more susceptible to blow over due storm and wind conditions resulting in a hazard to private property and the public.

In addition to the fire damage, a 12" open fissure was observed on the east side of the tree, most likely caused by a past lightning strike. Although the wound has partially healed and may be compartmentalized, there is evidence of rot and insect damage in this area of the tree which has further compromised its structural integrity.

**Recommendation:** Based on the noted issues, along with the persistent conflict with the overhead powerlines, we recommend removal of the tree.

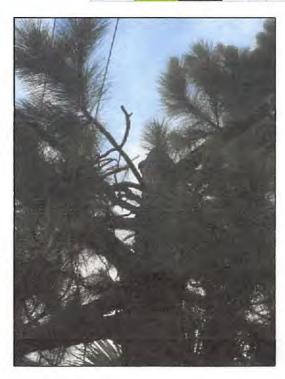
18" Loblolly Pine (Pinus taeda): This tree is located at the edge of the property along Jasper Blvd. As with the Cedar, this tree maintains the same conflict with the overhead power lines and has sustained persistent pruning.

During the inspection, it was observed that the central leader of the tree is missing. It is unclear whether this was due to previous pruning activities, or past storm damage. Regardless of cause, the open crown is susceptible to rot, disease and/or insect damage. It has also resulted in a misshaped canopy and compromised the structural integrity of the tree.

**Recommendation:** Due to the absence of a central leader, the susceptibility to infection and the persistent conflict with the existing power lines, we recommend removal of the tree.

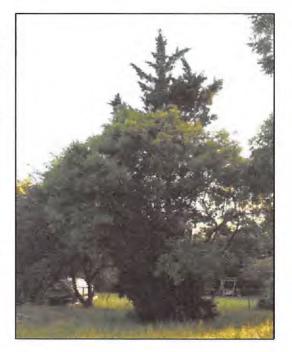
Clump (10" Hackberry - 7'/5' Hackberry - 8"/6" Red Cedar): This trio of trees is essentially growing in one clump. Cedar is a protected species on the island, where Hackberry is not and often considered a trash tree. The close proximity of the trunks compromises each tree from attaining its normal vigor and natural shape. None of the trees will thrive long term under these growing conditions as competition for space and soil will compromise each. It appears that the cedar is most affected by the growing conditions, as its center is completely void of living branches.

Recommendation: Each tree is compromised and declining due to the growing conditions. We recommend removal of the trees. Any replacement should include Red Cedars in more appropriate locations on the property.
