Charles Drayton  
Town of Sullivans Island Planning Department

February 20, 2024

Re: Tree Removal Request and Tree Preservation Plan  
2814 Brooks St.  
Sullivans Island, SC

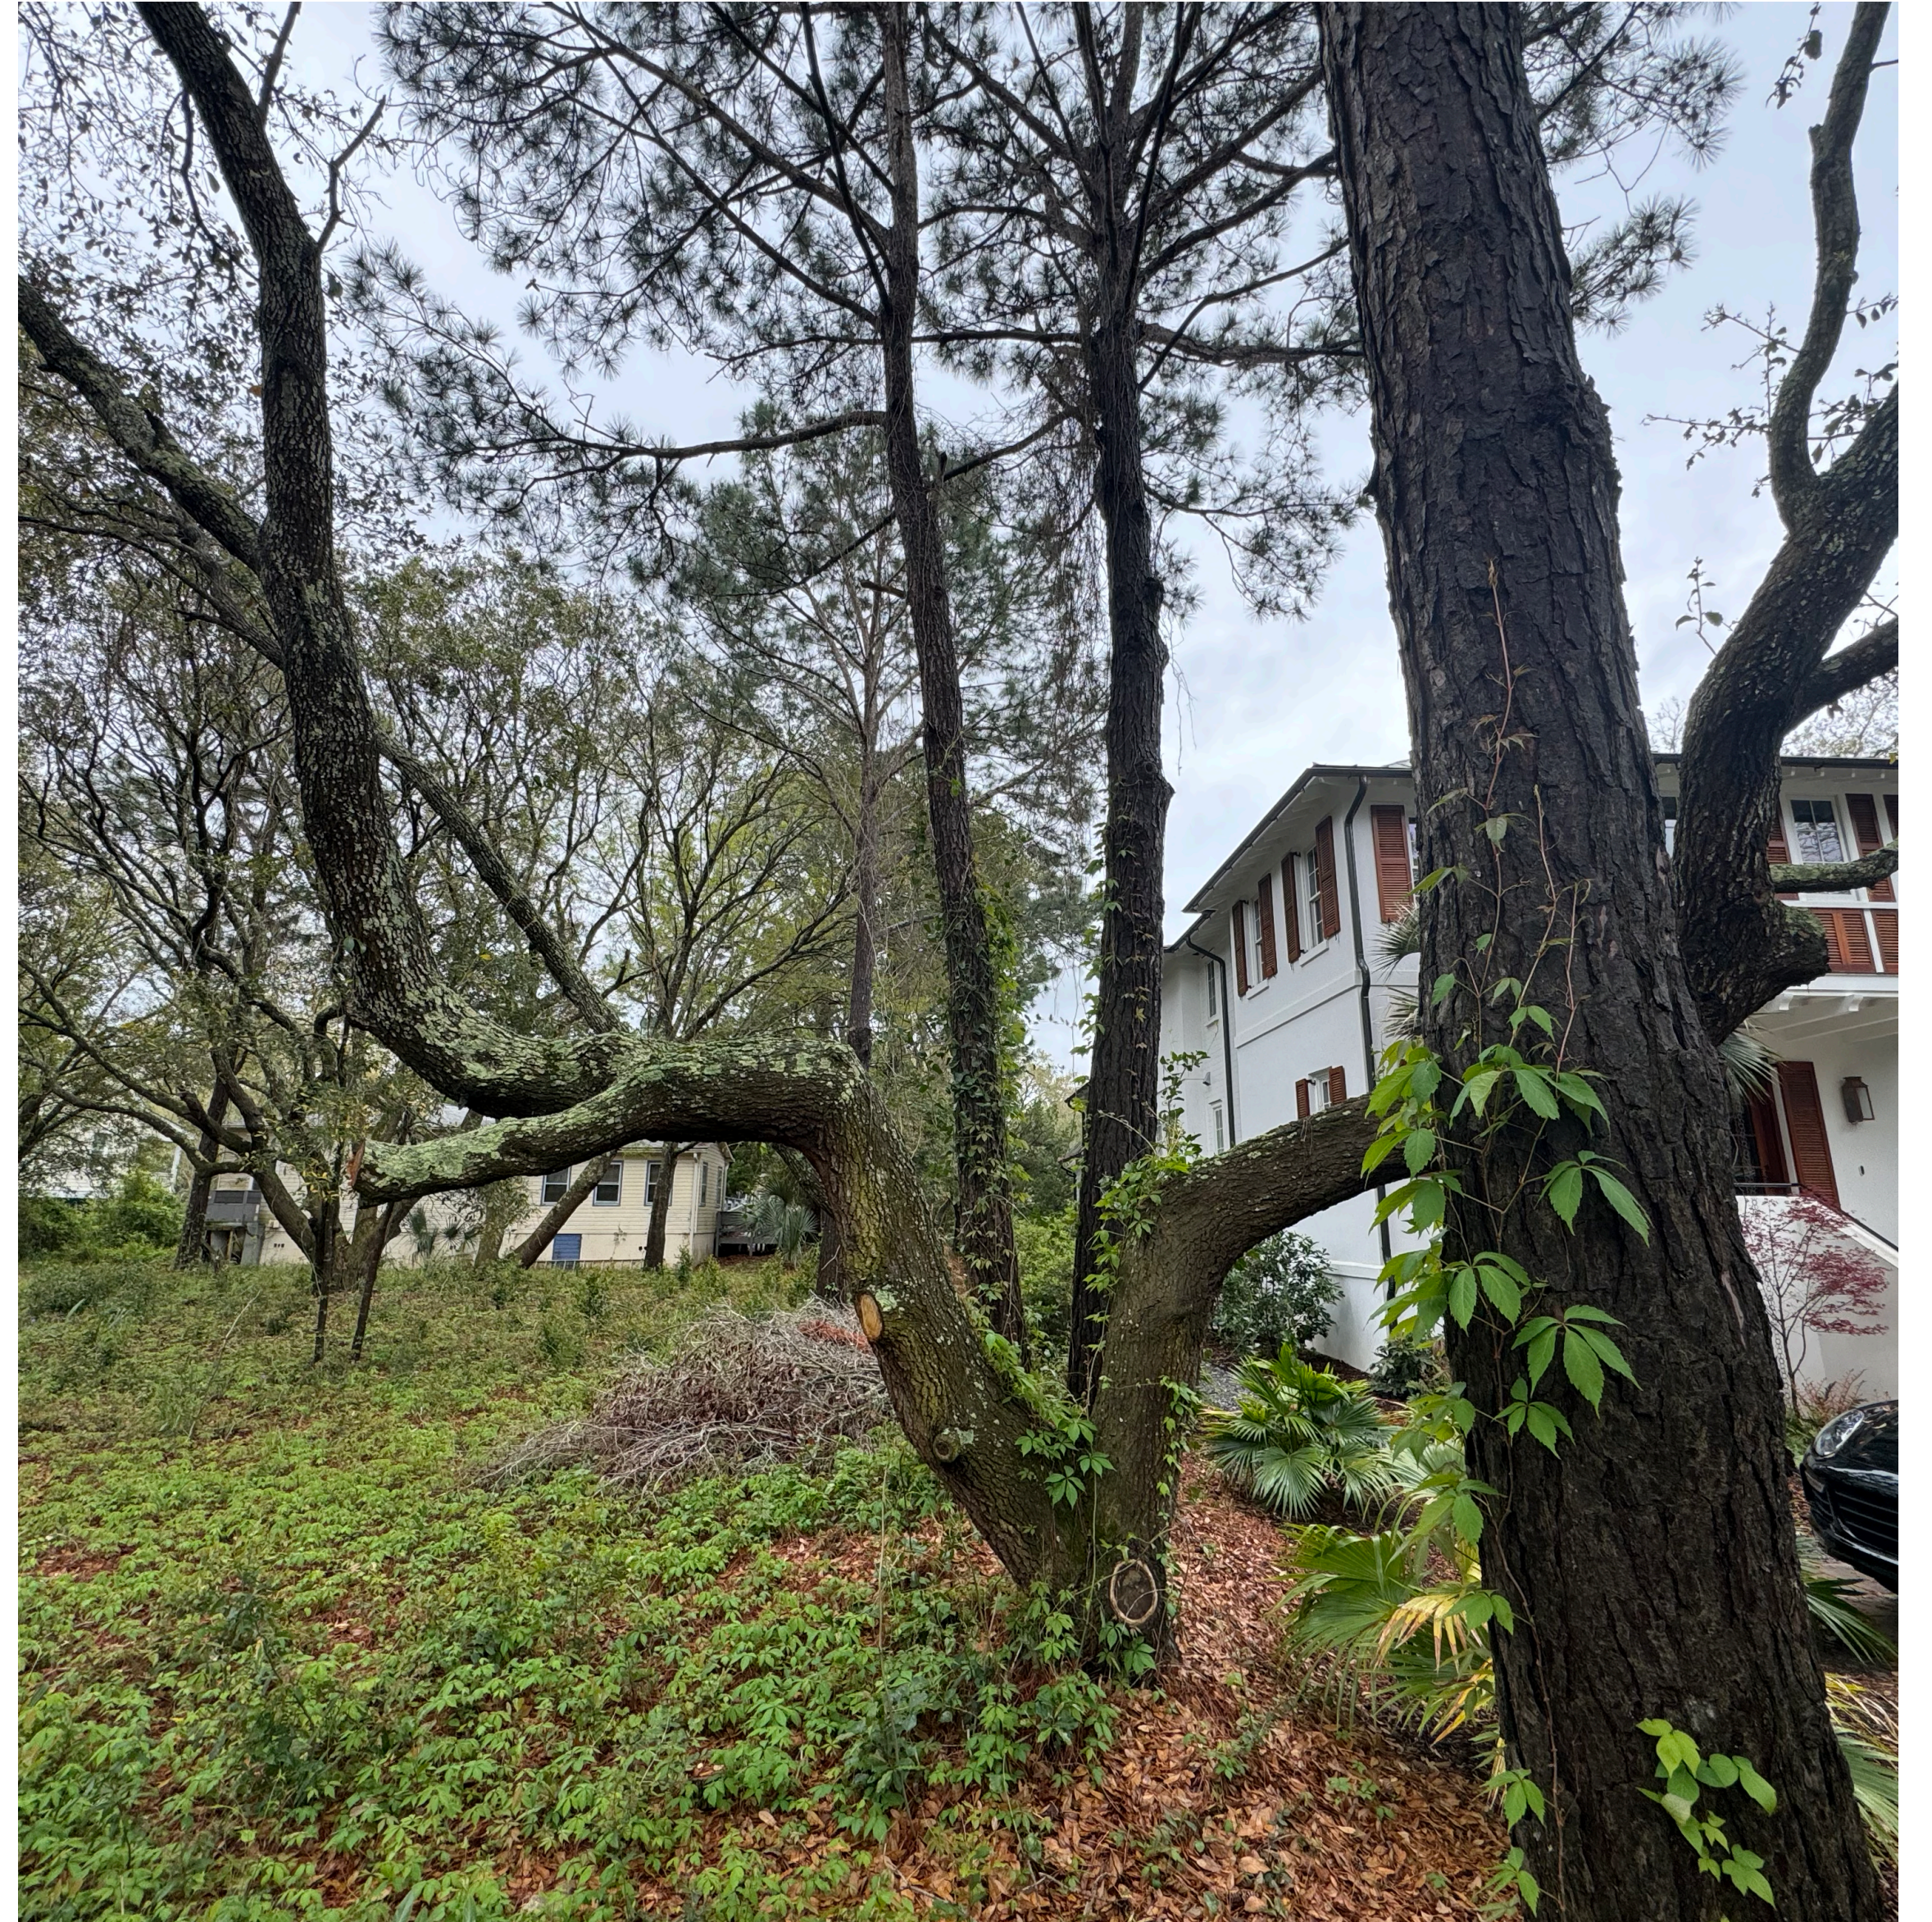
**#1 double live oak**

1. Category I "HAZARD REMOVAL" : 35" *Quercus virginiana* Double Live Oak – This tree has poor form. There is included bark at the attachment of the co-dominant structure and could pose risk to the existing neighbors parking and proposed new garage for 2814 Brooks St.

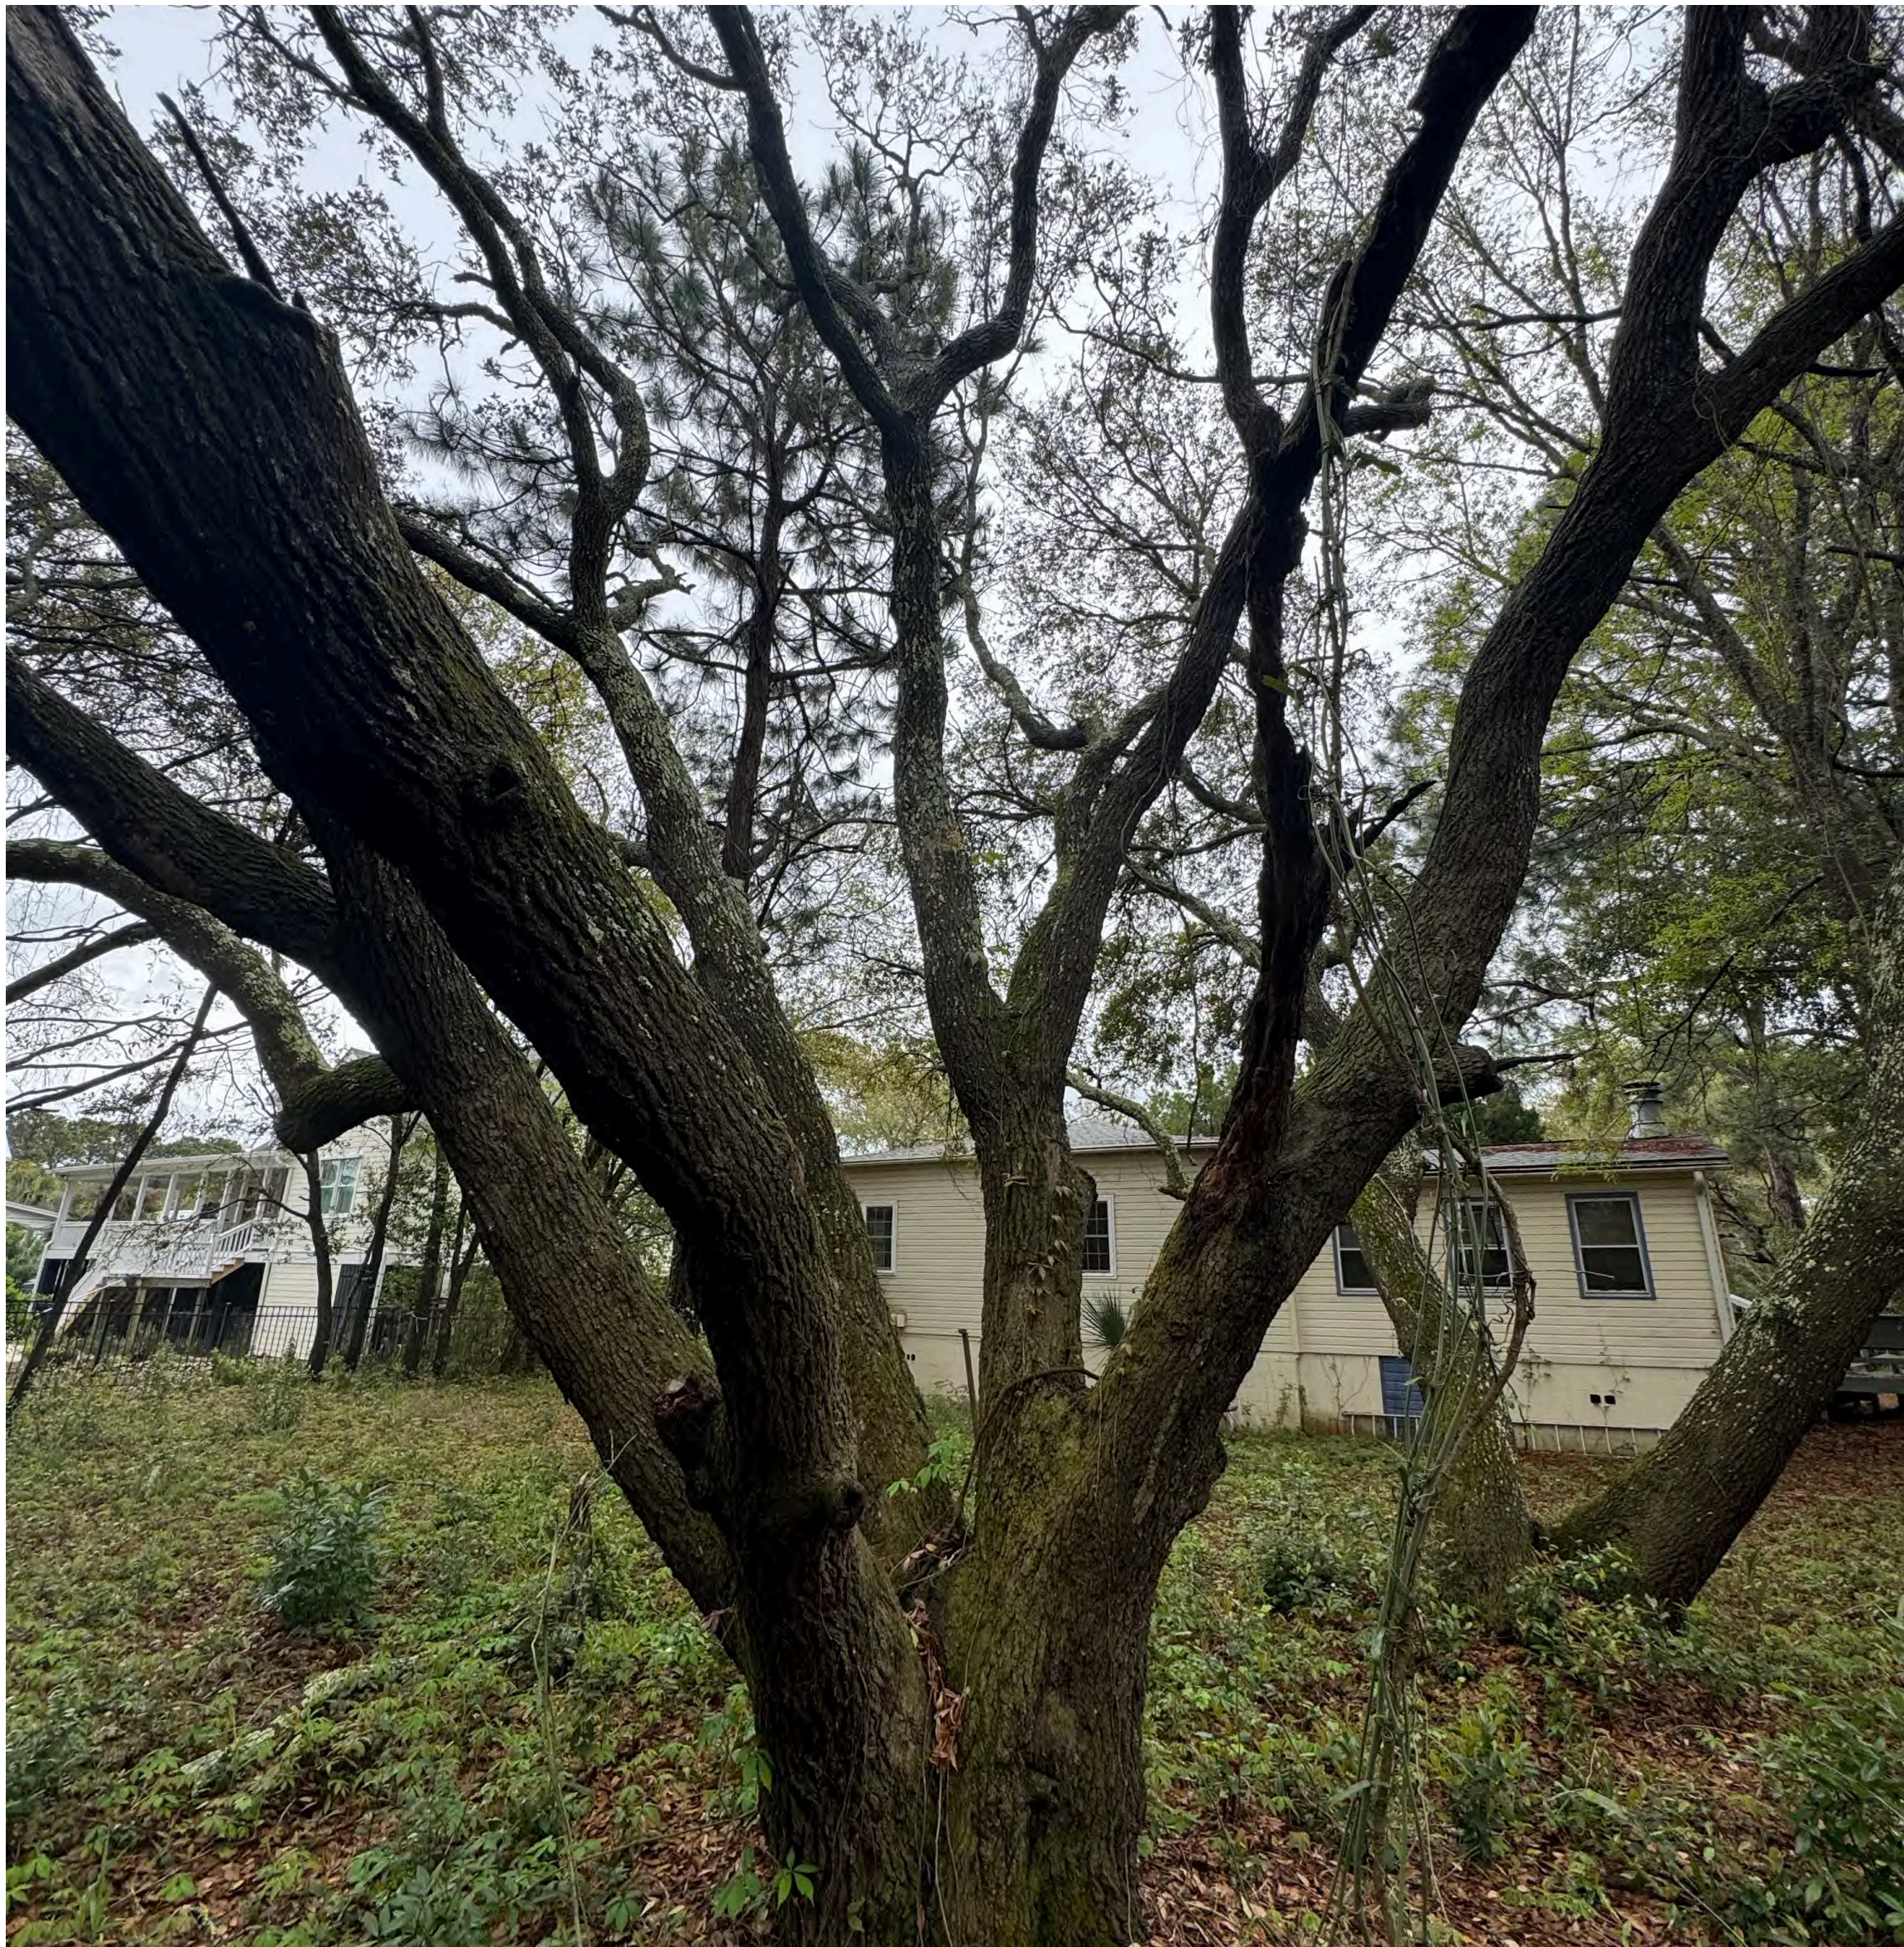
**#3 triple live oak**

3. Category I "HAZARD REMOVAL" : 23/15/20" *Quercus virginiana* Triple Live Oak – This cluster Live Oak has extensive dieback and crown thinning. There is fungal decay on several large limbs. The structure is compromised by competition from surrounding trees and the limbs are overextended due to the light and nutrient competition. There is also poor attachment of the multiple leaders at the base of the tree and failure is likely as the tree declines.

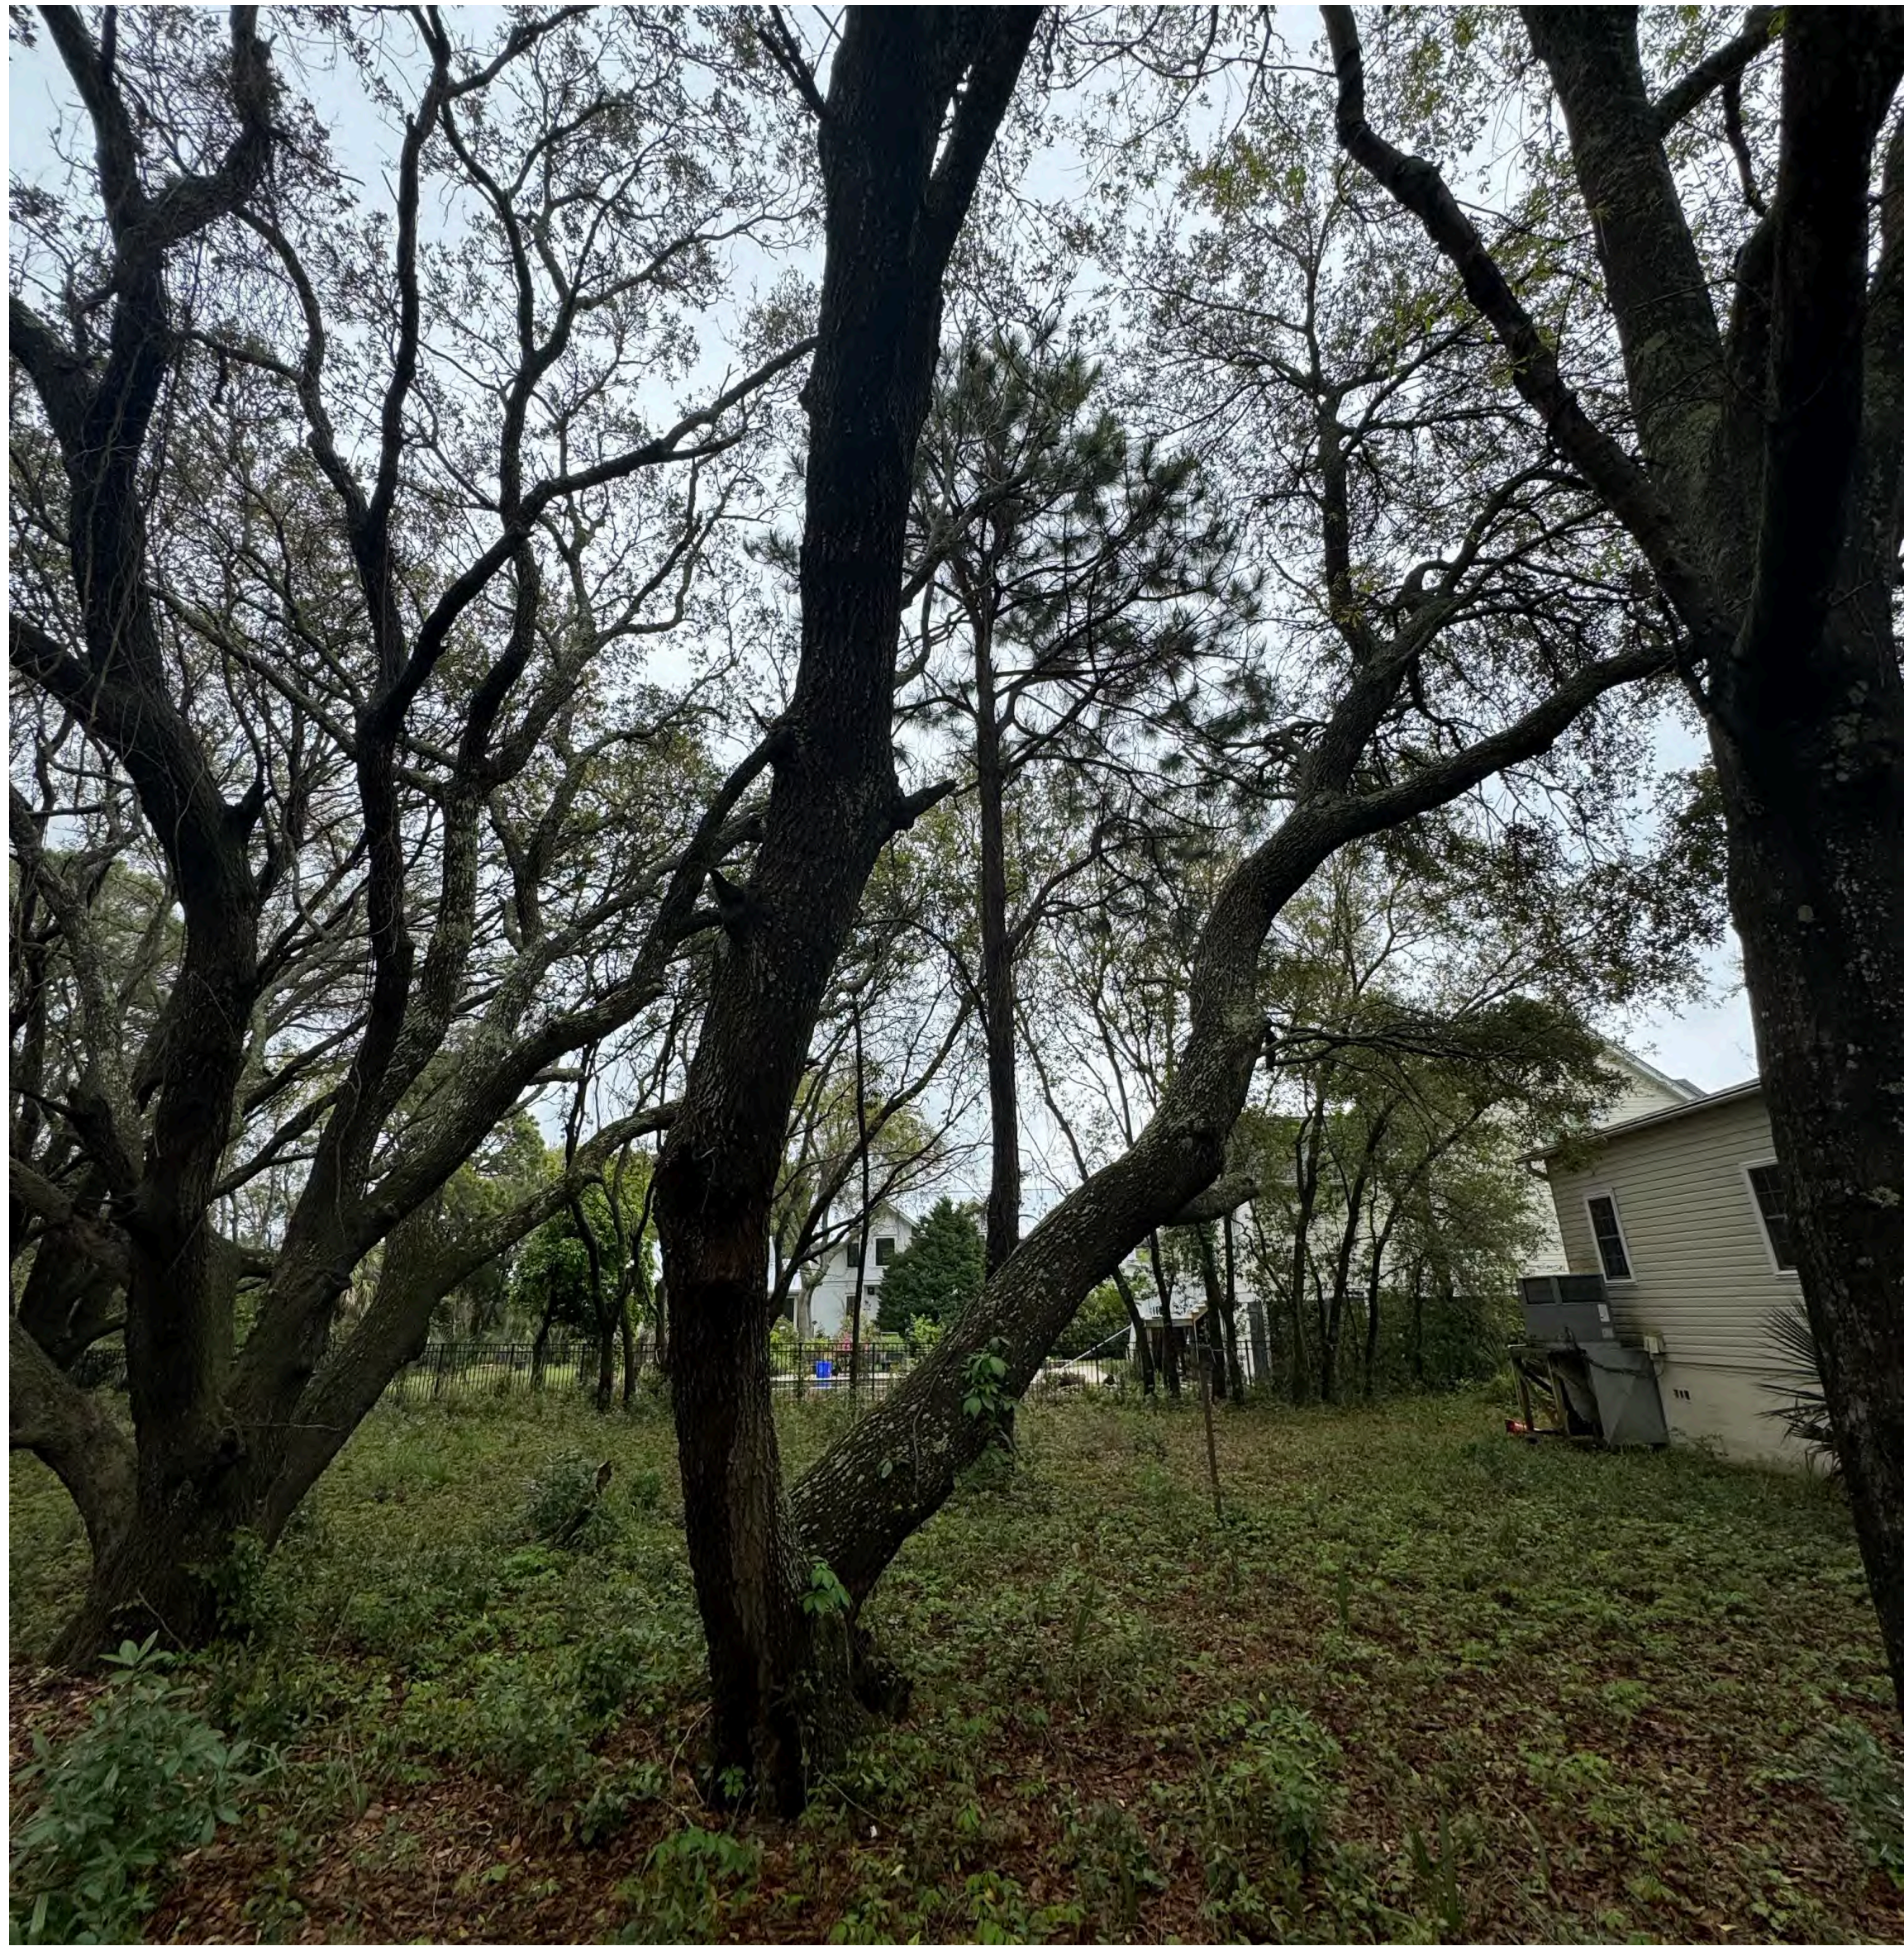
**#4 double live oak**  
**#6 pine (behind)**

4. Category I "HAZARD REMOVAL" : 34" *Quercus virginiana* Double Live Oak – This tree has spreading form and overextended limbs. The overextended leaders do not provide any opportunity for subordination pruning. The wide attachment at the base of the tree poses a risk for failure over time.

5. 16" *Quercus nigra* Water Oak – This tree has triple co-dominant crown structure with pocket of decay located in triple crotch area.
6. 14" *Pinus* sp. Pine – This tree has poor trunk taper from growth as a volunteer under existing mature oak canopy. Forked central leader at top is structural issue.

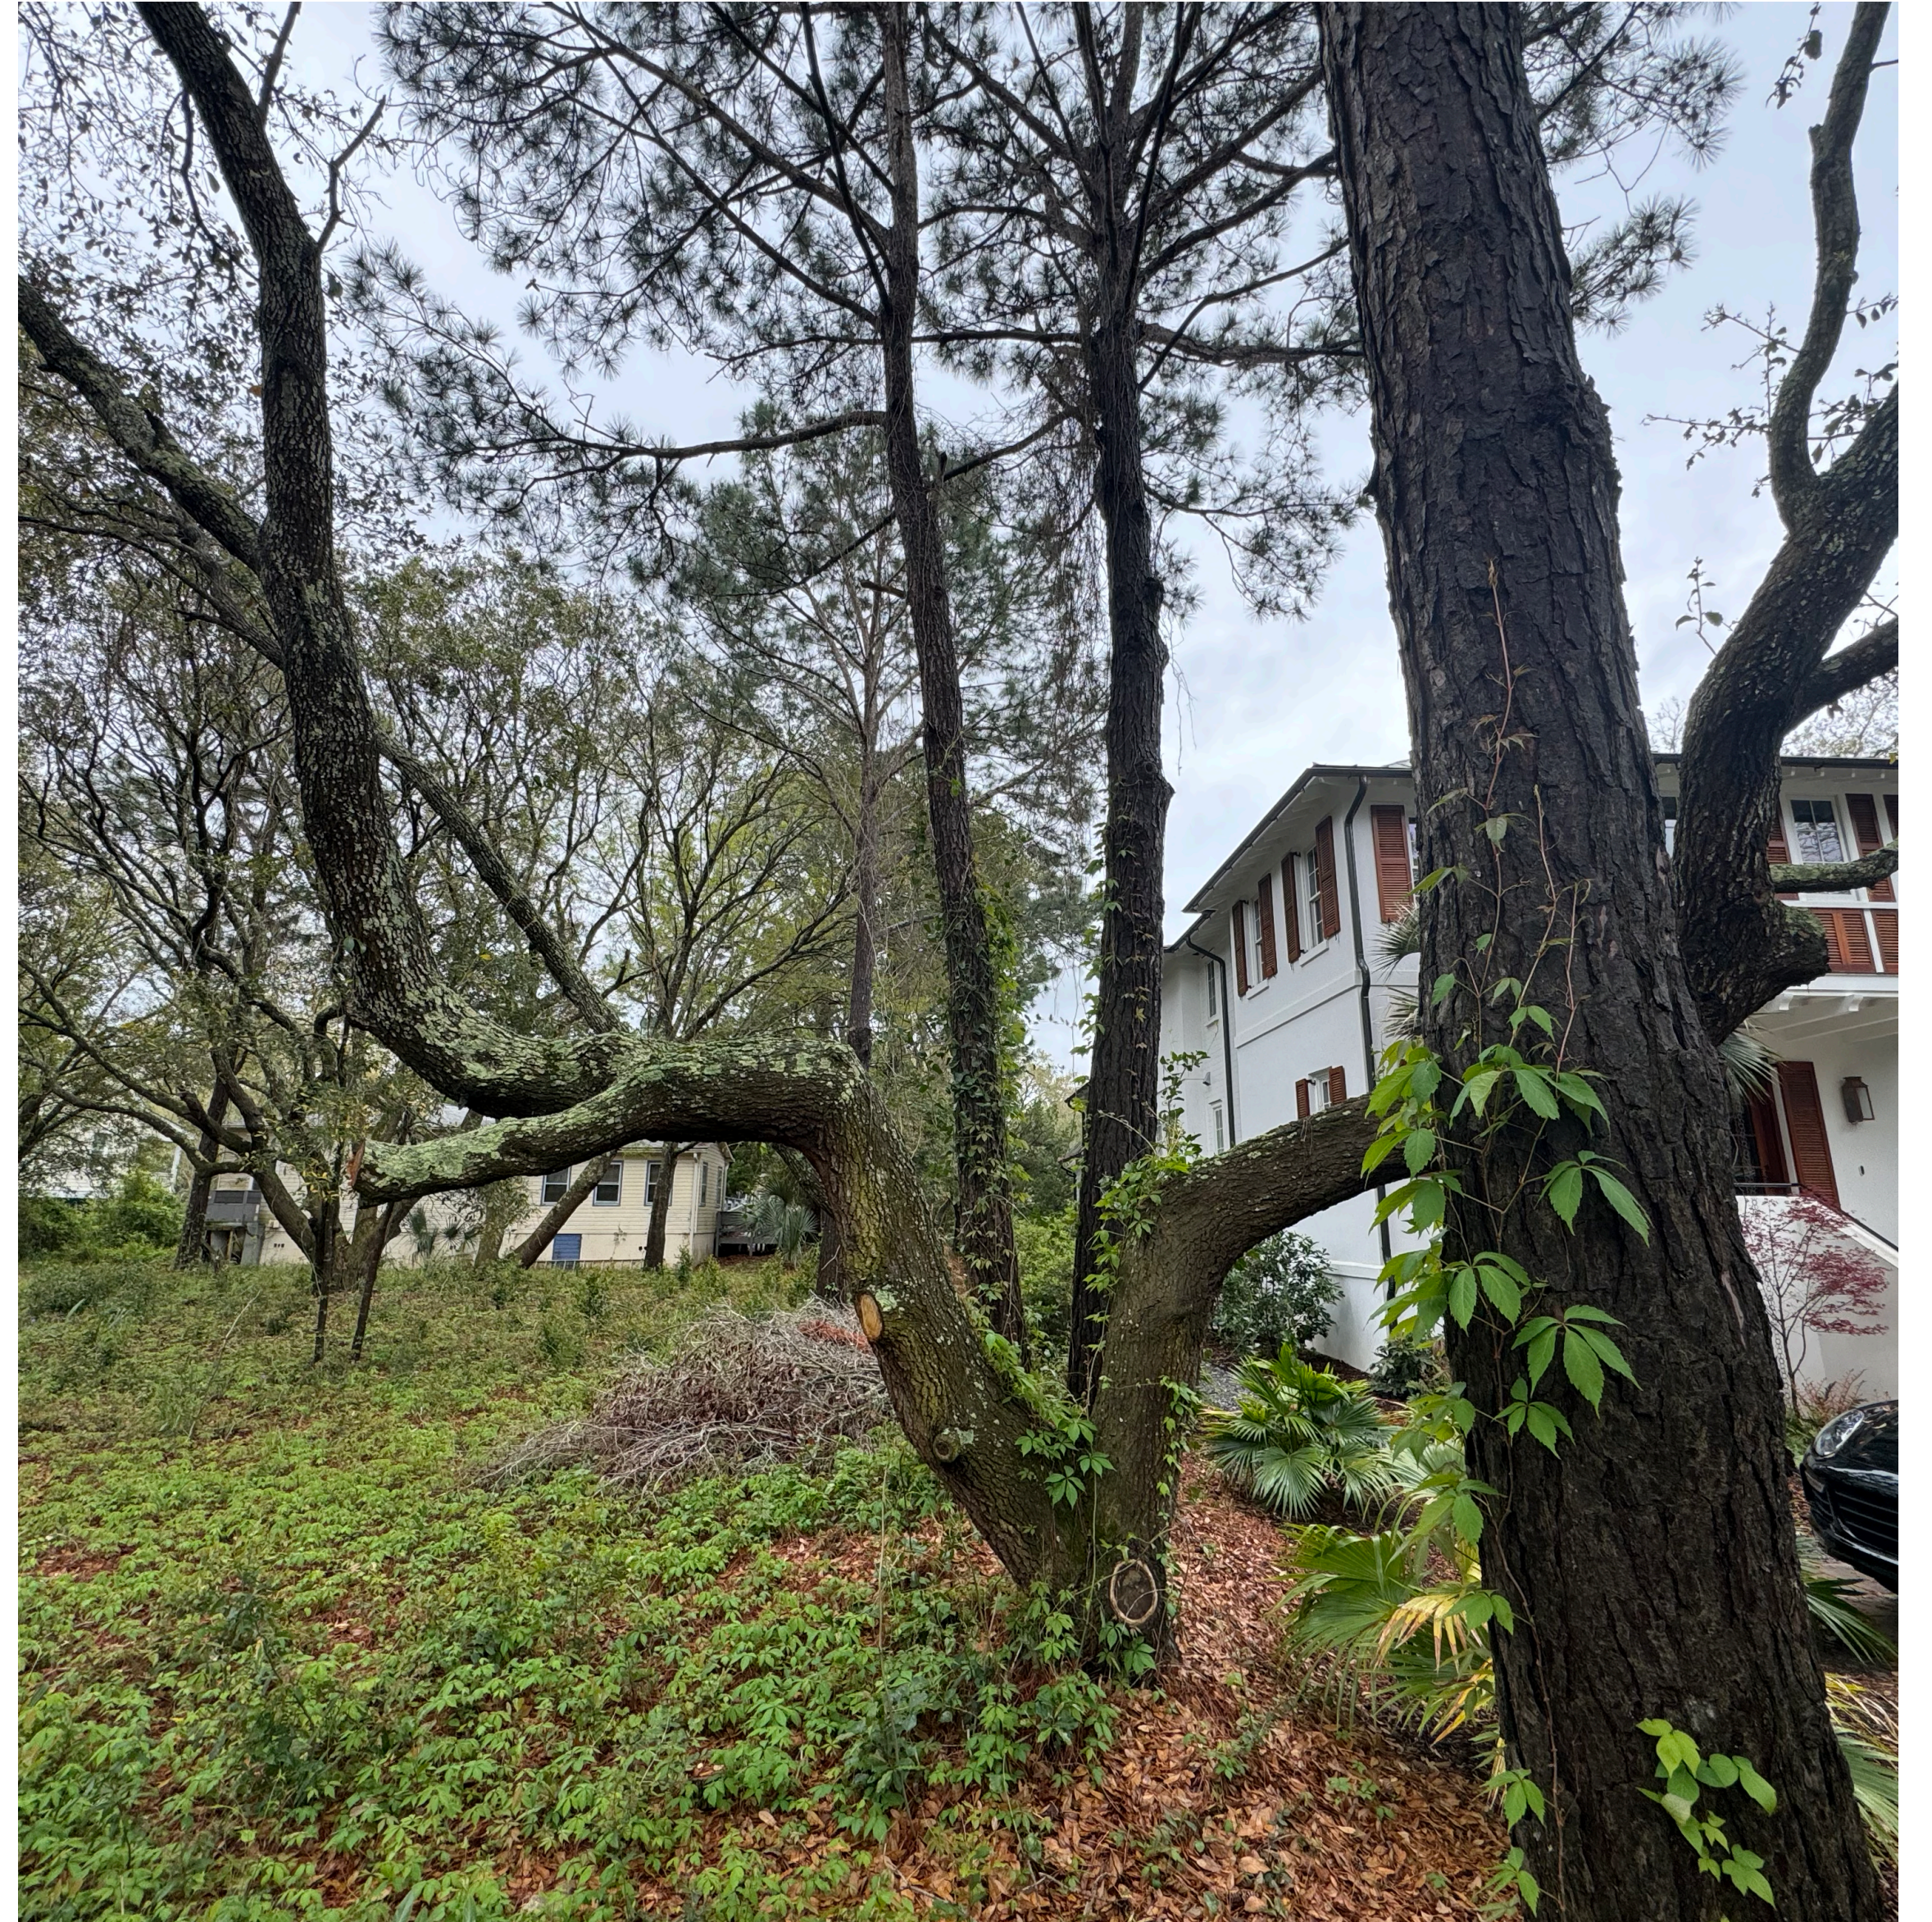
**#1 double live oak**

1. Category I "HAZARD REMOVAL" : 35" *Quercus virginiana* Double Live Oak – This tree has poor form. There is included bark at the attachment of the co-dominant structure and could pose risk to the existing neighbors parking and proposed new garage for 2814 Brooks St.

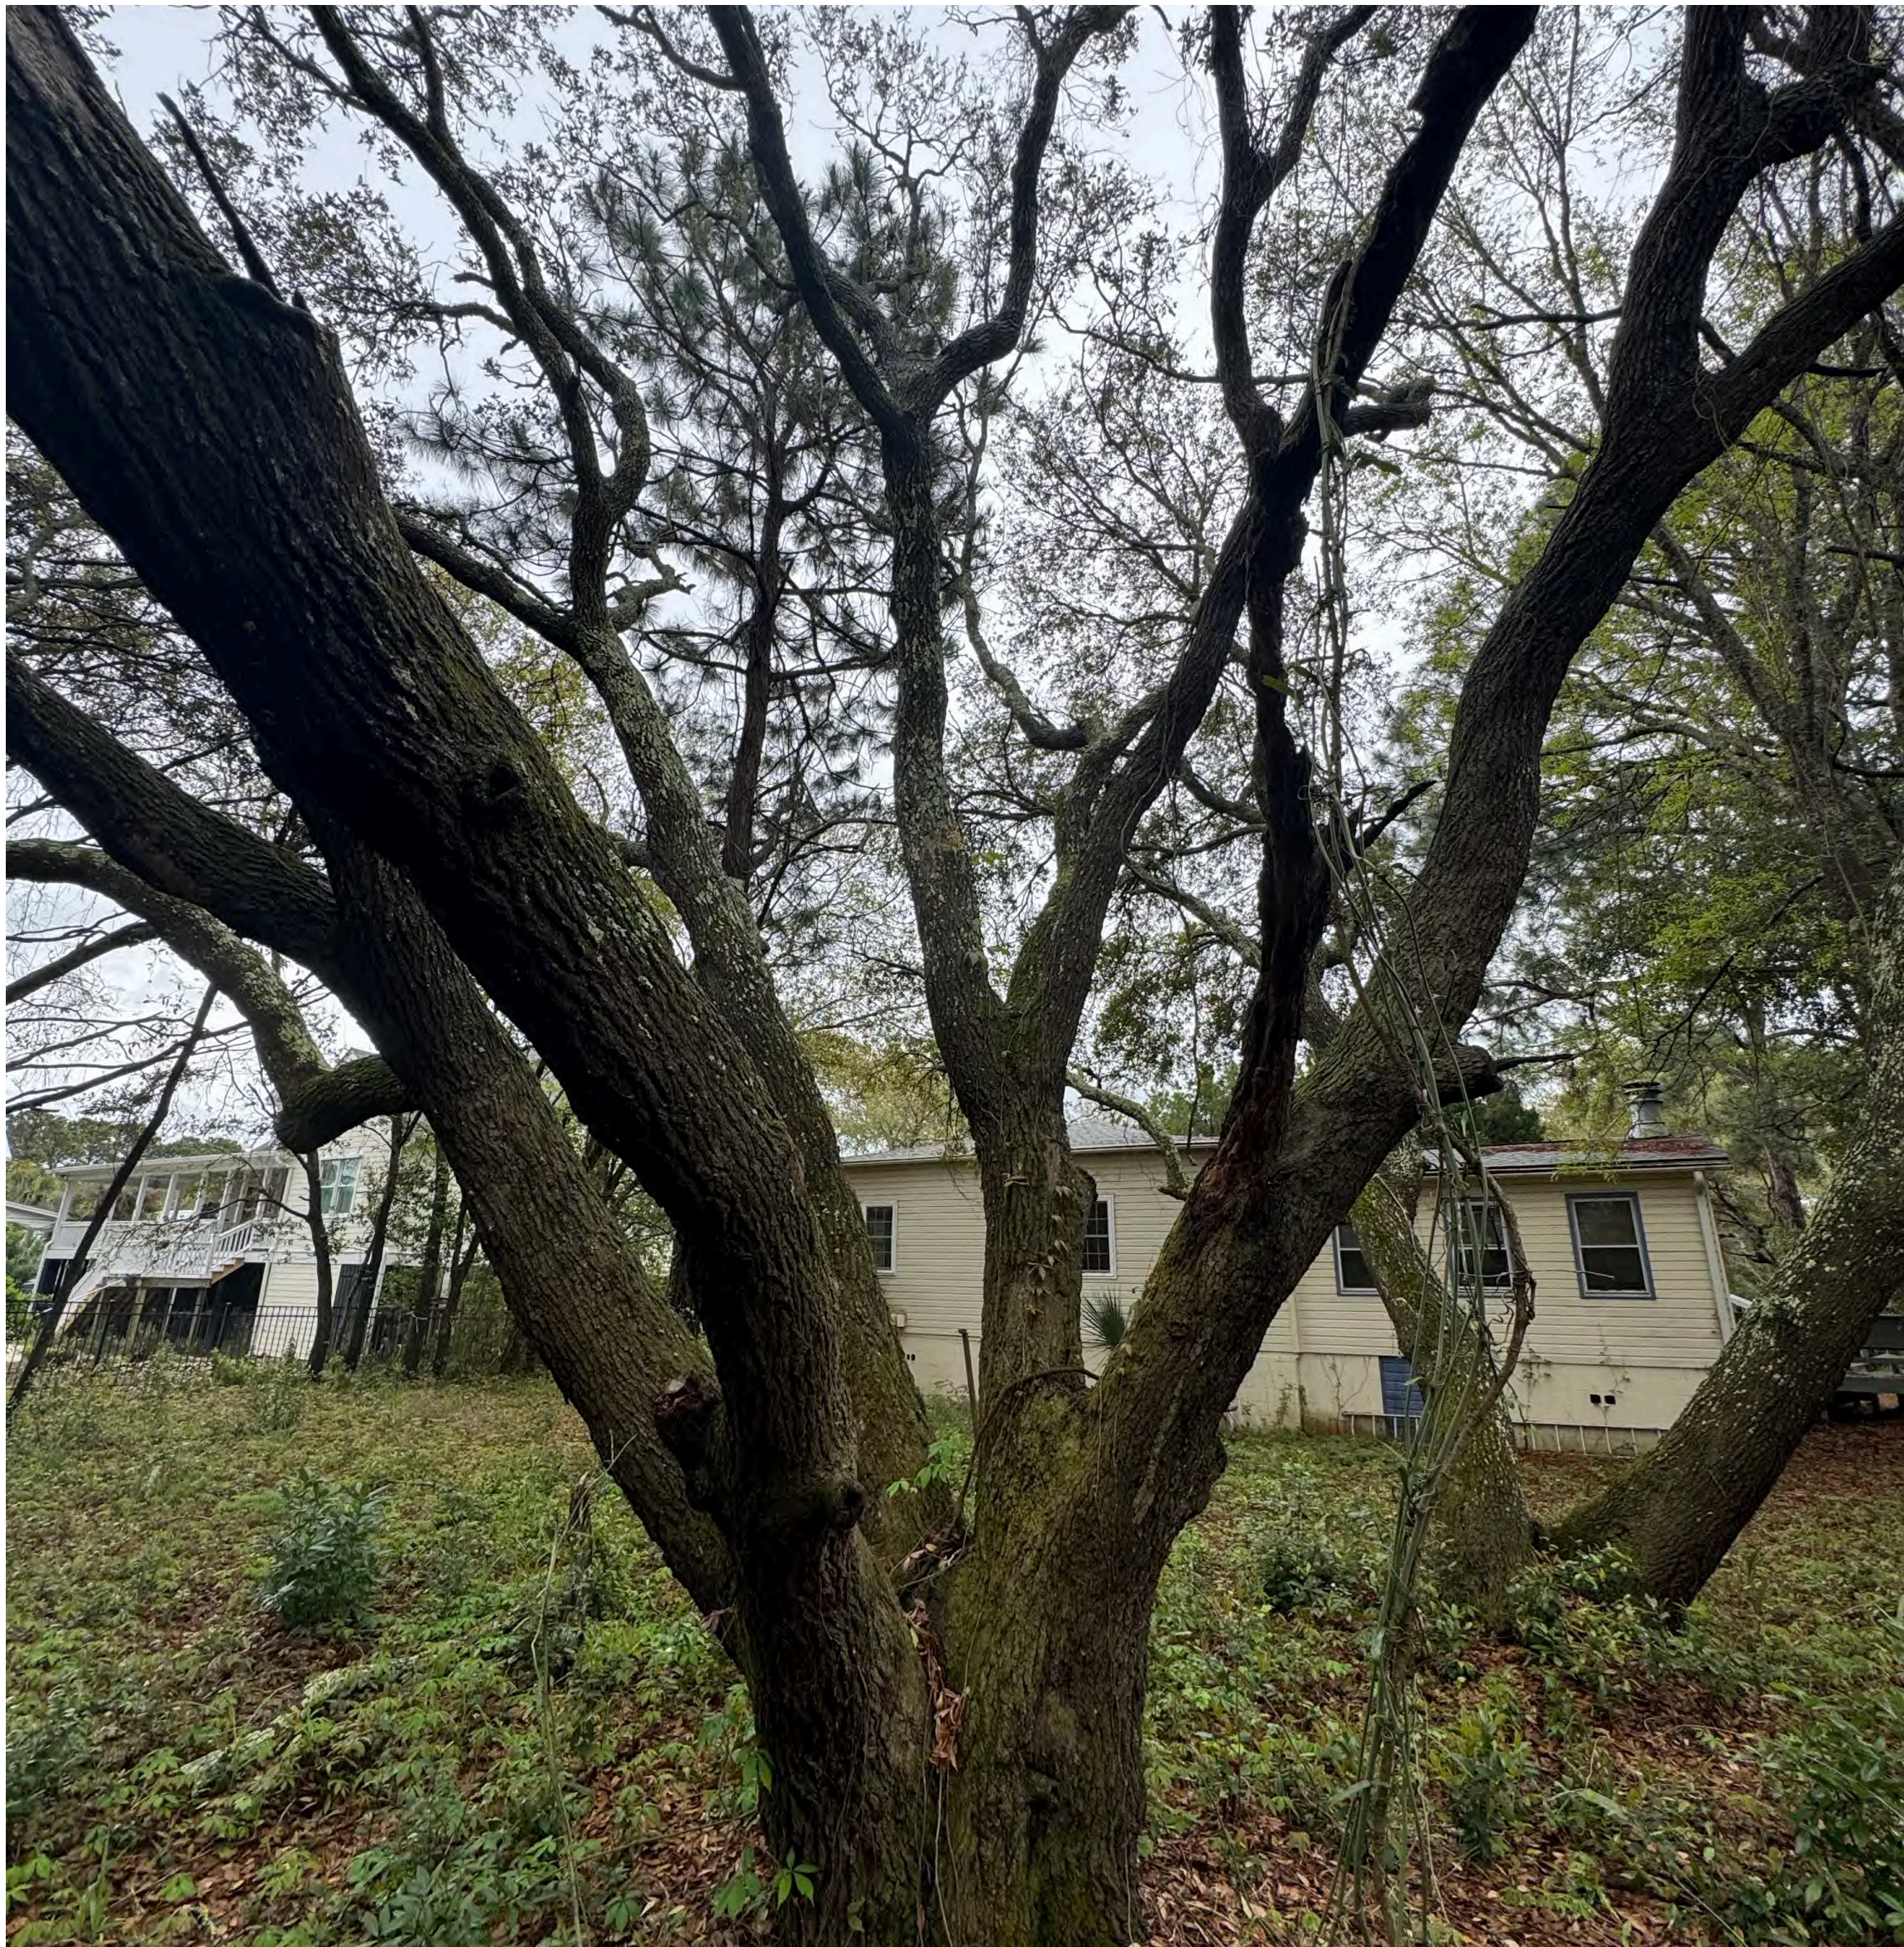
**#3 triple live oak**

3. Category I "HAZARD REMOVAL" : 23/15/20" *Quercus virginiana* Triple Live Oak – This cluster Live Oak has extensive dieback and crown thinning. There is fungal decay on several large limbs. The structure is compromised by competition from surrounding trees and the limbs are overextended due to the light and nutrient competition. There is also poor attachment of the multiple leaders at the base of the tree and failure is likely as the tree declines.

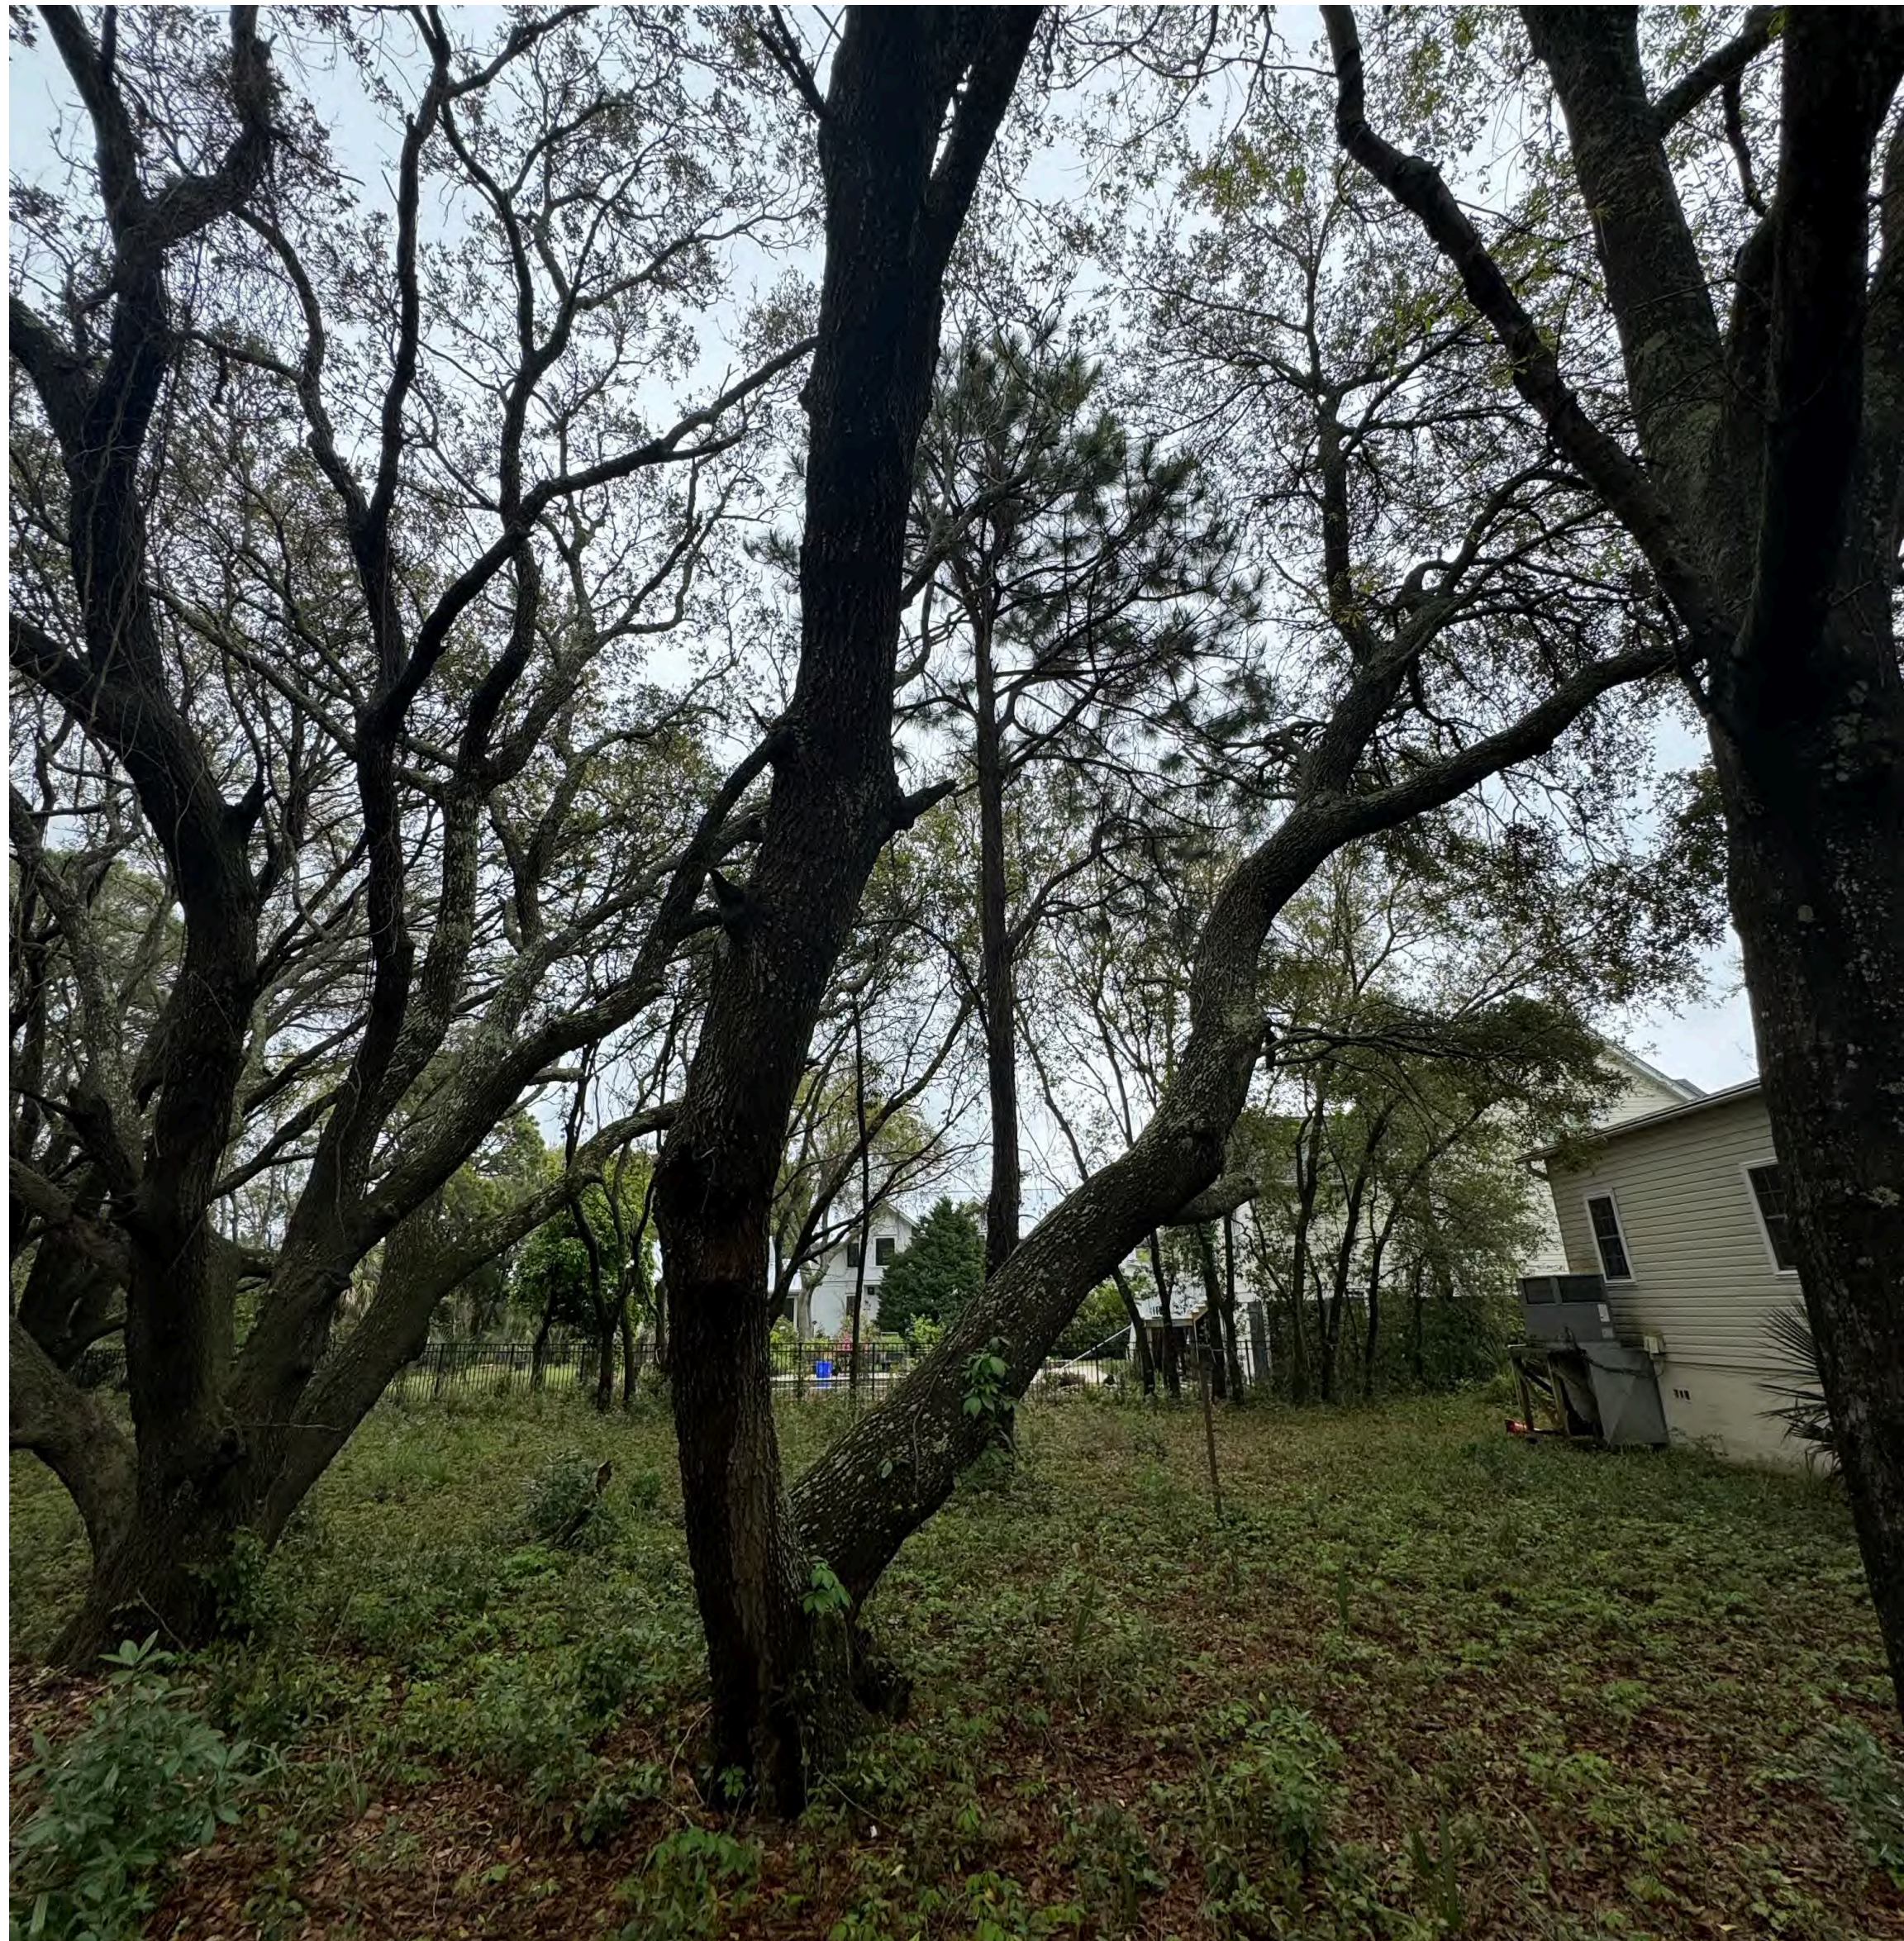
**#4 double live oak**  
**#6 pine (behind)**

4. Category I "HAZARD REMOVAL" : 34" *Quercus virginiana* Double Live Oak – This tree has spreading form and overextended limbs. The overextended leaders do not provide any opportunity for subordination pruning. The wide attachment at the base of the tree poses a risk for failure over time.

5. 16" *Quercus nigra* Water Oak – This tree has triple co-dominant crown structure with pocket of decay located in triple crotch area.
6. 14" *Pinus* sp. Pine – This tree has poor trunk taper from growth as a volunteer under existing mature oak canopy. Forked central leader at top is structural issue.
