2018 Beach Monitoring Survey

TOWN OF SULLIVAN'S ISLAND, SC

Elko Coastal Consulting, Inc. | July 2018

2018 Beach Monitoring Survey: Town of Sullivan's Island, SC

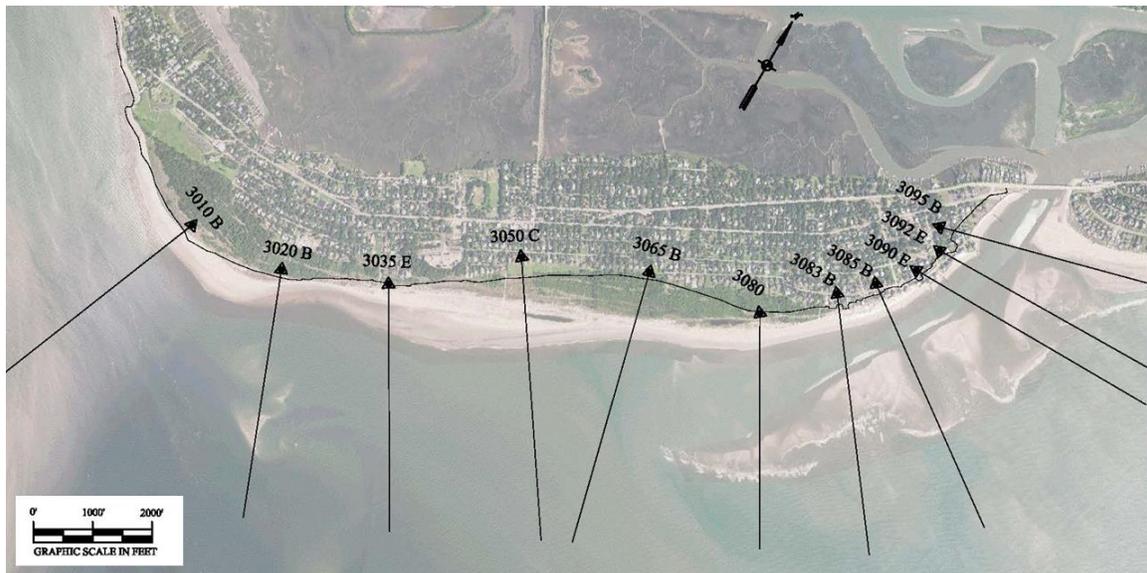
Figure 2. 2015 aerial photo illustrating the eleven (11) beach profile lines and corresponding SCDHEC-OCRM Monuments on Sullivan's Island. The solid black line running parallel to the shoreline through the dunes is the OCRM Baseline.

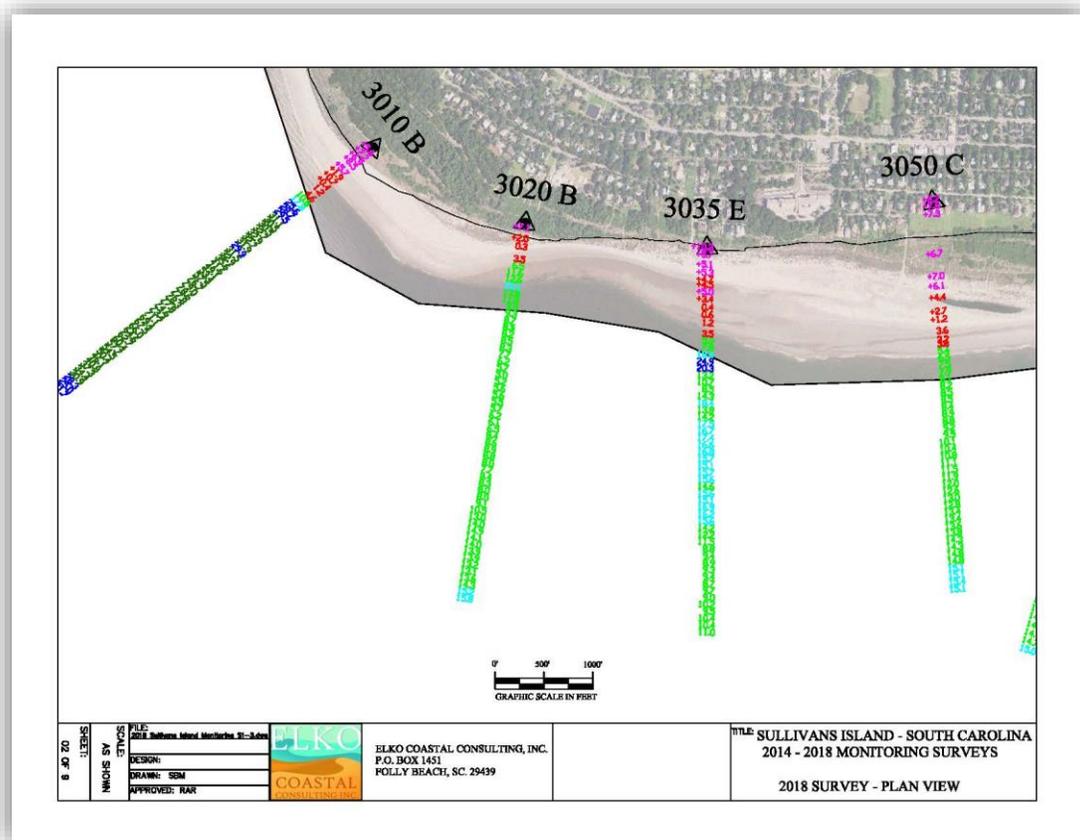
Figure 3. Topographic and bathymetric 2018 survey data illustrating the measured elevation along each line for the southwest end of Sullivan's Island.

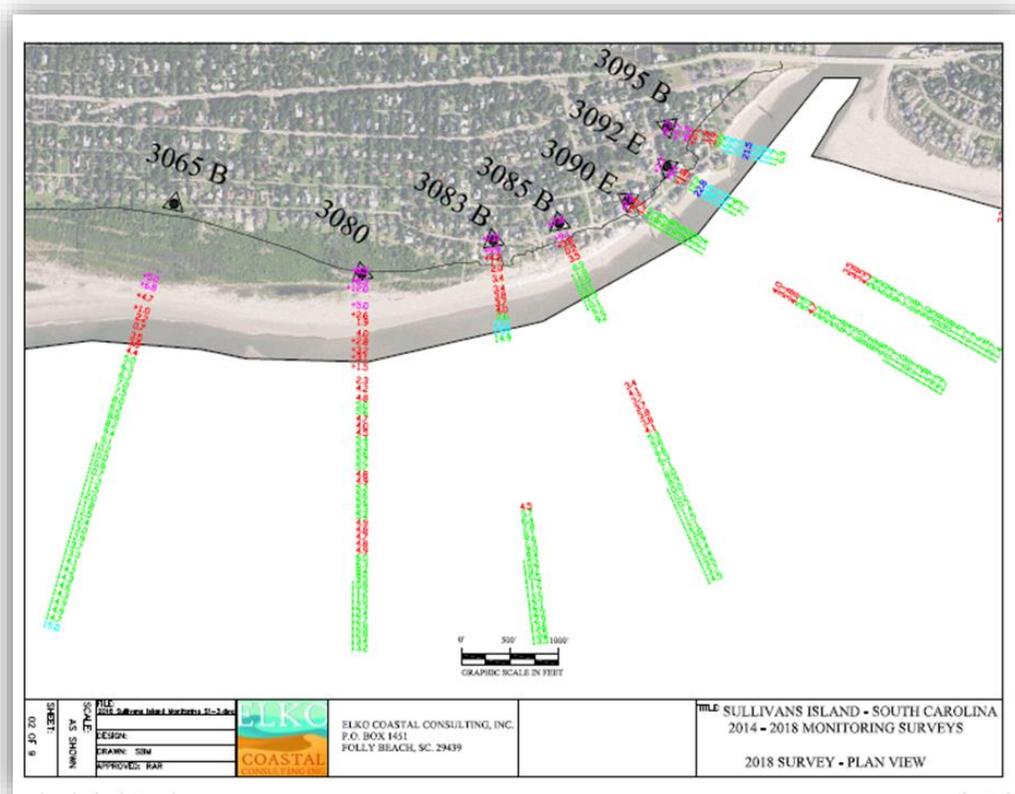
Figure 4. Topographic and bathymetric 2018 survey data illustrating the measured elevation along each line for the northeast end of Sullivan's Island.

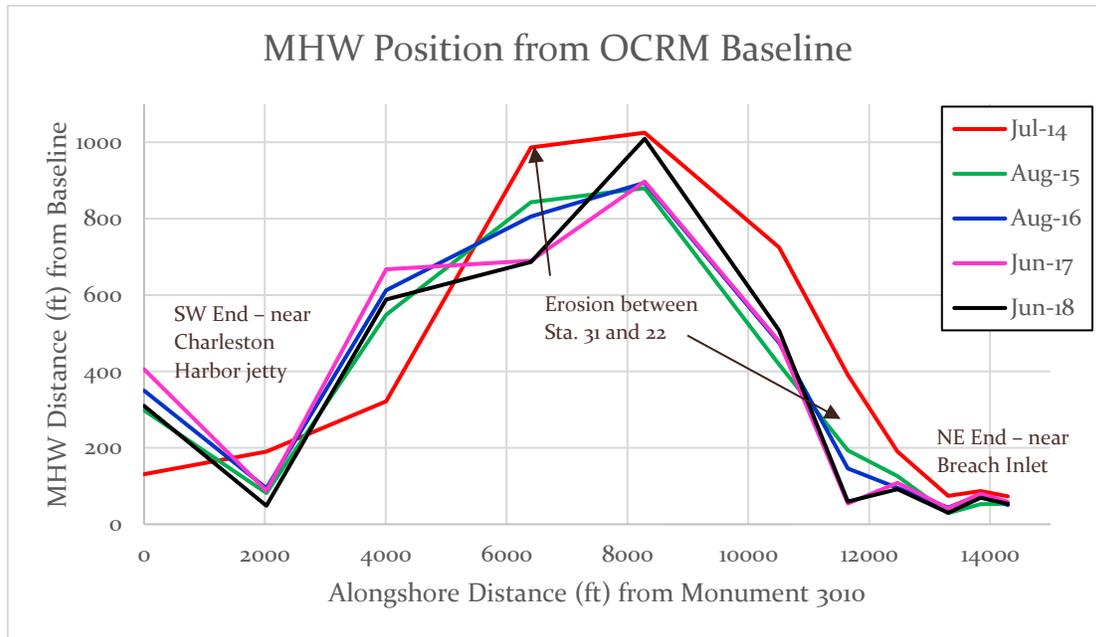
The position of MHW relative to the baseline is a useful measurement (Figure 5) because it illustrates both the change in shoreline position from year to year, as well as the distance between the shoreline and baseline – an indicator of the level of storm damage protection provided by the beach/dune system at each monument.

During the study period, the Sullivan's Island shoreline changed dramatically between 2014 and 2015, but exhibited less shoreline change between 2015 and 2018 (Figure 5). Several areas were flagged in the 2016 & 2017 monitoring reports and are discussed below.

The northeast end of the island, between Monuments 3090 and 3095 and adjacent to Breach Inlet, was flagged in the 2016 report. It is under continual erosional pressure due to the southwesterly migration of Breach Inlet, but has been stabilized by erosion control structures. Minor shoreline change has occurred along this northeastern end over the last three years; however, the small distance between the shoreline and the OCRM baseline suggests erosional pressure and the need for continued monitoring. There is little storm damage protection at this location.

The shoreline between Station 31 and 22 (OCRM Monuments 3050 and 3085) was also flagged in the 2016 report because the shoreline position moved landward an average of 180 ft between 2014 and 2016 (Figure 5). This dramatic shoreline retreat has stopped and the shoreline is advancing at most of the monuments in this section with the exception of the erosional 3083 (at Sta. 29).

Figure 5. Annotated MHW Position graph illustrating the change in shoreline position from 2014 to 2018, as well as the distance between the shoreline and baseline.

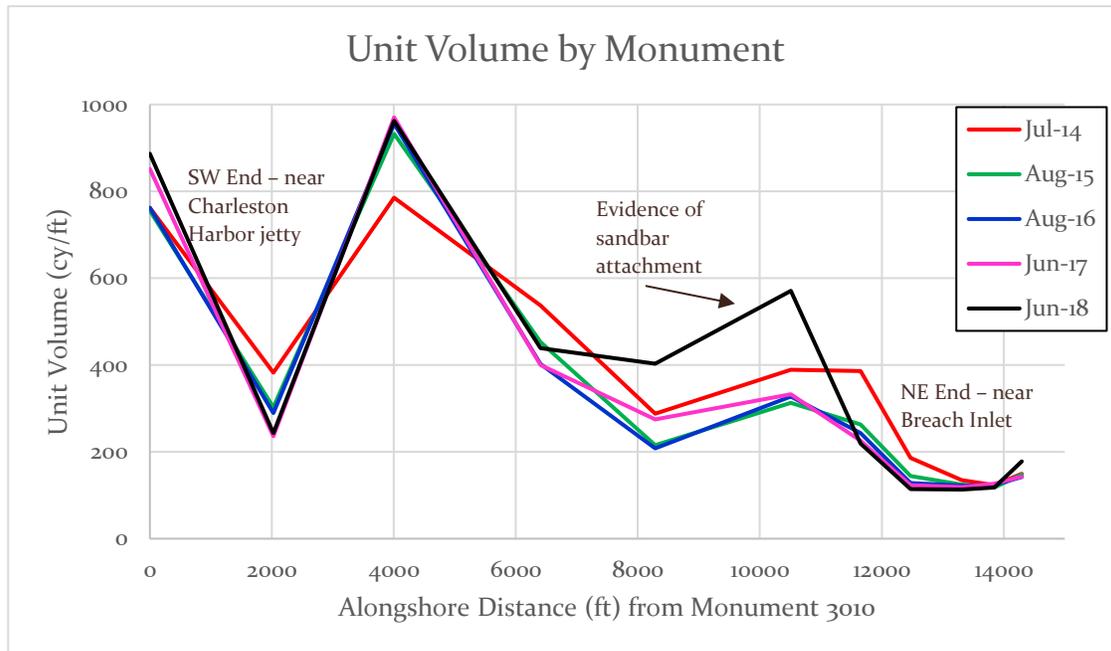
As suggested in the MHW analysis, northeastern Sullivan's Island has less storm protection in place than the rest of the island. Despite the narrow beach, the average unit volume to the depth of closure (DOC) has been stable at 130 cubic yards per foot (cy/ft) from 2016 to 2018. The rest of the island has at least 200 cy/ft of volume along each measured profile (Figure 6).

Figure 6. Annotated Unit Volume graph illustrating the change in unit volume at each profile from 2014 to 2018.

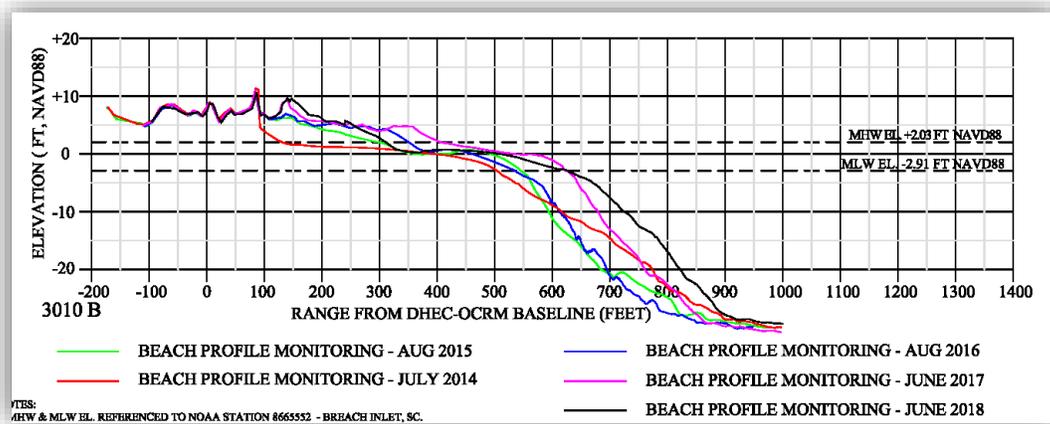
This is the southwesternmost OCRM Monument on Sullivan’s Island, located along the long beach access path at Station 16 with the nature trail. In 2017, this access path was flooded with standing water but it was dry in 2018. The beach is located on the Charleston Harbor side (“inside”) of the jetty. Consistent with the measured beach profile data (Figure 7), the beach displayed some evidence of past erosion, but in June 2018, the beach exhibited accretionary, healthy conditions. The backbeach and dune have accreted sediment in the last year. The sandbar was attaching to the beach.

The elevation at the seaward end of the dune access path is low relative to the adjacent dunes, leaving a discontinuity in the dune system. According to the 2018 volume calculation, this profile has a unit volume of 887 cy/ft.

Figure 7. Beach profile monitoring data from 2014-2018 in cross-section view at Monument 3010.

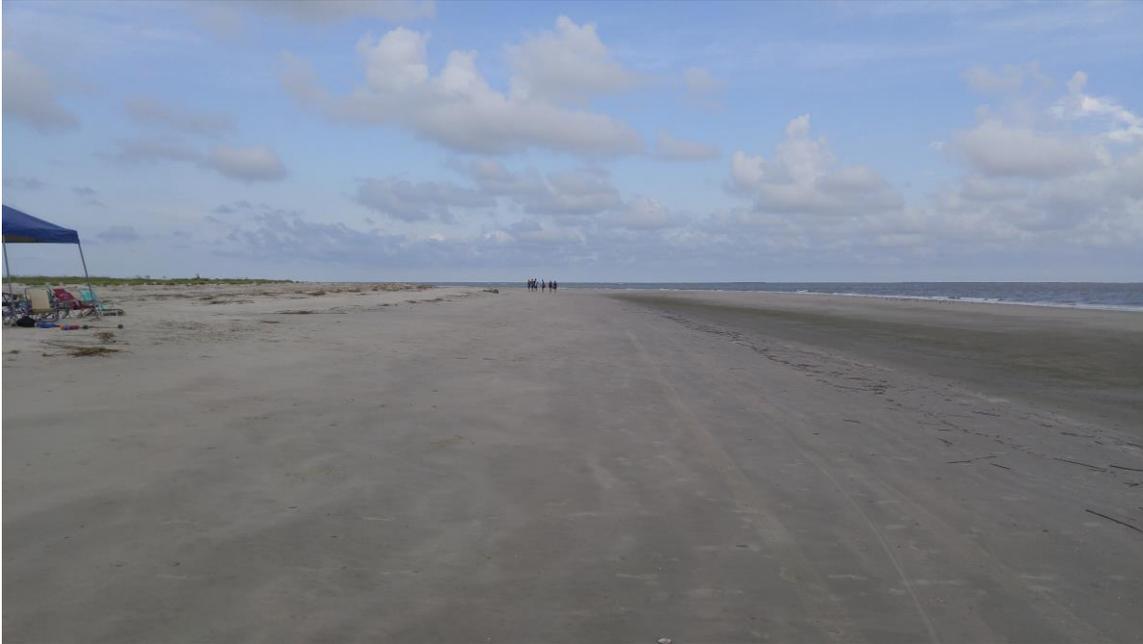
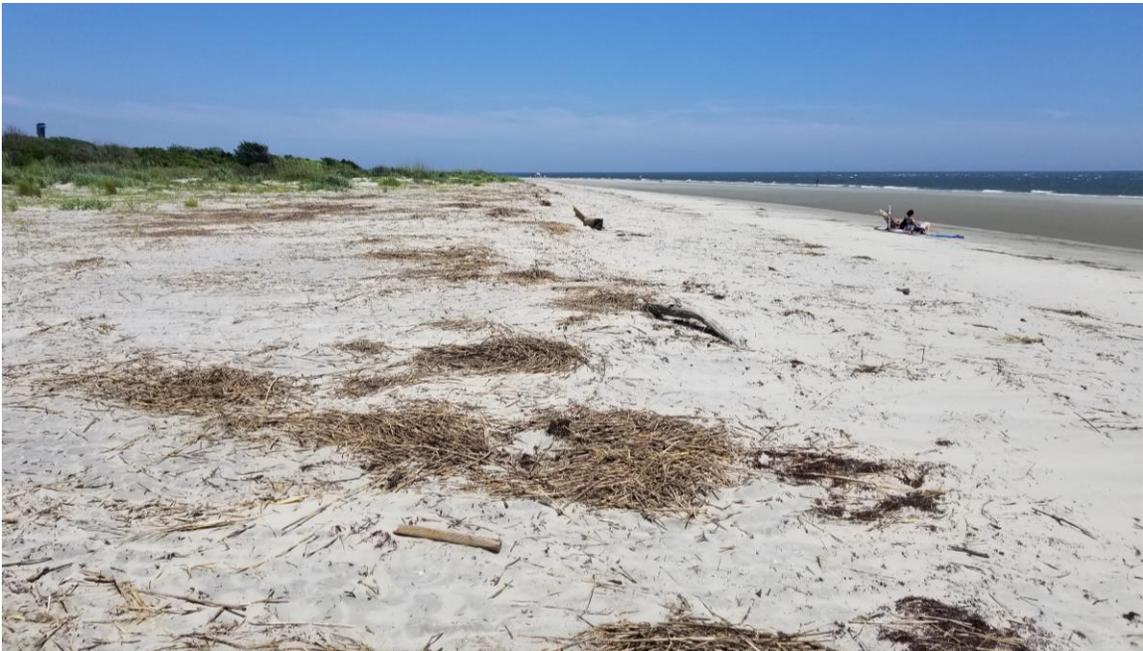
Incipient dunes were abundant at this location. The dry backbeach between the high tide line and the incipient dunes was wide and low with some evidence of overtopping (Figure 8 and Figure 9).

Figure 8. Ground photo taken at Monument 3010 looking east on August 4, 2016 (top) and June 11, 2018 (bottom). Note the higher elevation of the backbeach and dune in 2018.

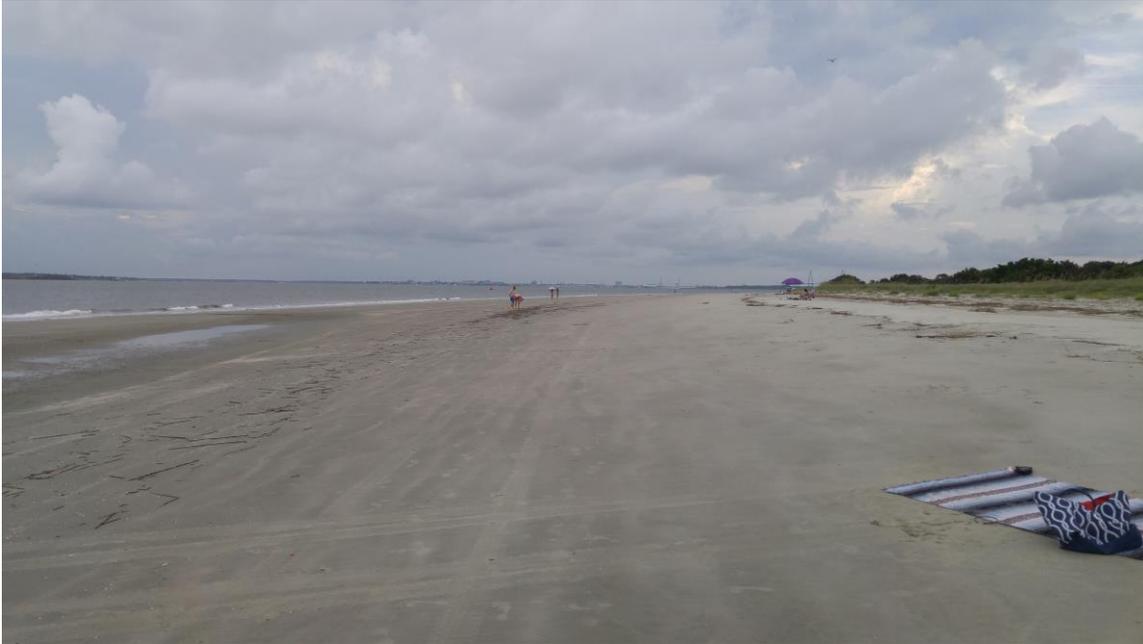
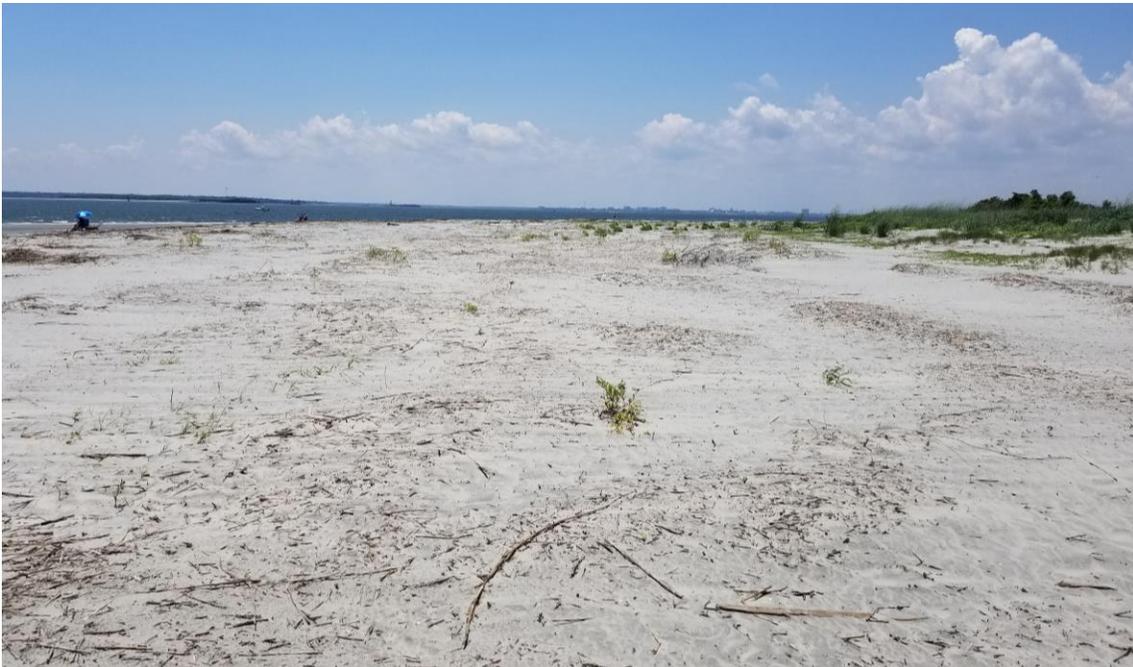
Figure 9. Ground photo taken at Monument 3010 looking west on August 4, 2016 (top) and June 11, 2018 (bottom). Note the higher elevation of the backbeach and dune in 2018.

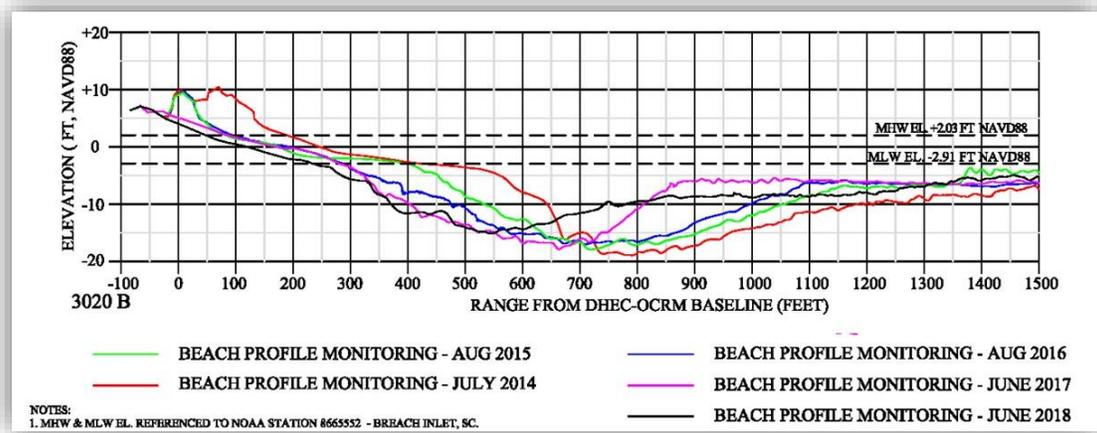
Hurricanes were not solely responsible for the condition of the beach at this location. Significant erosion has taken place here since 2014 that included loss of a large dune and submerged nearshore sand body (Figure 10). Now, sediment in the offshore sandbar is accumulating and the bar is migrating onshore. A sand bar had attached to the updrift beach (Figure 11) in 2018. Both may eventually supply sediment to this location. Considerable ongoing dune erosion was evident to the southwest in 2016, but recovery was evident in 2017 and 2018 (Figure 12).

According to the 2018 volume calculation, this profile has a unit volume of only 244 cy/ft, which is in stark contrast to the surrounding accretional areas. This monument is influenced by its location downdrift of the Charleston Harbor jetty.

Figure 10. Beach profile monitoring data from 2014-2018 in cross-section view at Monument 3020.

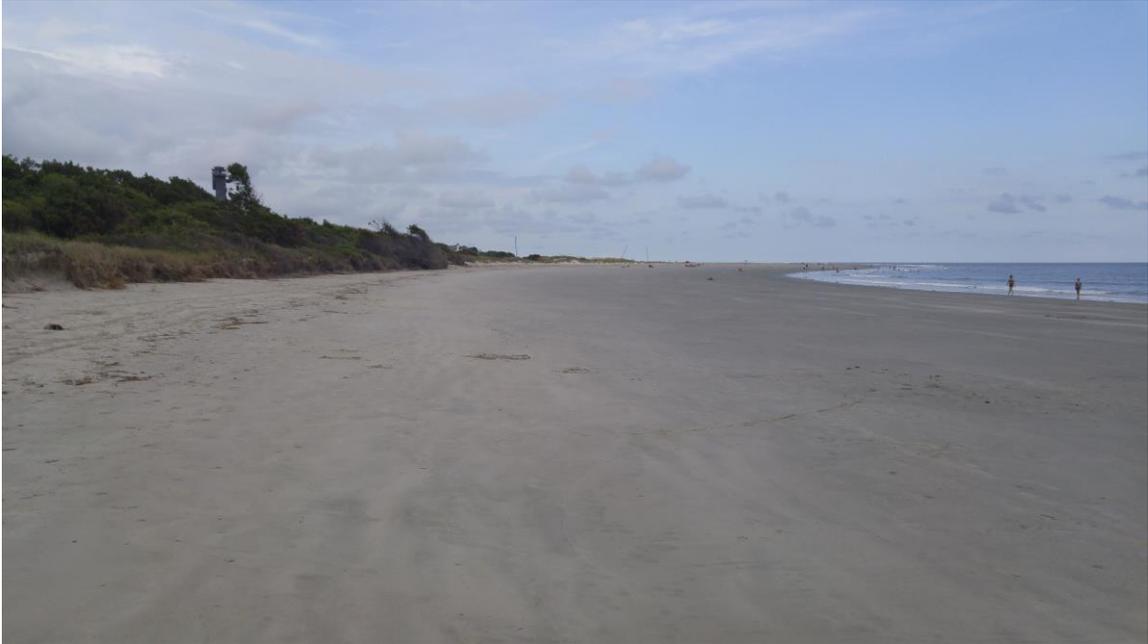
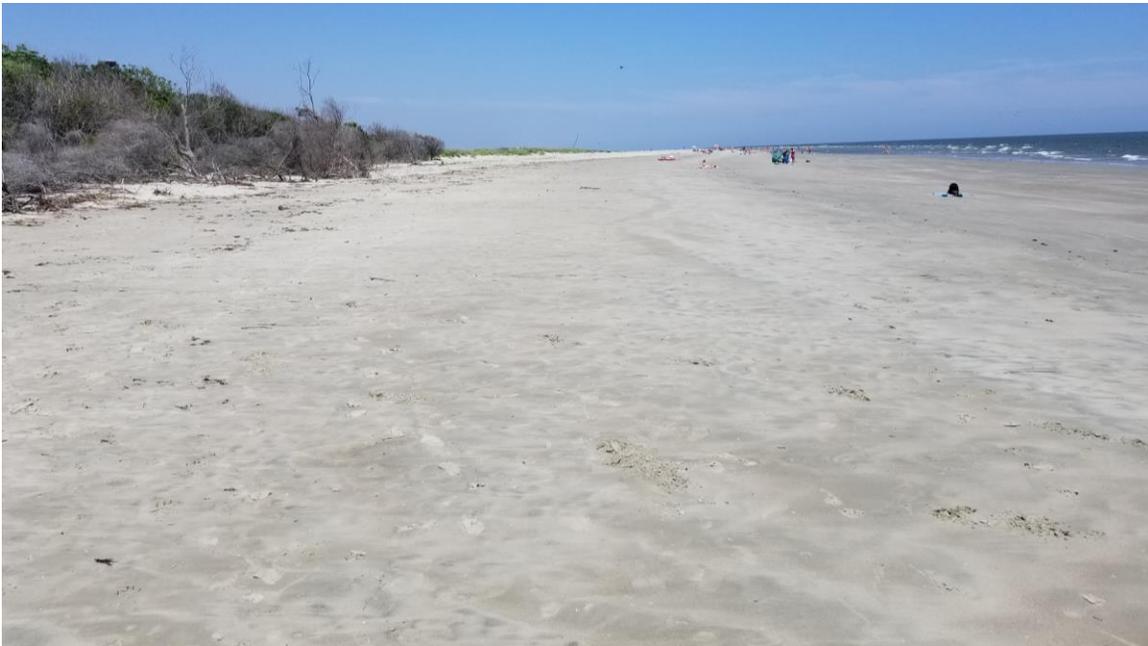
Monument 3020 is located along the long beach access path at the Sand Dunes Club. As in previous years, the beach at Monument 3020 exhibited erosional conditions in contrast to the beach conditions at the two adjacent monuments. All dune vegetation here has been removed and the toe of vegetation location is occupied by dead trees. The storm high tide rack line is reaching the (dead) vegetation.

Figure 11. Ground photo taken at Monument 3020 looking northeast on August 4, 2016 (top) and June 11, 2018 (bottom). Notice the sand bar attachment on the beach to the northeast.

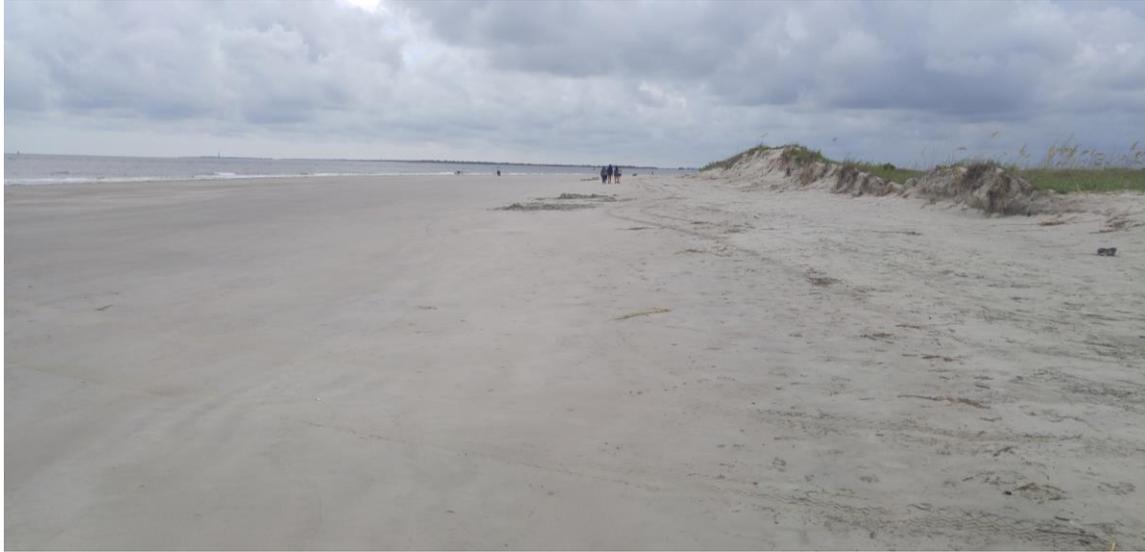
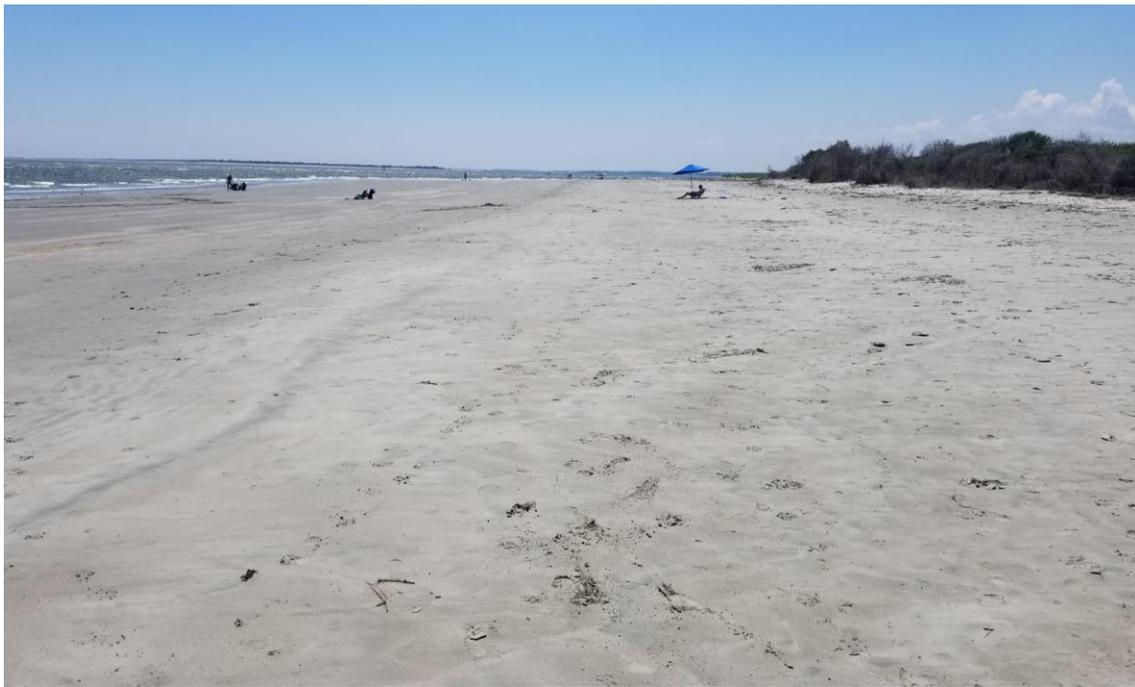
Figure 12. Ground photo taken at Monument 3020 looking southwest on August 4, 2016 (top) and June 11, 2018 (bottom). Note the recovery of dune vegetation to the southwest in 2018.

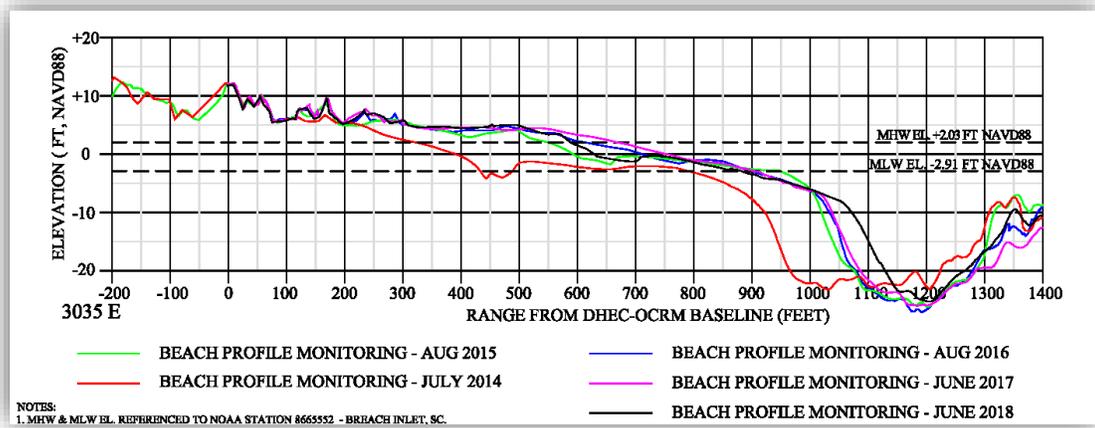
Monument 3035 is located along the long beach access path at Station 19. This area has been the beneficiary of the 2014 sandbar attachment event (Figure 13). The beach has been wide and accreting between August 2016 and June 2018 with at least 200 ft of dry beach between the vegetation line and the high tide line (Figure 14 and Figure 15). Continued accretion has occurred between 2016 and 2018 with development of incipient dunes (Figure 15). In contrast to 2016 and 2017, no ponding was observed in the backbeach (Figure 14), suggesting the backbeach elevation has increased.

According to the 2018 volume calculation, this profile has a unit volume of 962 cy/ft. The beach profile at this monument is influenced by the sediment trapping effect of the Charleston Harbor jetty.

Figure 13. Beach profile monitoring data from 2014-2018 in cross-section view at Monument 3035.

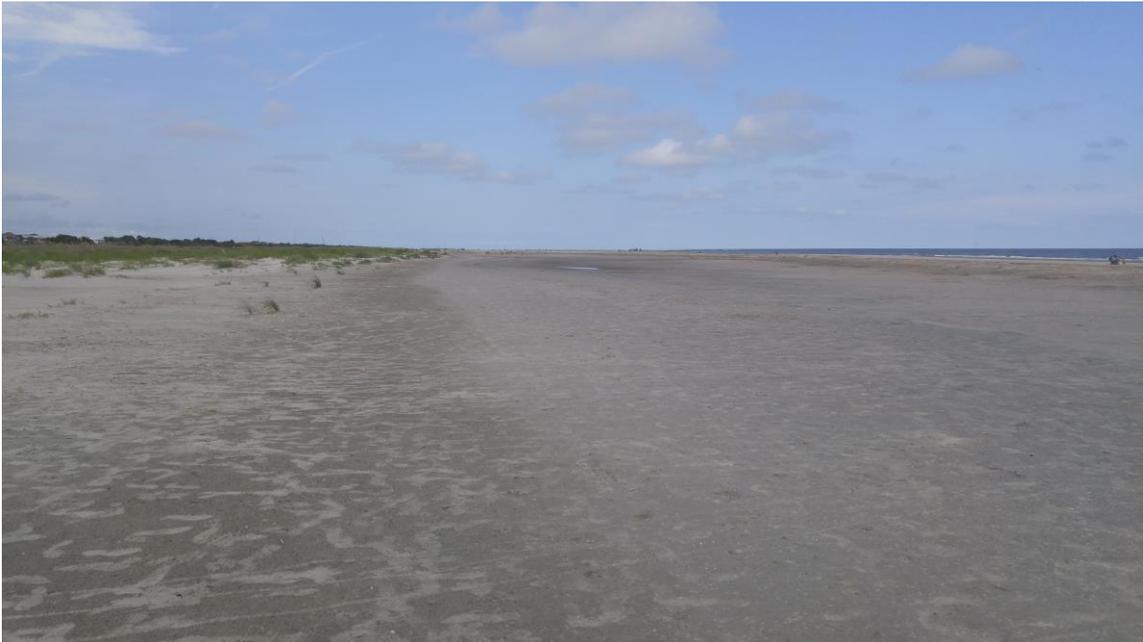
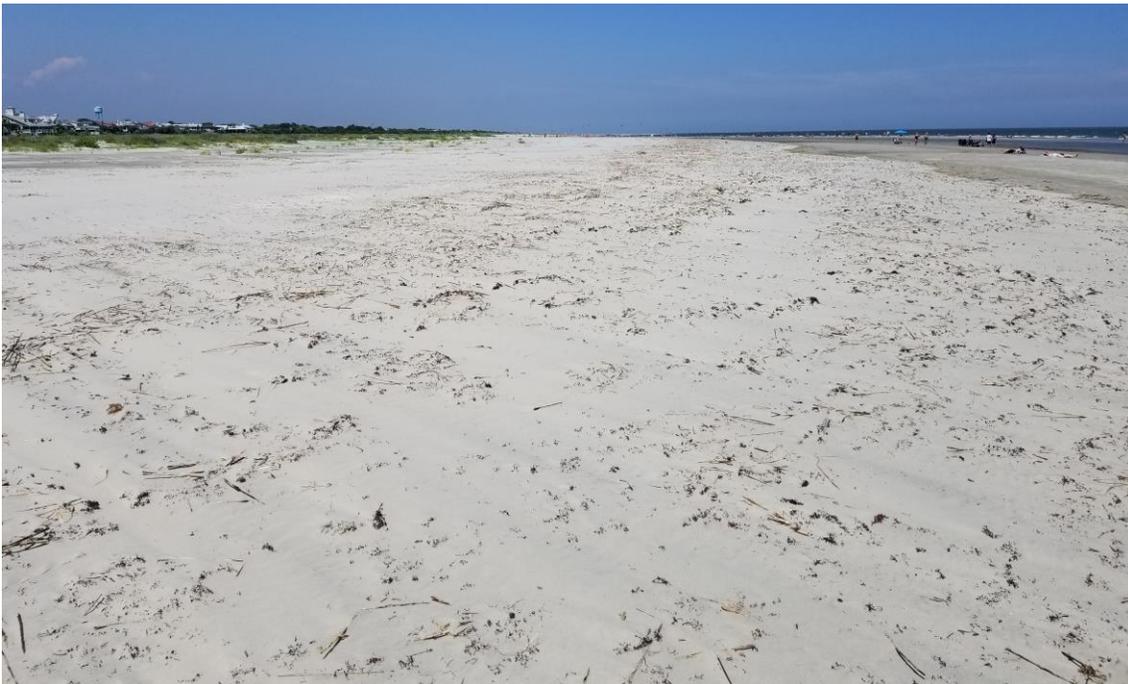
Figure 14. Ground photo taken at Monument 3035 looking northeast on August 4, 2016 (top) and June 11, 2018 (bottom). Note the abundance of incipient dunes (coppice mounds) and reduced ponding.

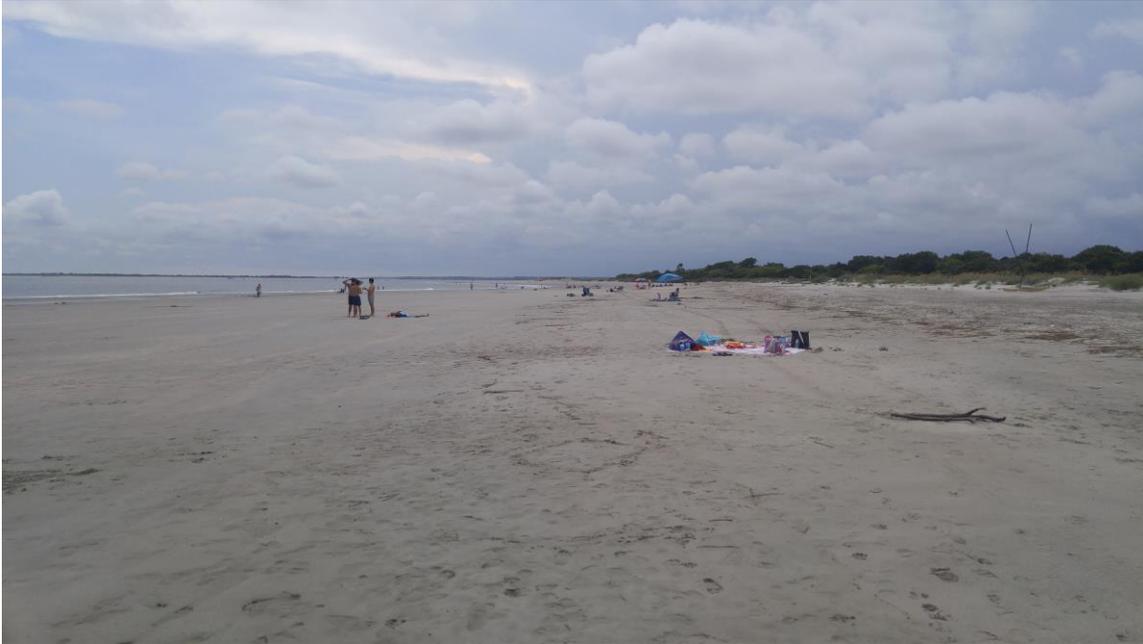
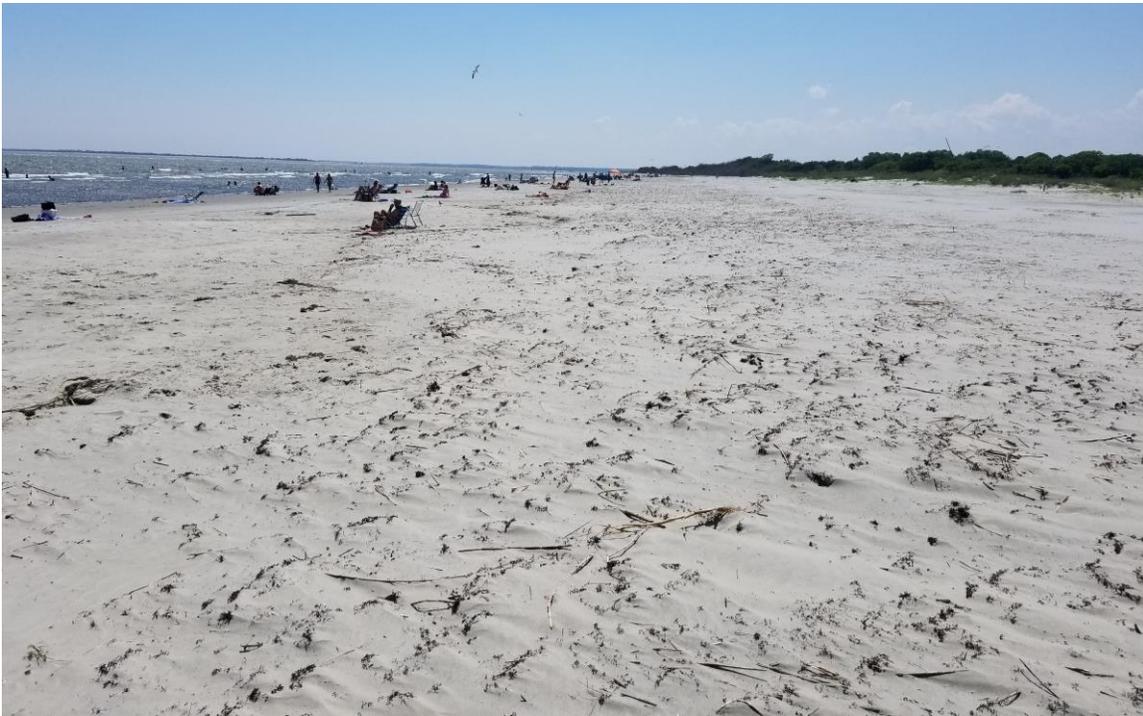
Figure 15. Ground photo taken at Monument 3035 looking southwest on August 4, 2016 (top) and June 11, 2018 (bottom). Note the abundance of incipient dunes (coppice mounds).

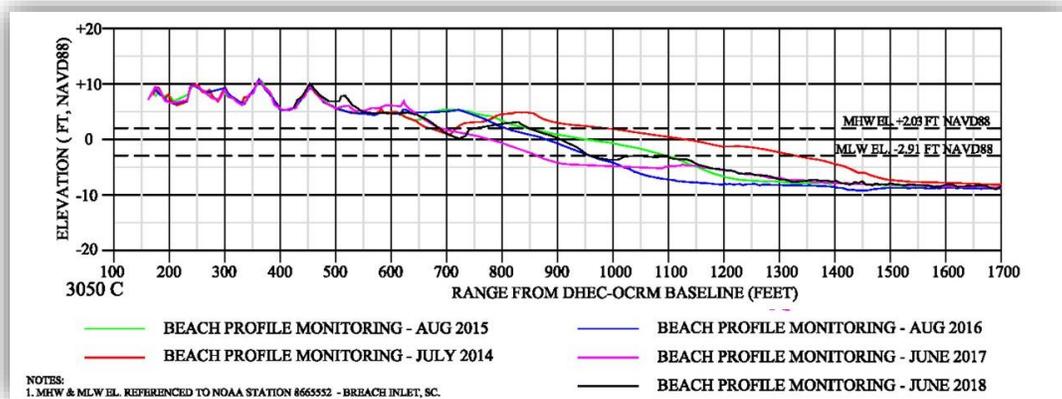
Monument 3050 is located along the long beach access path at Station 22.5 in the center of the island. Beach profile data indicate the recent sand bar attachment event that occurred here in 2014 (Figure 16). Over the last five years, sediment from this attachment bar has welded to the shoreface and resulted in the 2018 beach which includes a new primary dune and a slightly reduced berm width.

The elevation at the seaward end of the dune access path is low relative to the adjacent dunes, leaving a discontinuity in the dune system. According to the 2018 volume calculation, this profile has a unit volume of 439 cy/ft. The beach profile at this monument benefits from its location updrift of the Charleston Harbor jetty and indications are that accretion will continue.

Figure 16. Beach profile monitoring data from 2014-2018 in cross-section view at Monument 3050.

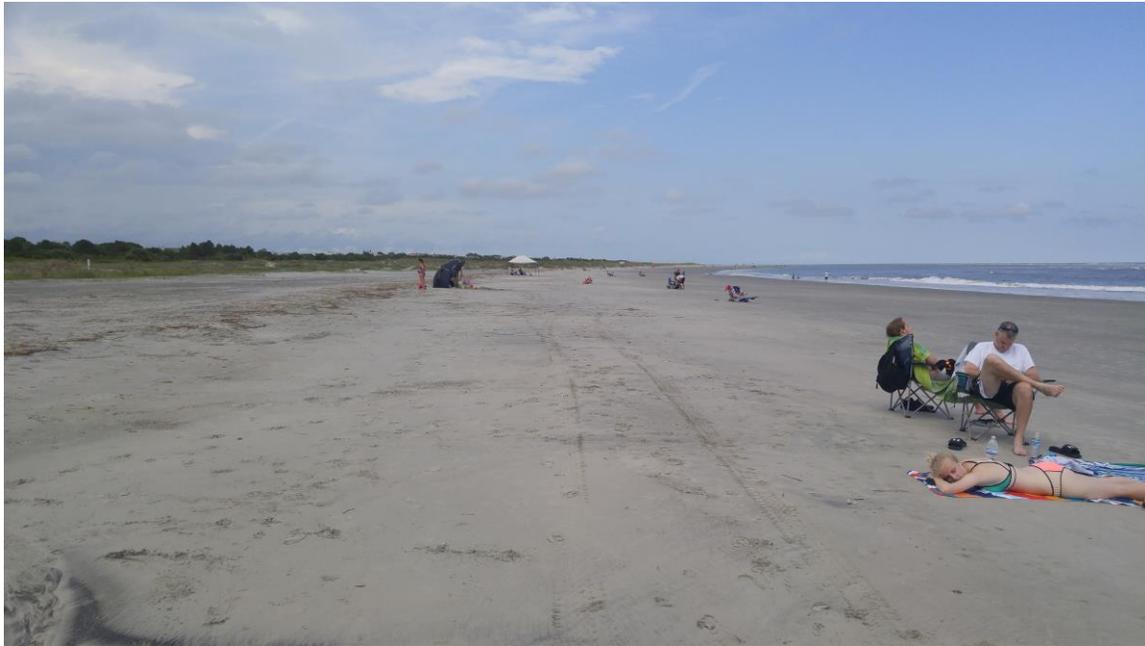
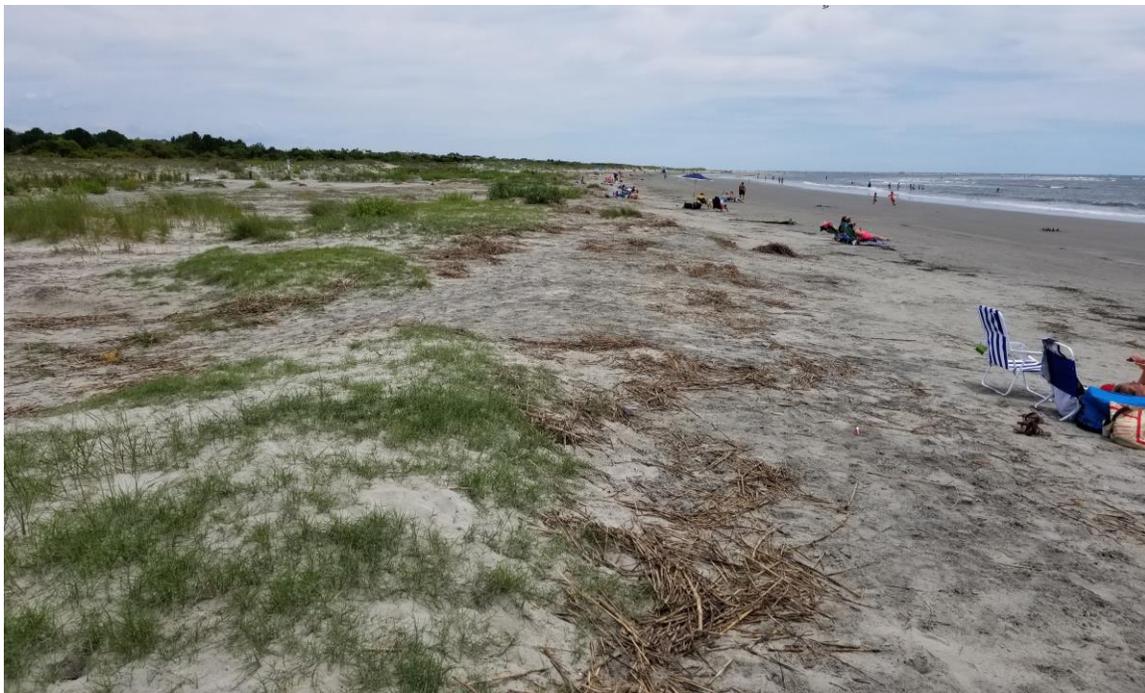
In 2018, the beach was wide an accretional. A new sand bar attachment event was underway. The dunes were healthy with new growth. The recreational beach was greater than 200 ft wide and the spring high tide line was at least 50 ft from the toe of vegetation.

Figure 17. Ground photo taken at Monument 3050 looking northeast on August 4, 2016 (top) and June 12, 2017 (bottom). Note the accretion and incipient dune formation along the backbeach in 2017.

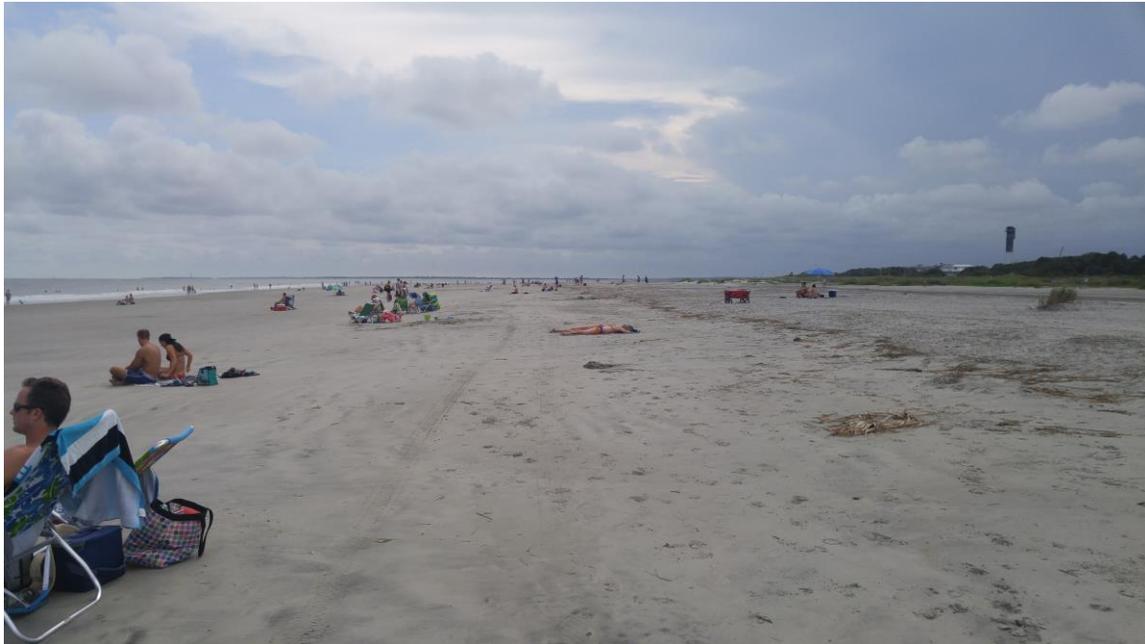
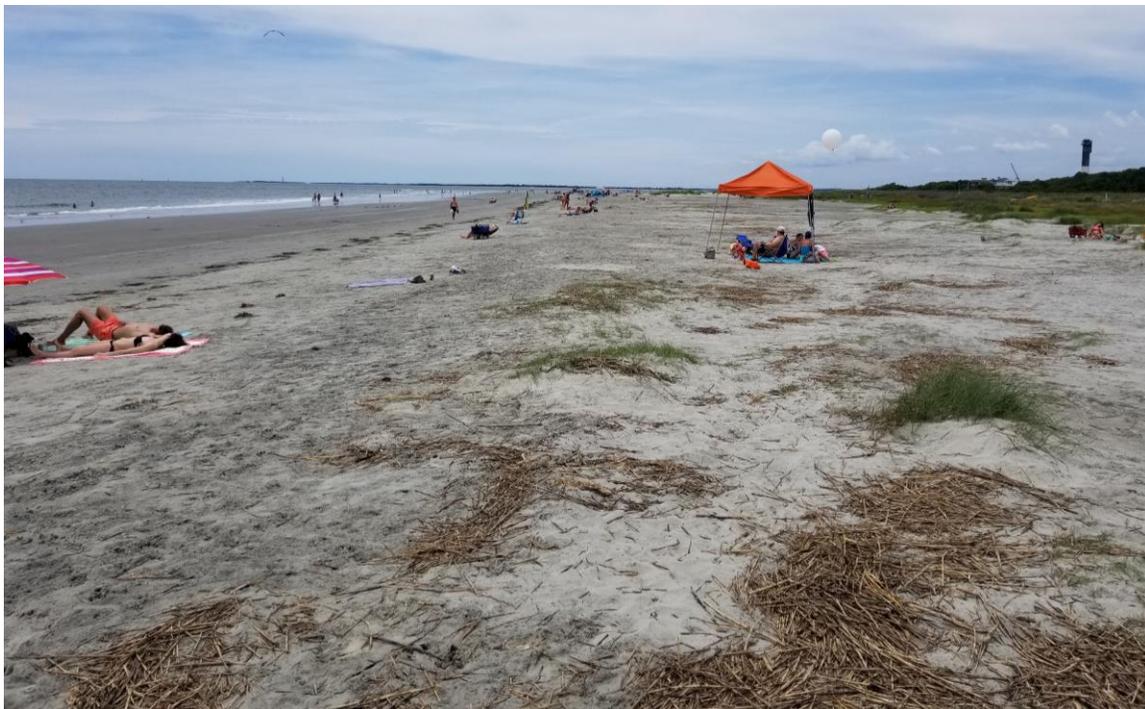
Figure 18. Ground photo taken at Monument 3050 looking southwest on August 4, 2016 (top) and June 12, 2017 (bottom). Note the accretion and incipient dune formation along the backbeach in 2017.

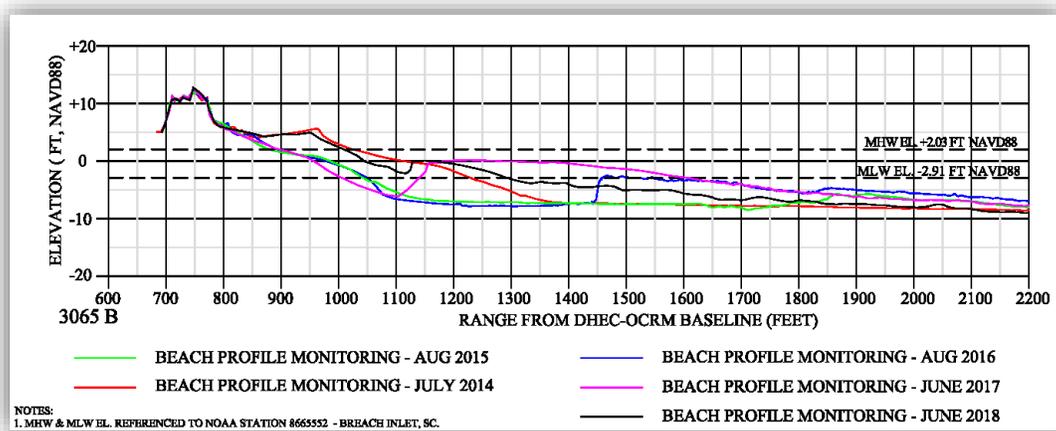
This is the sandbar attachment point. In June 2017, another sandbar was attaching to the beach profile and by June 2018, the bar had welded to the beachface. Prior to the attachment of this sandbar, past beach profile data indicated substantial beachface erosion following the 2014 attachment event (Figure 19) as the sediment spread along the beach.

Figure 19. Beach profile monitoring data from 2014-2018 in cross-section view at Monument 3065.

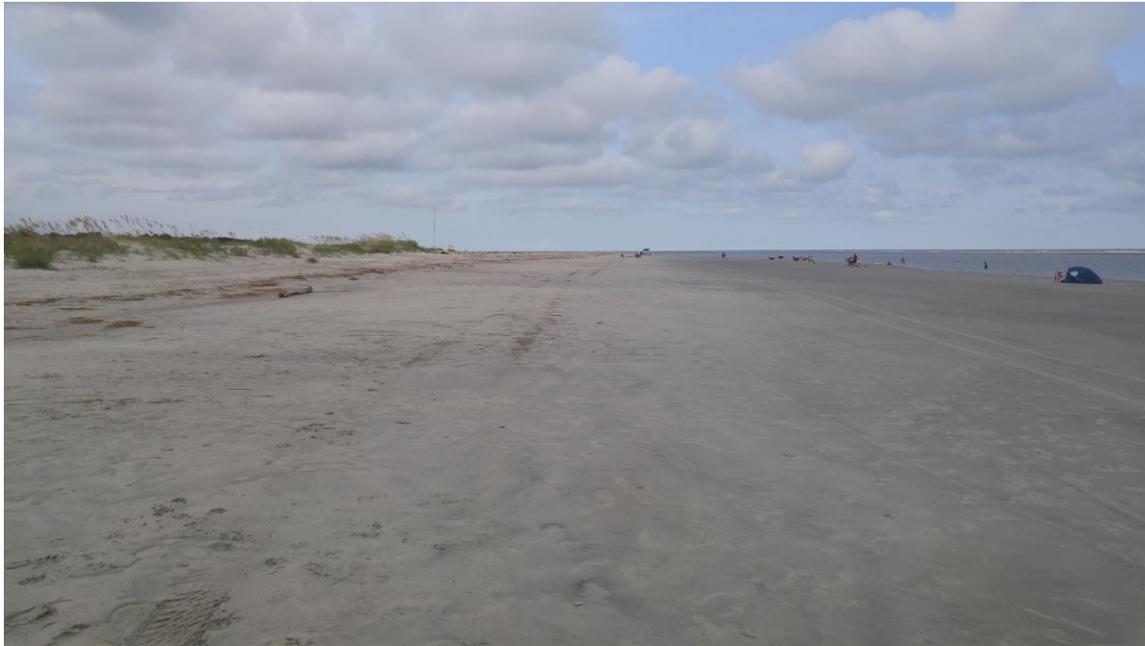
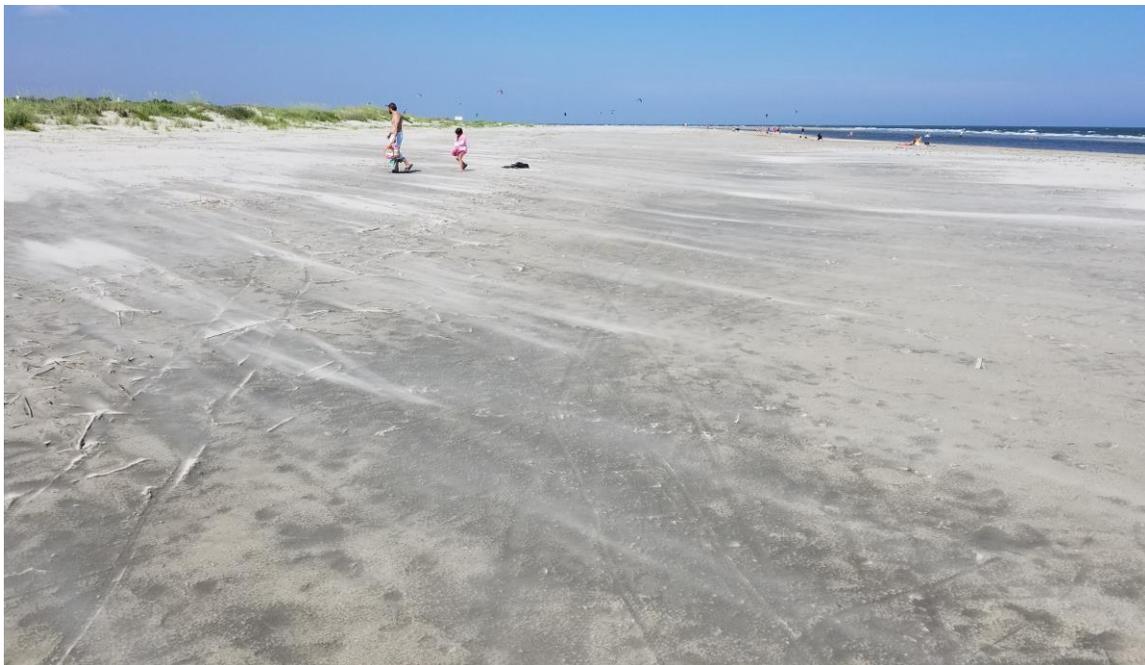
In 2018, incipient dunes were forming and accretional conditions were dominant. The recent storm rack line was 40 ft from the toe of vegetation with some evidence of previous dune erosion. The dry beach is over 100 ft wide at high tide and exhibits a wide, gently sloping low tide terrace and a robust dune system (Figure 20 and Figure 21).

Figure 20. Ground photo taken at Monument 3065 looking northeast on August 4, 2016 (top) and June 11, 2018 (bottom).
