2018 Beach Monitoring Survey

TOWN OF SULLIVAN'S ISLAND, SC

Elko Coastal Consulting, Inc. | July 2018

2018 Beach Monitoring Survey: Town of Sullivan's Island, SC

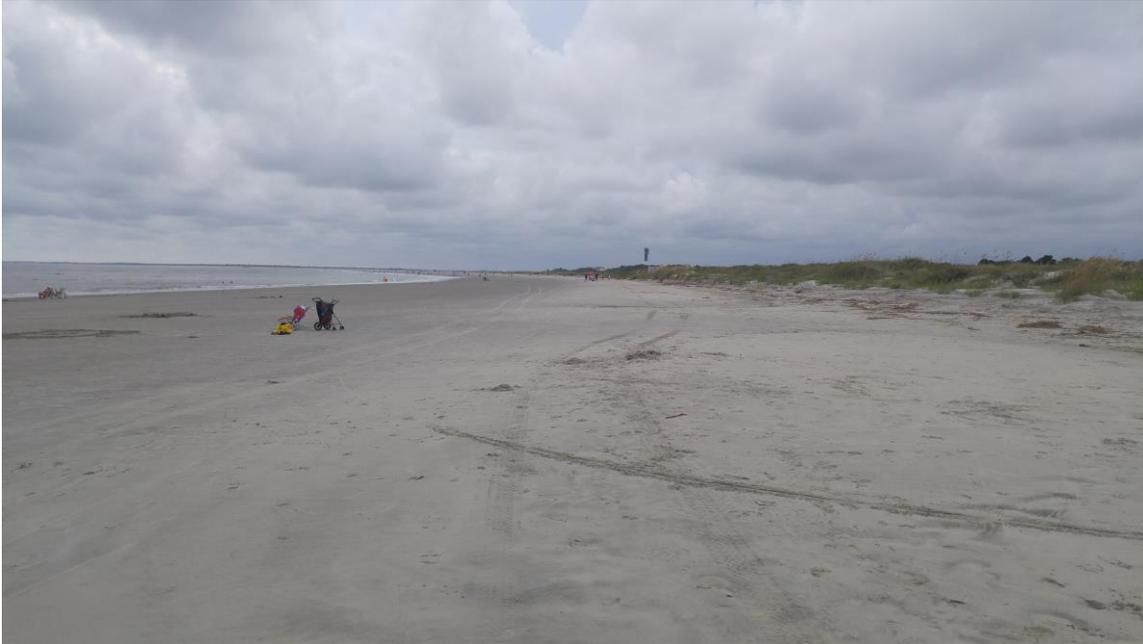
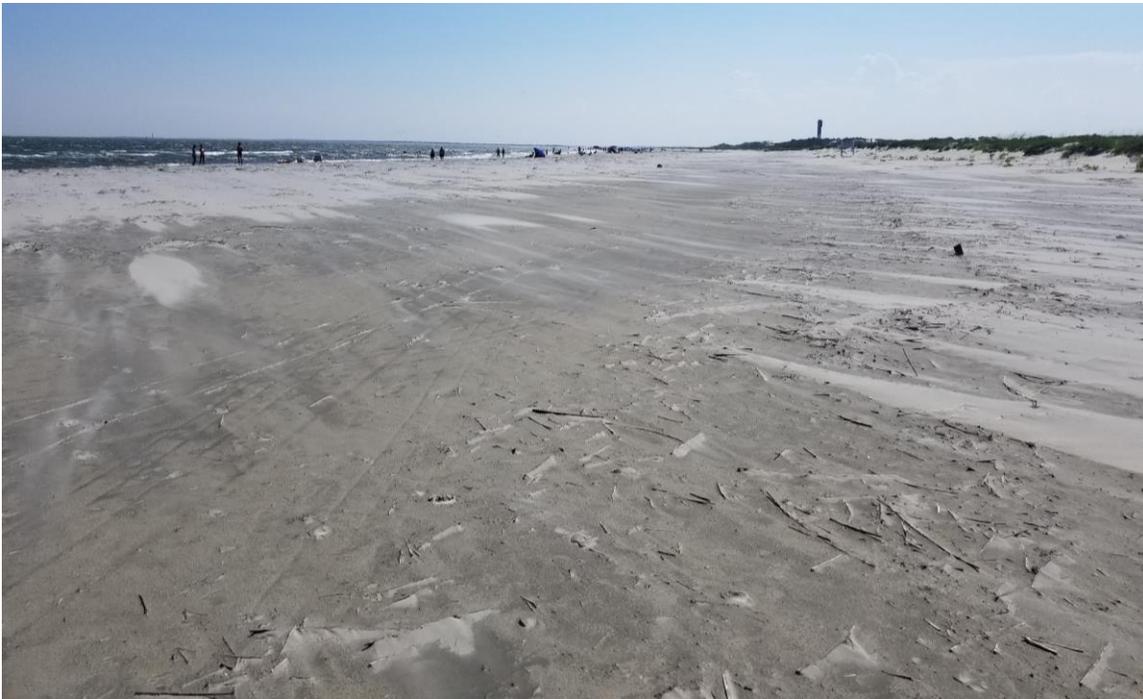
In 2018, incipient dunes were forming and accretional conditions were dominant. The recent storm rack line was 40 ft from the toe of vegetation with some evidence of previous dune erosion. The dry beach is over 100 ft wide at high tide and exhibits a wide, gently sloping low tide terrace and a robust dune system (Figure 20 and Figure 21).

Figure 21. Ground photo taken at Monument 3065 looking southwest on August 4, 2016 (top) and June 11, 2018 (bottom).

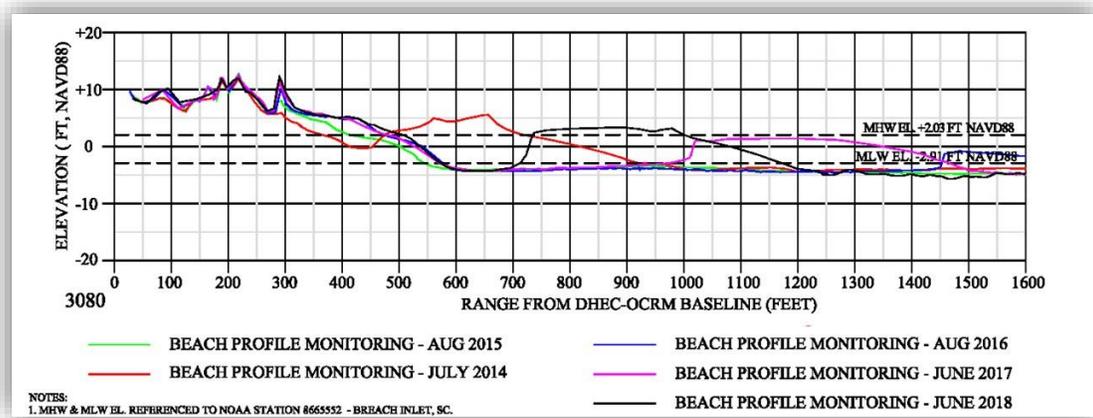
The sand bar was in the process of attaching to the beach at 3080 (Figure 22). The beach at this location displayed classic signs of accretion with a large ridge and runnel (attaching sand bar) and wide healthy dunes (Figure 23 and Figure 24). The high tide dry beach is over 100 ft wide and the dune vegetation is healthy and flourishing with a high foredune. Spring high tide is about 70 ft from the toe of vegetation.

Figure 22. Beach profile monitoring data from 2014-2018 in cross-section view at Monument 3080.

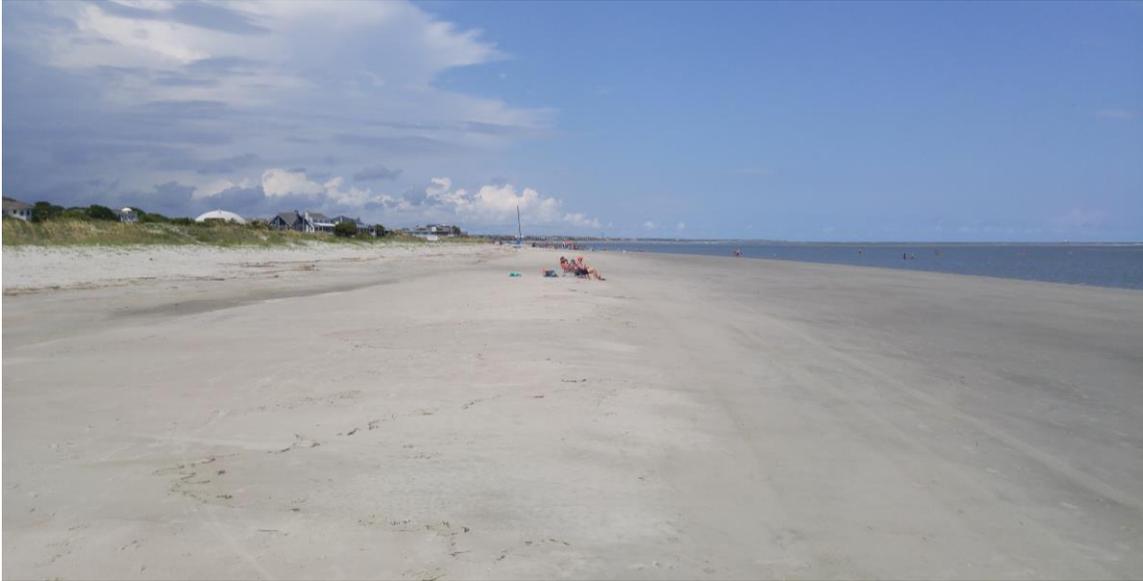
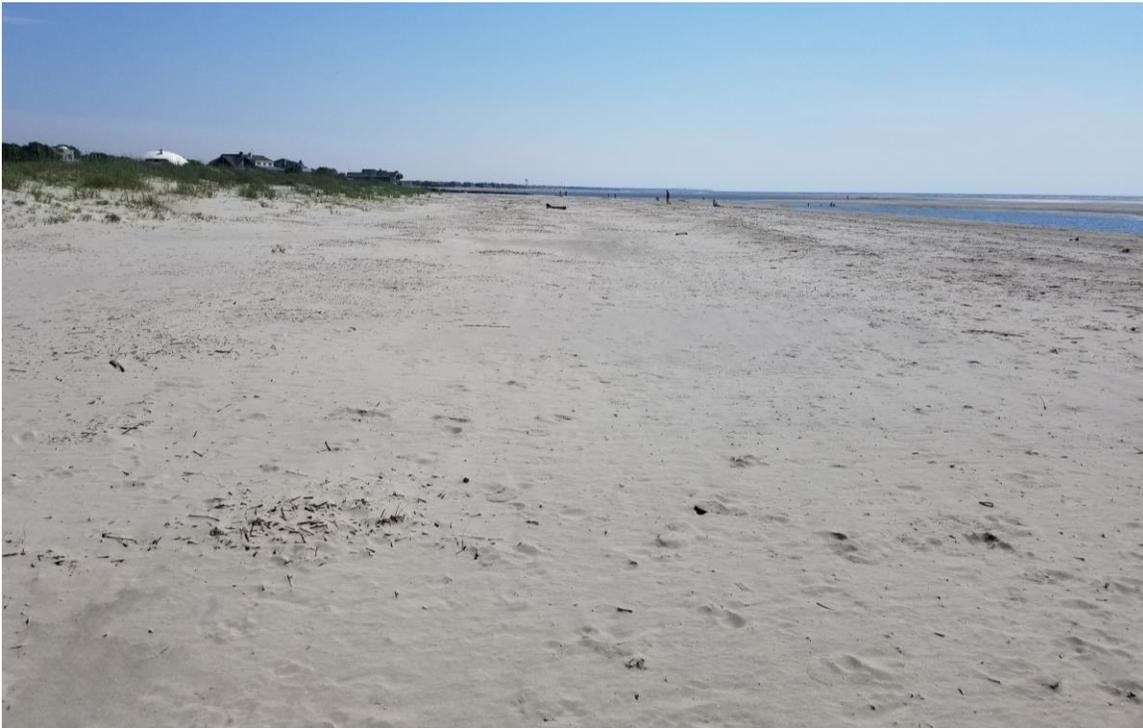
Figure 23. Ground photo taken at Monument 3080 looking northeast on August 4, 2016 (top) and June 11, 2018 (bottom). Note the backbeach accretion in 2018.

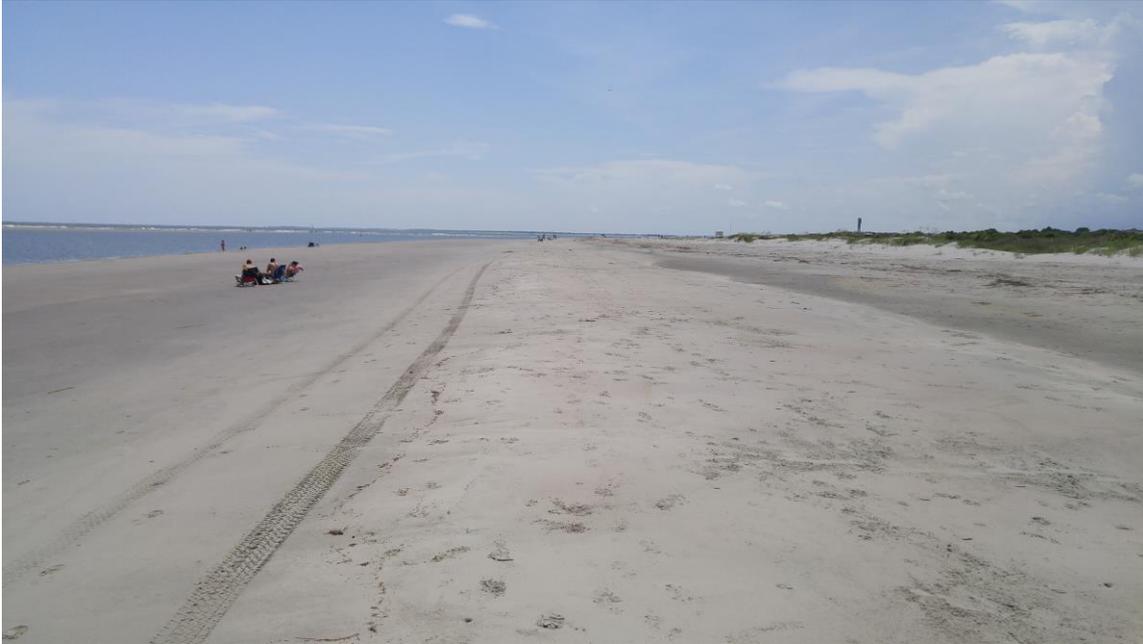
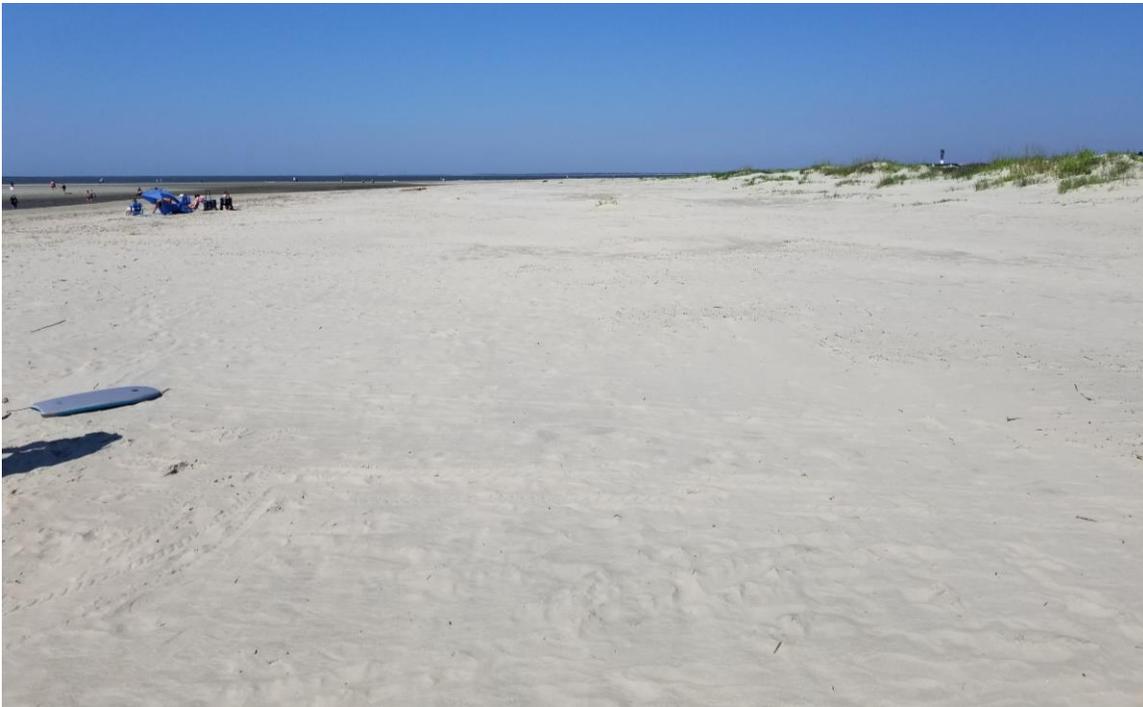
Figure 24. Ground photo taken at Monument 3080 looking southwest on August 4, 2016 (top) and June 11, 2018 (bottom). Note the backbeach accretion in 2018 (ponding low spot filled in).

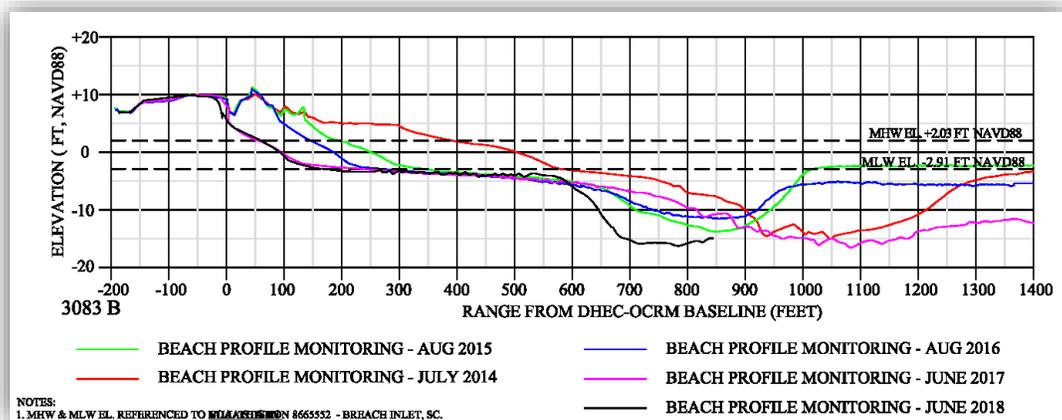
Monument 3083 is located near Station 29 and is in an area of critical erosion. This profile represents the southwest end of the groin field along northeastern Sullivan’s Island. This area of the island has experienced considerable erosion since the last sand bar attachment event in 2014 (Figure 25), including the loss of three rows of low sand dunes. In 2018, large sand bags were exposed at the base of the dune. There is no recreational beach at high tide. Groins and seawalls dominate this portion of the island.

According to the 2018 volume calculation, this profile has a unit volume of 219 cy/ft.

Figure 25. Beach profile monitoring data from 2014-2018 in cross-section view at Monument 3083.

Ideally, sand from the ongoing sand bar attachment event will be transported to this area during the coming year. This profile will be monitored closely.

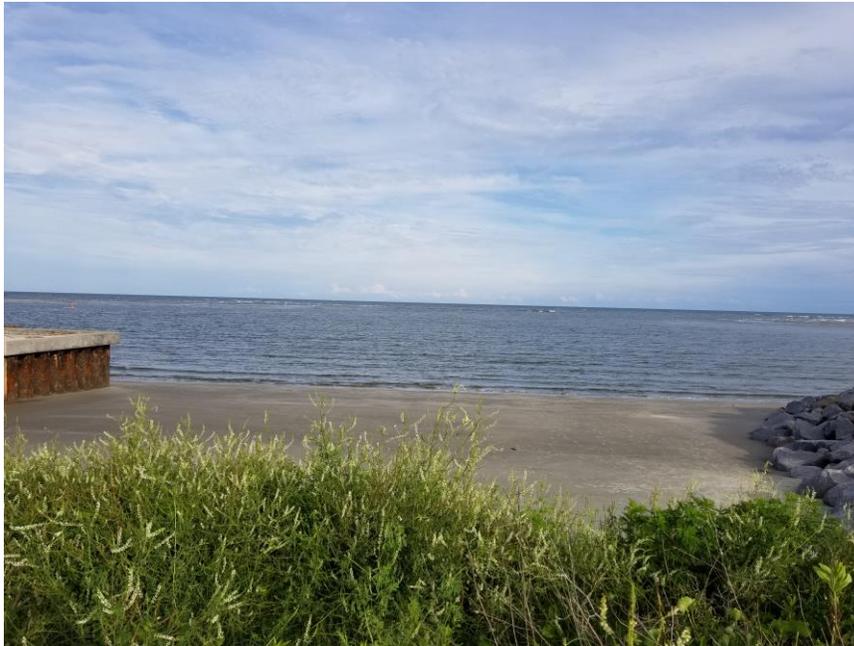
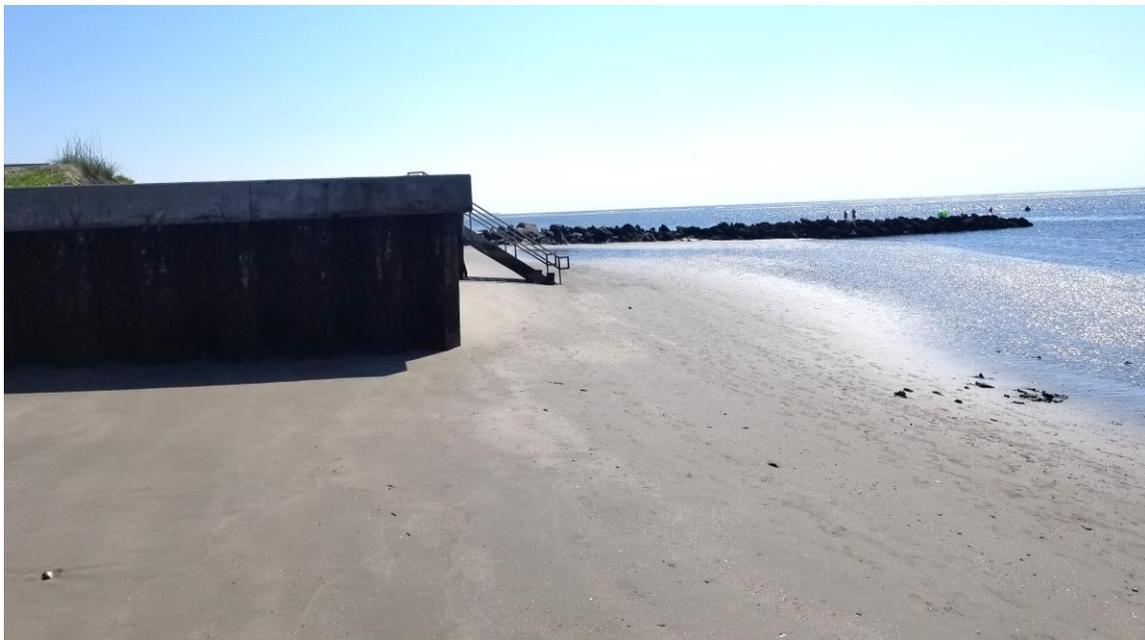
This location marks the transition between the northeast end of the island, which has been stabilized with erosion control structures (Figure 26) and the wide, fluctuating beach of the central portion of the island to the southwest (Figure 27).

Figure 26. Ground photo taken at Monument 3083 looking seaward on June 12, 2017 (top) and looking northwest on June 11, 2018 (bottom).

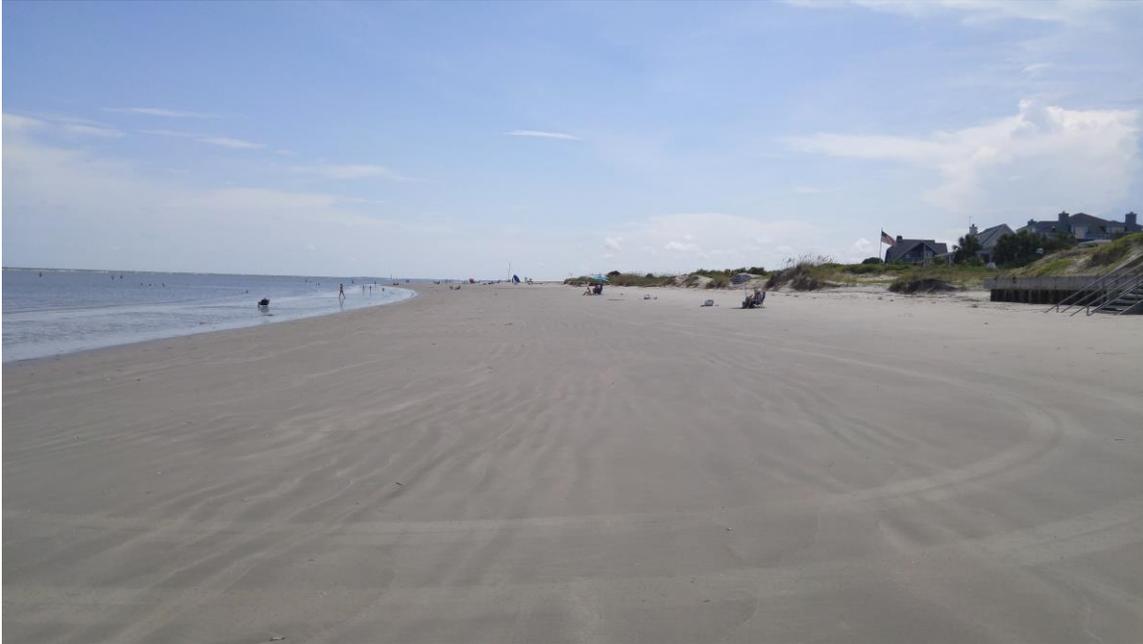
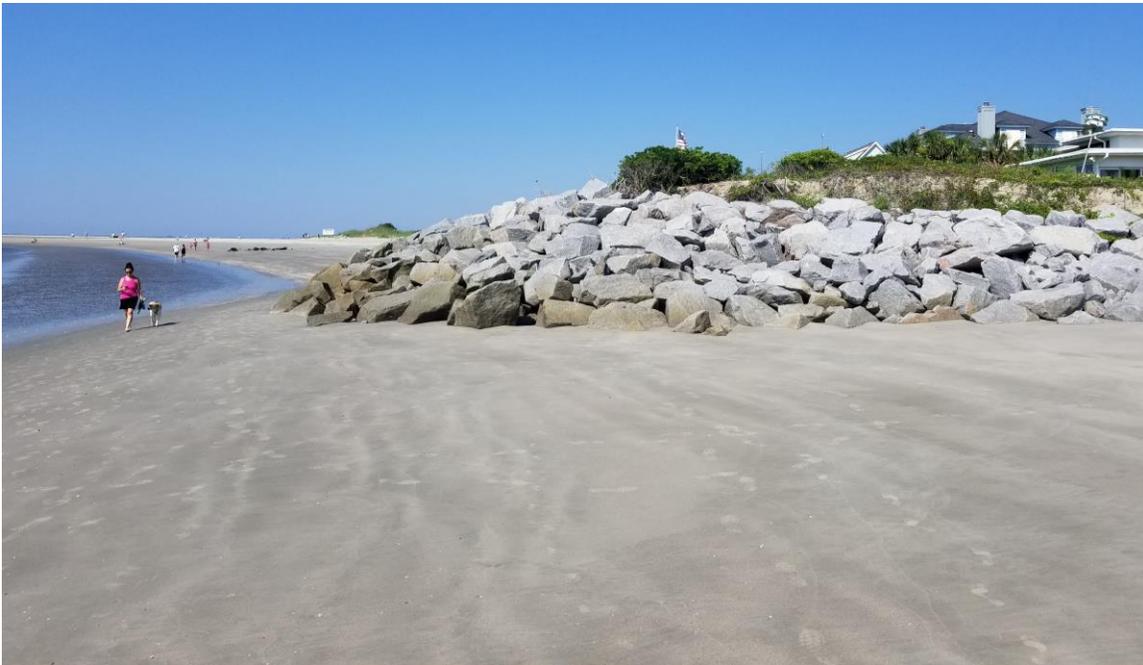
Figure 27. Ground photo taken at Monument 3083 looking southwest on August 4, 2016 (top) and on June 11, 2018 (bottom). The entire dry beach in the 2016 photo had eroded by 2018.

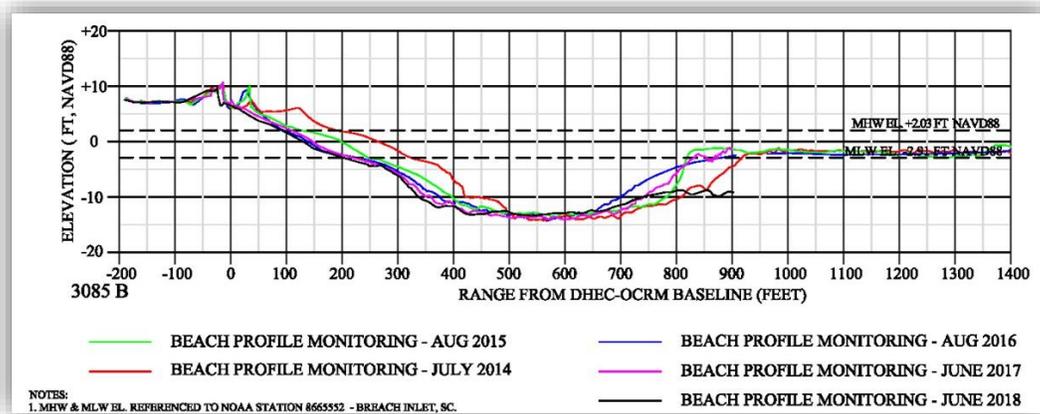
Monument 3085 is located near Station 30. This area is influenced by both erosion control structures and the sand bar attachment events. Beach profile data indicates evidence of the 2014 sand bar attachment and the subsequent beachface erosion (Figure 28). Although a sandbar had attached to the island in 2018, there is no evidence of sediment delivery to this part of the island yet. In fact, erosion is severe in this location and at 3083. Past dune erosion, likely a result of the passage of Hurricane Irma, was ongoing at 3085 in 2018 but some new vegetation was recruiting at the toe of the scarp. A 50 ft wide recreational beach existed.

According to the 2018 volume calculation, this profile has a unit volume of 114 cy/ft.

Figure 28. Beach profile monitoring data from 2014-2018 in cross-section view at Monument 3085.

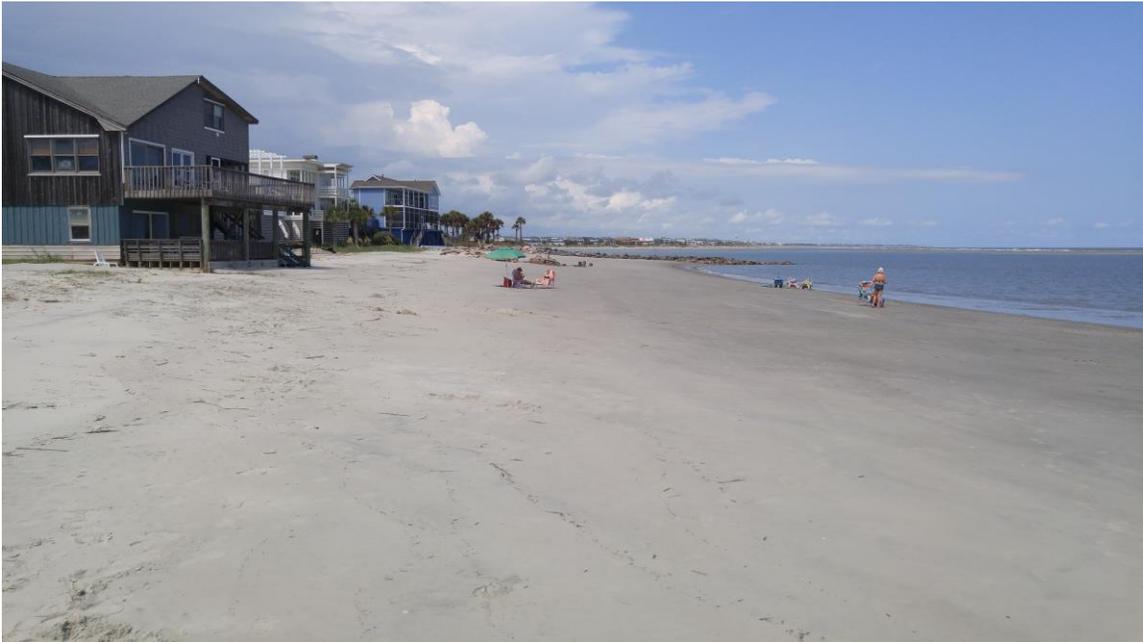
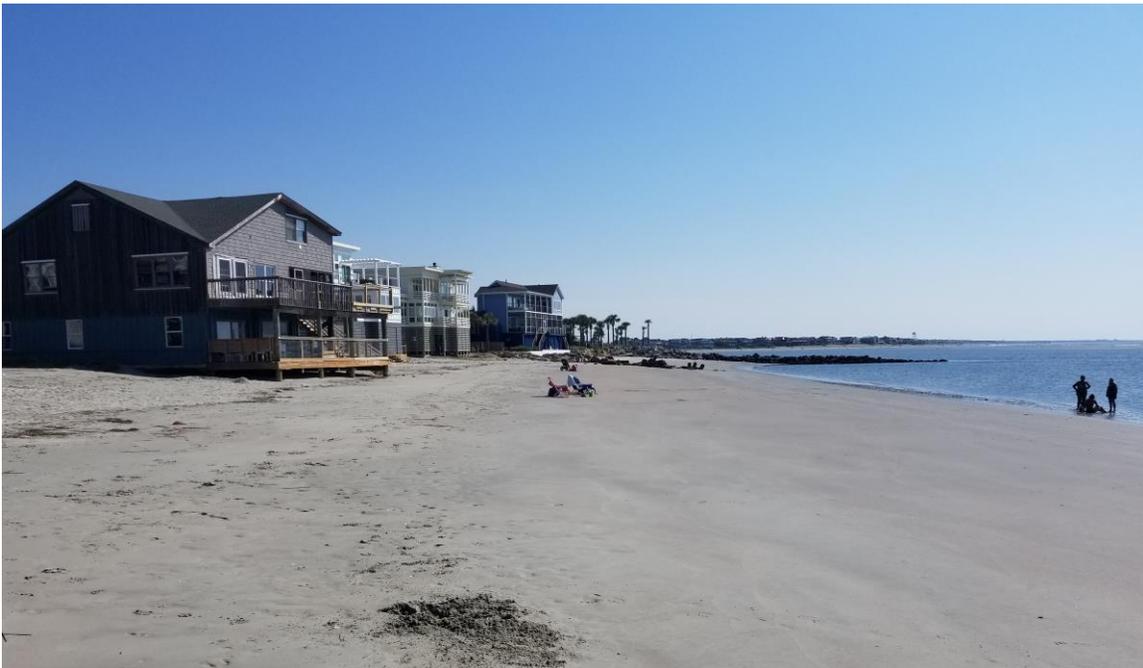
This pocket beach between groins is erosional. The high tide rack line was about 20 ft from the houses in 2018 with evidence of more severe erosion and higher water levels in the past. No dunes are present in front of the houses. Despite the structures, erosion continues to dominate this portion of the island between sandbar attachment events (Figure 29 and Figure 30). Ideally, sediment will be transported to this portion of the island during the next monitoring interval. This profile will be monitored closely.

Figure 29. Ground photo taken at Monument 3085 looking northwest on August 4, 2016 (top) and June 11, 2018 (bottom). Notice the profile deflation under the deck in 2018.

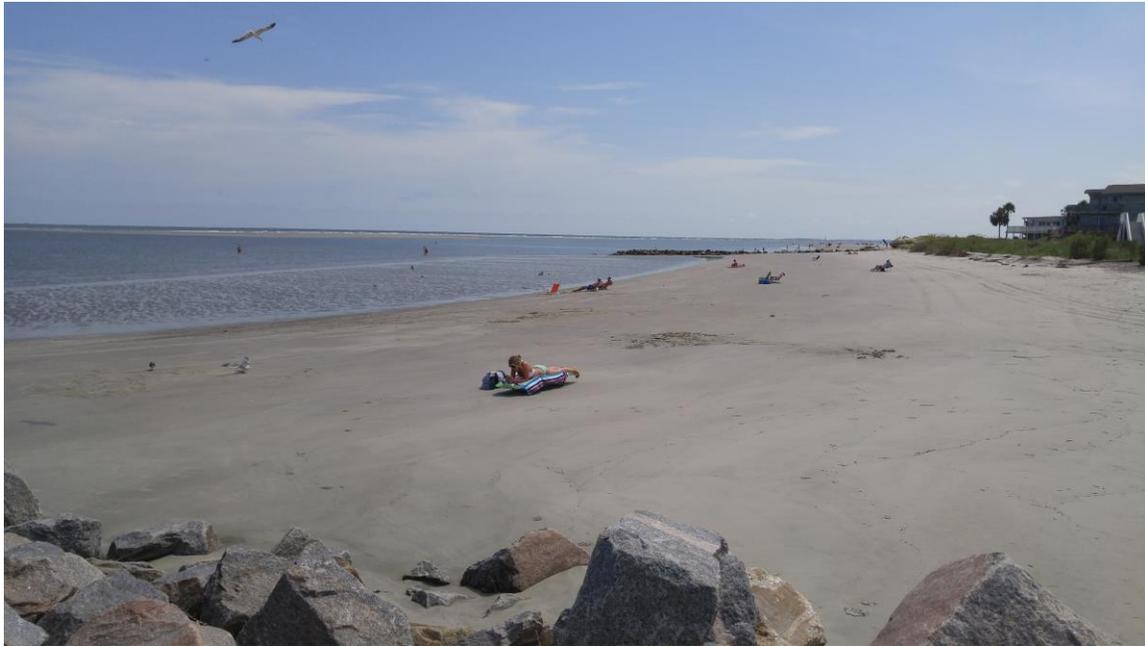
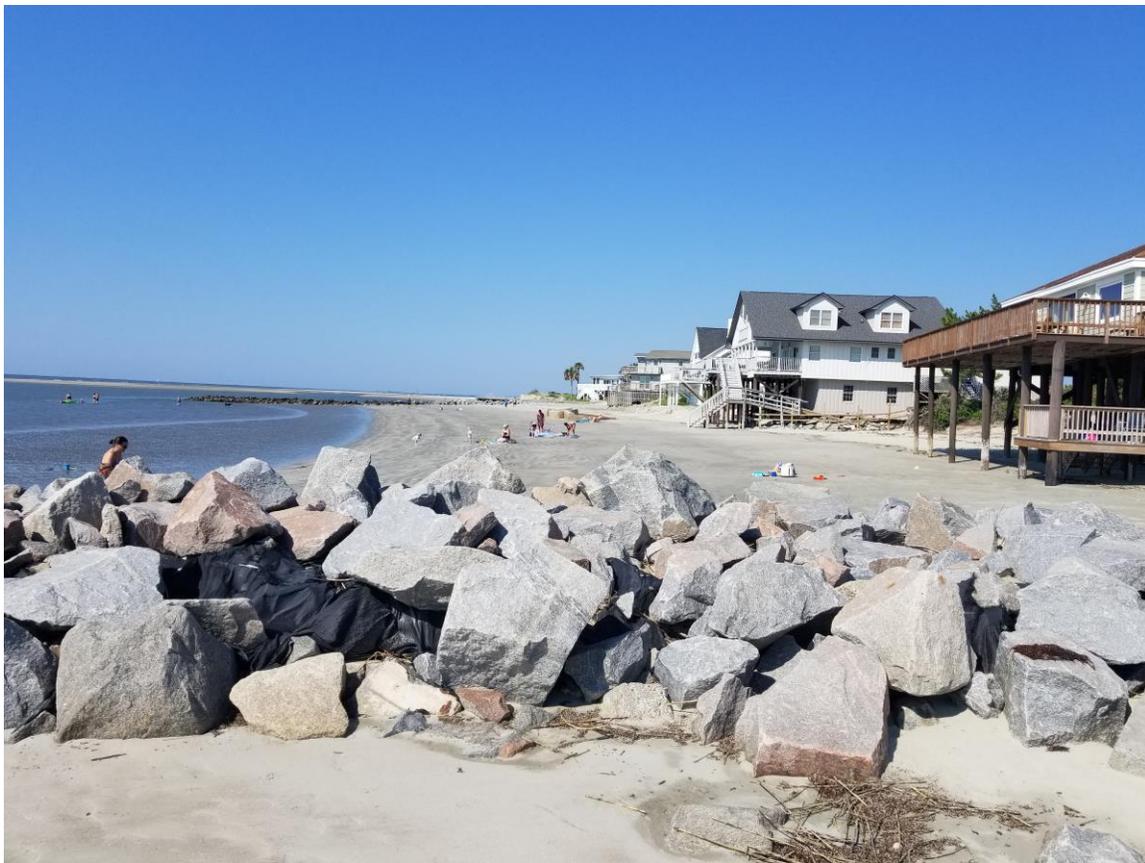
Figure 30. Ground photo taken at Monument 3085 looking southwest on August 4, 2016 (top) and June 11, 2018 (bottom). Note the considerably narrower beach in 2018.

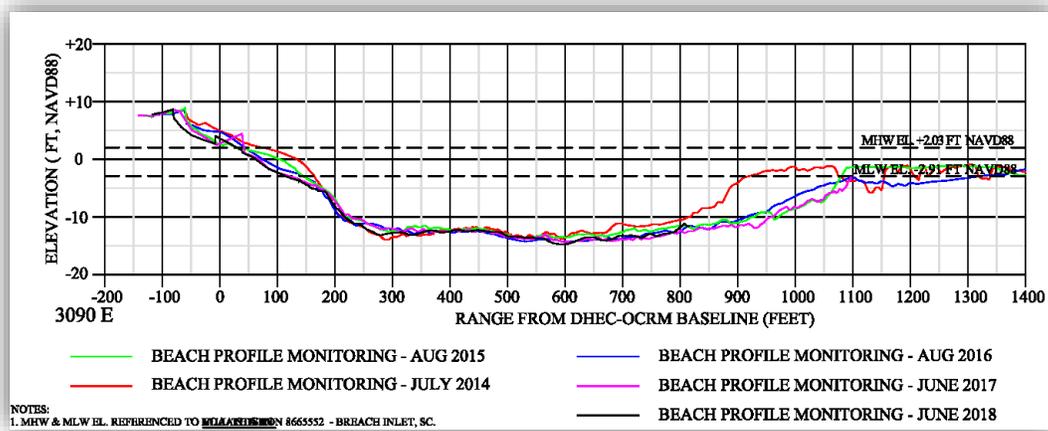
Monument 3090 is located just south of Station 31 on northeastern Sullivan’s Island near Breach Inlet. It represents a small (<250 ft long) pocket beach that has been stabilized between two groins. The beach is completely armored. The beach profile has exhibited erosion despite the stabilization structures (Figure 31). No dry beach is exposed at high tide and no dunes are present. Upland erosion continues; the 2018 condition is the most eroded over the past five years of monitoring (Figure 32 and Figure 33).

According to the 2018 volume calculation, this profile has a unit volume of 113 cy/ft.

Figure 31. Beach profile monitoring data from 2014-2018 in cross-section view at Monument 3090.

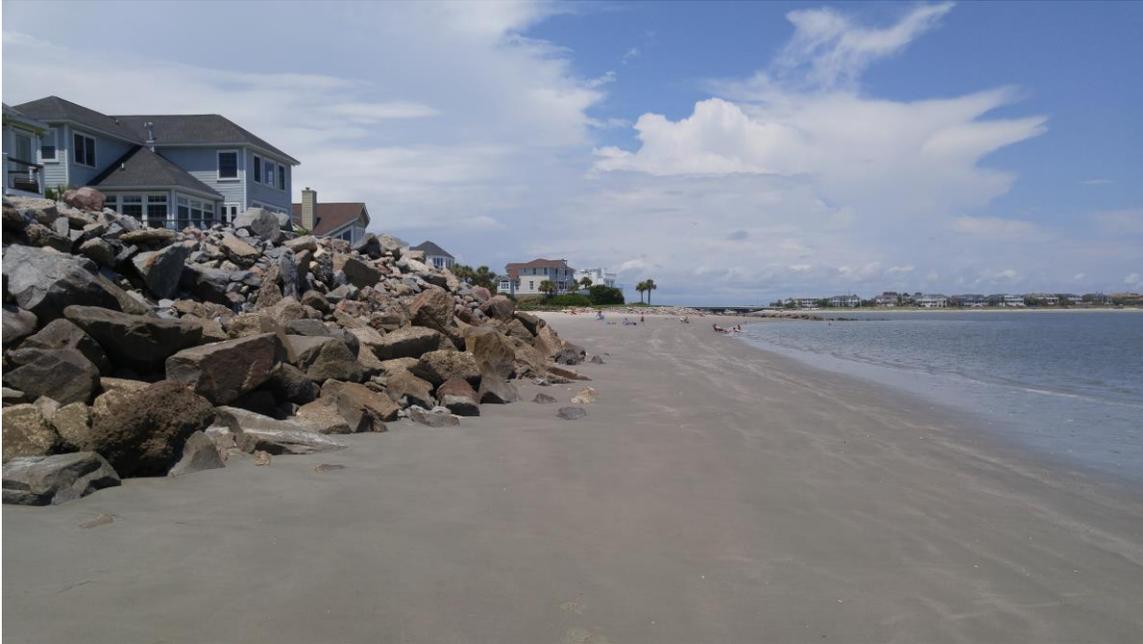
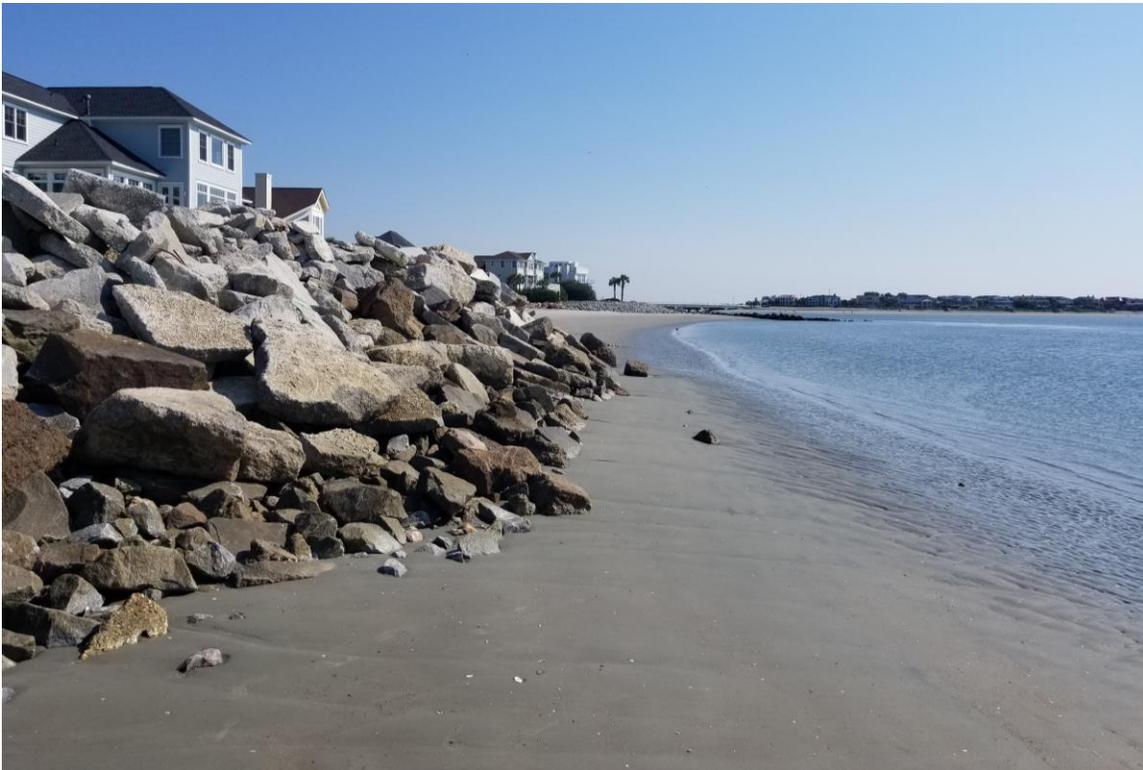
Figure 32. Ground photo taken at Monument 3090 looking north on August 4, 2016 (top) and June 11, 2018 (bottom).

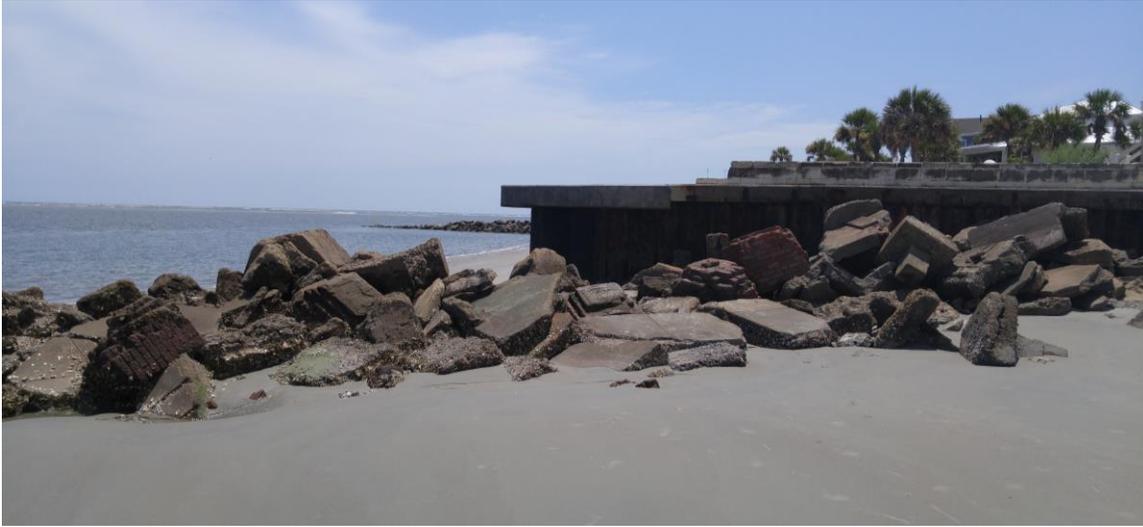
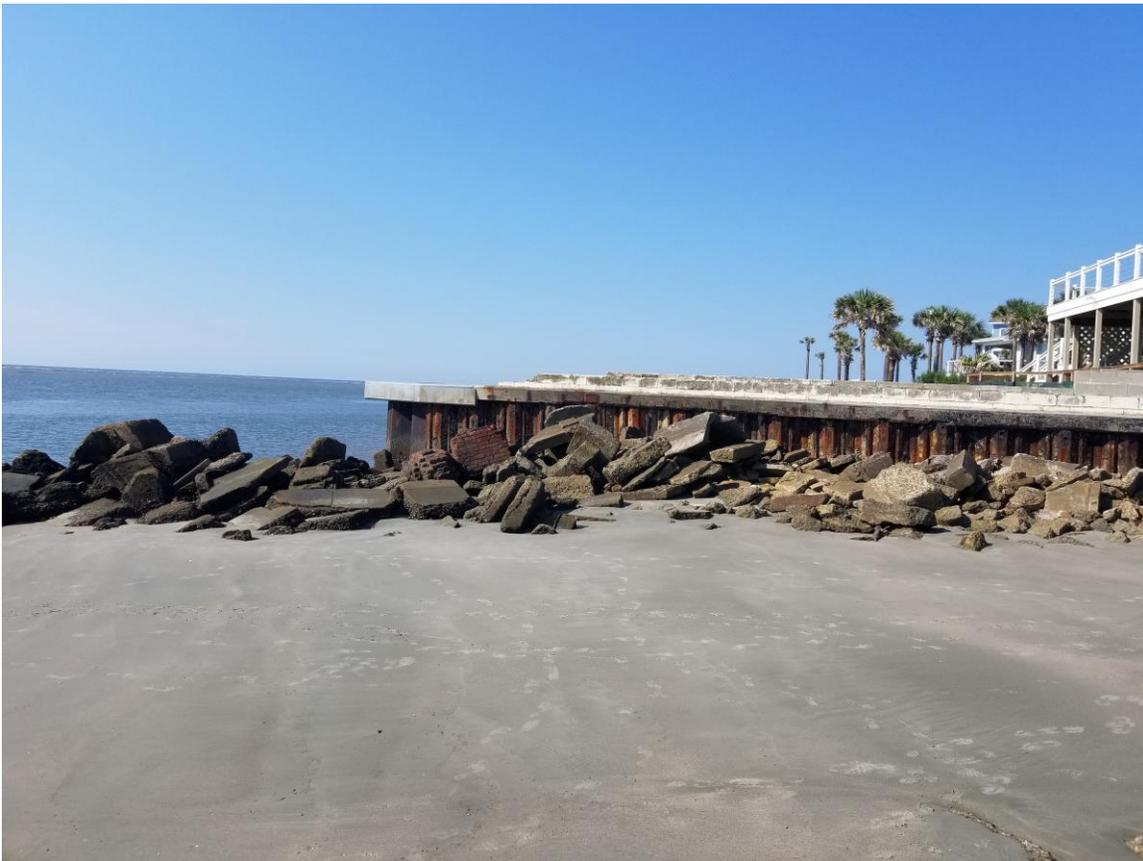
Figure 33. Ground photo taken at Monument 3090 looking southwest on August 4, 2016 (top) and June 11, 2018 (bottom).

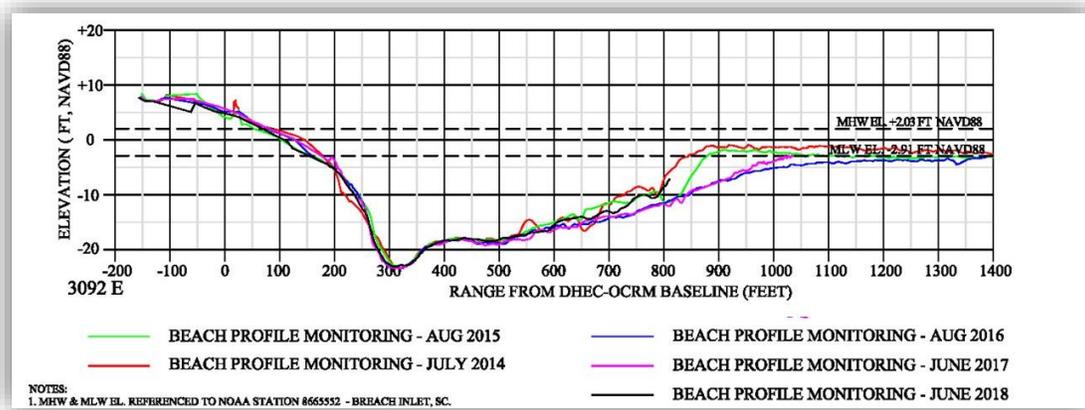
Monument 3092 is located south of Station 32 on northeastern Sullivan’s Island near Breach Inlet. This profile line represents a section of the island that has been armored with erosion control structures; however, erosion continues (Figure 34). The spring high tide line was 5 ft from the seawall. A 40 ft recreational beach existed in 2018. The structures have stabilized this portion of the beach, but minor erosion continues (Figure 35 and Figure 36).

According to the 2018 volume calculation, this profile has a unit volume of 118 cy/ft.

Figure 34. Beach profile monitoring data from 2014-2018 in cross-section view at Monument 3092.

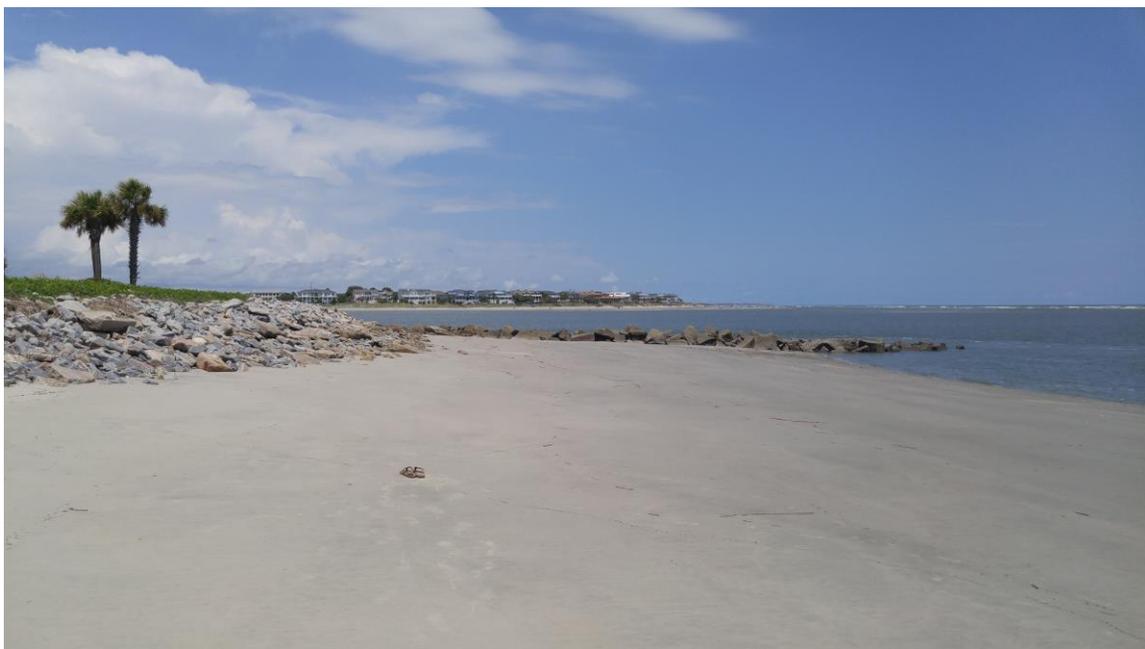
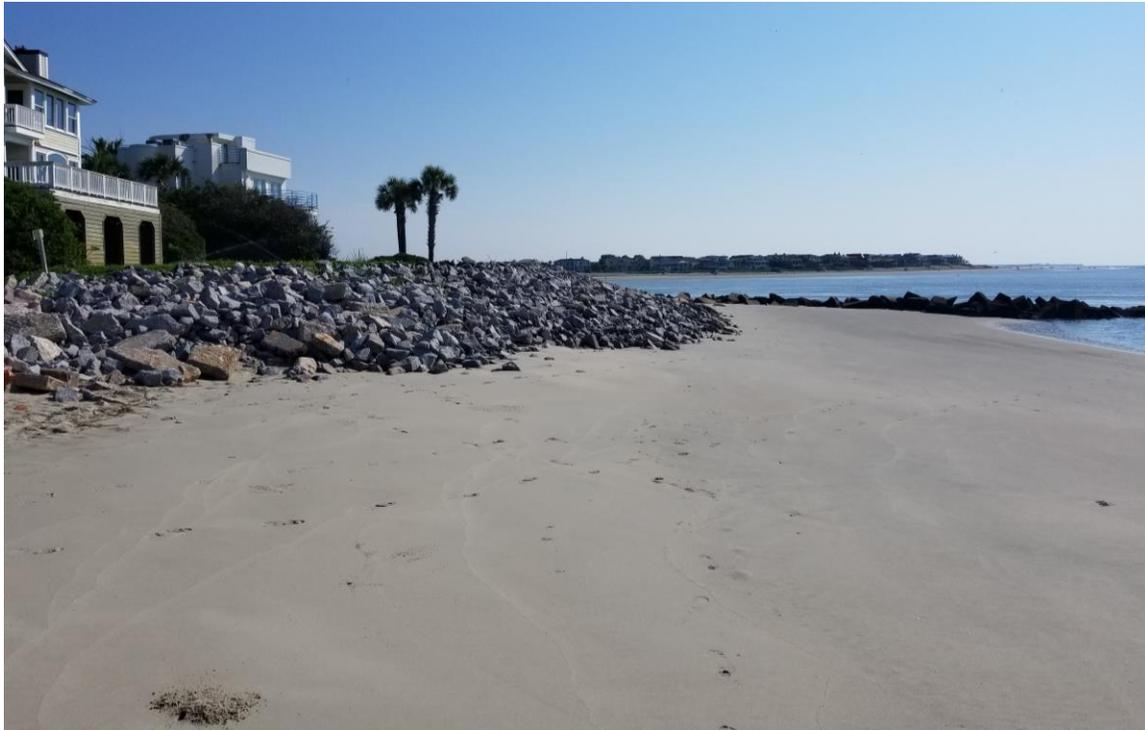
Figure 35. Ground photo taken at Monument 3092 looking north on August 4, 2016 (top) and June 11, 2018 (bottom).

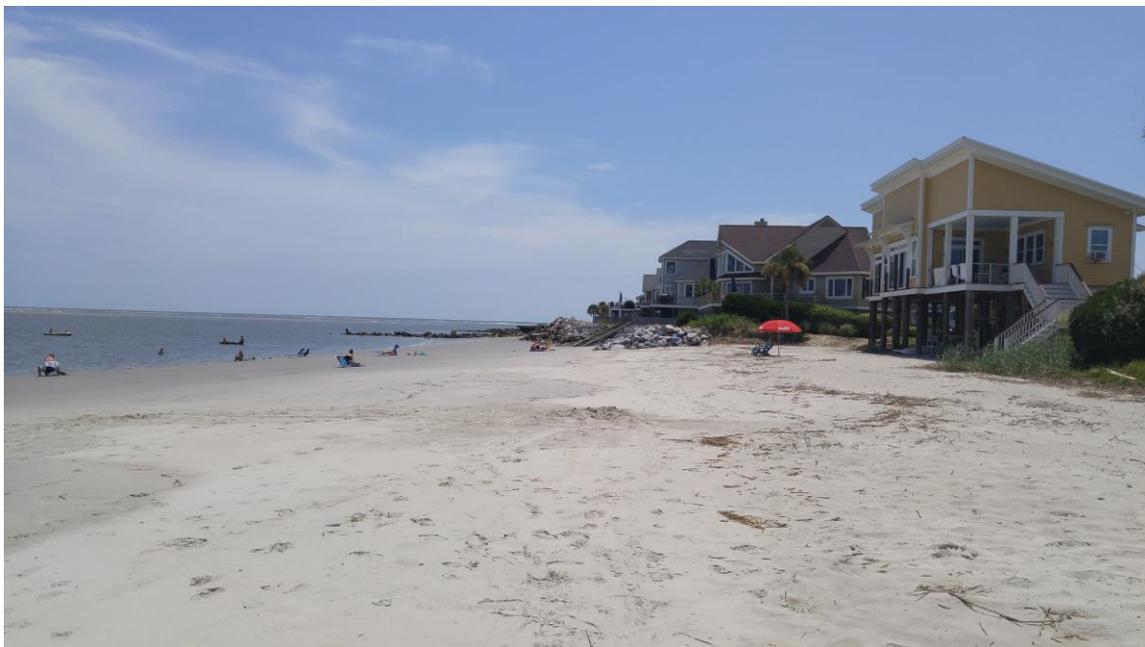
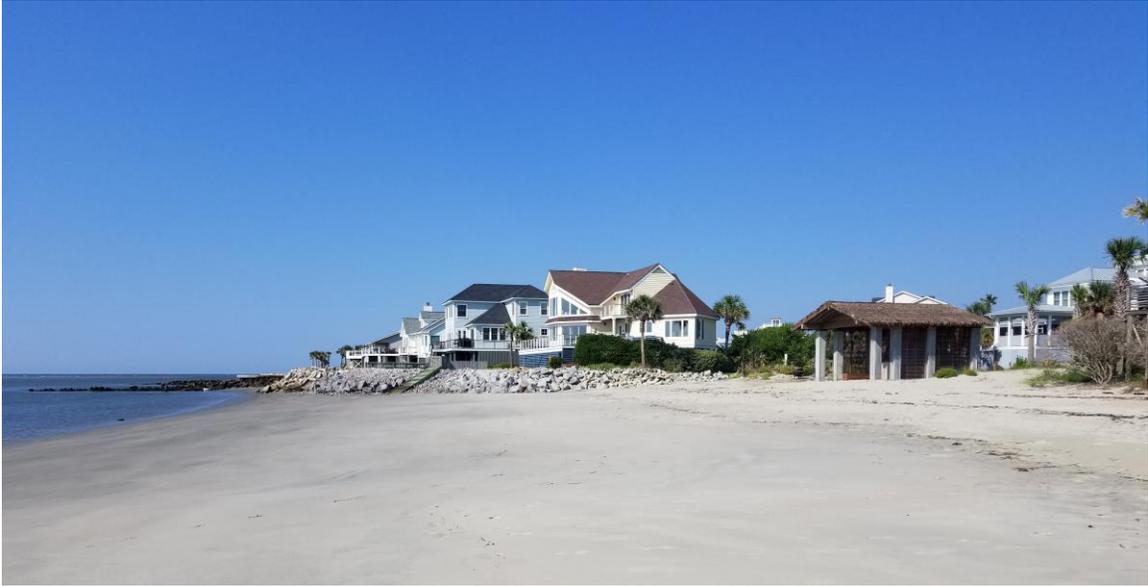
Figure 36. Ground photo taken at Monument 3092 looking south on August 4, 2016 (top) and June 11, 2018 (bottom). The yellow house in the foreground of the 2016 photo was removed in 2017. Note the beach deflation in the background, exposing the riprap wall.

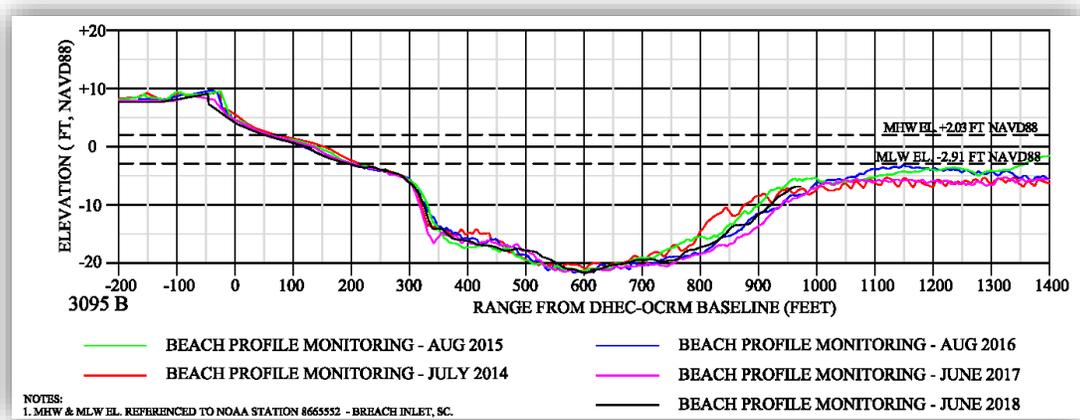
Monument 3095 is located on Station 32 at the northeastern tip of Sullivan’s Island on Breach Inlet. It represents a cusped beach anchored by erosion control structures (groins). The beach profile has exhibited little change over time due to the stabilization structures (Figure 37) although upland erosion and beach face deflation have occurred recently, likely during the passage of Hurricanes Matthew and Irma. In June 2018, erosion was dominant with a storm rack line at the toe of vegetation and a 40 ft wide recreational beach. Some upland/dune recovery is occurring with sand trapping and vegetation recruitment at the toe of the scarp (Figure 38 and Figure 39).

According to the 2018 volume calculation, this profile has a unit volume of 178 cy/ft.

Figure 37. Beach profile monitoring data from 2014-2018 in cross-section view at Monument 3095.
