2018 Beach Monitoring Survey

TOWN OF SULLIVAN'S ISLAND, SC

Elko Coastal Consulting, Inc. | July 2018

2018 Beach Monitoring Survey: Town of Sullivan's Island, SC

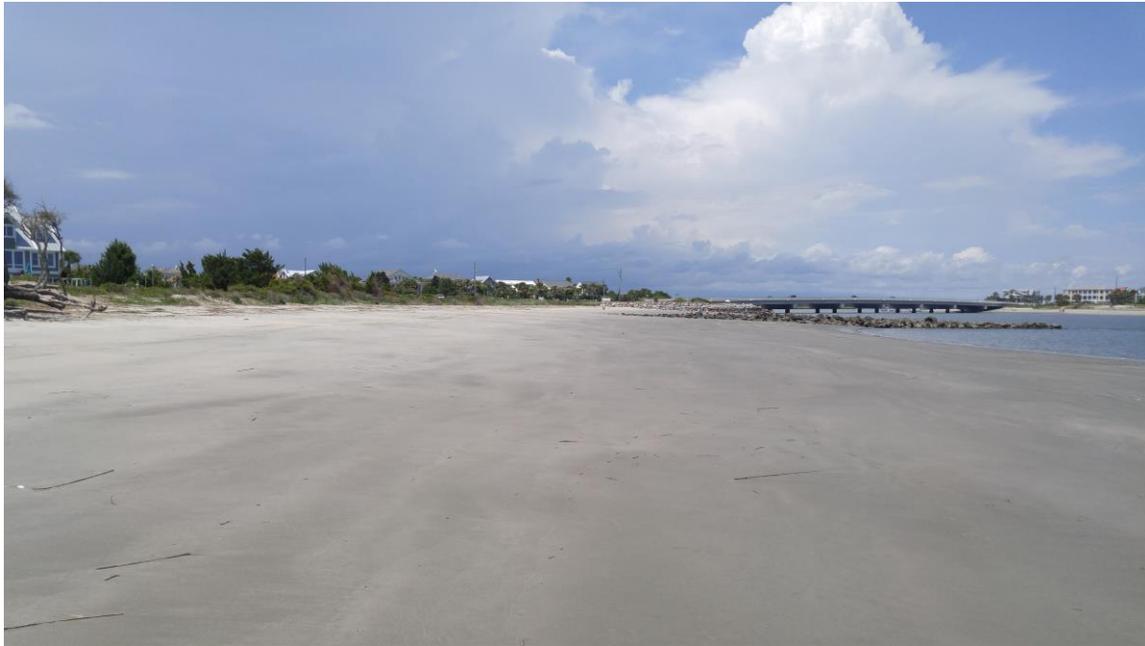
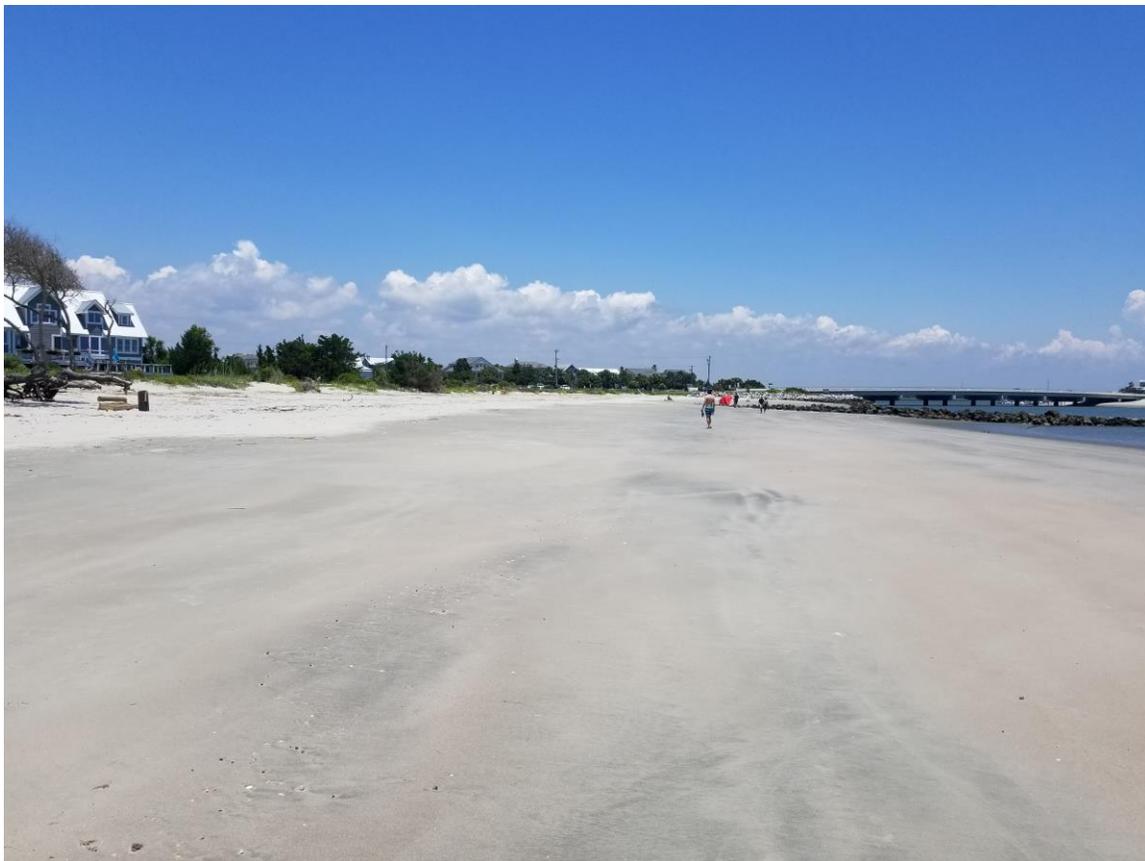
Monument 3095 is located on Station 32 at the northeastern tip of Sullivan’s Island on Breach Inlet. It represents a cusped beach anchored by erosion control structures (groins). The beach profile has exhibited little change over time due to the stabilization structures (Figure 37) although upland erosion and beach face deflation have occurred recently, likely during the passage of Hurricanes Matthew and Irma. In June 2018, erosion was dominant with a storm rack line at the toe of vegetation and a 40 ft wide recreational beach. Some upland/dune recovery is occurring with sand trapping and vegetation recruitment at the toe of the scarp (Figure 38 and Figure 39).

Figure 38. Ground photo taken at Monument 3095 looking north on August 4, 2016 (top) and June 11, 2018 (bottom).

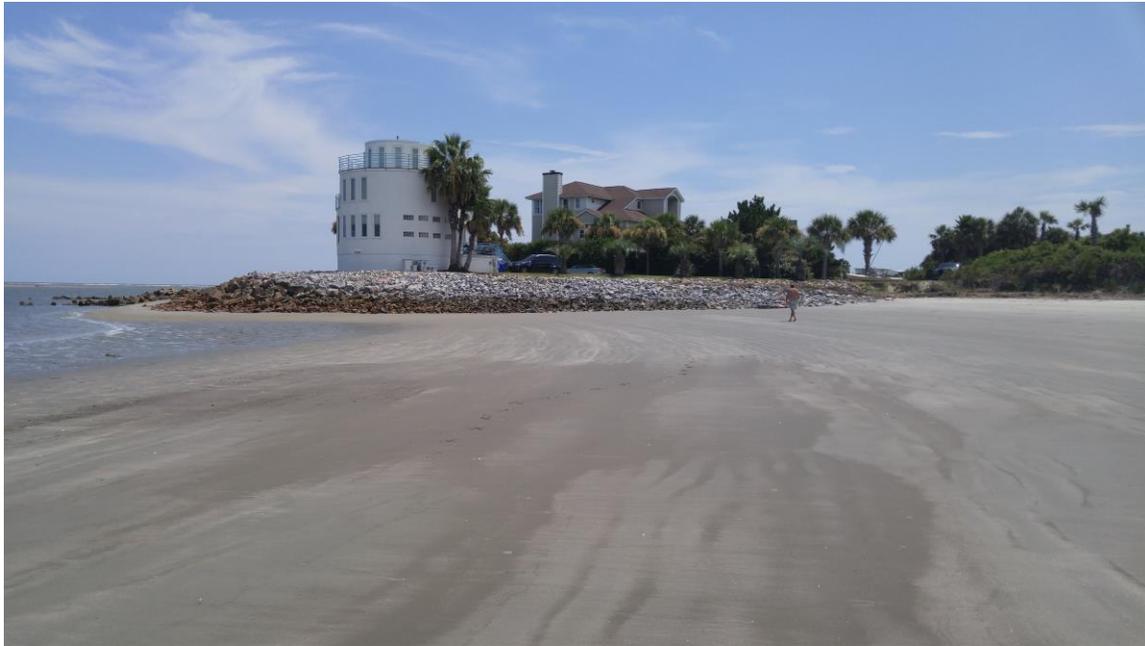
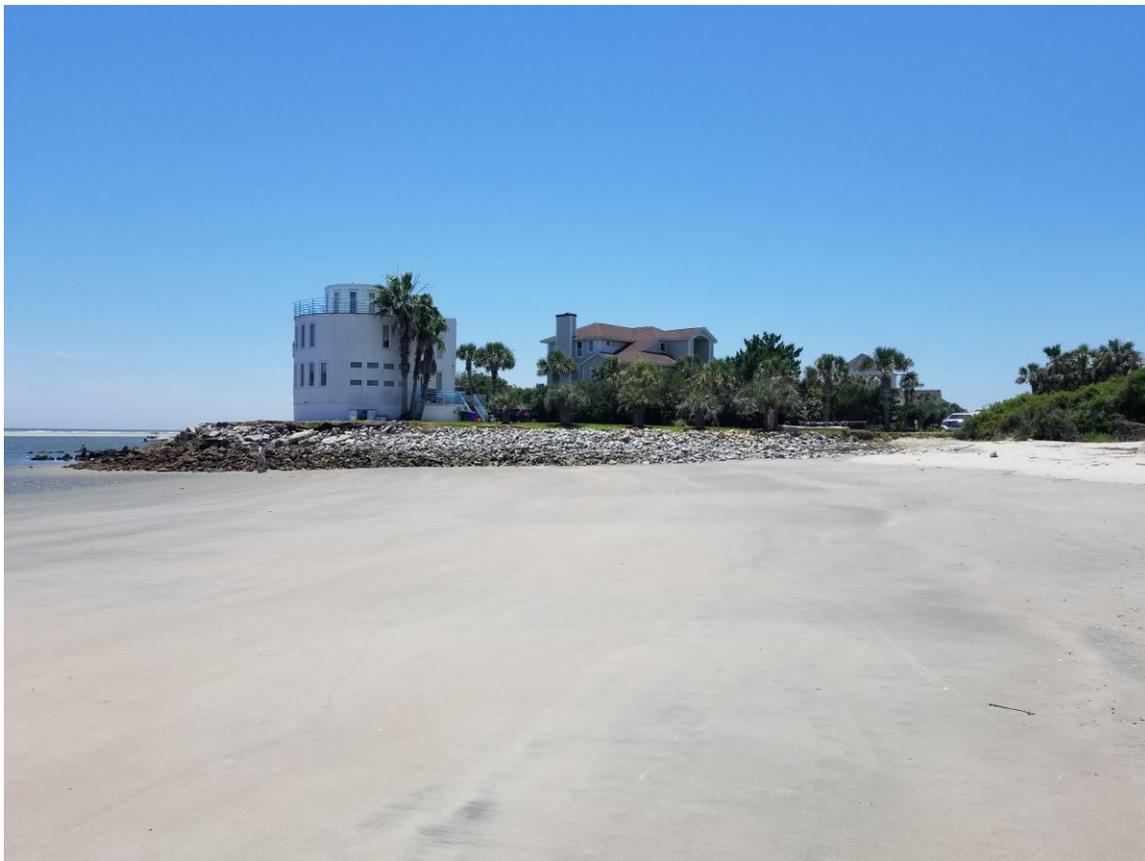
Figure 39. Ground photo taken at Monument 3095 looking south on August 4, 2016 (top) and June 11, 2018 (bottom).
