THE SECRETARY
OF THE INTERIOR'S
**STANDARDS FOR
THE TREATMENT
OF HISTORIC
PROPERTIES**

WITH
**GUIDELINES FOR
PRESERVING,
REHABILITATING,
RESTORING &
RECONSTRUCTING
HISTORIC
BUILDINGS**

U.S. Department of the Interior
National Park Service
Technical Preservation Services

2017

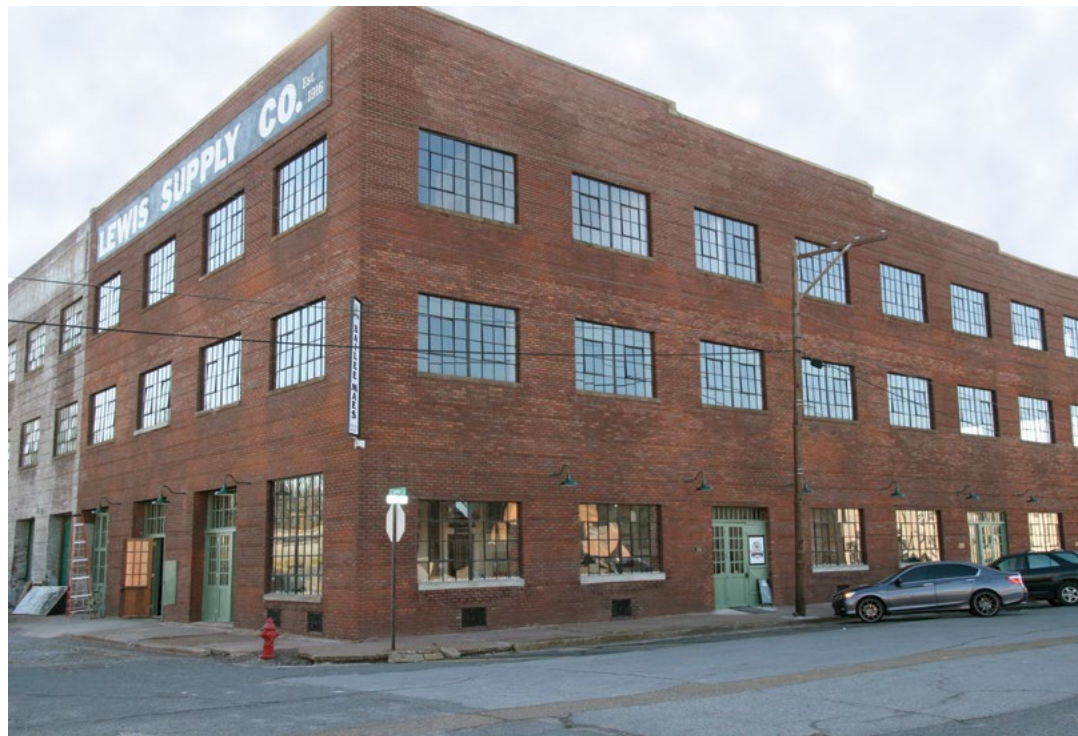
[20 a-d] The original steel windows in this industrial building were successfully repaired as part of the rehabilitation project (left).
