Accreted Land Management Plan

Sullivan's Island, South Carolina

**ACCRETED LAND MANAGEMENT PLAN
Town of Sullivan's Island South Carolina**

[2253-ALMP]
JULY 2010

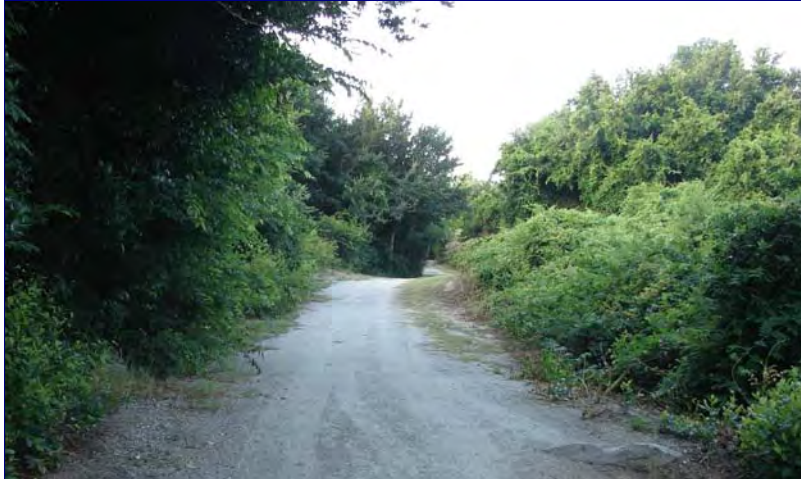
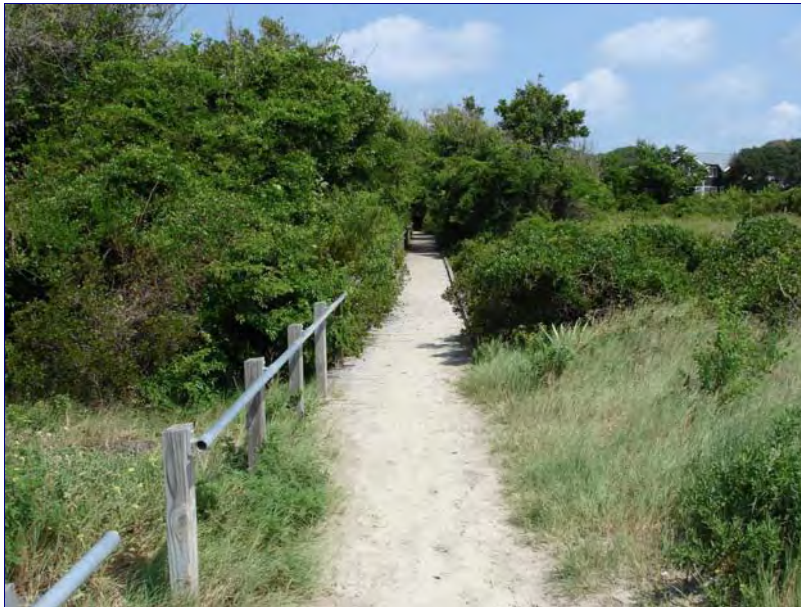
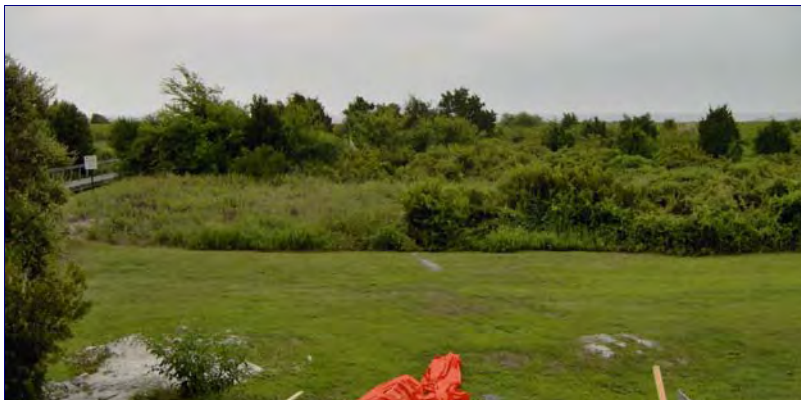
FIGURE 1.2. Representative accesses in the study area in 2008: [upper] the heavily wooded west end (Station 16), [center] narrow central section near Station 18, and [lower] the east end around Station 26.

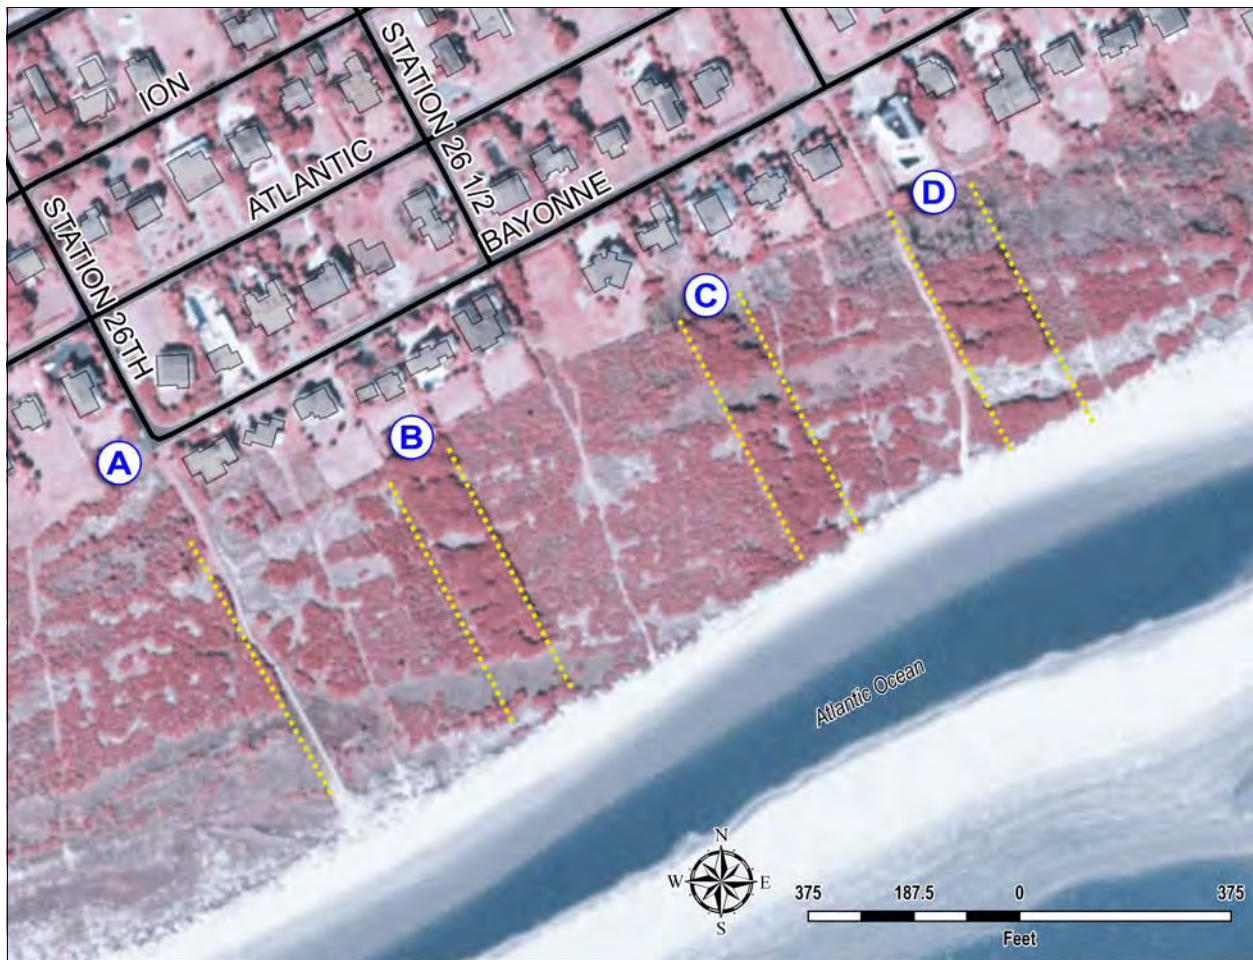
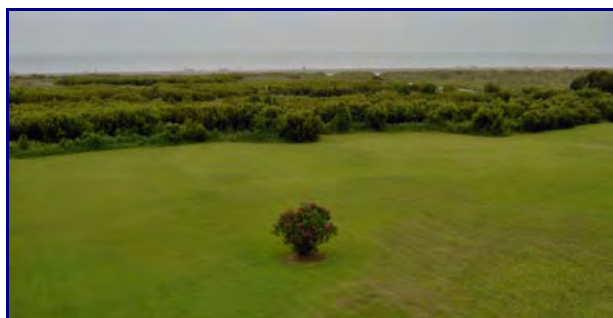
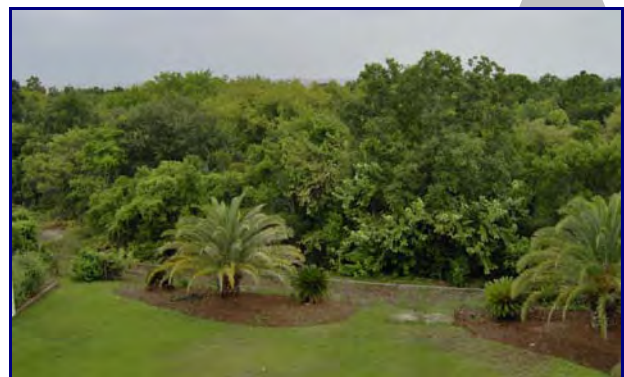
FIGURE 1.3.

The upper infrared aerial photo (SCDNR 2006) shows swaths of vegetation (swaths A, B, C, and D) which have not been pruned, situated between areas which have been pruned.

The ground photos (T Hair, August 2008) show representative areas which have been pruned (center left) and unpruned (center right). The lower right photo is a view of a variable canopy of shrubs, trees, and dune grasses which can be seen in the AL area.

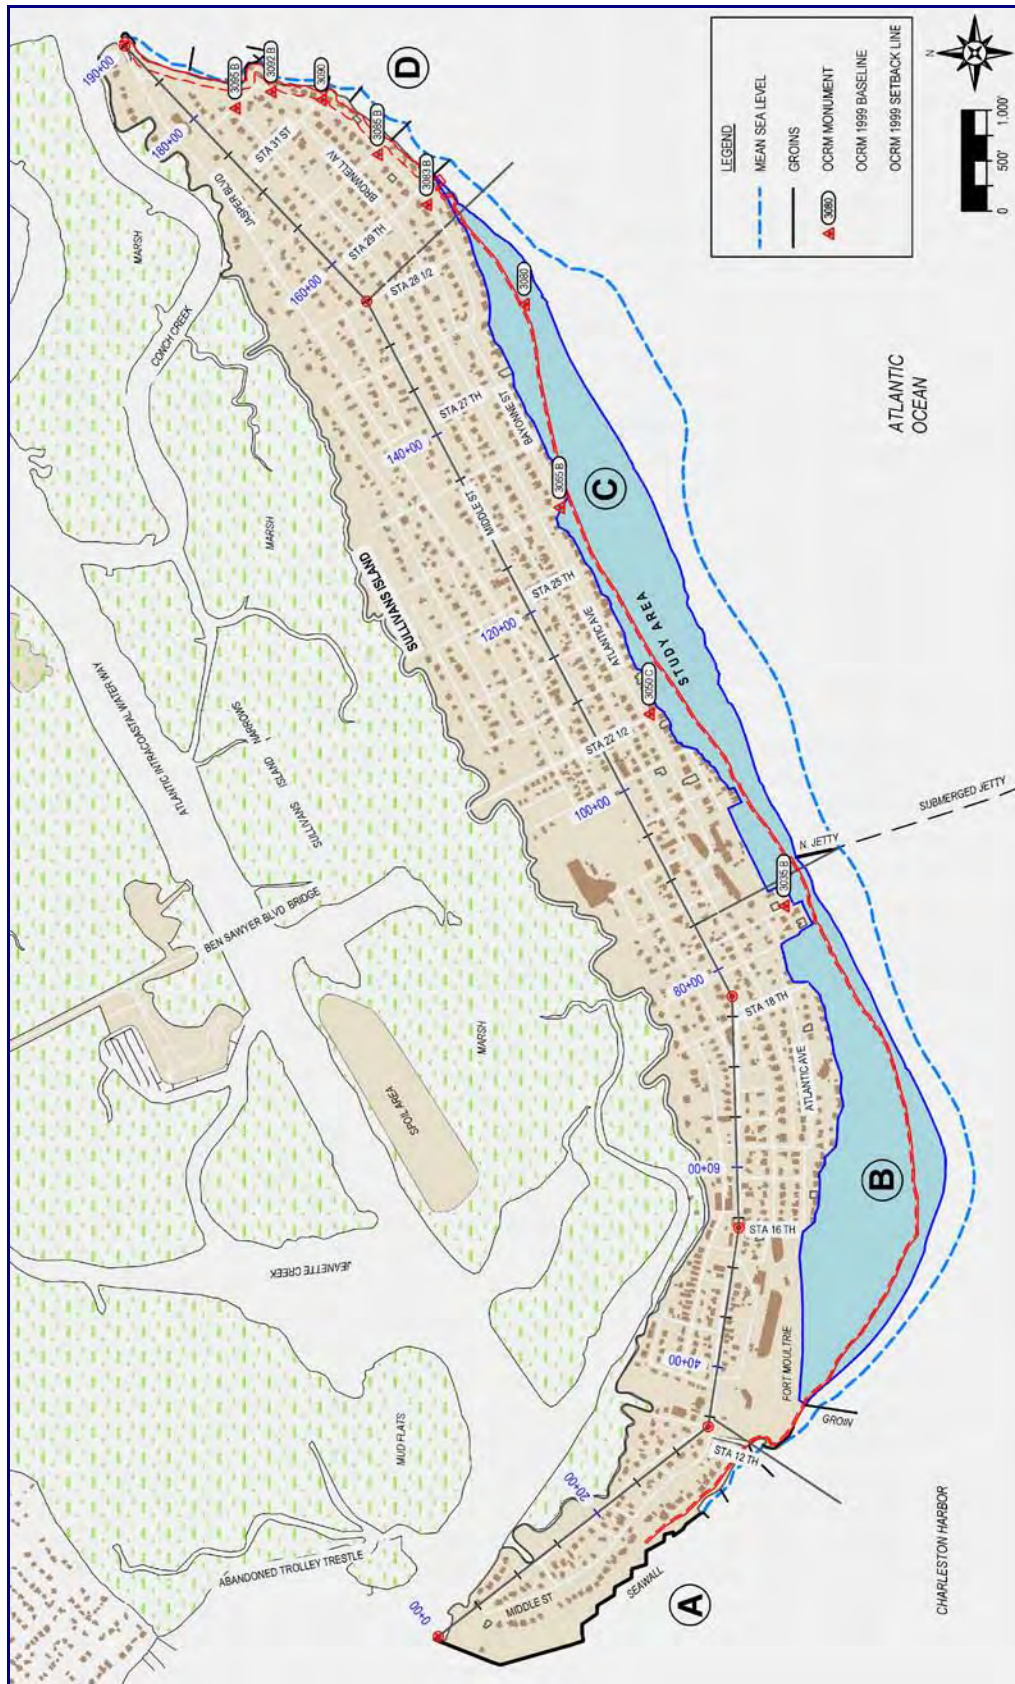
FIGURE 1.5. Jurisdictional baselines and setback lines under the BMA for the oceanfront along Sullivan's Island. The lines are revised every ~10 years by OCRM based on the erosion and accretion trends for the area. Under the BMA, the lines may move seaward over time due to natural accretion or beach nourishment. Local governments may impose additional restrictions (establish more landward development control lines) at their discretion.

Figure 1.5 illustrates the present baseline and setback line for Sullivan’s Island. Under the BMA, jurisdictional lines are to be updated every ten years or so. The present lines were established in 2009. As shown in Figure 1.5, the baseline and setback line pass through the middle of the AL study area and are seaward of existing development parcels in Reach B and Reach C by ~200–800 ft. The fact that the lines closely parallel each other (20 ft apart) confirms the official determination that most of Sullivan’s Island accreted during the past ~40 years.

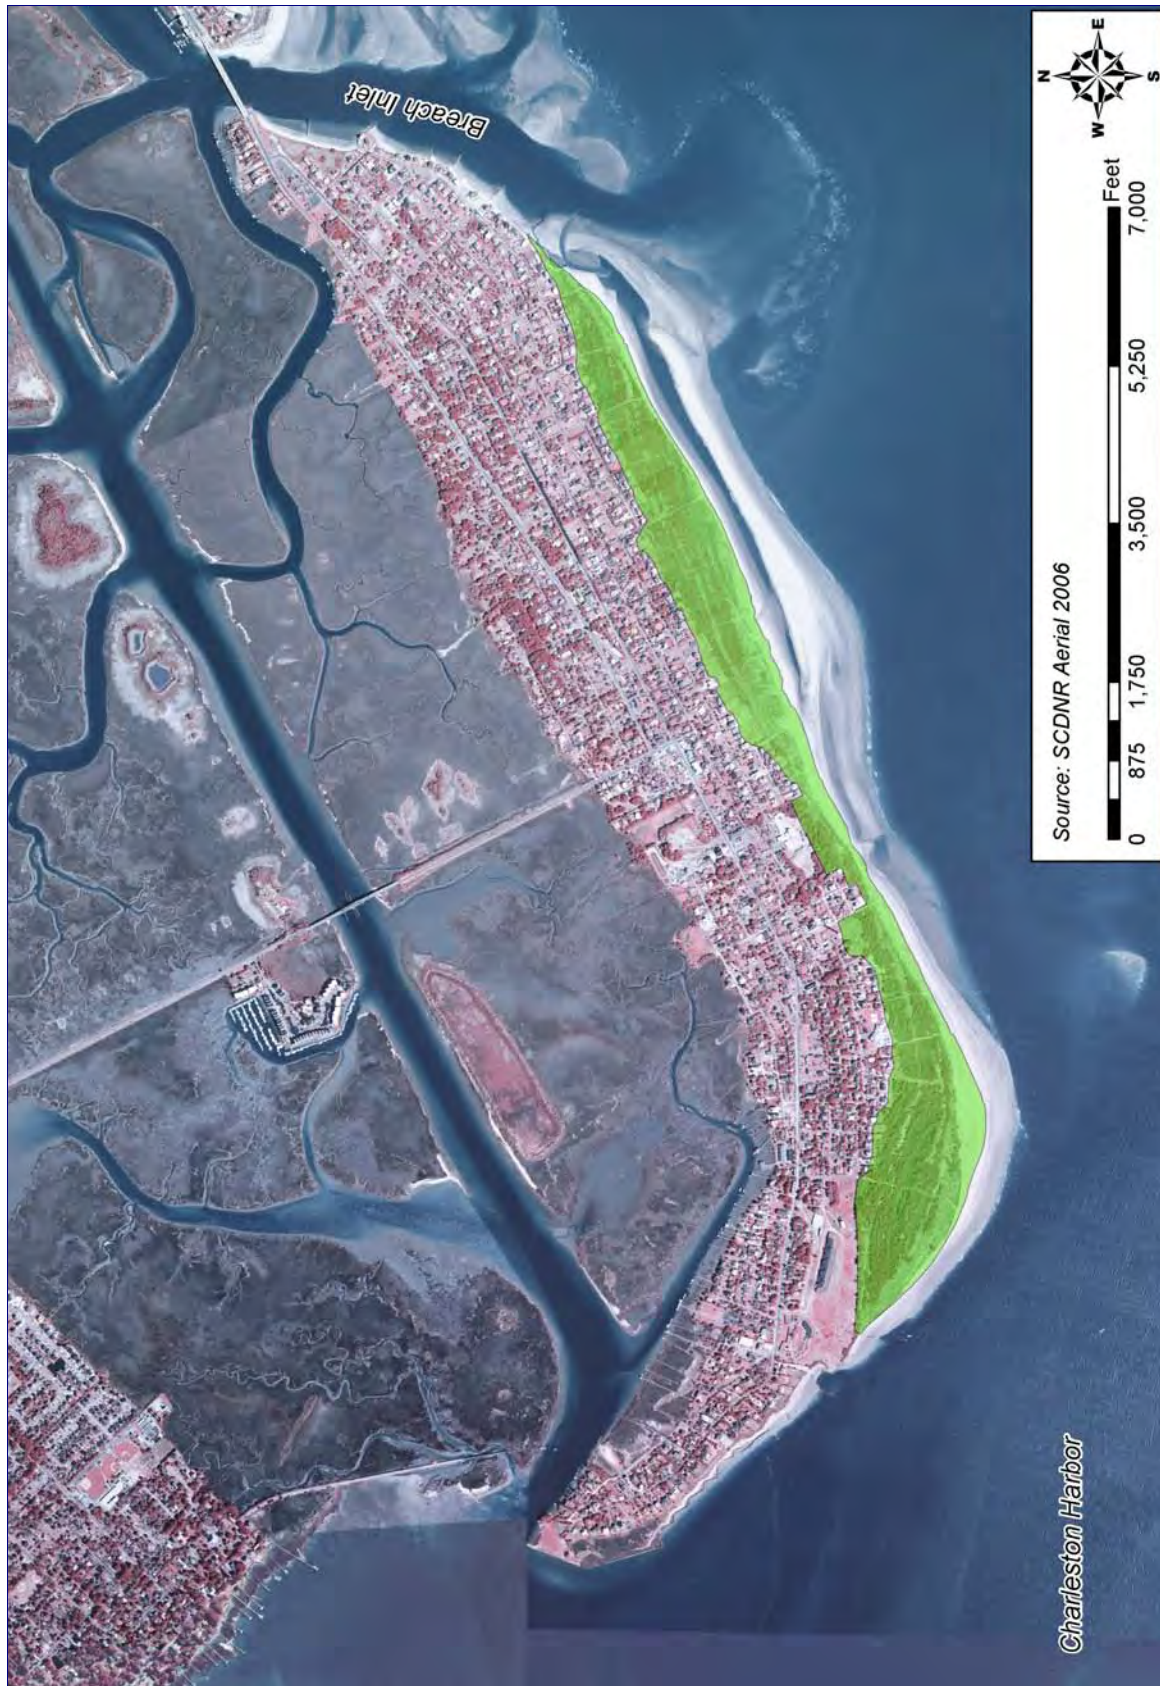
FIGURE 2.2. Infrared aerial orthophoto of Sullivan's Island (2006) showing the AL study area. [Source: SCDNR]

Today, Sullivan's Island is a residential development with primary and vacation houses occupying most of the high ground (Fig 2.2). The island's sandy and armored shoreline is ~3.8 miles long (including the margins along Breach Inlet and Charleston Harbor). Highland area comprises ~885 acres of platted property plus an estimated 190 acres* in the accreted land (AL) study area. Recent census lists a population of 1,878 in 1,045 houses on the island (source: www.city-data.com). Approximately 800 houses (77 percent) are occupied with resident owners in over 70 percent of them and resident renters in the remainder.

*There are various estimates for the accreted land area. The study Team calculates this value from the highlighted area in Figure 2.2, which extends from platted lots to the seaward vegetation line.

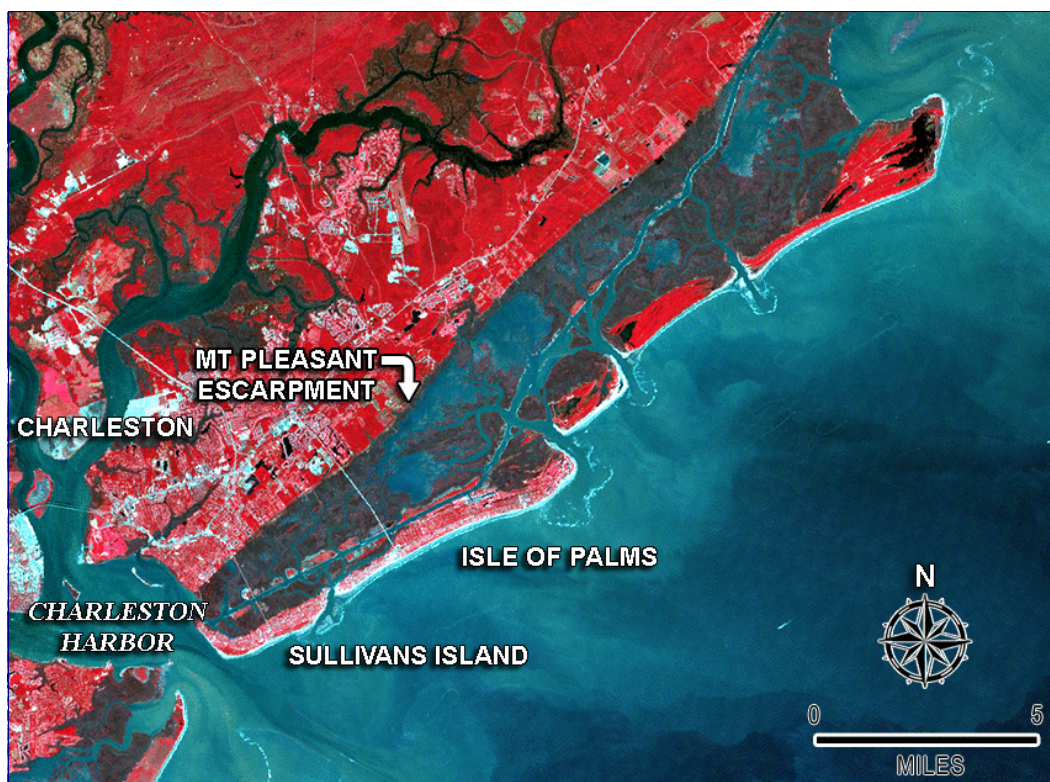
FIGURE 2.5. False-color aerial photo of the barrier islands east of Charleston Harbor. High ground is bright red, whereas tidal wetlands are dark red to purple. Note the distinct break between high ground and marsh along the mainland. This is the Mt. Pleasant escarpment thought to match the South Carolina shoreline of ~120,000 years ago when sea level was similar to today's. [2006 image courtesy of Research Planning Inc and SCDNR]

Interestingly, they parallel an ancient shoreline that marks the mainland of Mt. Pleasant (Fig 2.5). Geologists place the age of the Mt. Pleasant shore at about 120,000 years old (Pleistocene Age), coincident with the previous high stand (see Fig 2.3). Between 120,000 and 5,000 years ago, sea level fell and the South Carolina coast moved dozens of miles out on the continental shelf. When sea level returned to its high-stand position, sands accumulated as barrier islands, and the low area between Sullivan’s Island and the Mt. Pleasant escarpment

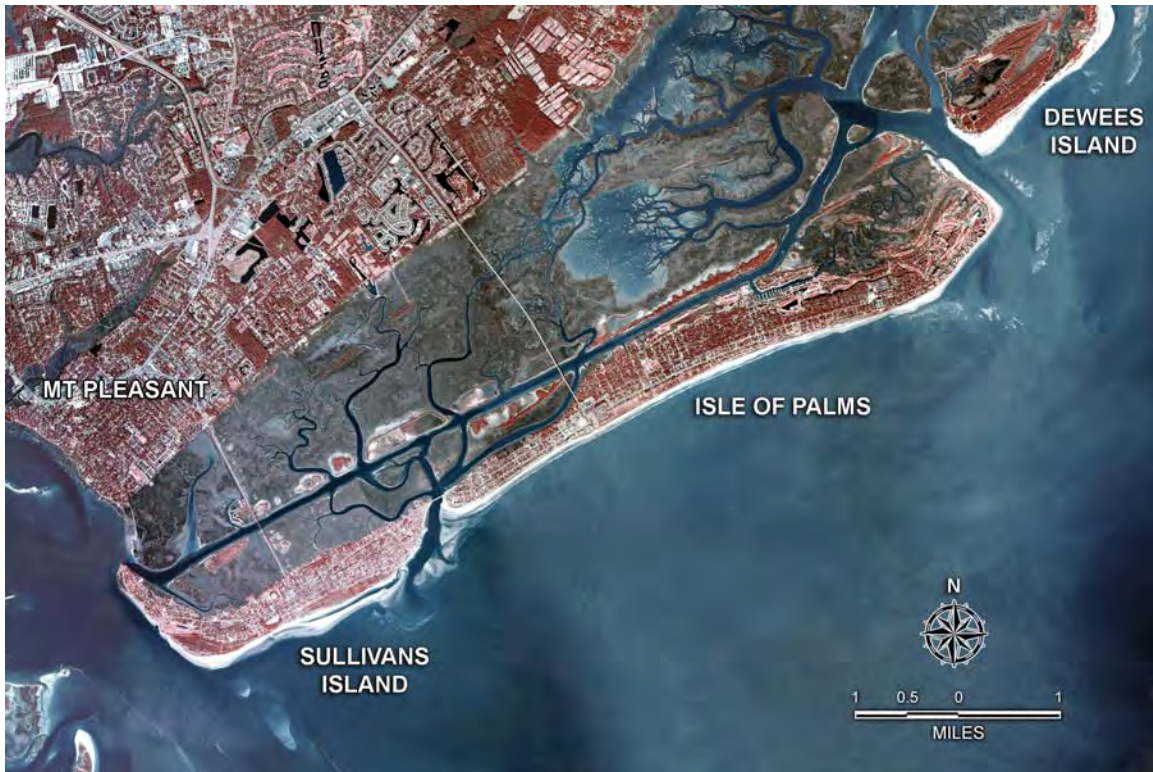
FIGURE 2.10. Isle of Palms, a classic “drumstick”-shaped mesotidal barrier island, and Sullivan’s Island, another “beach-ridge” barrier island, which match the Hayes (1976, 1979) classification illustrated in Figure 2.9. [Source: SCDNR 2006 and Research Planning Inc]

Hayes (1979) coined the term "drumstick" barrier island based on the shapes found along the South Carolina coast. Note the similarity of Isle of Palms to a chicken drumstick (Fig 2.10). The upcoast (east) end tends to be bulbous, whereas the downcoast (west) end tends to be elongate. The overall shape of the island reflects net sand transport moving from the bulbous end to the elongated end (Hayes 1979).

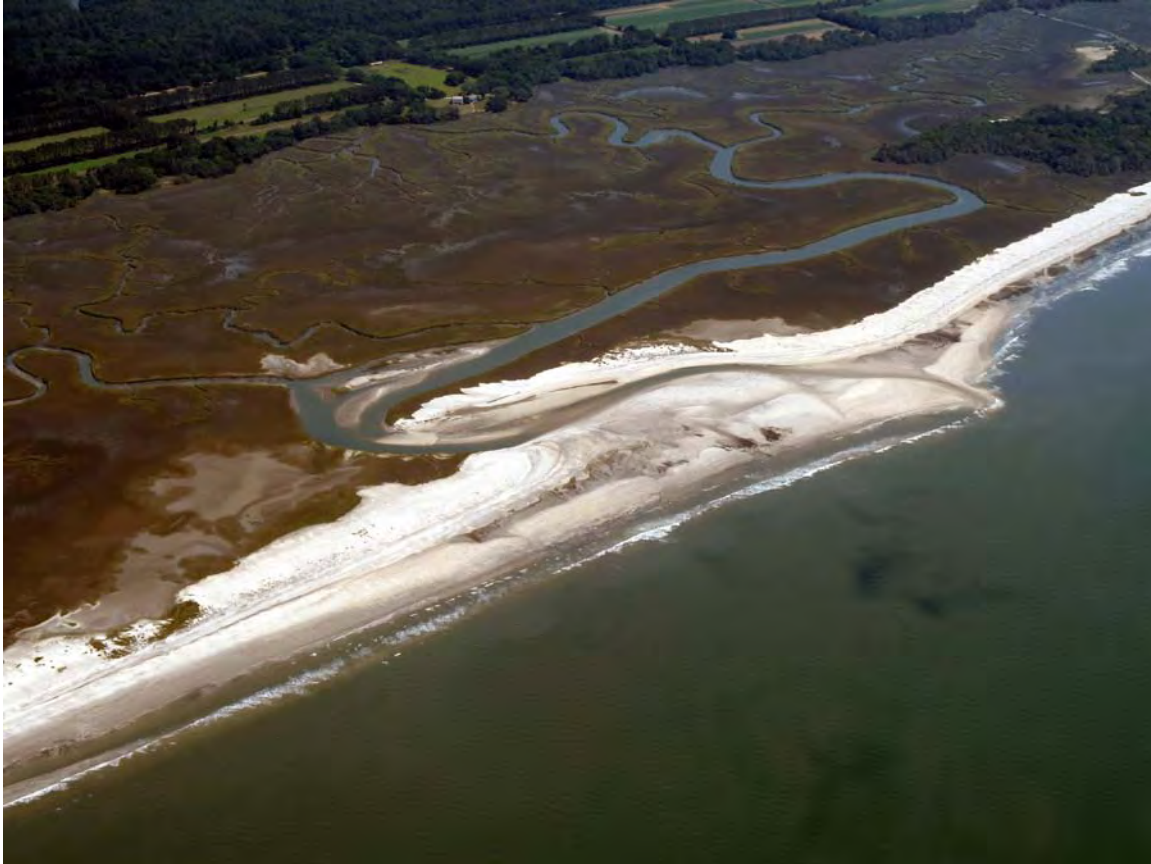
FIGURE 2.11. Edingsville Beach off Edisto Island, an example of a “transgressive” washover barrier island, unsuitable for development. Dark patches on the beach are marsh deposits re-exposed as the barrier washes over the marsh during storm events. [Photo by TW Kana, 31 May 2008]

“Transgressive” barrier islands are characterized by erosion, low elevation, and washovers. They lack sufficient inputs of sand and lose sand to the adjacent inlets or lagoon. Because of their low elevations, the ocean frequently overtops the beach and “transgresses” the land. Waves “wash over” the barrier island and sweep sand into the marsh or lagoon on the back side. Examples of transgressive barrier islands in South Carolina are Racoon Key near Cape Romain and Edingsville Beach off Edisto Island (Fig 2.11).

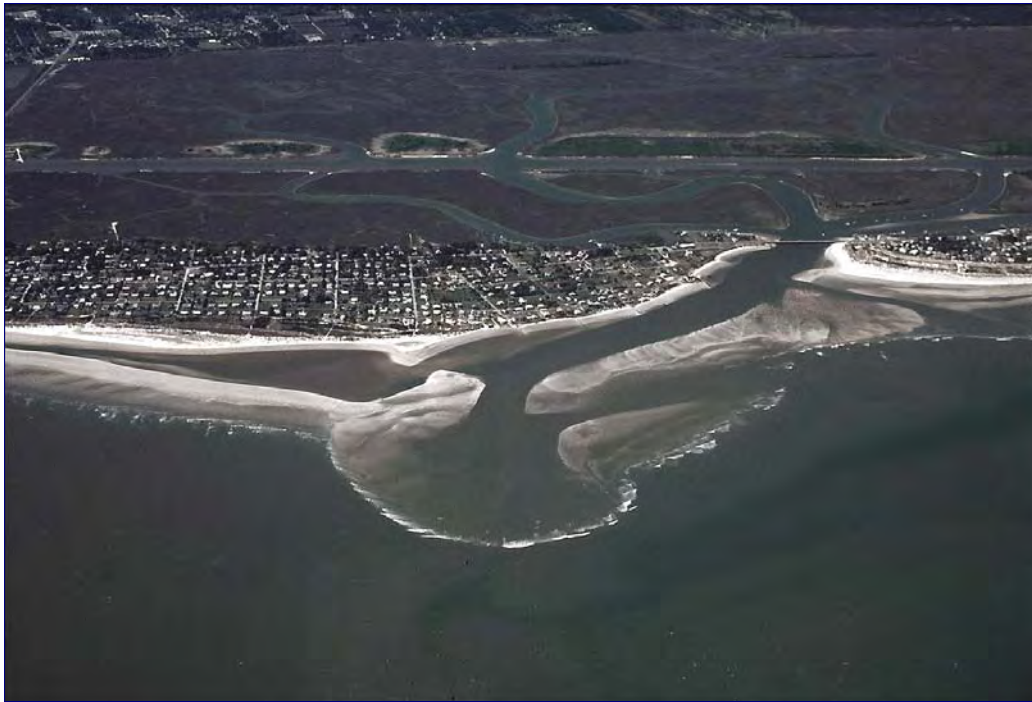
FIGURE 2.14. Oblique aerial photograph at low tide showing the deflection of Breach Inlet around shoals extending from Isle of Palms (right side of photo). Breaks in the shoals allow the channel to shift, freeing sand further west (left side of photo) to move onshore and accrete along Sullivan's Island. [Photo circa 2005 by TW Kana]

Stage 2 – The shoal merges with the beach usually at one end leaving a small lagoon between the bar and the beach. (See Figure 2.14 – area in the left half of the photo.) This is generally the time of maximum erosion along the beaches flanking the shoal because of the severe protrusion of the shoreline by the accreting bar. The examples in Figure 2.15 are from the east ends of Kiawah Island and Isle of Palms. A 1983 event at Isle of Palms caused property damage and forced some owners to build seawalls. A similar event in 2007 made headlines until the community nourished the eroding areas in June 2008 (CSE 2007).

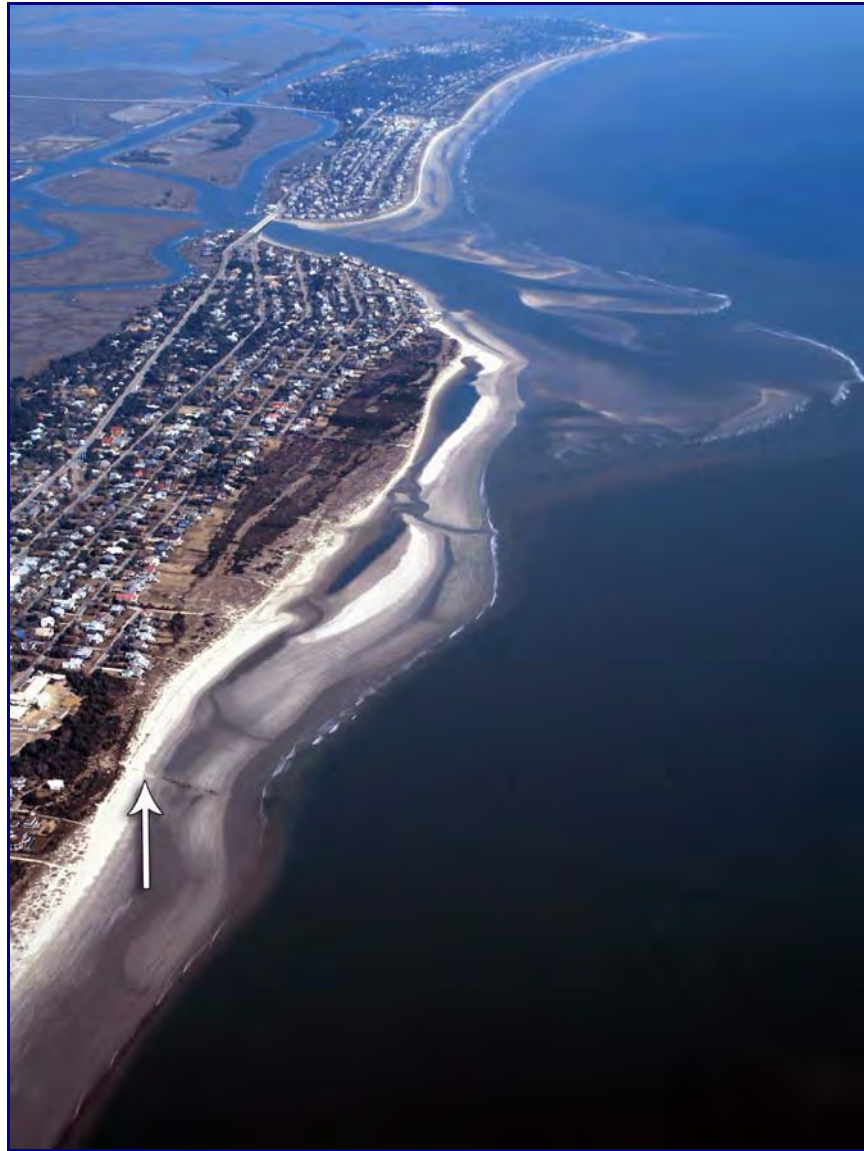
FIGURE 2.18. Oblique aerial photo of Sullivan's Island looking north at low tide on 17 February 2007. The landward end of the north jetty for Charleston Harbor (arrow) is generally buried and nonfunctional. Sullivan's Island is accretional because of excess sand bypassing Breach Inlet and accumulating along the beach on both sides of the jetty — not because of sand trapping by the jetty. Its effect on sand trapping diminished soon after construction. Note the sand bars merging with the beach in the center of the photo (Stations 23–29). [Photo by TW Kana]

Sullivan's Island, by comparison, accumulated sand moving downcoast. There are no surveys available covering the initial ~25 years after jetty construction. However, based on observations in similar settings, it is believed the landward end of the north jetty was quickly buried by littoral drift. Once buried, excess sand moved past the weir section to the west end of the island. Sand-retaining structures, such as jetties or groins, are no longer functional if they cannot be seen. The onshore part of the jetty, today, is partially exposed at points across the beach (Fig 2.18) but, in general, remains nonfunctional as a sand trap by virtue of its burial. Sand trapping by the north jetty may have accounted for Sullivan's Island's accretion a century ago, but shoal bypassing from Breach Inlet accounts for the buildup in recent decades.

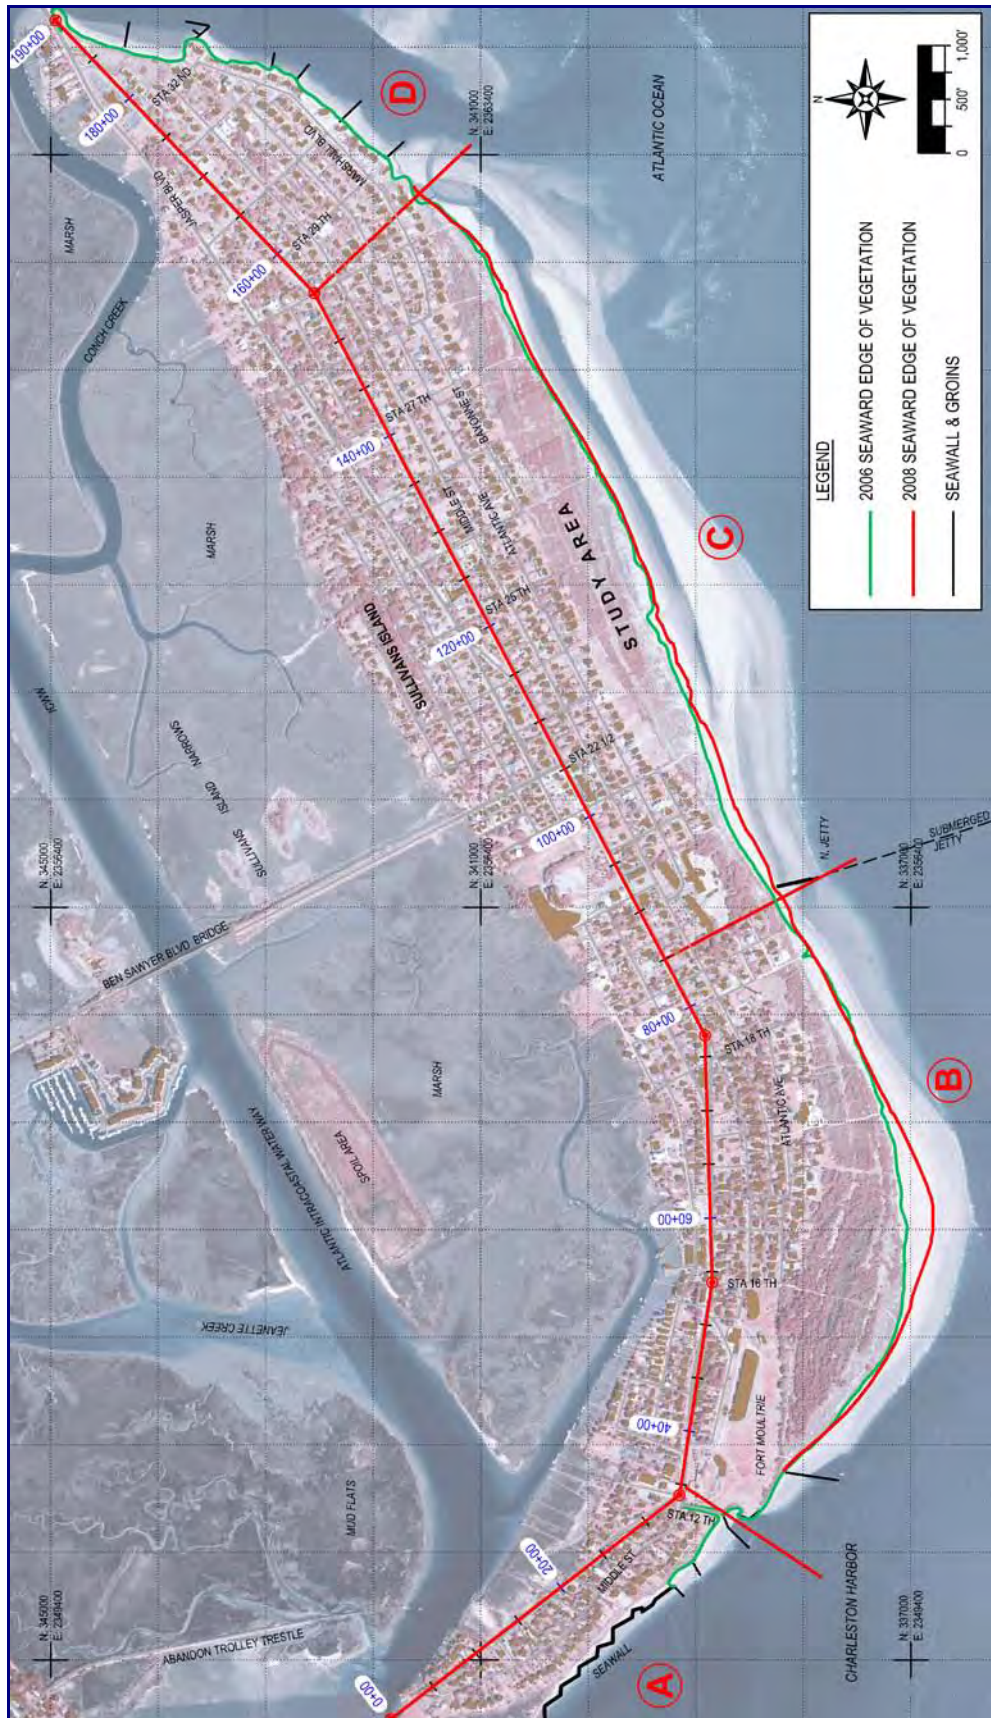
FIGURE 3.2. Infrared aerial orthophoto (2006) of Sullivan's Island showing the 2006 and 2008 seaward edge of vegetation and study reaches. [Source: SCDNR]

Using the aerial orthophotograph and ground-truth survey, the team identified four areas (“reaches”) for evaluation:

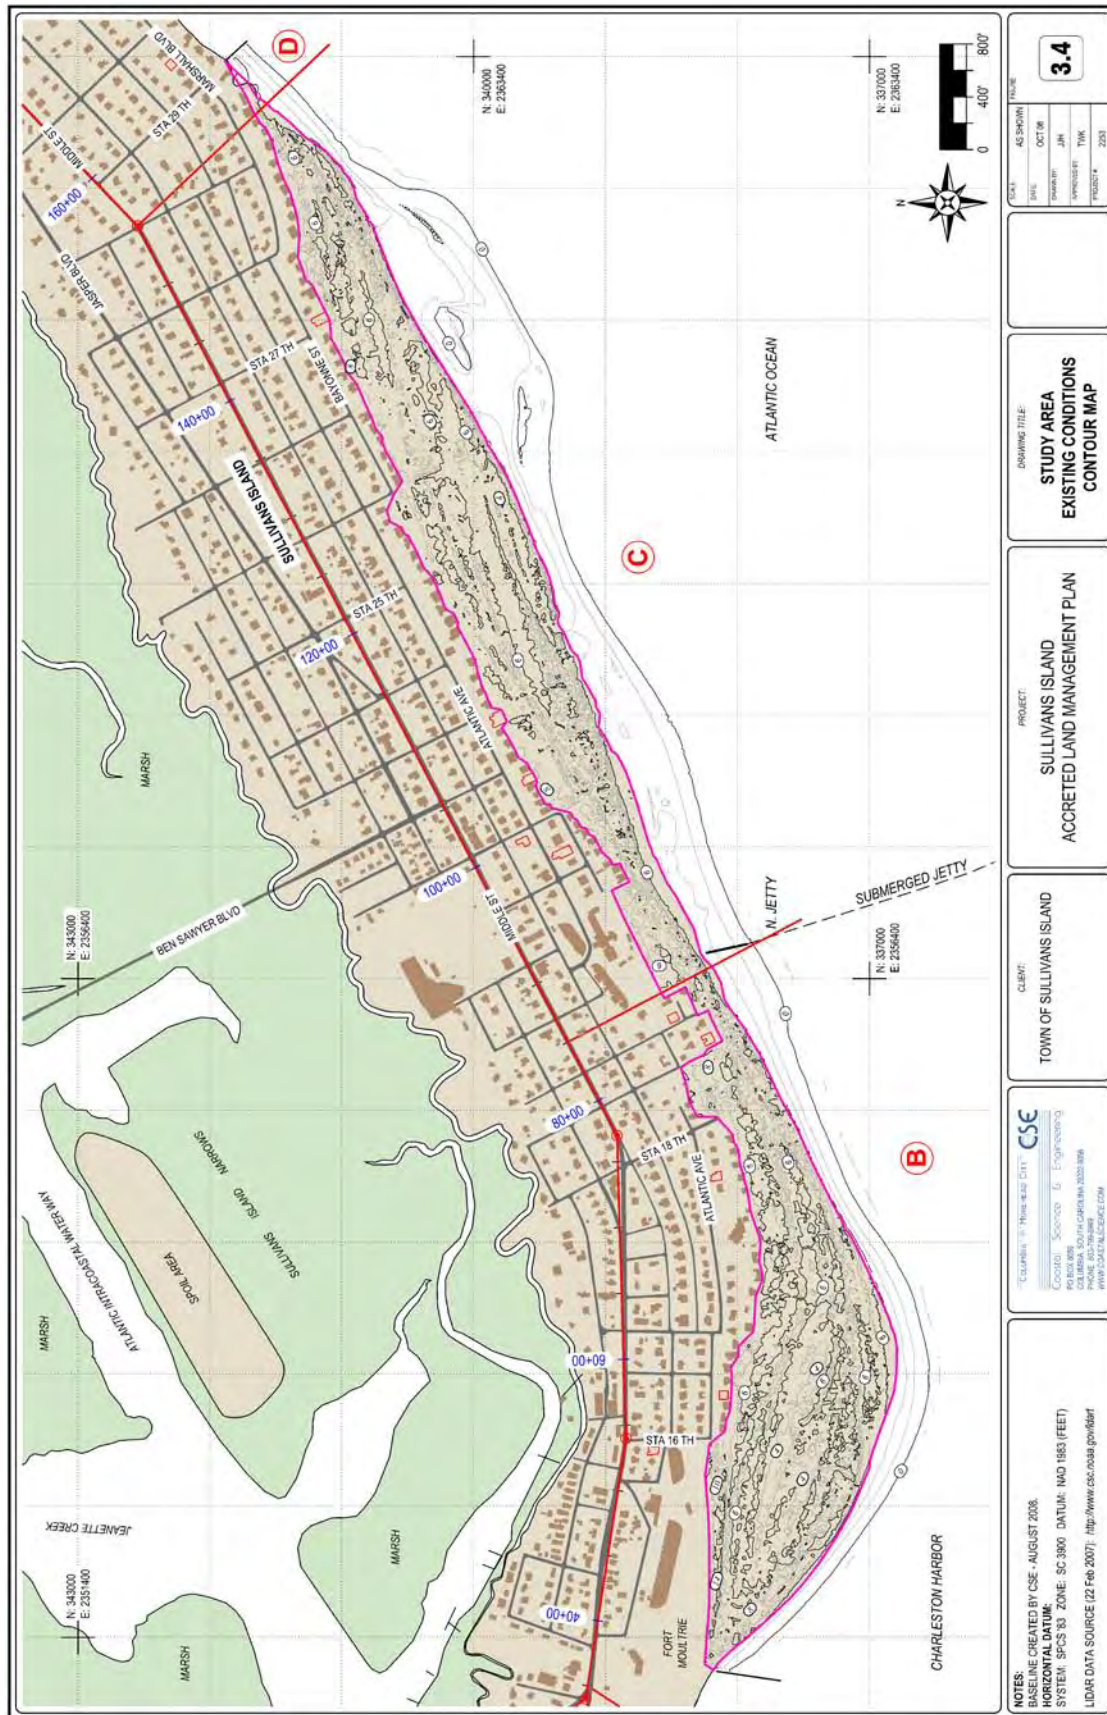
FIGURE 3.5. Color-coded DTM (digital terrain model) contour map of the ALMP study area and active beach showing the relatively small variations in elevation between the dune ridges (typically @ 6–12 ft) and the swales (typically @ 4–6 ft. Map developed from a combination of LIDAR and RTK-GPS data obtained between February 2007 (LIDAR) and August 2008 (RTK-GPS).

Figure 3.5 is a color version of the DTM for the study area. This illustrates the relatively low relief of most of the AL study area. The majority of elevations are between 6 ft and 8 ft NAVD.* Low areas which accumulate water can be seen between ridges around Station 16 (about transects 45+00 to 60+00) and Station 25 (about transects 110+00 to 130+00). There are other swales at somewhat higher elevations which also collect standing water. Note in the color-coded DTM the relatively small differences in elevation between the dune ridges and swales. Typical relief is less than 5 ft. The highest dune ridge with elevations of >12 ft fronts Fort Moultrie. No continuous dune ridges exceed 12 ft above sea level over the remaining study area.

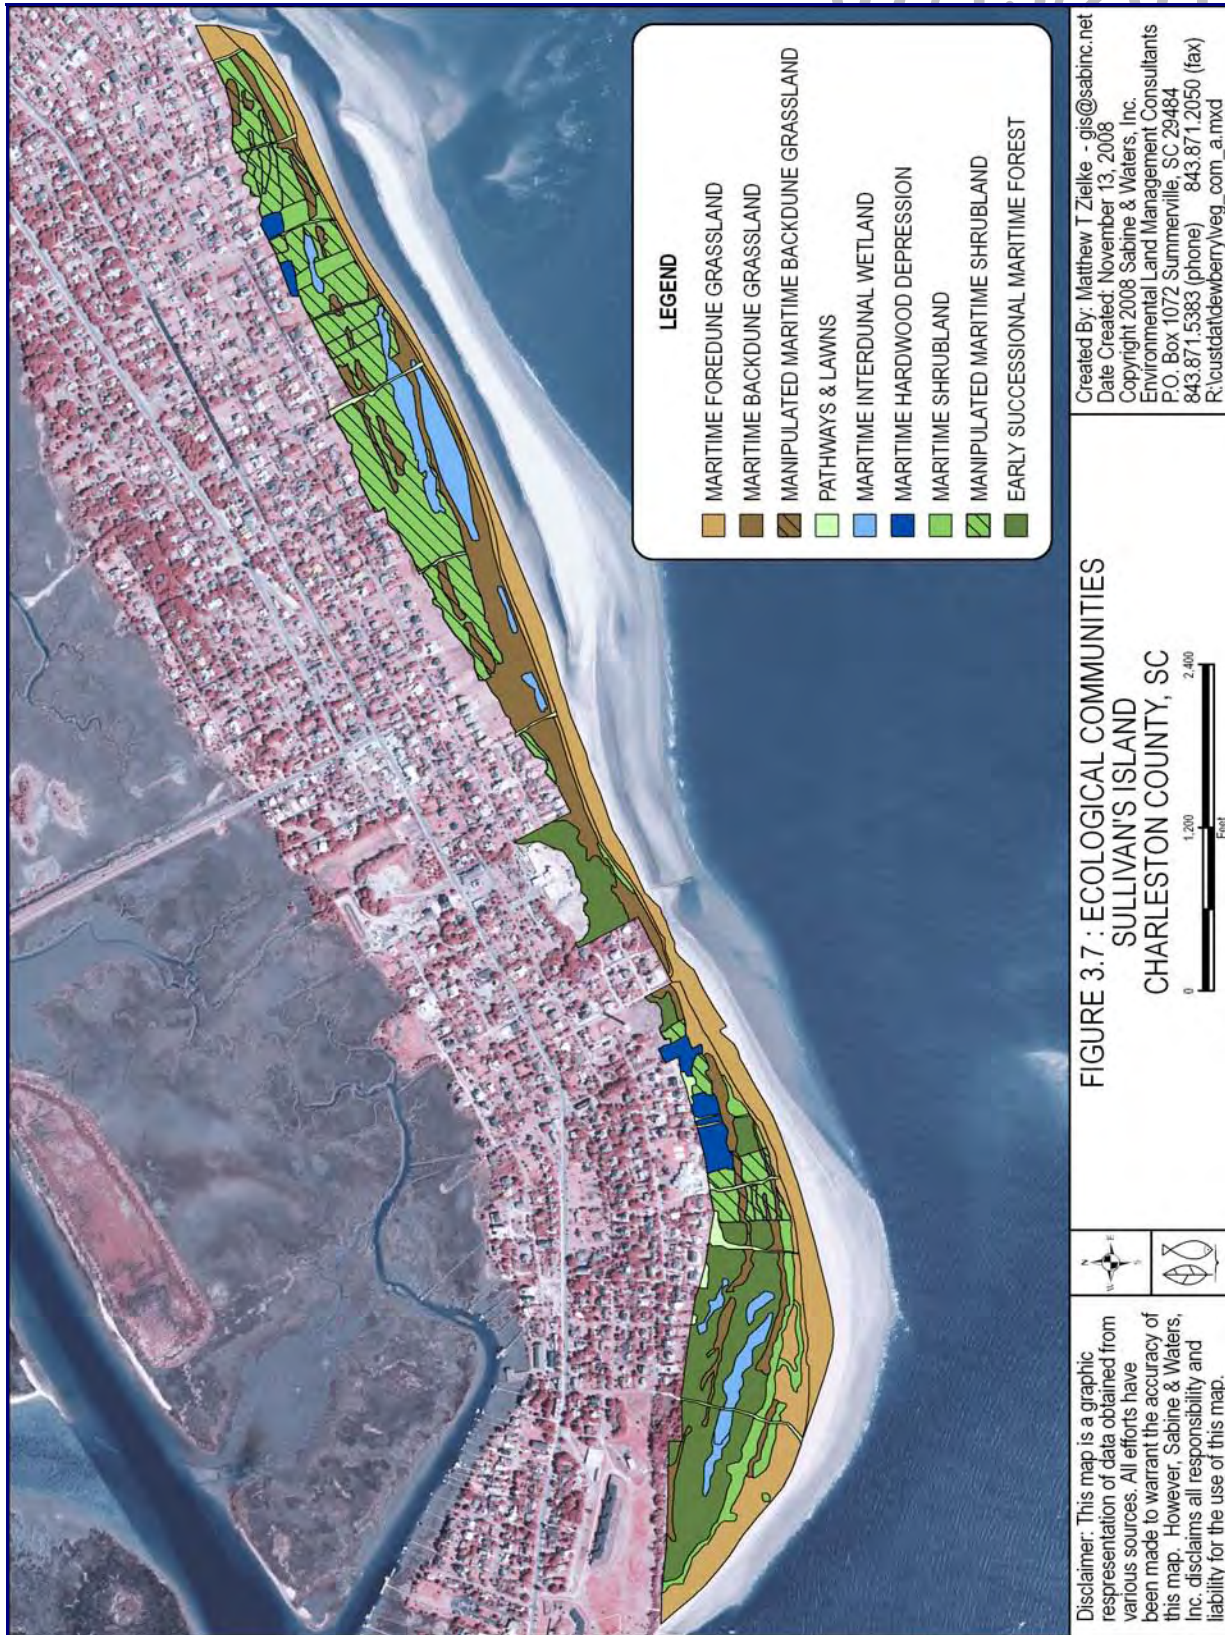
FIGURE 3.7. The nine ecological communities in the AL study area identified by Sabine & Waters in summer 2008.

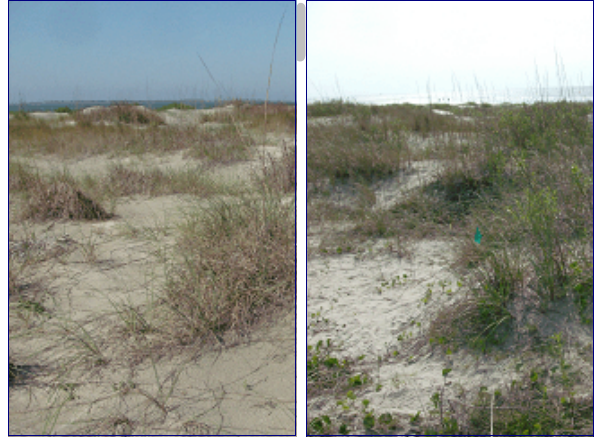
This coastal dune community occurs on and just inland of the foredune ridge, immediately adjacent to the beach (cf – Fig 3.7). The extreme environment (including harsh sun, deep xeric sand, salt spray, and high winds) limits vegetation to hardy grasses and broad-leaved herbs (forbs) (Nelson 1986, Schafale & Weakley 1990, Martin 1991). The grasses, such as sea oats, that thrive in this environment have

extensive root and rhizome systems which allow them to produce new growth after burial by windblown sand (Duncan & Duncan 1987). This vegetation traps windblown sand which accumulates to form low dunes.

Herbaceous vegetation such as sea oats, seaside pennywort (*Hydrocotyle bonariensis*), saltgrass (*Distichlis spicata*), beach morning glory (*Ipomoea imperati*), and seabeach evening primrose (*Oenothera humifusa*) were common throughout this community. Trailing vines such as fiddle-leaf morning-glory (*Ipomoea stolonifera*) occurred on the foredune ridge, often in dense colonies, with trailing runners reaching seaward toward the beach. While none were seen during the survey, island glass lizards (*Ophisaurus ventralis*), a rare legless lizard, have been found in this habitat (pers comm, Stephen Bentley). Sea turtles use this area as nesting sites, and painted buntings (*Passerina ciris*) were found foraging on seeds in this community.

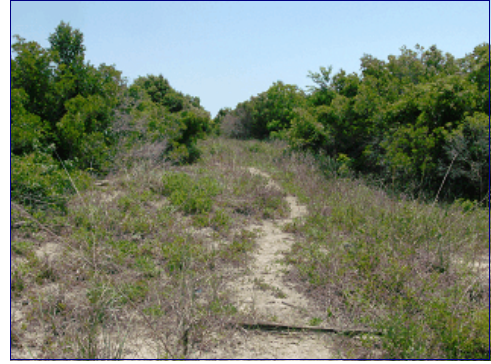
This community occurs on back dune ridges, often bisecting maritime forest or inland of maritime foredune grassland communities. Back-dune scrub communities support no overstory and only scattered shrub species [such as prickly pear (*Opuntia* spp)] and low thickets of dune and sawtooth greenbrier (*Smilax auriculata* and *Smilax bonanox*). These sandy ridges may have remained open due to extremely dry, sandy soils that limit colonization by shrub species. The herbaceous community is diverse and includes spiderwort (*Tradescantia ohiensis*), seaside pennywort, prickly pear, seabeach evening primrose, gulf croton (*Croton punctatus*), sea oats, camphorweed (*Heterotheca subaxillaris*), and others. These sandy ridges appear to be regularly traveled by pedestrians, evidenced by the distinct trail seen in the above photograph. Wildlife signs, including tracks and scat, are common on these pathways. Mammals such as raccoons (*Procyon lotor*) and swamp rabbits (*Sylvilagus aquaticus*) frequently use these pathways. A gray fox (*Urocyon cinereoargenteus*) was spotted early one morning walking along one of these trails.

ICEC Type:	Seaside Greenbrier / Camphorweed – Trailing Wild Bean – (Sea oats) Herbaceous Vegetation
NatureServe Identifier:	CEGL004234
ICEC Fit:	Excellent

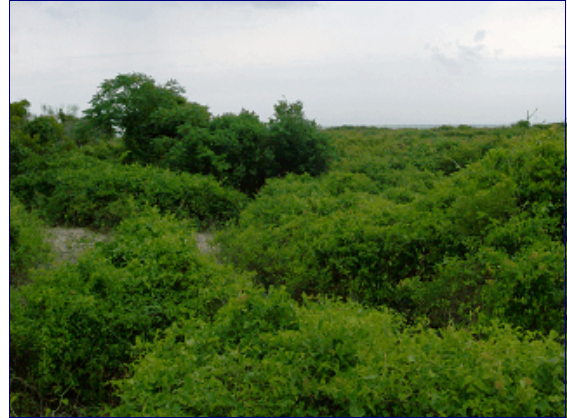
This community contains similar vegetation as the maritime backdune grassland. However, regular pruning has resulted in dense thickets of dune greenbrier and sawtooth greenbrier, which appear to be displacing other vegetation. The ICEC classification with the best fit for this community is provided; however, due to heavy manipulation in the form of regular pruning, this community lacks the plant species diversity described for the ICEC classification.

Compare photographs of maritime backdune grassland and manipulated maritime backdune grassland.

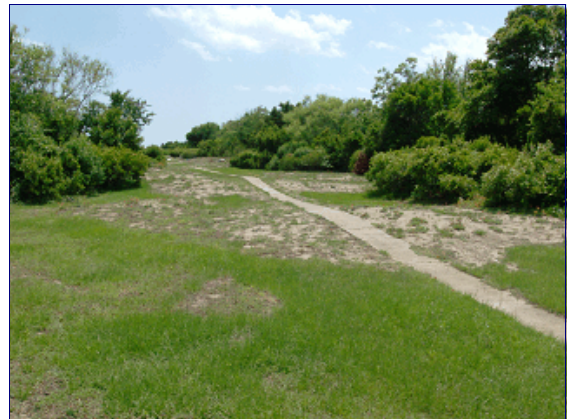
The vegetation found along pedestrian pathways and lawns is a mix of typical, barrier-island dune inhabitants as well as those commonly found in rural areas. No overstory or shrubs are present. Herbaceous vegetation includes various typical lawn grasses [eg – bahia grass (*Paspalum notatum*) and crabgrass (*Digitaria* sp)], frog fruits (*Phyla nodiflora*), English plantain (*Plantago lanceolata*), buttonweed (*Diodia virginiana*), prickly pear, and others.

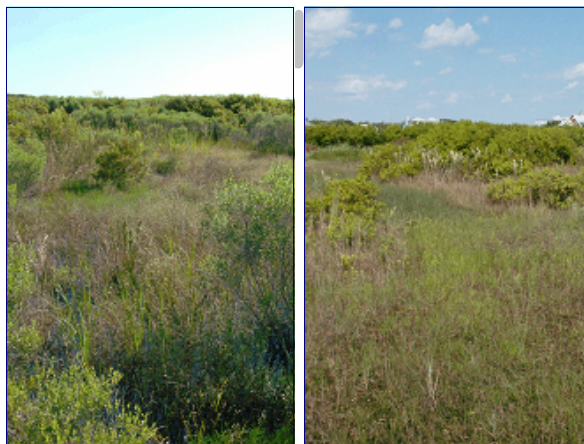
This community occurs in the flats and interdunal swales behind the foredune ridge. Protected from most tidal flooding, these areas are kept in a state of early succession by strong winds, salt spray, and occasional flooding during storm events and spring tides. Freshwater from inland runoff and rain mix with occasional saltwater, creating pools with varying degrees of salinity (Duncan & Duncan 1987). Vegetation within this community varies by elevation, salinity, and hydroperiod, but generally supports grasses, sedges, rushes, forbs, and pioneer woody vegetation. Common among the vegetation present is the ability to withstand the harsh conditions present and constant burial by windblown sand (Stalter and Odum 1993). The vegetation composition within this community type varied widely due to environmental conditions listed herein. Describing each wetland community type was beyond the scope and needs of this report. For this reason, the ICEC classification listed includes many vegetation community types, some of which occur within the AL area. For more information regarding the vegetation community types within this classification, visit www.NatureServe.org.

Shrub species are limited to scattered seashore elder (*Iva imbricata*), wax myrtle, and groundsel tree (*Baccharis halimifolia*). The herbaceous community is most prolific. In low-lying mesic flats, dominant herbaceous species include pennywort, fern flatsedge (*Cyperus filicinus*), Carolina fimbry (*Fimbristylis caroliniana*), frog-fruits, and fingergrass (*Eustachys petraea*). In the wettest portions of this community, which were flooded at the time of the survey, herbaceous vegetation included narrowleaf cattail (*Typha angustifolia*), bushy bluestem (*Andropogon glomeratus*), pennywort, saltmarsh morning glory (*Ipomoea sagittata*), bulrush (*Scirpus* sp), common rush (*Juncus effusus*), and many others. Common shrubs are groundsel tree and wax myrtle. American alligators (*Alligator mississippiensis*) potentially occur in the wettest portions of this community (Nelson 1986).

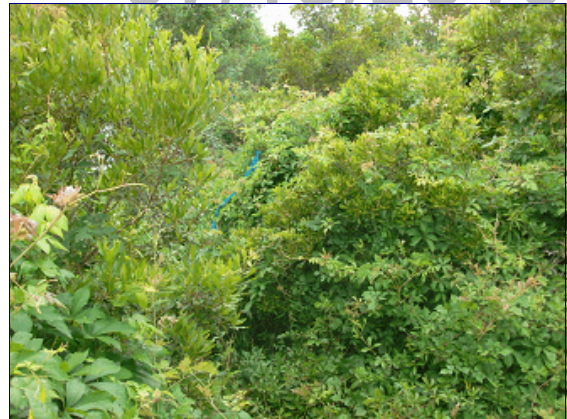
This shrub-dominated community occurs inland of open grassland communities and is an intermediate successional stage between maritime grassland and maritime forest (Duncan & Duncan 1987). It is closely related to the maritime interdunal wetland; however, the maritime shrubland is rarely flooded (Nelson 1986). This habitat type forms an impenetrable thicket that protects inland vegetation from salt spray and strong winds, allowing trees to colonize, forming the Early Successional Maritime Forest described later (Stalter & Odum 1993).

Characterized by very dense vegetation ~2–3 m tall, the maritime shrubland community has little or no overstory present, except for a few scattered sugarberry (*Celtis laevigata*) and large wax myrtle. The shrub layer is very dense and is composed of pioneer shrub species such as wax myrtle, groundsel tree and vine thickets of blackberry (*Rubus* sp), Virginia creeper (*Parthenocissus quinquefolia*), peppervine (*Ampelopsis arborea*), poison ivy (*Toxicodendron radicans*), and maypop (*Passiflora incarnata*). For the most part, herbaceous vegetation is absent; where it does occur, smartweeds (*Polygonum* sp) are prevalent. Chinese tallow, an invasive exotic, was encountered in this vegetation community. These wax myrtle thickets are suitable nesting habitat for painted buntings.

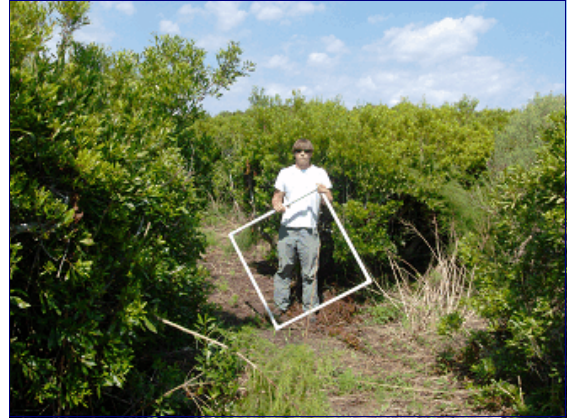
Manipulated Maritime Shrubland

This community receives regular pruning and has resulted in a hedge-like condition ~7–8 ft high. No overstory exists in this habitat type, but shrub and vine species form a nearly continuous dense thicket. The photograph was taken on a beach access path cut through the AL area. Wax myrtle, rattlebush (*Daubentonia punicea*), groundsel tree, and Chinese tallow are the most common shrubs in the thickets. Occasional openings in the thickets allow an herbaceous community to develop. Common herbaceous species are maypop, Virginia creeper, blackberry, poison ivy, prickly pear, dog fennel (*Eupatorium capillifolium*), camphorweed, and others. The ICEC classification with the best fit for this community is listed; however, due to heavy manipulation in the form of regular pruning, this community lacks the plant species diversity described for the ICEC classification.
