Accreted Land Management Plan

Sullivan's Island, South Carolina

**ACCRETED LAND MANAGEMENT PLAN
Town of Sullivan's Island South Carolina**

[2253-ALMP]
JULY 2010

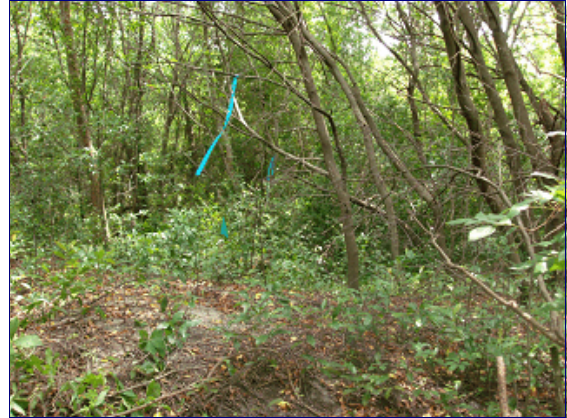
Early Successional Maritime Forest

At maturity, the maritime forest is the climax vegetation community of coastal dune systems (Stalter & Odum 1993). While this community in the AL area is too young to be considered a mature maritime forest, it is the oldest habitat found in the AL study area. Historical photography reveals that much of this area was vegetated as early as 1963.

Residing on stabilized dune ridges and swales and protected from salt spray, strongest winds, and tidal overwash, this habitat type generally occurs farther inland than other community types and supports the greatest quantity of trees in the area. Though somewhat protected, vegetation in the maritime forest is well adapted to salt spray, harsh sunlight, wind shear, low water availability, and nutrient-poor soils (Stalter & Odum 1993). Due to the early successional nature of this community, it does not fit well with the ICEC classification listed. The classification listed is a climax forest that is most likely to develop in this area over time. Many of the species present in the AL area today will be replaced by those described in the ICEC classification as it matures and approaches a climax community. This process may take as many as several hundred years.

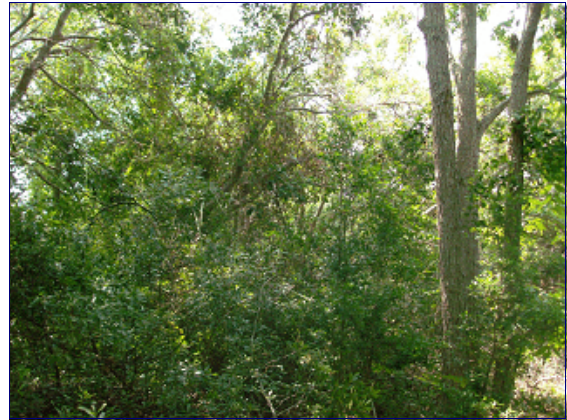
Maritime Hardwood Depression

Occupying dune swales of the inland portions of the AL area, these low-area habitats are characterized by a moderately dense overstory of sugarberry, black willow, Chinese tallow, pecan and mulberry (*Morus rubra*). The shrub layer is moderately dense to dense and contains laurel cherry, yaupon, groundsel tree, eastern red cedar, beautyberry (*Callicarpa americana*), and many of the same species found in the overstory.

Due to the density of the shrub and overstory layers, very little sunlight reaches the forest floor, resulting in a sparse understory. Species include common vines, goldenrod (*Solidago* spp), dog fennel, spiderwort, common tree saplings, and others.

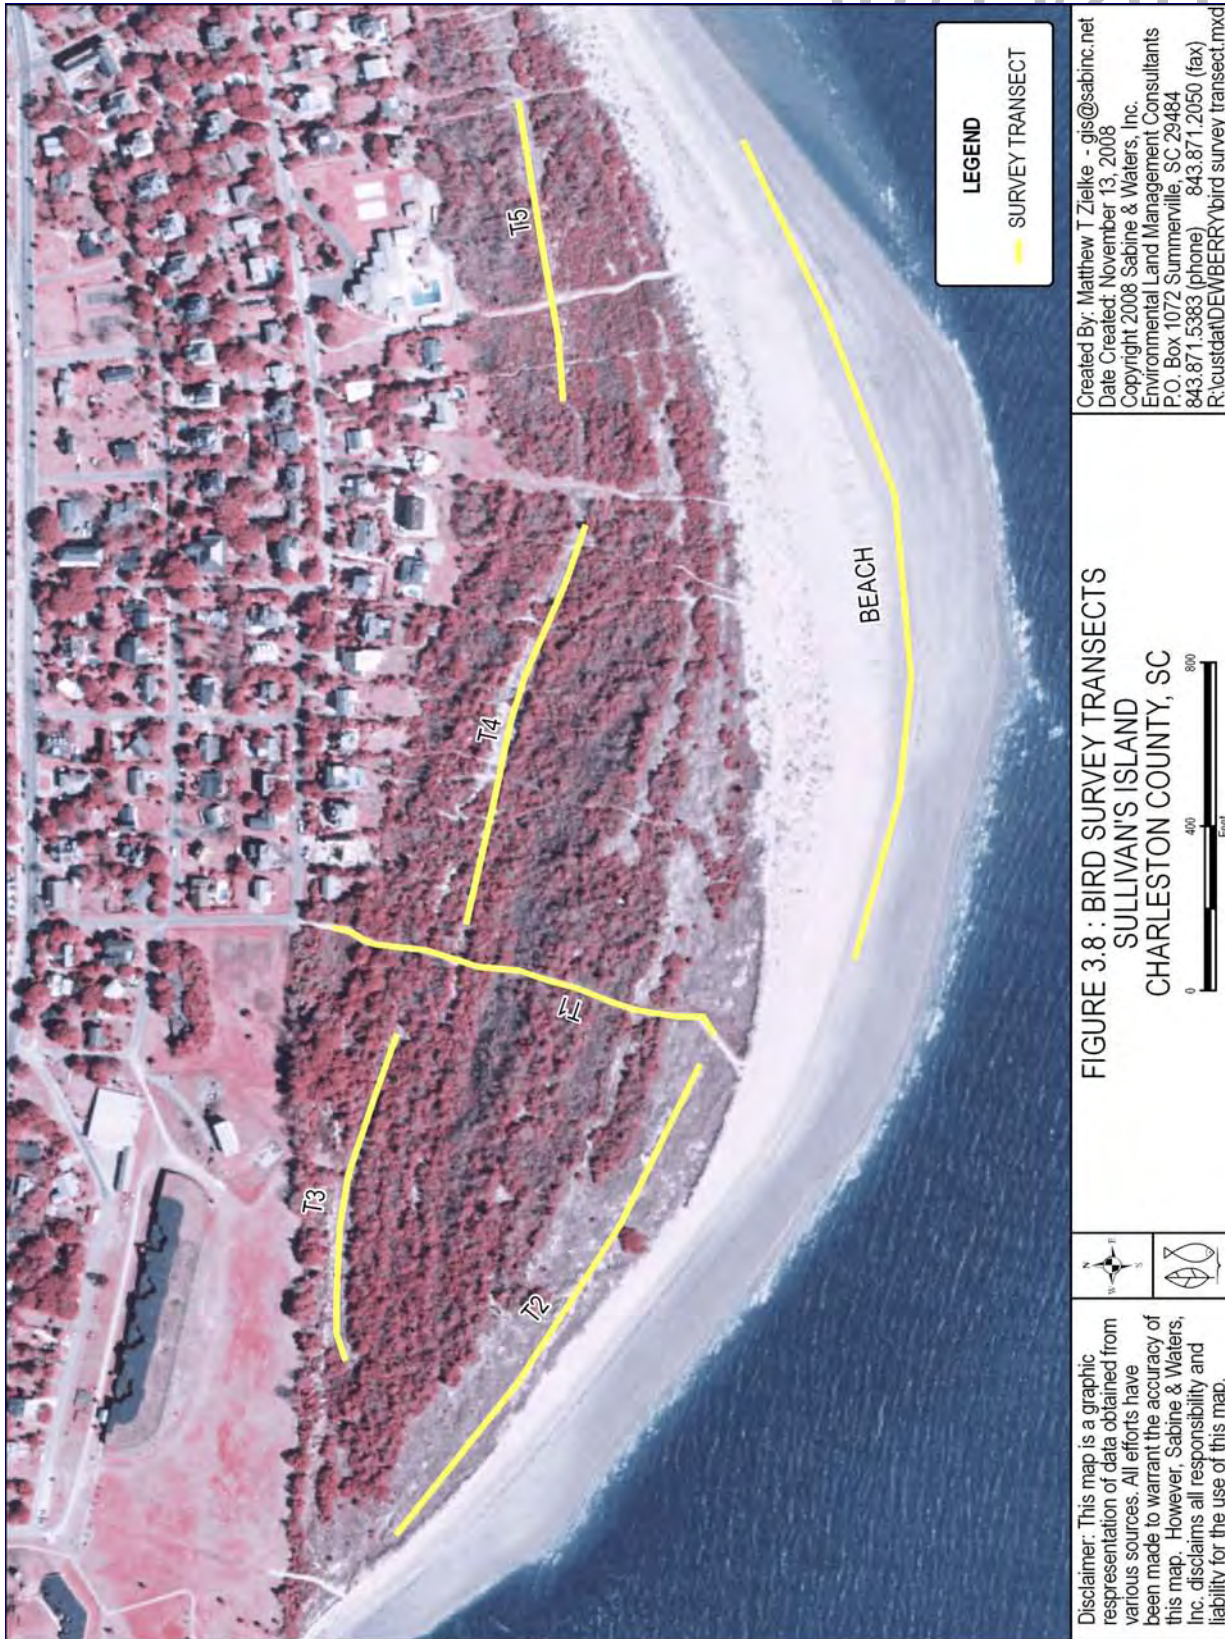
FIGURE 3.8. Bird survey transects in the AL study area identified by Sabine & Waters in summer 2008.

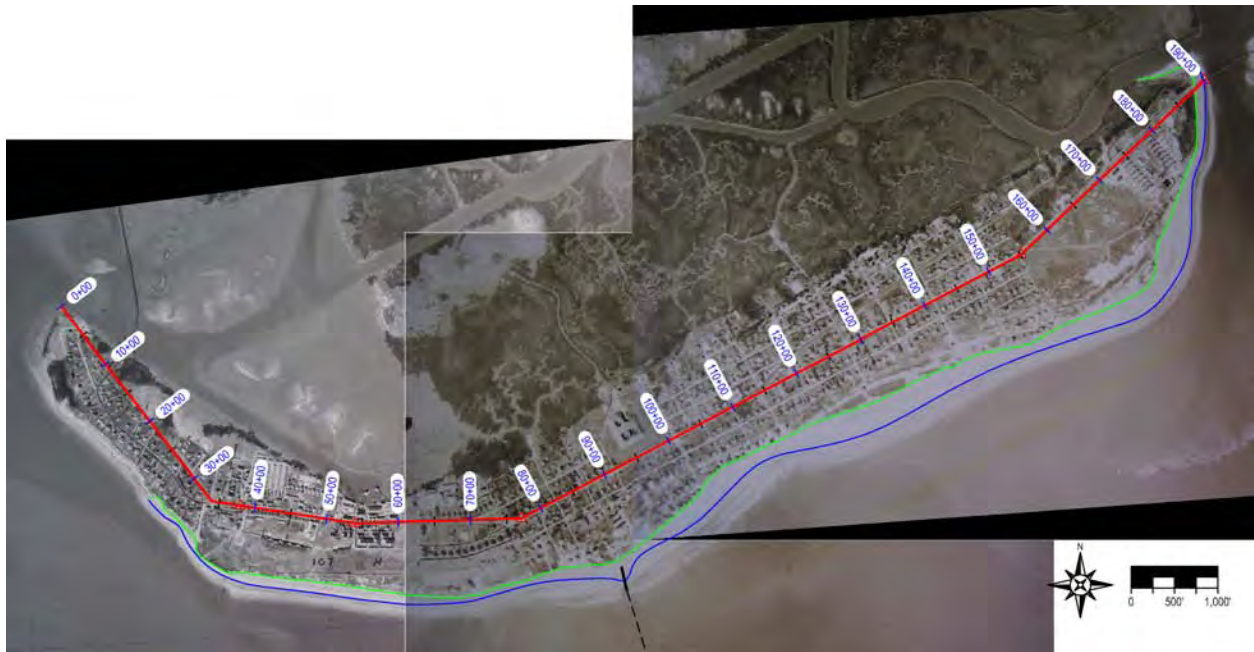
FIGURE 4.1. Scale-adjusted vertical aerial photographs of Sullivan's Island in **1941** (upper) and in **1949** (lower) by US Department of Agriculture with roads, seaward vegetation line, and the wet-sand/dry-sand contact line superimposed. [Scale-adjusted images courtesy of WPC Inc]

A quick perusal of Figures 4.1–4.5 shows that the accreted land did not exist in 1941. Note in Figure 4.1 (upper) how the oceanfront buildings were situated close to the seaward vegetation line, particularly around transect 90+00 to transect 110+00. By 1949 (Fig 4.1, lower), the central section of Sullivan’s Island had widened by 100 ft along the vegetation line. One interesting observation for the 1940s is the demolition (which reportedly occurred in 1947) of old Army quarantine barracks at the eastern end of the island. Breach Inlet fronted the eastern end and was oriented obliquely to the strandline of the coast. During this time, there were no groins along the inlet. A terminal groin is visible off the western end of Fort Moultrie ~1 mile from the north jetty for Charleston Harbor.

Another noteworthy feature in 1949 (Fig 4.1, lower) is the bar at the mouth of Breach Inlet. Wave-breaking over the bar is visible, and its sheltering effect probably accounts for the broad bulge in the shoreline at the mouth of the inlet. Between 1949 and 1963, Breach Inlet shifted position and allowed the shoal at the mouth of the inlet to migrate onshore (cf – Fig 4.2). Note the bulge around transect 150+00 in the 1963 image (Fig 4.2, lower).

In 1941, the coastline consisted of a mix of residential development and early successional maritime dune grassland (see Fig 4.1). Dune grassland vegetation, probably dominated by sea oats as it is today, was most extensive in Reach B, the eastern half of Reach C, and Reach D. These areas contained little or no development and appeared to be in a natural

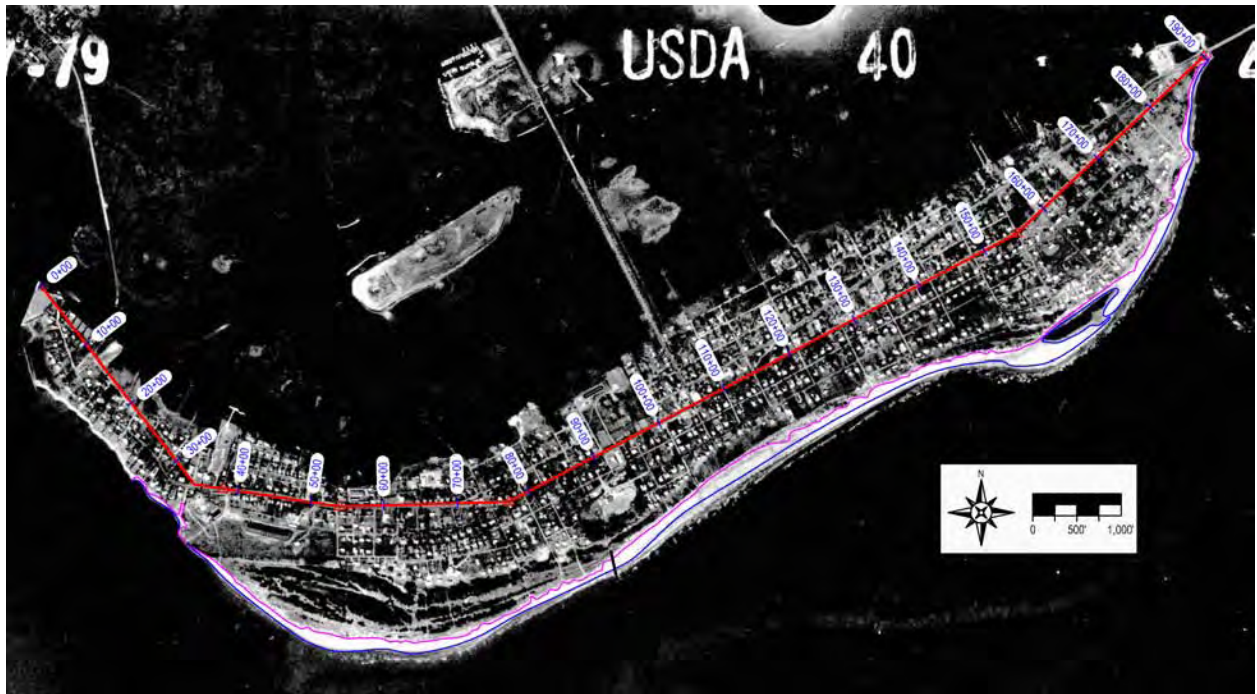
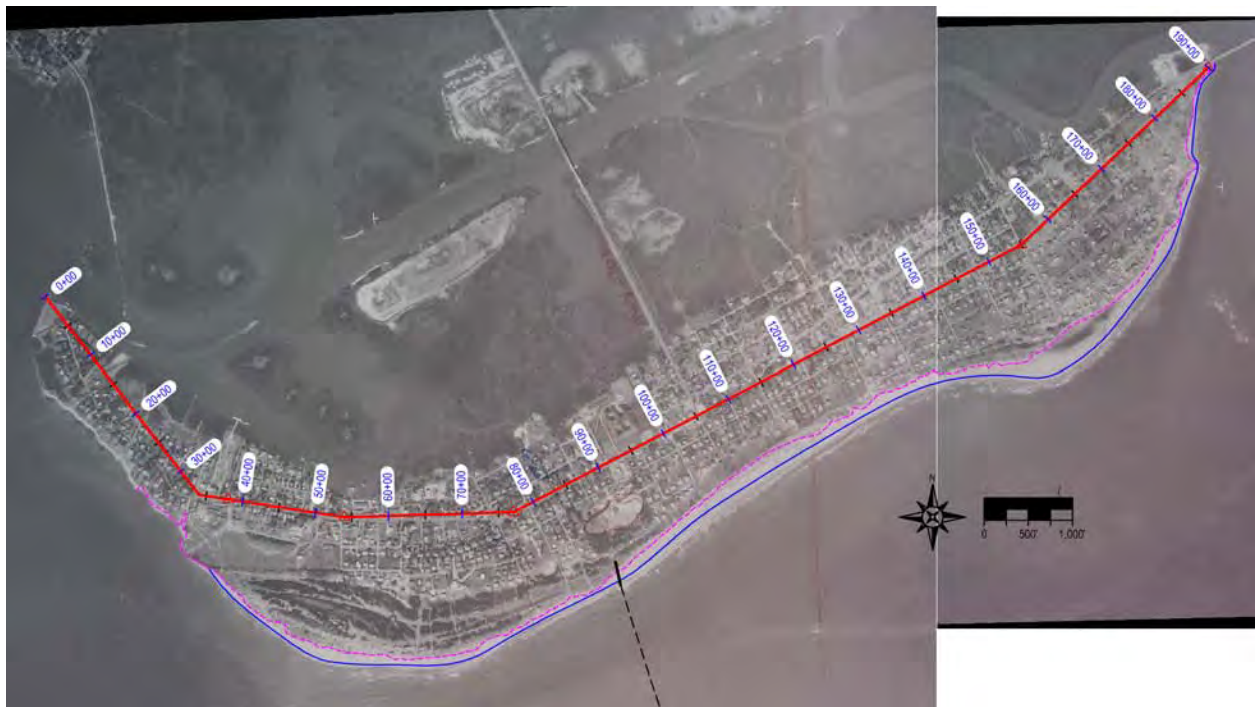
FIGURE 4.4. Scale-adjusted vertical aerial photographs of Sullivan's Island in 1979 (upper) and in 1983 (lower) by US Department of Agriculture with roads, seaward vegetation line, and the wet-sand/dry-sand contact line superimposed.

The 1979 photo reveals that the vegetation line along Reach B is about 1,000 ft seaward of buildings, which is close to the present-day extent of vegetation (see Fig. 4.4). Maritime shrub vegetation on the interior portion of the area has matured to early successional maritime forest, and inland dune swales are developing into hardwood depressions. The interior area of Reach C around 90+00 continues to develop into maritime forest, and accretion adds new land between 140+00 and 160+00. With that accretion, there was further development of the interior maritime shrub habitat and an expansion seaward of dune grassland habitat in Reach C.

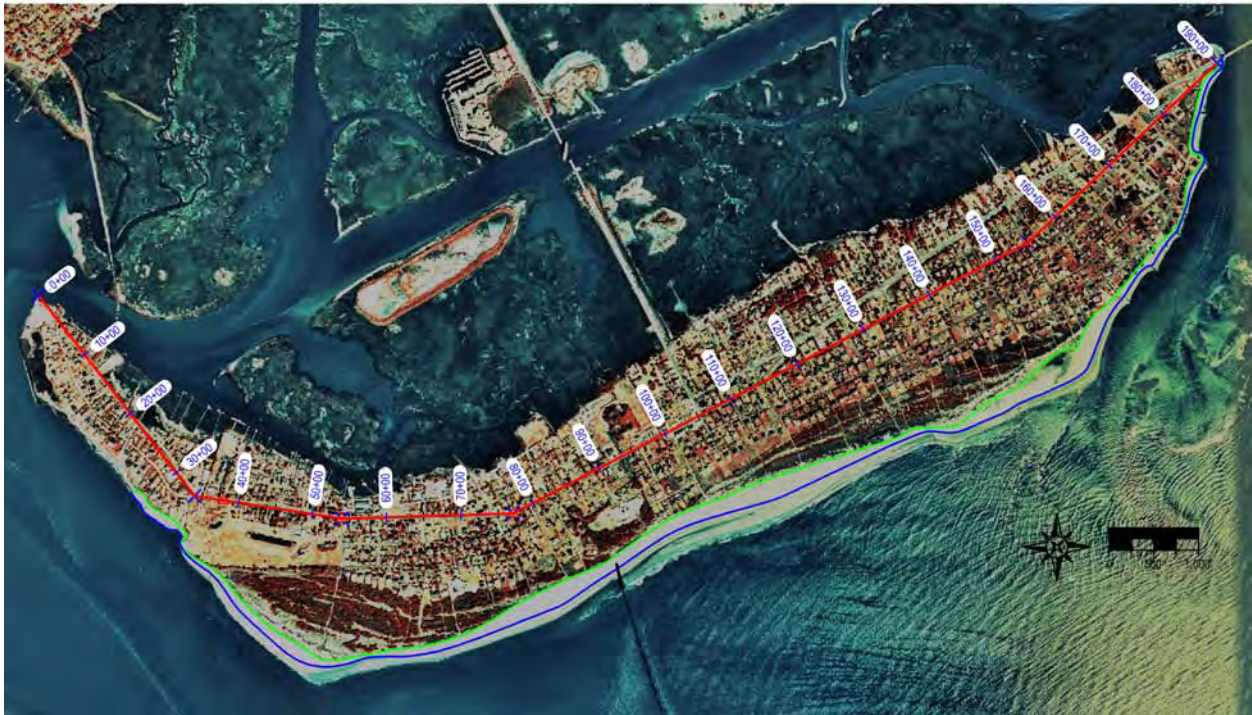
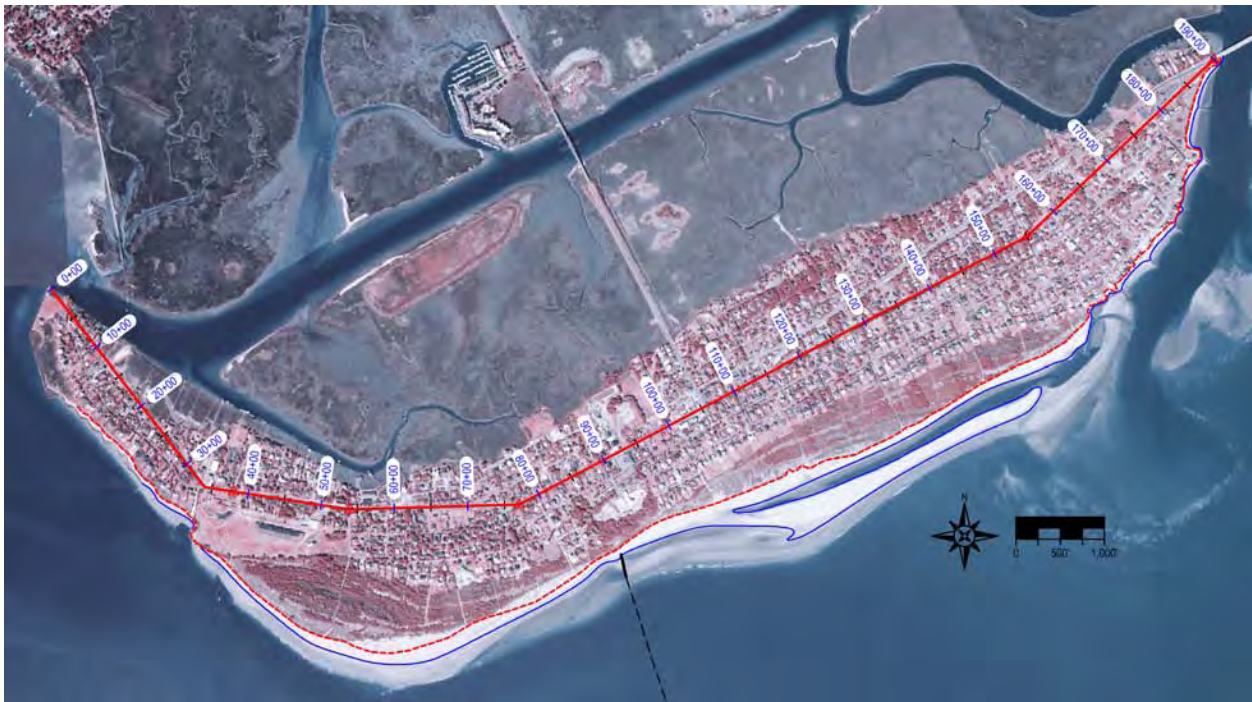
FIGURE 4.5. Orthorectified, vertical aerial photographs of Sullivan's Island in **1999** (upper) and in **2006** (lower) by SCDNR with roads, seaward vegetation line, and the wet-sand/dry-sand contact line superimposed.

Between 1979 and 1983, the island experienced moderate erosion along most of its coastline. Erosion continued through 1999 for most of the eastern half of Reach B and the western half of Reach C. Much of the maritime grassland community and some of the seaward portion of maritime shrub community present in this area were eroded, leaving a very narrow transition from intertidal beach to maritime shrub. The eastern half of Reach C saw rapid accretion and development of dune grassland and interdune flats and wetlands. Interior portions of Reach B continued to mature into early successional maritime forest and depressional wetland. Figure 4.15 shows the extent of shrub and forest vegetation in 1983. The eastern half of Reach B and all of Reach C accreted through 2006 and developed an outer band of maritime fore-dune grassland community (see Fig 4.5). Though some accretion continued through 2008, the 2006 vegetation community appears very similar to what it is today.

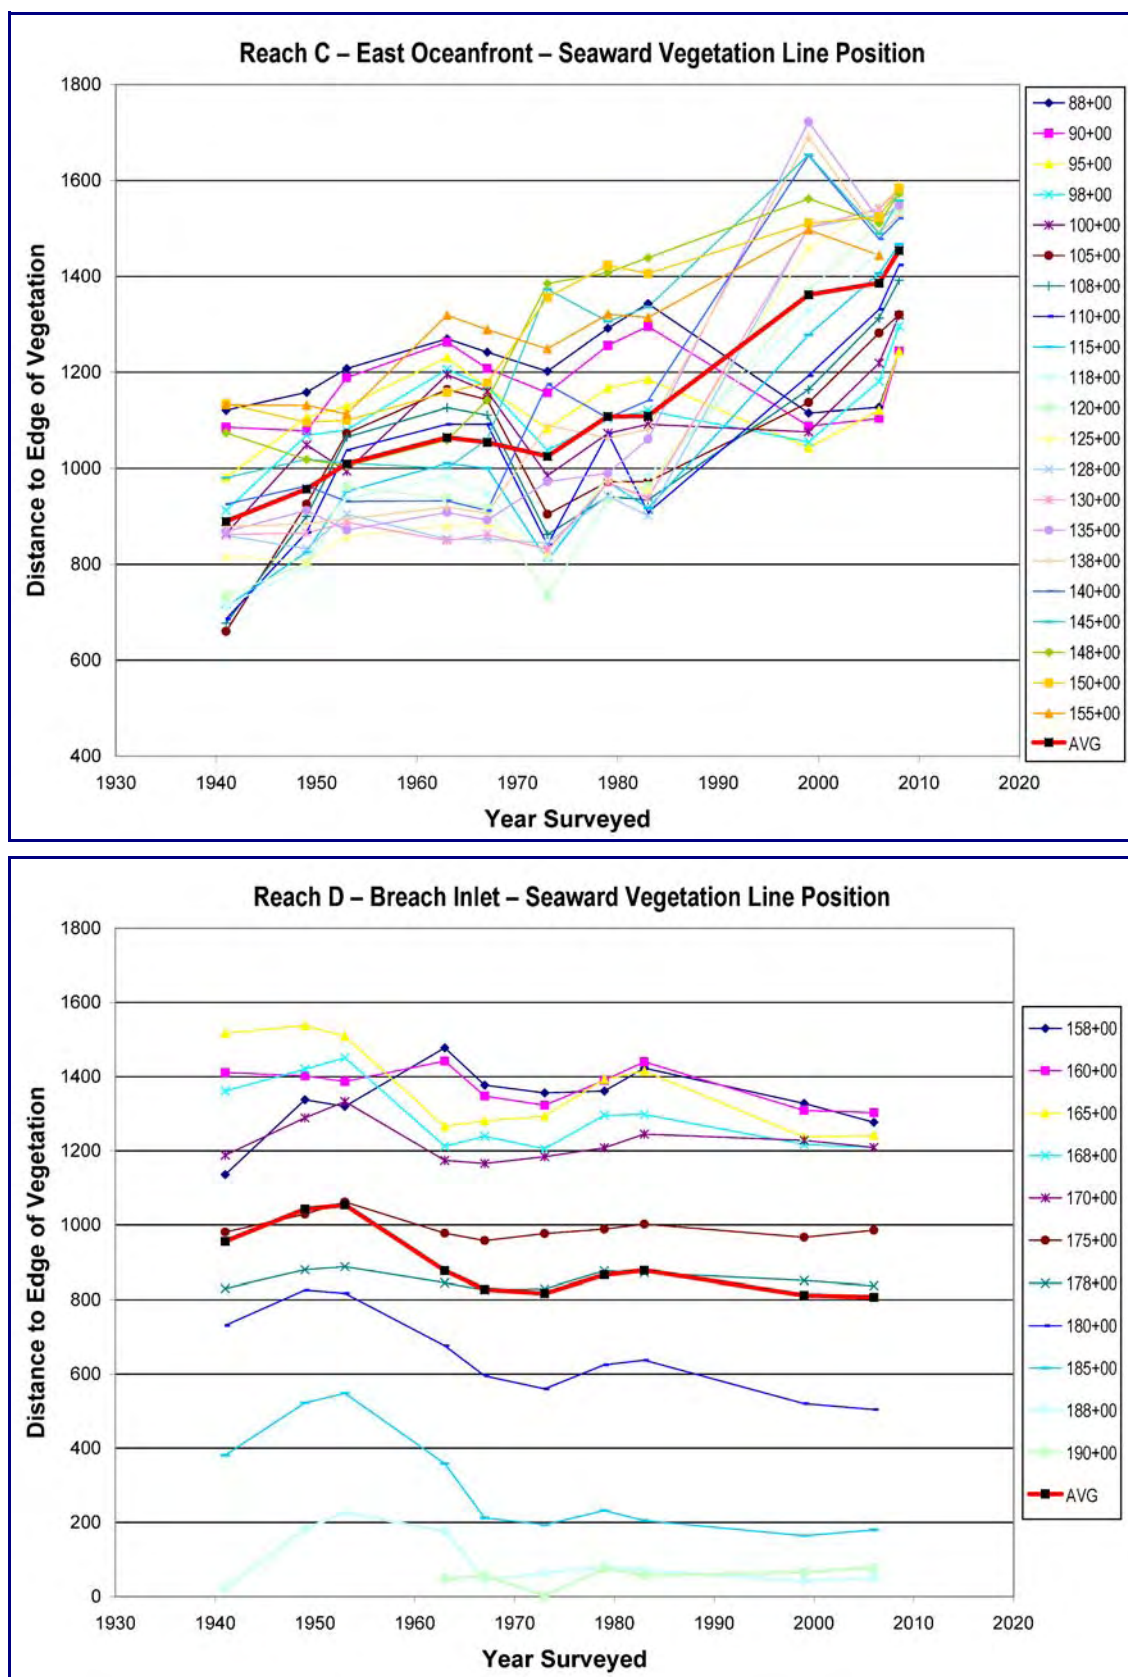
FIGURE 4.8. Trends in seaward vegetation line position by reach for 1941–2008 (based on the data in Appendix 10).

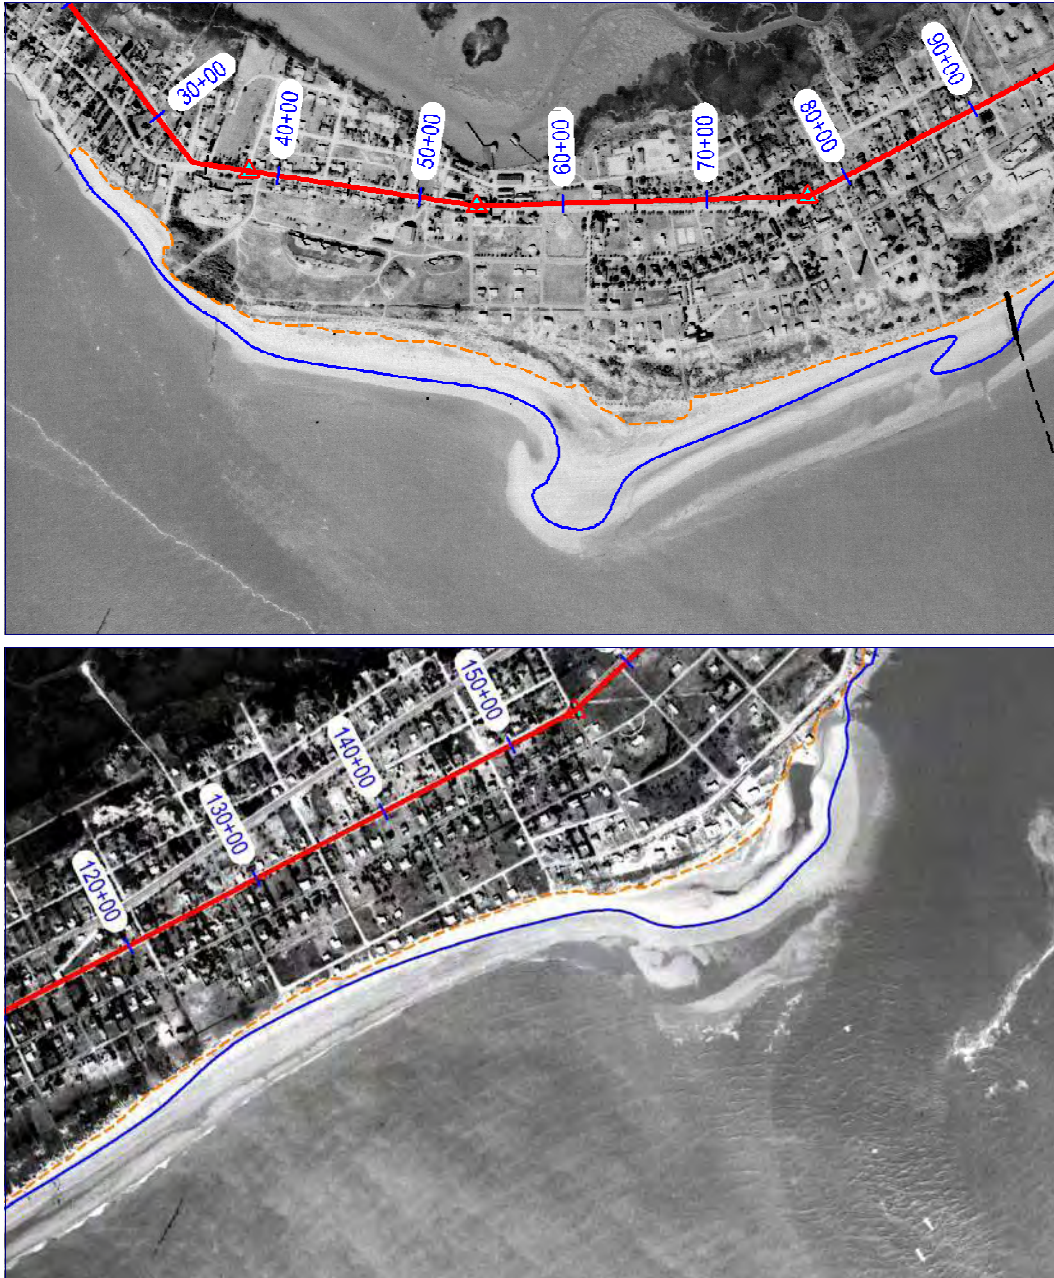
FIGURE 4.13. Sullivan's Island AL study area in 1963 (Reach B – upper, Reach C – lower). Note seaward buildup along with expanding patches of shrub vegetation (dark zones seaward of buildings).

By 1963, accretion along Reach B can be seen (Fig 4.2 and Fig 4.13). Maritime foredune grassland has expanded ~1,000 ft from the seaward row of houses. Some maritime shrub growth on the inland edge of the AL area has developed and appears as dark blotches on the aerial photograph. The shoreline bulge at Breach Inlet has also continued to grow, as has residential development following that growth. The seaward row of residential homes was established in both areas by 1963. Seaward of the homes, ~250 ft of dune grassland appear to have been established at the Breach Inlet bulge (Reach C).

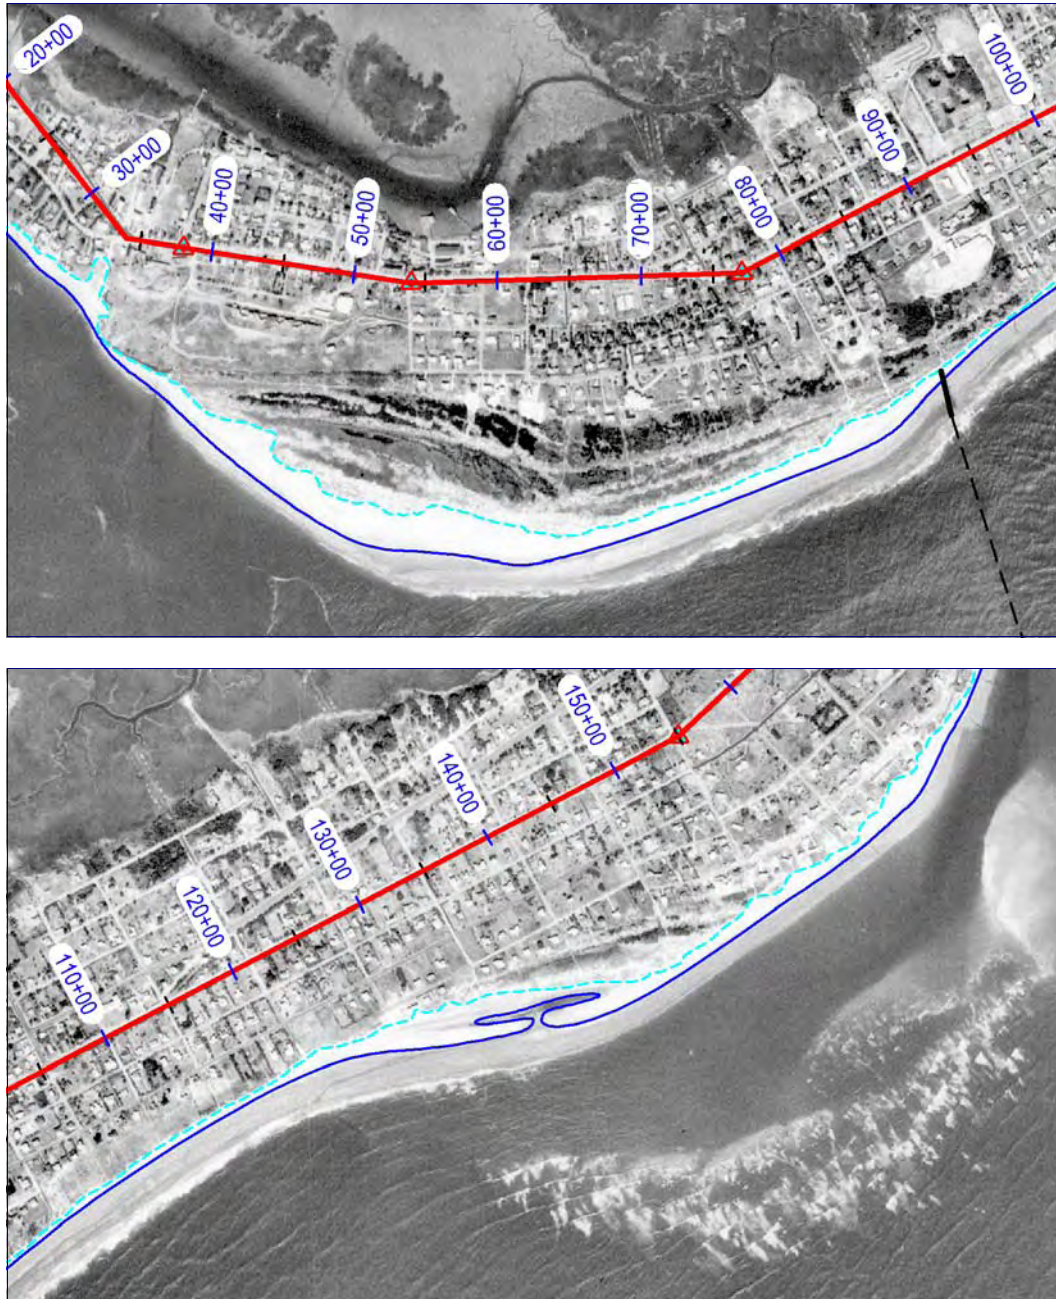
FIGURE 4.14. Sullivan's Island AL study area in 1973. Note greatly expanded areas of shrub vegetation in Reach B (upper panel) compared with 1963 conditions (Fig 4.13).

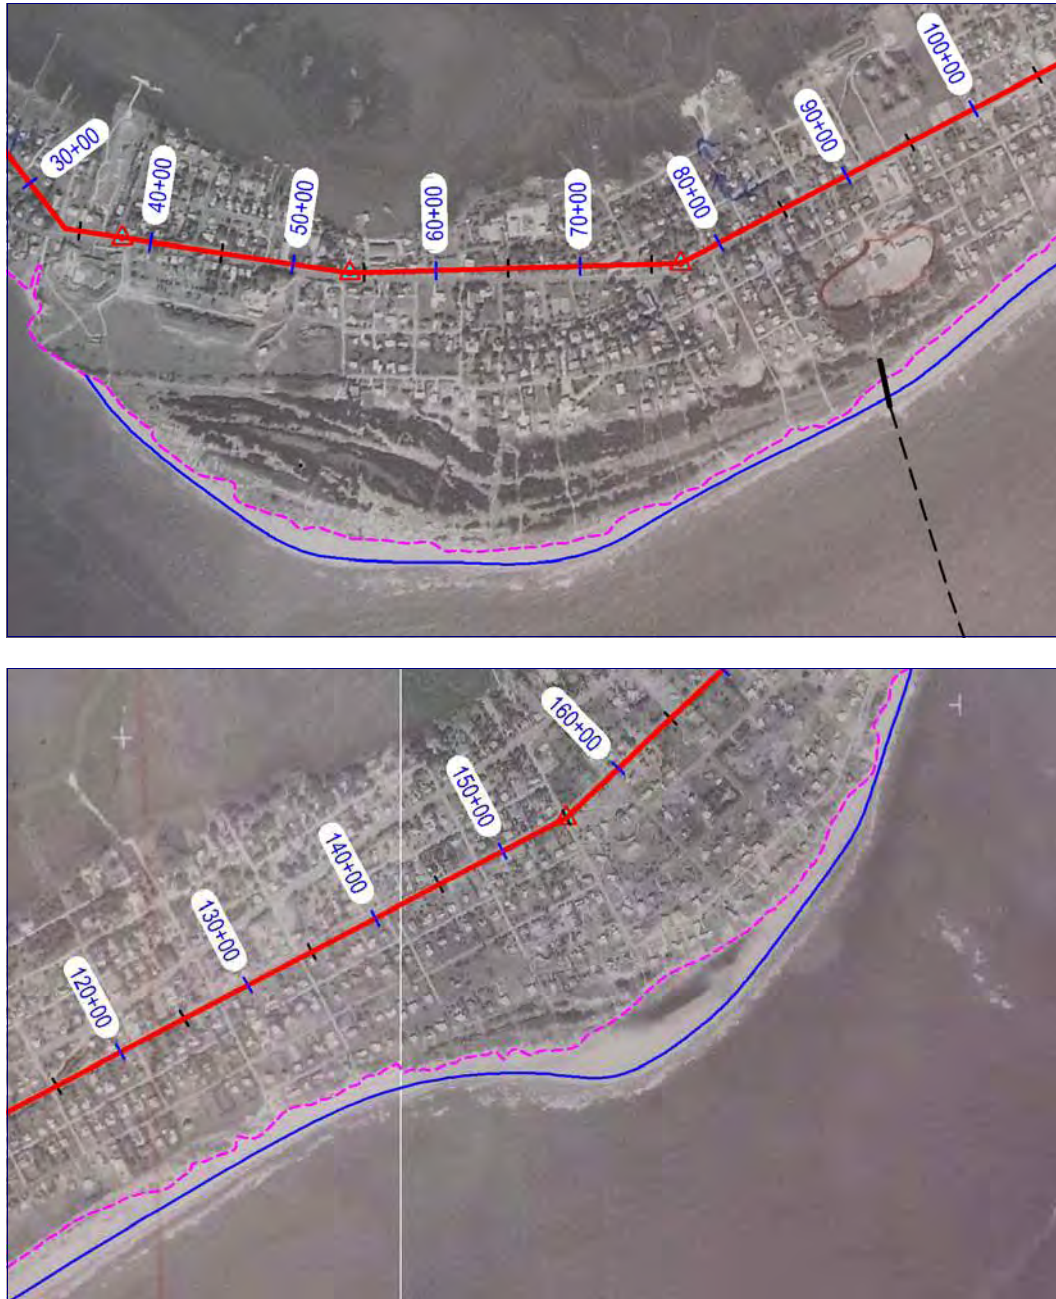
FIGURE 4.15. Sullivan's Island AL study area in **1983**. Note greatly expanded areas of shrub vegetation in Reach B (upper panel) compared with 1963 conditions (Fig 4.13).

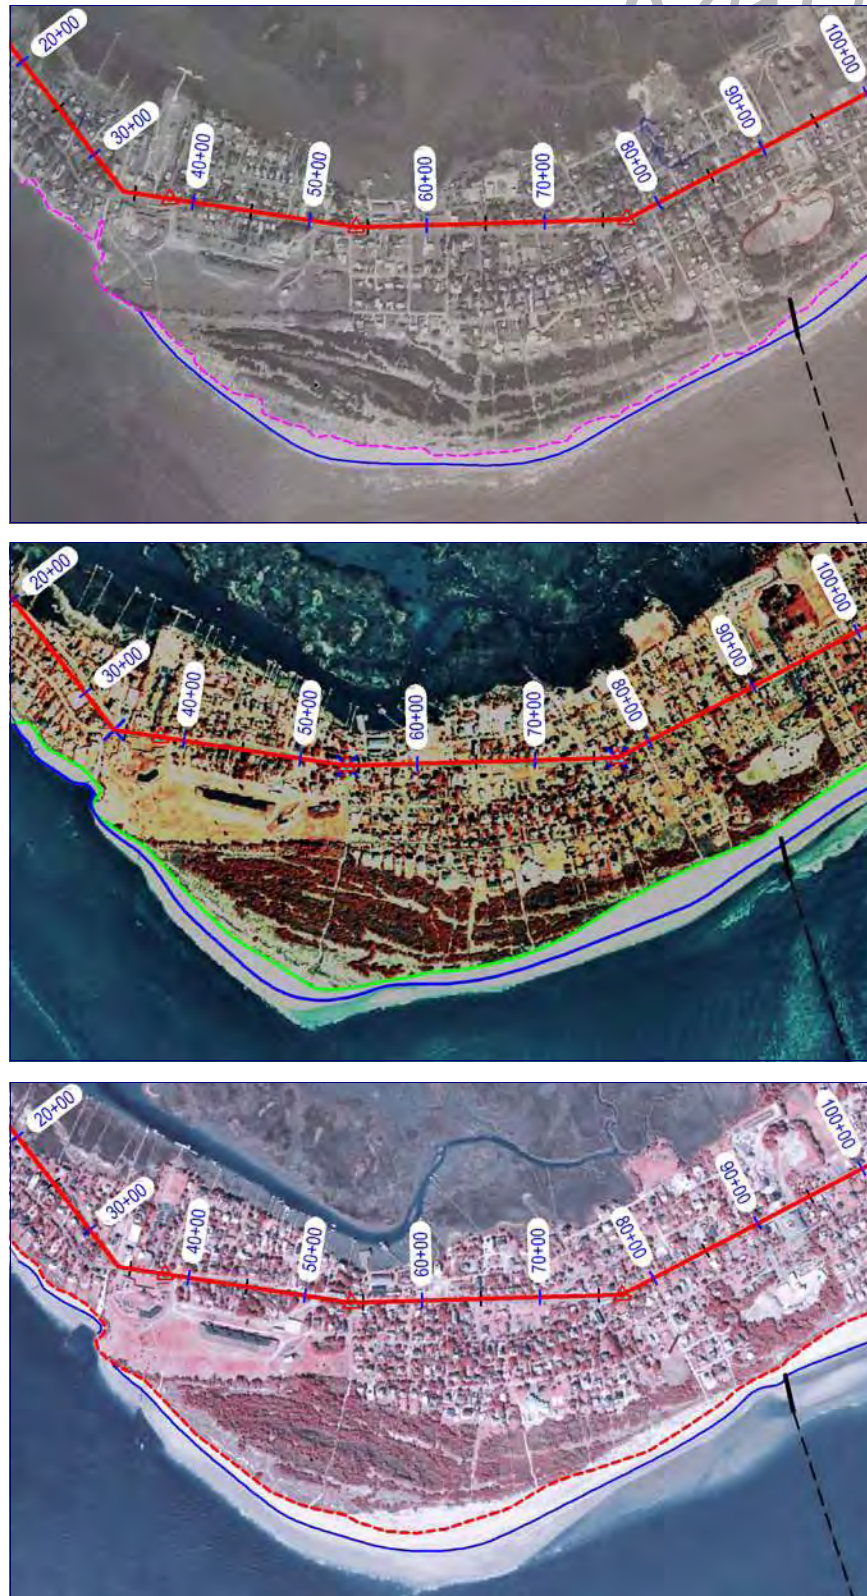
FIGURE 4.16. Reach B in 1983, 1999, and 2006 (top to bottom) showing the increased density of shrub and forest vegetation.

Figures 4.16 and 4.17 show portions of the 1983, 1999, and 2006 aerial photos for Reach B and Reach C (respectively). These images show how the Reach B shrub and forest community matured over two decades while the Reach C shrub and forest community was in a much earlier stage of succession.

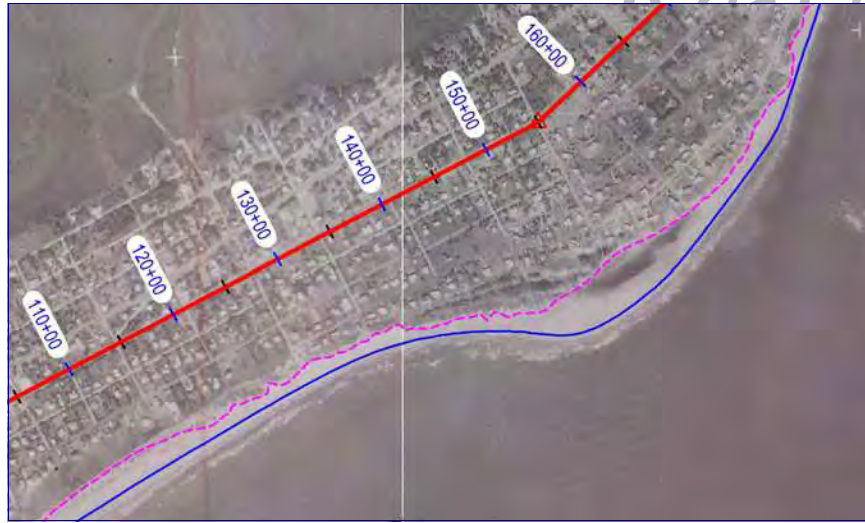
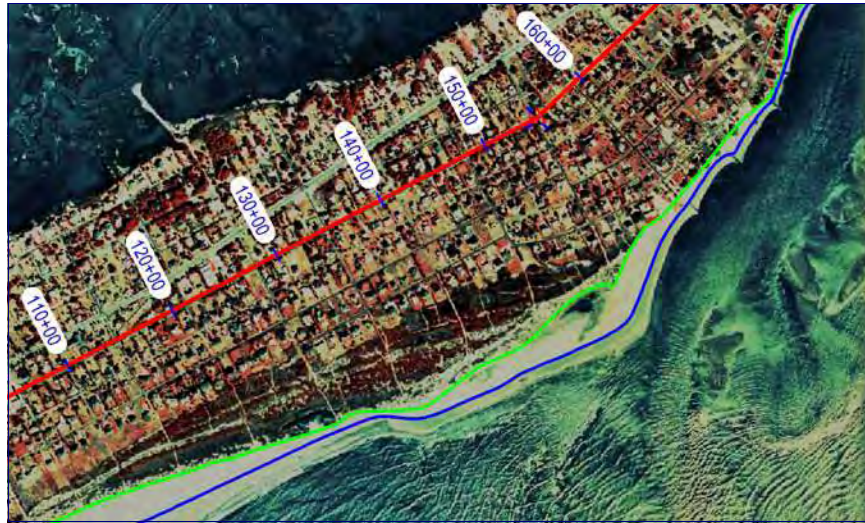
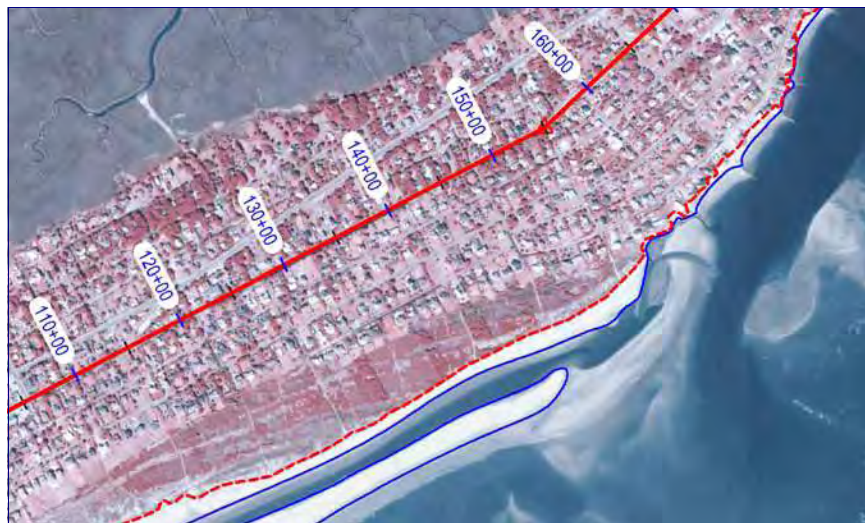
FIGURE 4.17. Reach C in 1983, 1999, and 2006 (top to bottom) showing incipient shrub and forest vegetation (1983) expanding greatly by 2006.

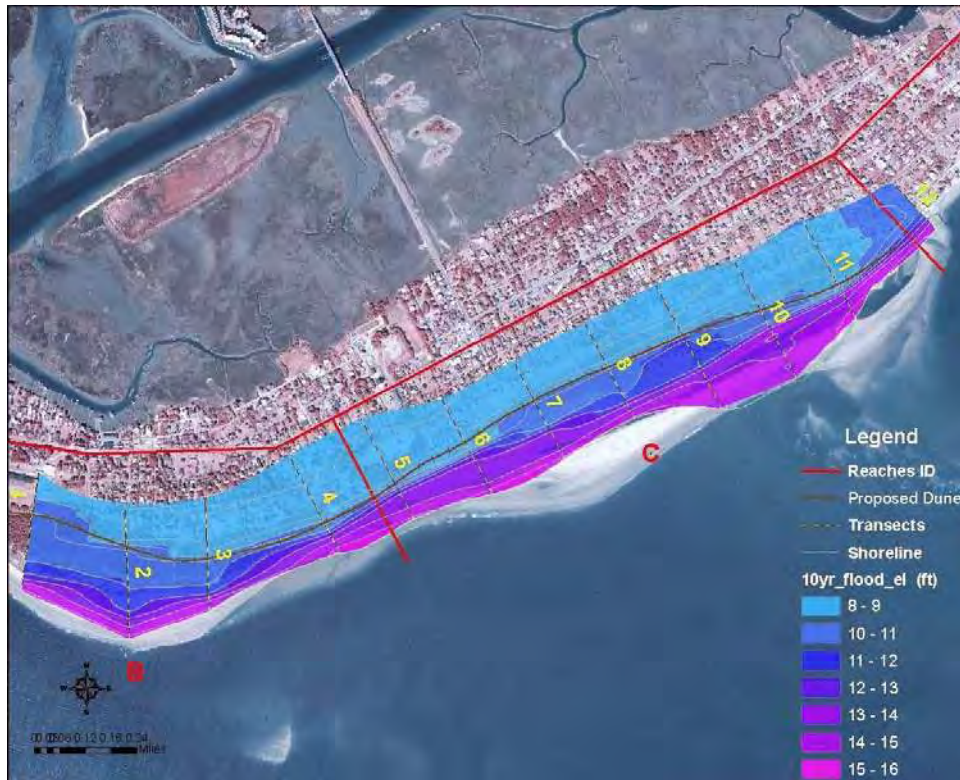
[UPPER] 10-year event [LOWER] 100-year event

FIGURE 5.10. Scenario 1 – total flooding depth. The distinct reduction in water levels along the interior half of the AL study area is the result of the presence of the dune ridge at ~14-ft NAVD assumed under this scenario.

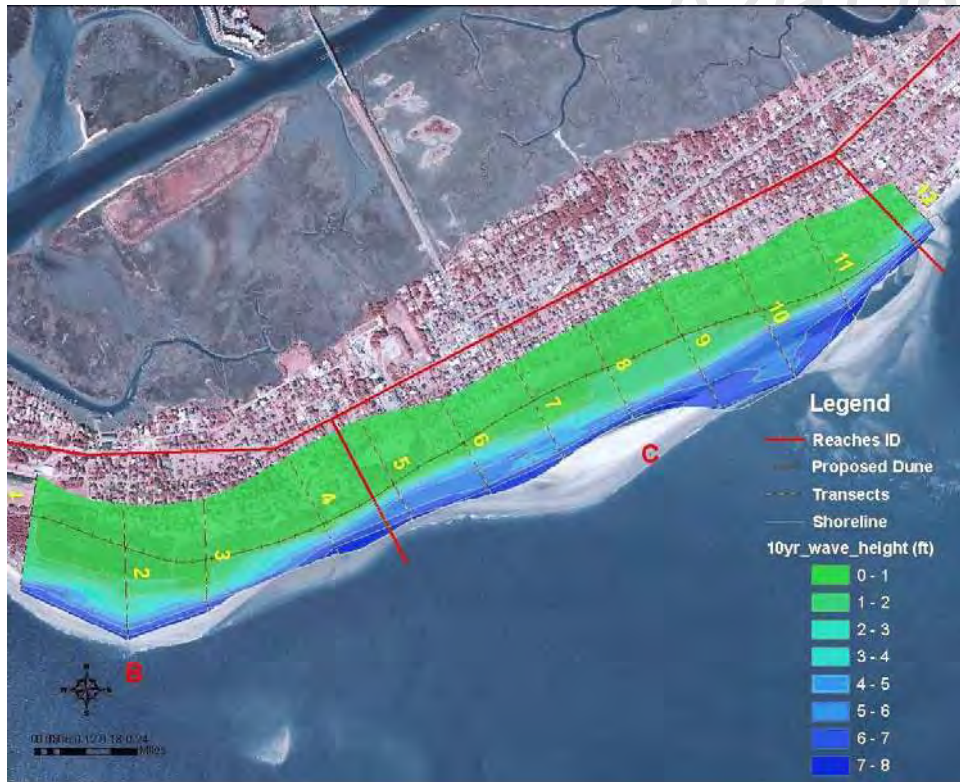
FIGURE 5.11. Scenario 1 – wave height surface.
 [UPPER] 10-year event [LOWER] 100-year event

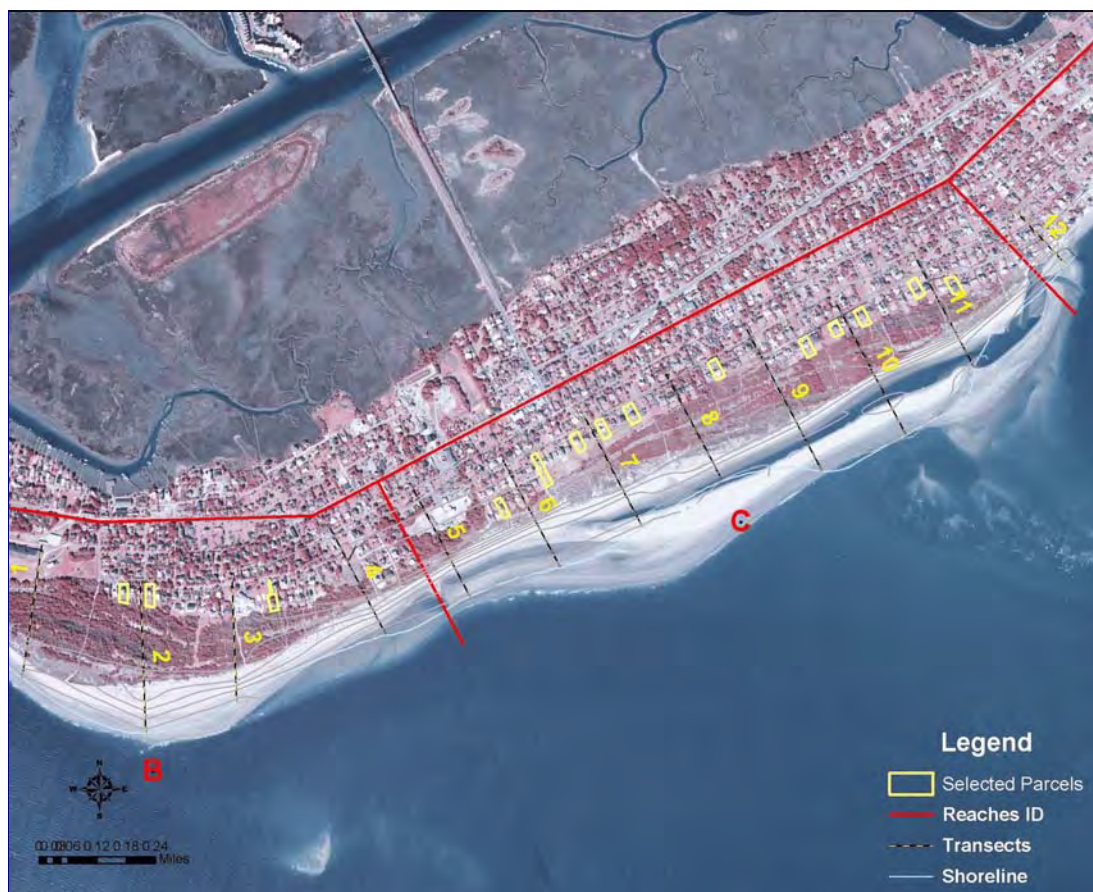
FIGURE 5.19. Representative parcels selected for the computation of structural damages for the Sullivan’s Island AL study area. Data for each parcel were extracted from official elevation certificates on file with the town of Sullivan’s Island.

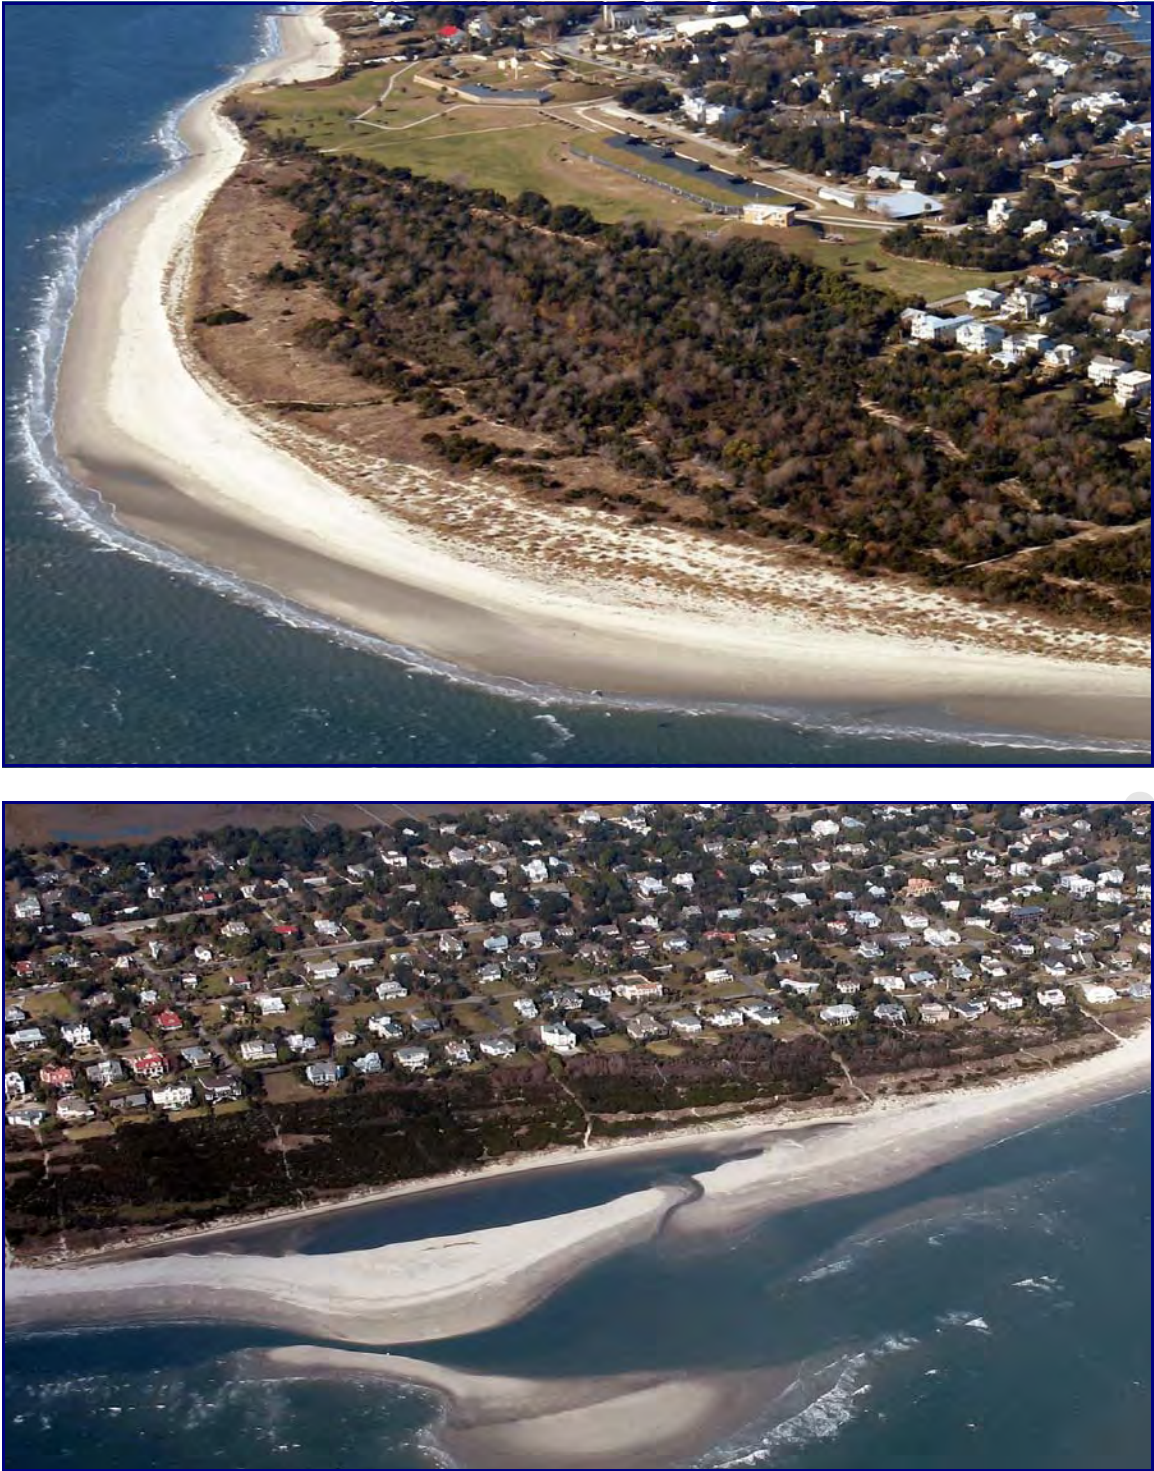
FIGURE 6.1. Typical vegetation cover in Reach B (west half of AL) and Reach C (east half of AL) in 2008.

The future transformation of the AL can be seen by visiting the east and west halves of the area (Fig 6.1). Land west of the Charleston jetty (referenced as Reach B herein) accreted rapidly between the 1940s and 1970s and is well established today. Its predominant vegetation is early maritime forest with a dense canopy of trees reaching more than 40 ft in height. By comparison, the eastern half of the AL (Reach C – east of the jetty) did not begin accreting rapidly until the 1970s. As a result of its younger age, vegetation tends to be dominated by shrubs and small trees reaching heights of the order 15–25 ft. Pruning along some sections of Reach C has maintained a shrub/tree height of the order 5–10 ft. If left to natural succession processes, Reach C will likely look much like Reach B two or three decades from now.
