Accreted Land Management Plan

Sullivan's Island, South Carolina

**ACCRETED LAND MANAGEMENT PLAN
Town of Sullivan's Island South Carolina**

[2253-ALMP]
JULY 2010

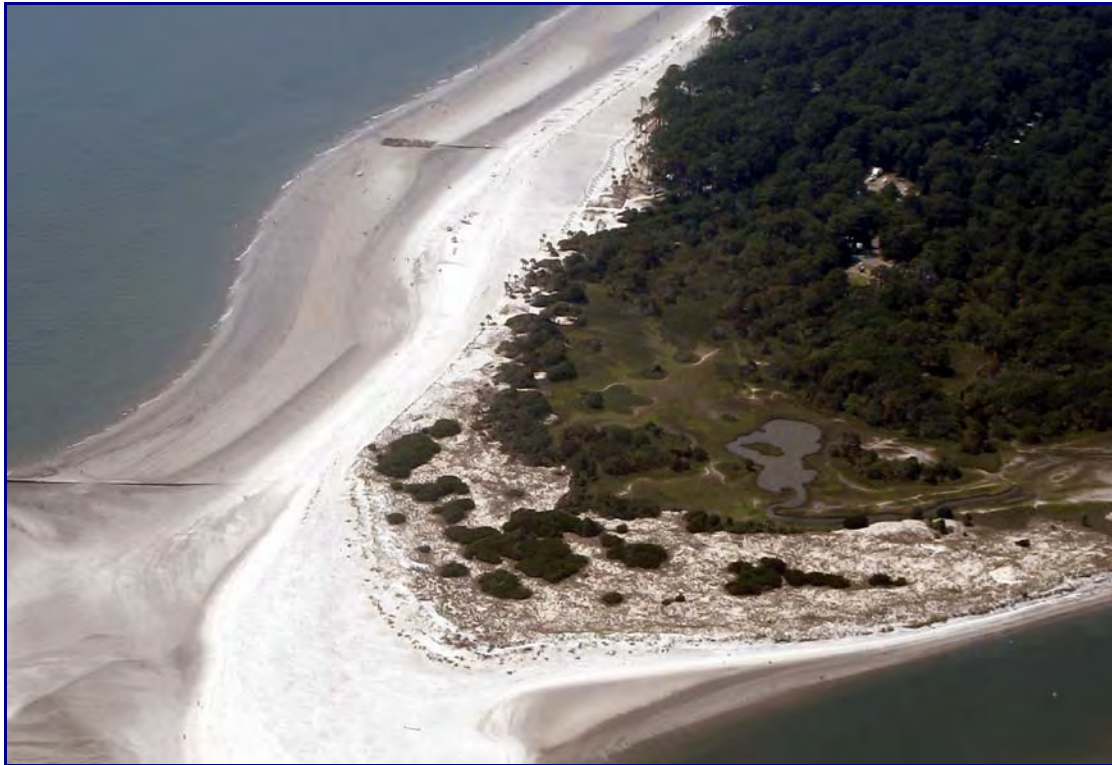
FIGURE 6.3. Example of accreted land exhibiting a variety of habitats in close proximity including forest hammocks, freshwater pond, and grassland habitat backed by mature maritime forest. (Hunting Island, SC – 31 May 2008 – Photo by TW Kana)

along the oceanfront with some degree of management. Figure 6.3 illustrates a diversity of habitats along an accreting spit at Hunting Island. This example includes open grassland habitat interspersed with shrub vegetation, an interior wetland and open-pond habitat, and early maritime forest. Compared with the forested beach ridges of Capers Island (see Fig 6.2), this portion of Hunting Island contains a greater diversity of habitats and, therefore, can attract and maintain a greater diversity of wildlife. The Hunting Island example also offers more visual interest to beach goers.

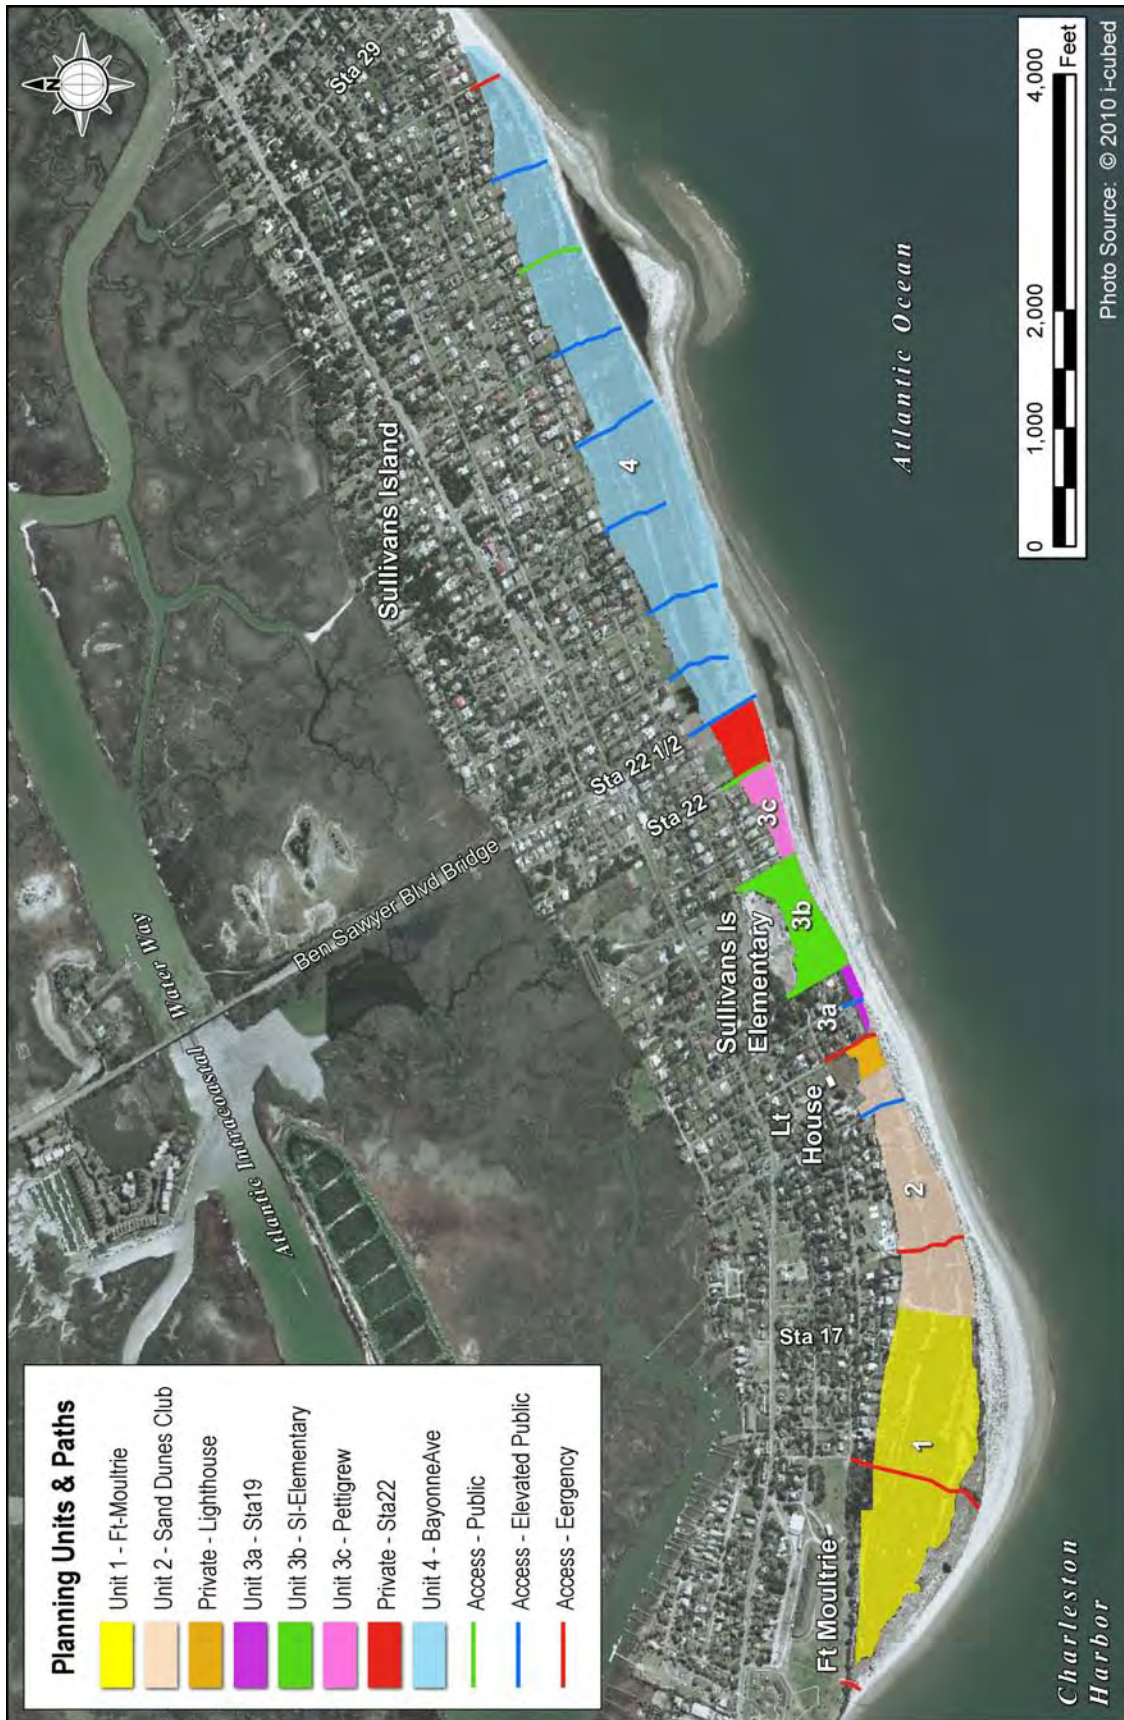
FIGURE 7.1. Four planning units as delineated within the AL. Grasslands immediately seaward of each colored boundary are an integral part of each unit, but are excluded in the area calculations and target area percentages because of uncertainties in the grassland boundary. Image is from March 2008.

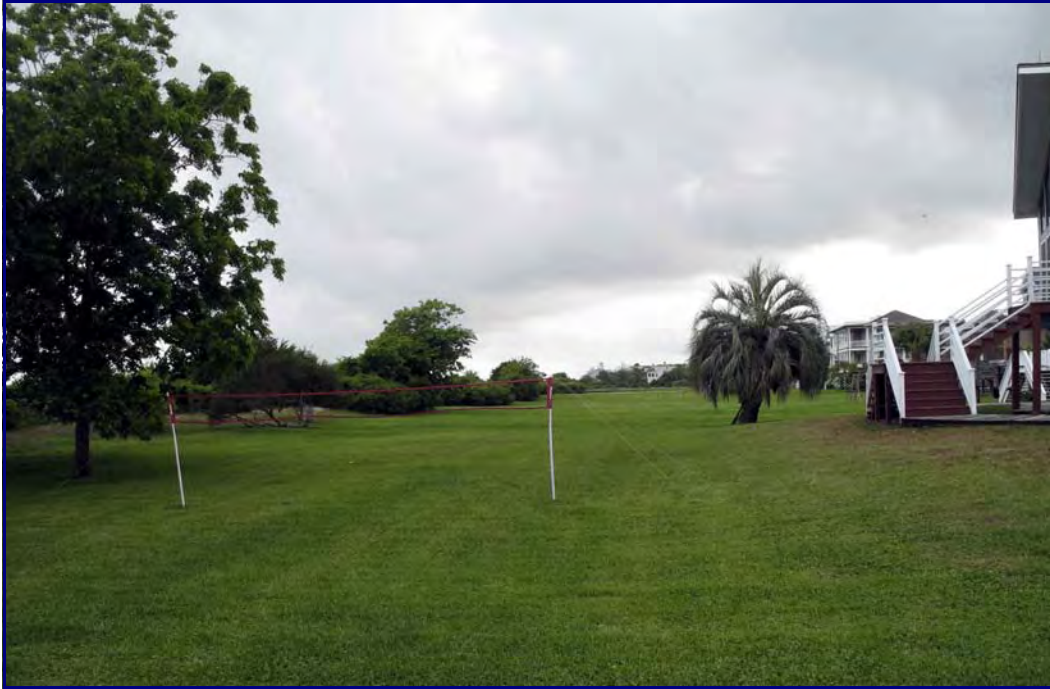
FIGURE 7.3. Managed lawns by property owners along portions of the Bayonne Avenue unit provide a buffer zone and fire break between development and the natural vegetation of the AL.

A portion of the Bayonne Unit within the buffer is currently being maintained by adjacent landowners as lawn, specifically, between stations 22 and 24 (Fig 7.3). In these areas, lawns will suffice in place of the buffer, as long as the 32-ft width is maintained.

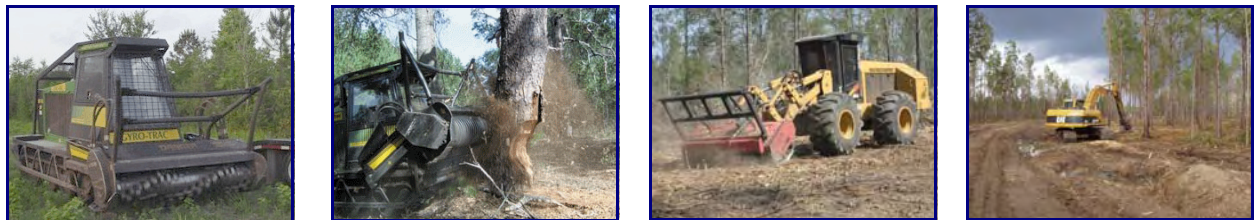
FIGURE 7.6. Mechanical equipment such as Gyro-Tracs®, Hydro-axes, and similar equipment would facilitate clearing of unwanted vegetation in the AL at possibly lower cost, but they are noisy and invasive.
