# TOWN OF SULLIVAN'S ISLAND, SC

Elko Coastal Consulting, Inc. | July 2017

# 2017 Beach Monitoring Survey: Town of Sullivan's Island, SC

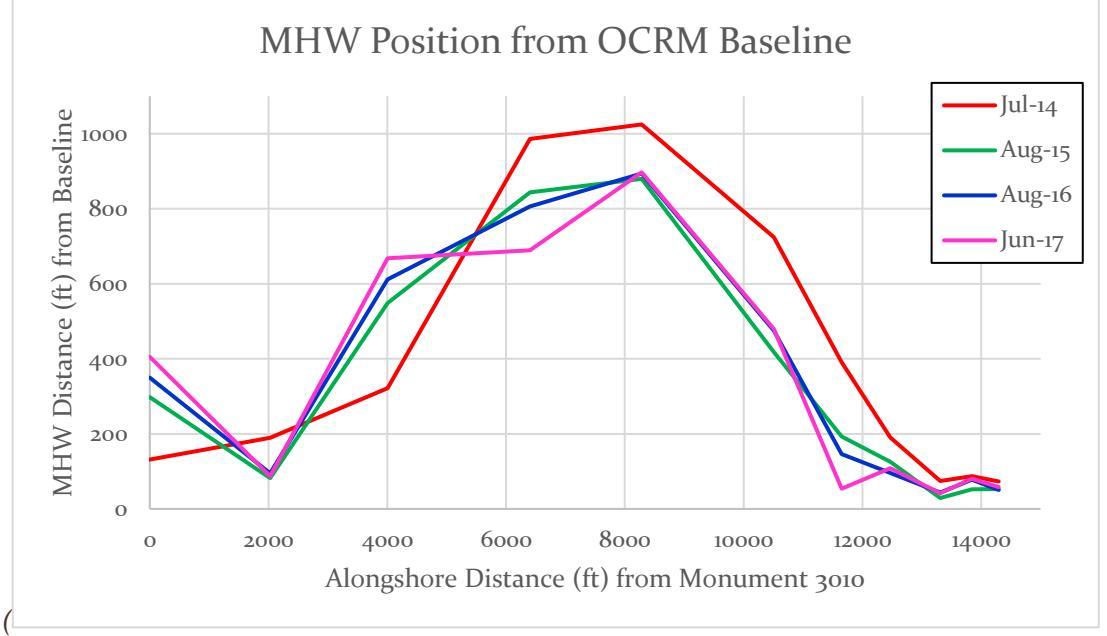
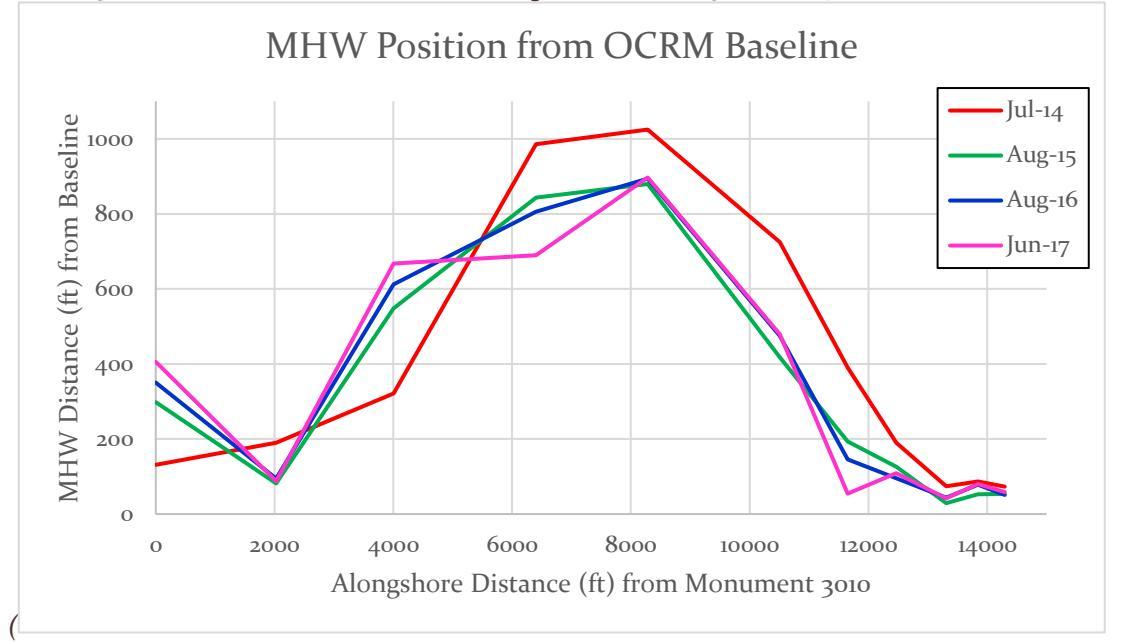
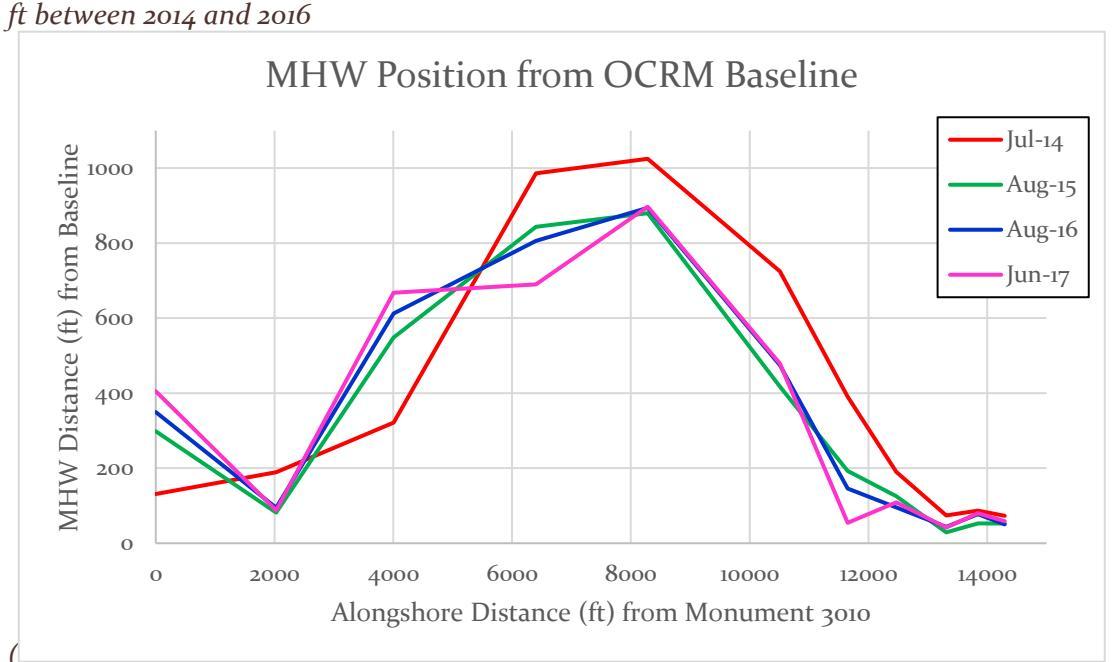
Figure 5) because it illustrates both the change in shoreline position from year to year, as well as the distance between the shoreline and baseline – an indicator of the level of storm damage protection provided by the beach/dune system at each monument.

During the study period, the Sullivan's Island shoreline changed dramatically between 2014 and 2015, but exhibited less shoreline change between 2015 and 2017

Figure 5). Several areas were flagged in the 2016 monitoring report and are discussed below. Two additional monuments are flagged in this 2017 monitoring report: 3050 and 3083 which have been eroding rapidly over the last four years.

The northeast end of the island, between Monuments 3090 and 3095 and adjacent to Breach Inlet, was flagged in last year's report. It is under continual erosional pressure due to the southwesterly migration of Breach Inlet, but has been stabilized by erosion control structures. Little shoreline change occurred along this northeastern end during the study period; however, the small distance between the shoreline and the OCRM baseline suggests erosional pressure and the need for continued monitoring. There is little storm damage protection at this location.

The shoreline between Station 31 and 22 (OCRM Monuments 3050 and 3085) was also flagged in last year's report because the shoreline position moved landward an average of 180

Figure 5). This dramatic shoreline retreat has stopped and shoreline positions have stabilized at most of the monuments in this section with two previously mentioned exceptions.

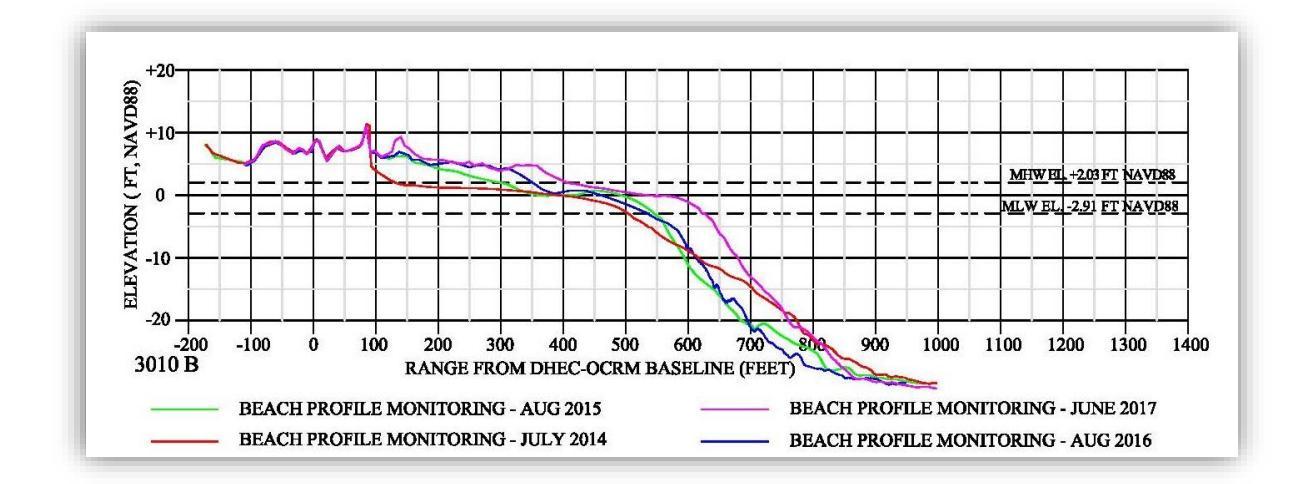
This is the southwesternmost OCRM Monument on Sullivan's Island, located along the long beach access path at Station 16 with the nature trail. In 2017, this access path was flooded with standing water. The beach is located on the Charleston Harbor side ("inside") of the jetty. Consistent with the measured beach profile data (Figure 7), the beach displayed some evidence of past erosion, but in June 2017, the beach exhibited accretionary, healthy conditions. The dry beach and the beachface have accreted sediment in the last year.

The elevation at the seaward end of the dune access path is low relative to the adjacent dunes, leaving a discontinuity in the dune system. According to the 2017 volume calculation, this profile has a unit volume of 851 cy/ft.

*Figure 7. Beach profile monitoring data from 2014-2017 in cross-section view at Monument 3010.*

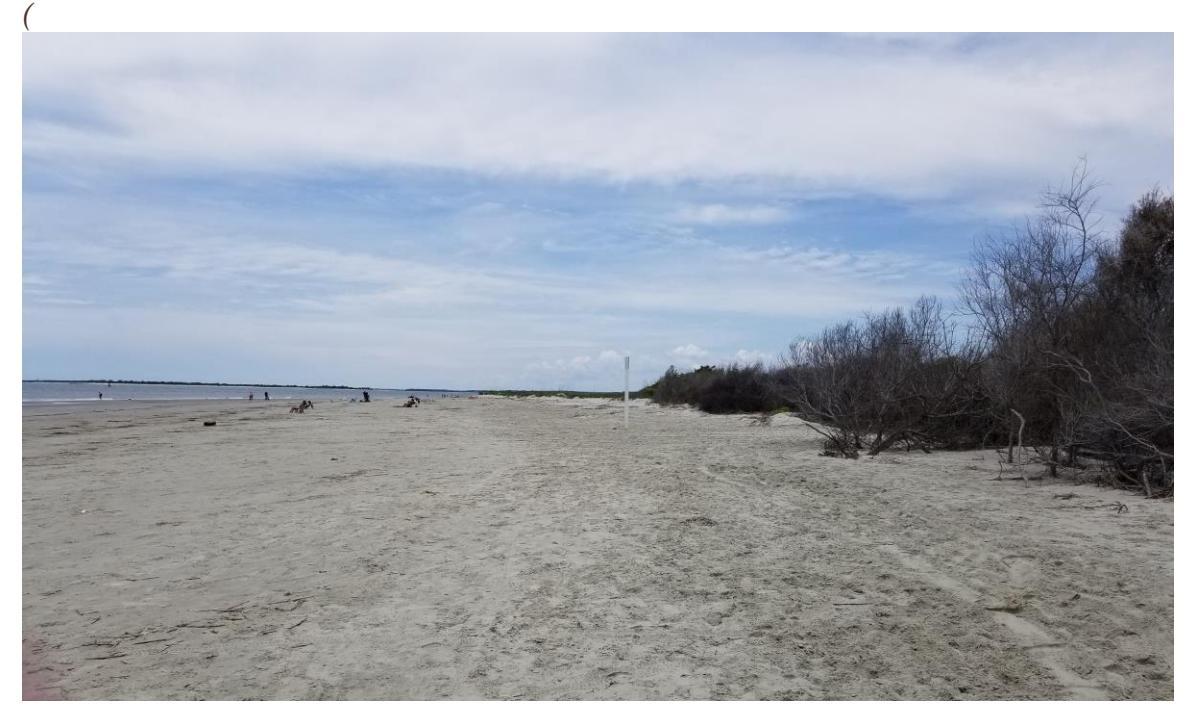
Hurricane Matthew was not solely responsible for the condition of the beach at this location. Significant erosion has taken place here since 2014 that included loss of a large dune and submerged nearshore sand body (Figure 10). Now, sediment in the offshore sandbar is accumulating and the bar is migrating onshore. A sand bar was attaching to the updrift beach (Figure 11) in 2017. Both may eventually supply sediment to this location. Considerable ongoing dune erosion was evident to the southwest in 2016, but some recovery was evident in 2017

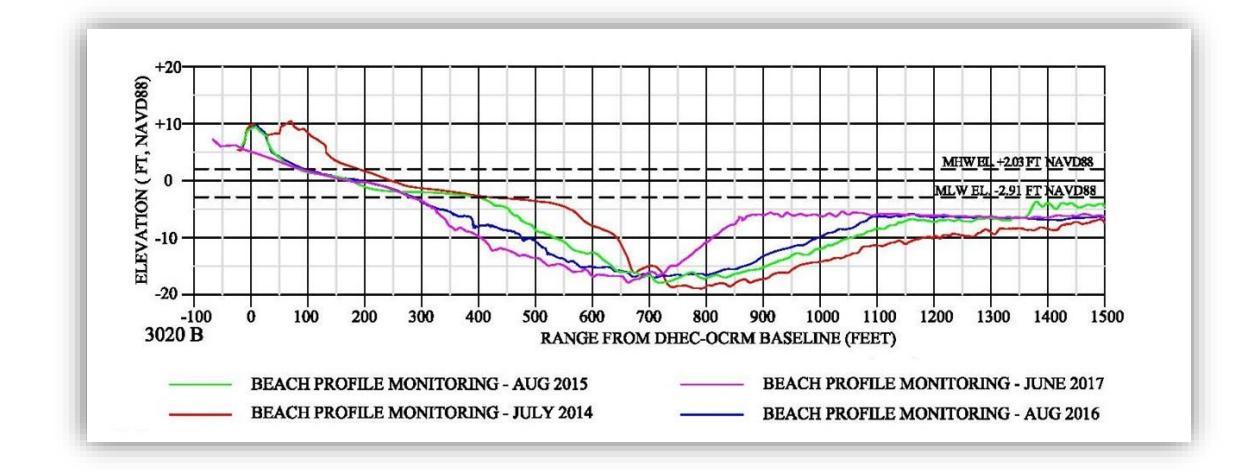
According to the 2017 volume calculation, this profile has a unit volume of only 236 cy/ft, which is in stark contrast to the surrounding accretional areas. This monument is influenced by its location downdrift of the Charleston Harbor jetty.

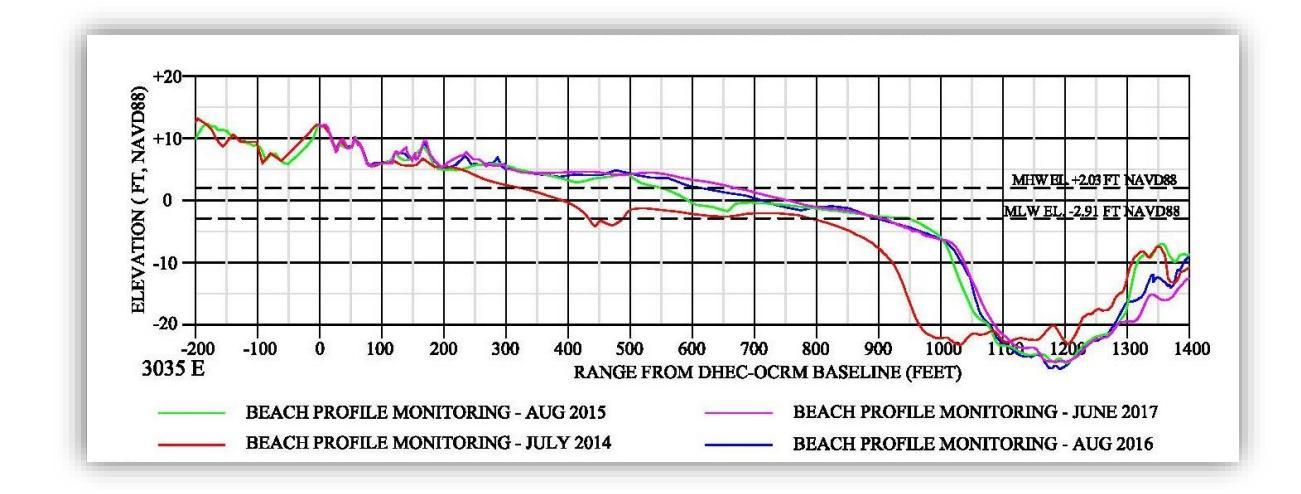
Monument 3035 is located along the long beach access path at Station 19. This area has been the beneficiary of the 2014 sandbar attachment event (Figure 13). The beach was wide and accreting in August 2016 and June 2017 with about 120 ft of dry beach between the vegetation line and the high tide line (Figure 14 and Figure 15). Continued accretion has occurred between 2016 and 2017 with the growth of the incipient dunes (Figure 15). Ponding was observed during both years in the backbeach (Figure 14), which is common on very wide, accreting beaches.

According to the 2017 volume calculation, this profile has a unit volume of 970 cy/ft. The beach profile at this monument is influenced by the sediment trapping effect of the Charleston Harbor jetty.

*Figure 13. Beach profile monitoring data from 2014-2017 in cross-section view at Monument 3035.*

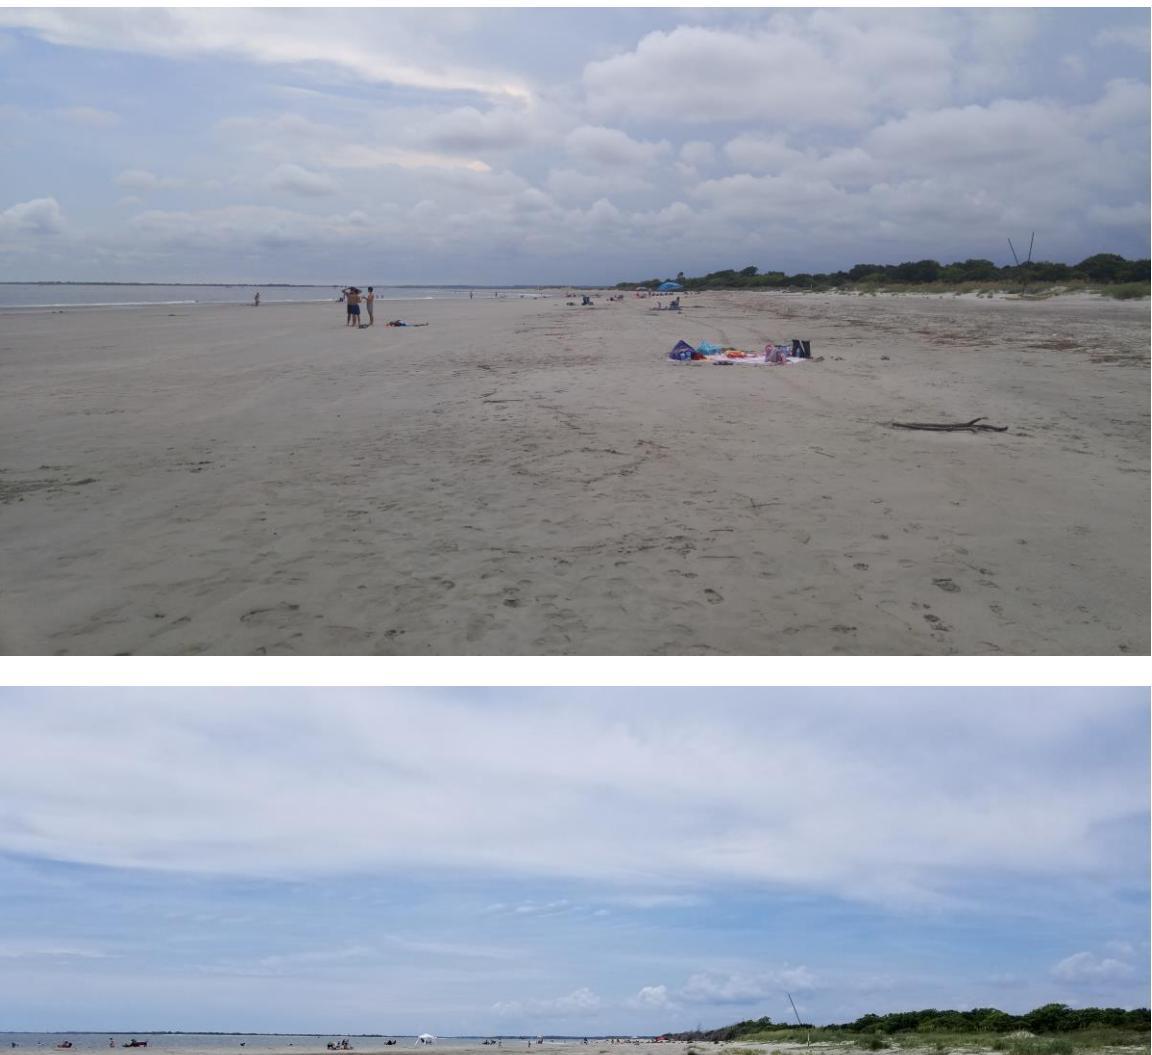
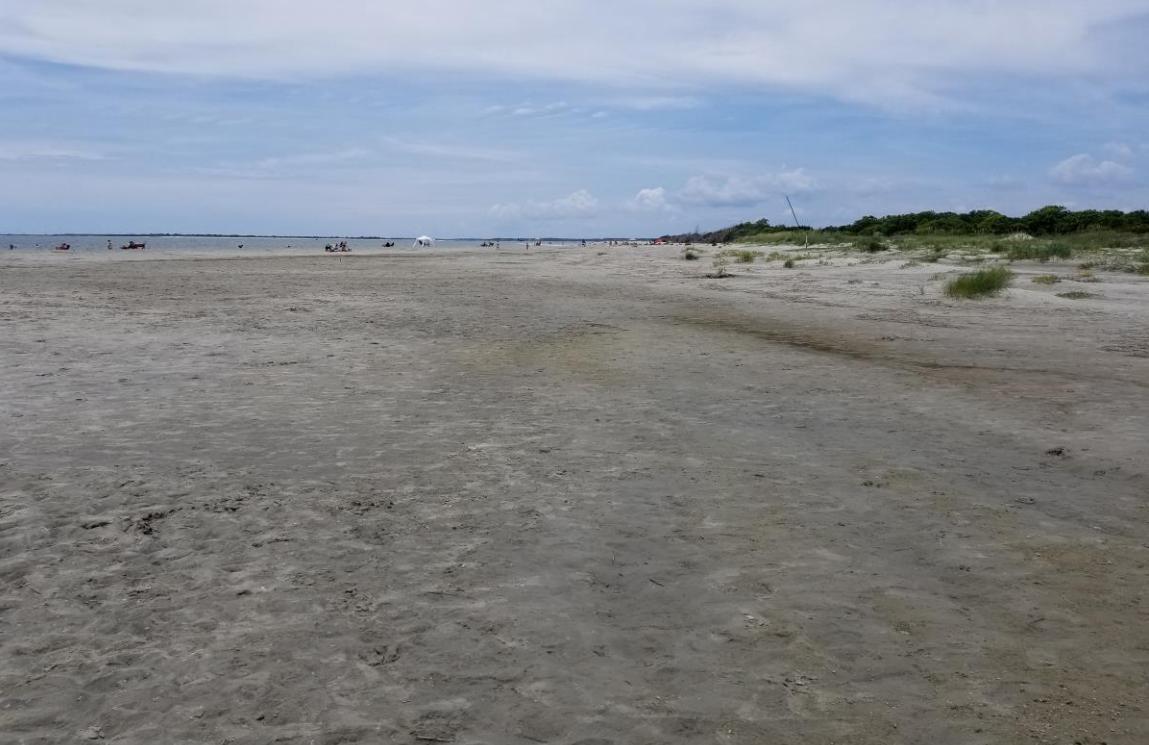
*Figure 15. Ground photo taken at Monument 3035 looking southwest on August 4, 2016 (top) and June 12, 2017 (bottom).*

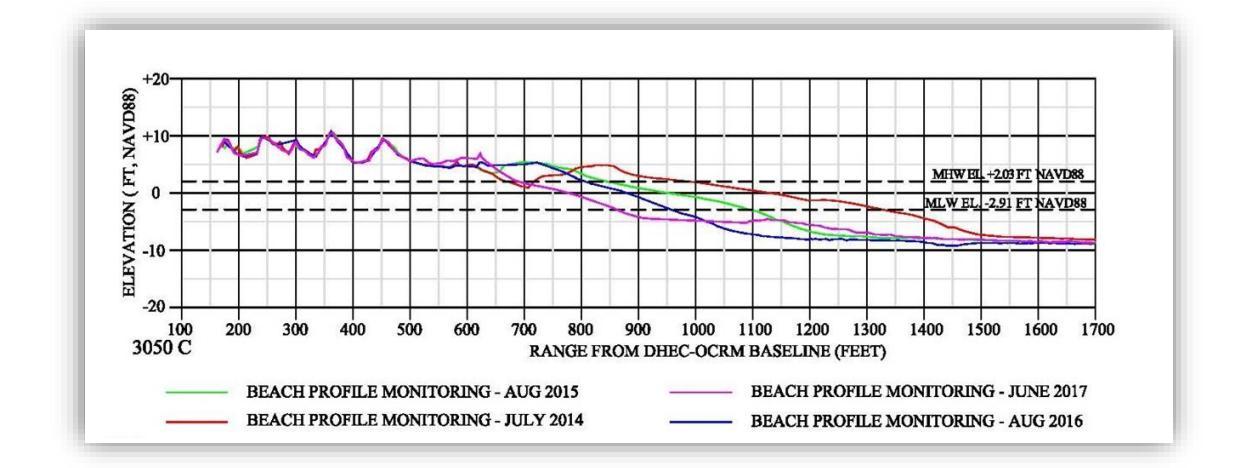
Monument 3050 is located along the long beach access path at Station 22 in the center of the island. Beach profile data indicate the recent sand bar attachment event that occurred here in 2014 (Figure 16). Over the last four years, sediment from this attachment bar has welded to the shoreface and resulted in the 2017 beach which includes a higher primary dune and a slightly reduced berm width. In 2017, a substantial amount of accretion was evident along the berm and backbeach with evidence of multiple storm events (rack lines) intermixed with incipient dune formation.

The elevation at the seaward end of the dune access path is low relative to the adjacent dunes, leaving a discontinuity in the dune system. According to the 2016 volume calculation, this profile has a unit volume of 400 cy/ft. The beach profile at this monument benefits from its location updrift of the Charleston Harbor jetty and indications are that accretion will continue.

*Figure 16. Beach profile monitoring data from 2014-2017 in cross-section view at Monument 3050.*

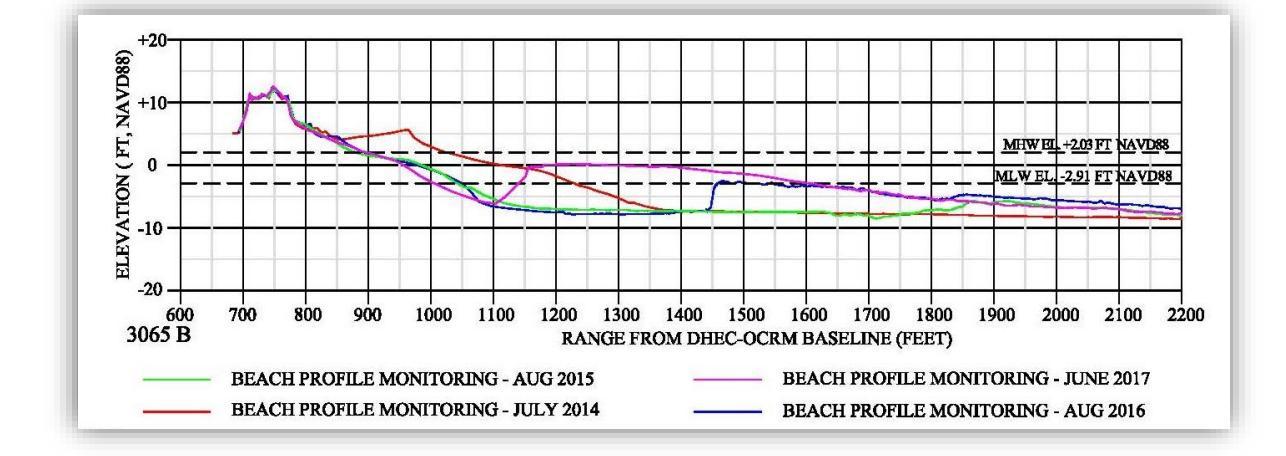
This is the sandbar attachment point. In June 2017, another sandbar was attaching to the beach profile. Prior to the attachment of this sandbar, past beach profile data indicated substantial beachface erosion following the 2014 attachment event (Figure 19). In 2017, incipient dunes were forming and accretional conditions were dominant. The recent storm rack line was 15 ft from the toe of vegetation with some evidence of previous dune erosion. The dry beach is 50 ft wide at high tide. exhibits a wide, gently sloping low tide terrace and a robust dune system (Figure 20 and Figure 21).

The elevation at the seaward end of the dune access path is low relative to the adjacent dunes, leaving a discontinuity in the dune system. According to the 2017 volume calculation, this profile has a unit volume of 275 cy/ft.

*Figure 19. Beach profile monitoring data from 2014-2017 in cross-section view at Monument 3065.*

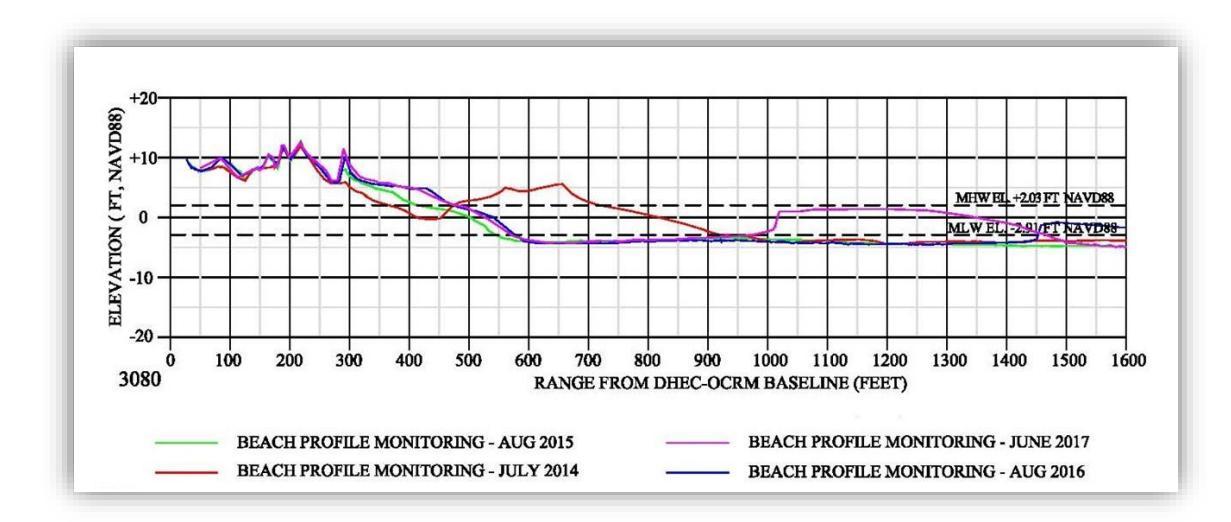
Beach profile data indicate a sand bar attachment event in 2014 (Figure 22). The sand bar was farther offshore at this location than at profile 3065 in 2017. The beach at this location displayed classic signs of accretion with no dune erosion in 2016 and 2017 (Figure 23 and Figure 24). The high tide dry beach is 75 ft wide and the dune vegetation is healthy and flourishing. Backbeach ponding was no longer present in 2017.

According to the 2017 volume calculation, this profile has a unit volume of 333 cy/ft.

*Figure 22. Beach profile monitoring data from 2014-2017 in cross-section view at Monument 3080.*

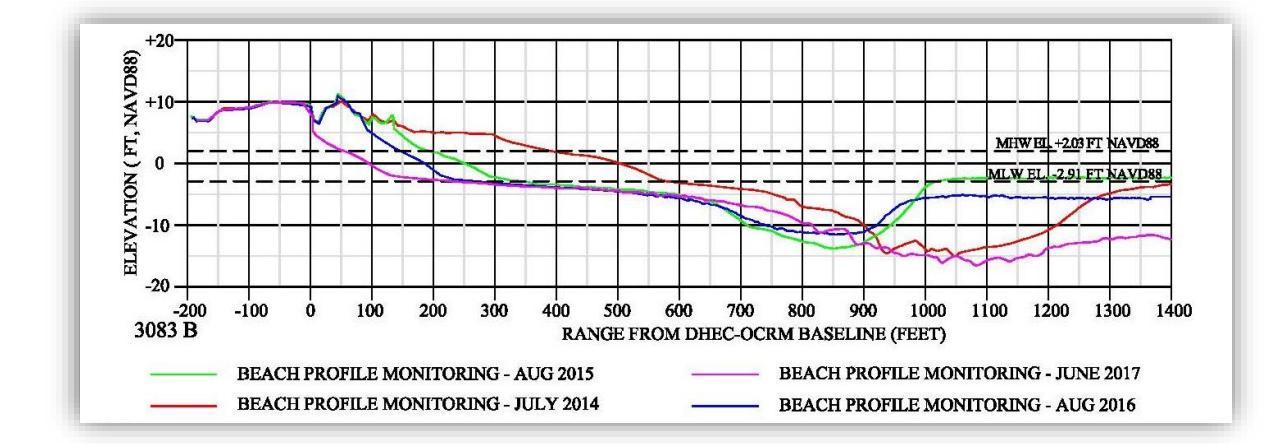
Monument 3083 is located near Station 28 ½. This area of the island has experienced considerable erosion since the last sand bar attachment event in 2014 (Figure 25), including the loss of three rows of low sand dunes. This is the typical beach response after a sand bar attachment event, as the sand migrates downdrift. Interestingly, the sand bar that attached to the shoreface just to the southwest did not benefit this beach profile. Some of the sand may spread to this location over the next year. This profile will be closely monitored.

According to the 2017 volume calculation, this profile has a unit volume of 226 cy/ft.

*Figure 25. Beach profile monitoring data from 2014-2017 in cross-section view at Monument 3083.*

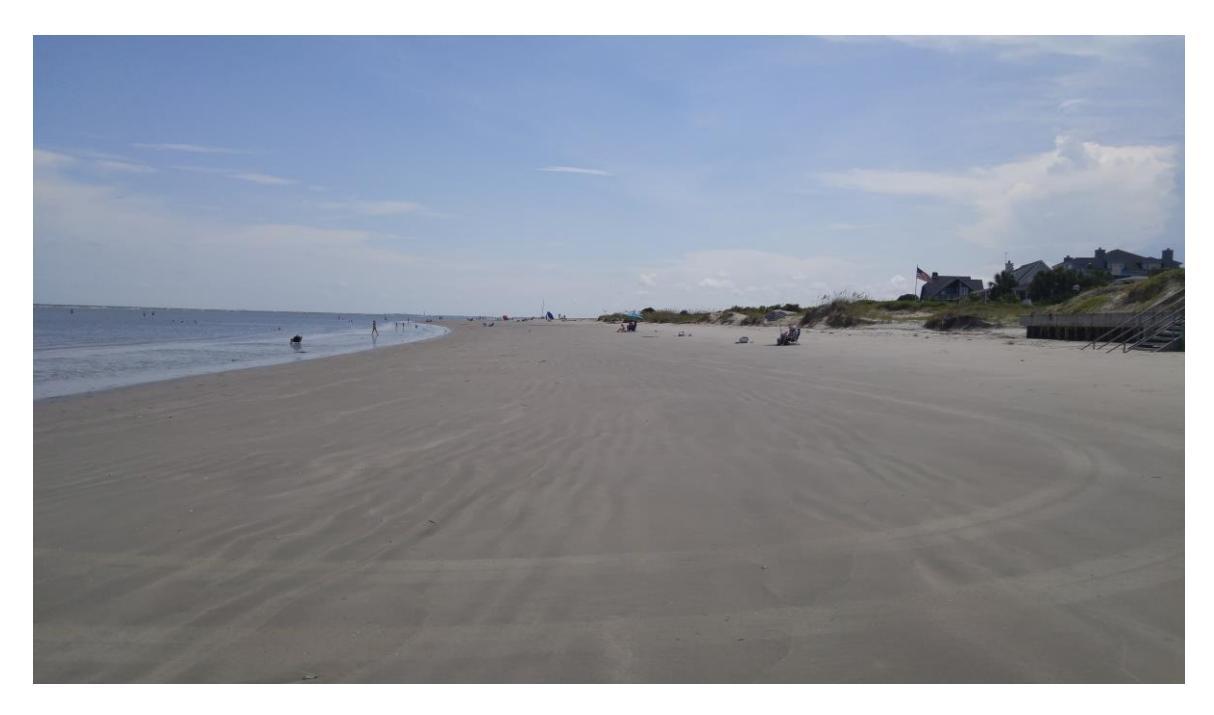
This location marks the transition between the northeast end of the island, which has been stabilized with erosion control structures (Figure 26) and the wide, fluctuating beach of the central portion of the island to the southwest (Figure 27). There is little to no dry beach at high tide to the northeast

Figure 27. Ground photo taken at Monument 3083 looking southwest on August 4, 2016.

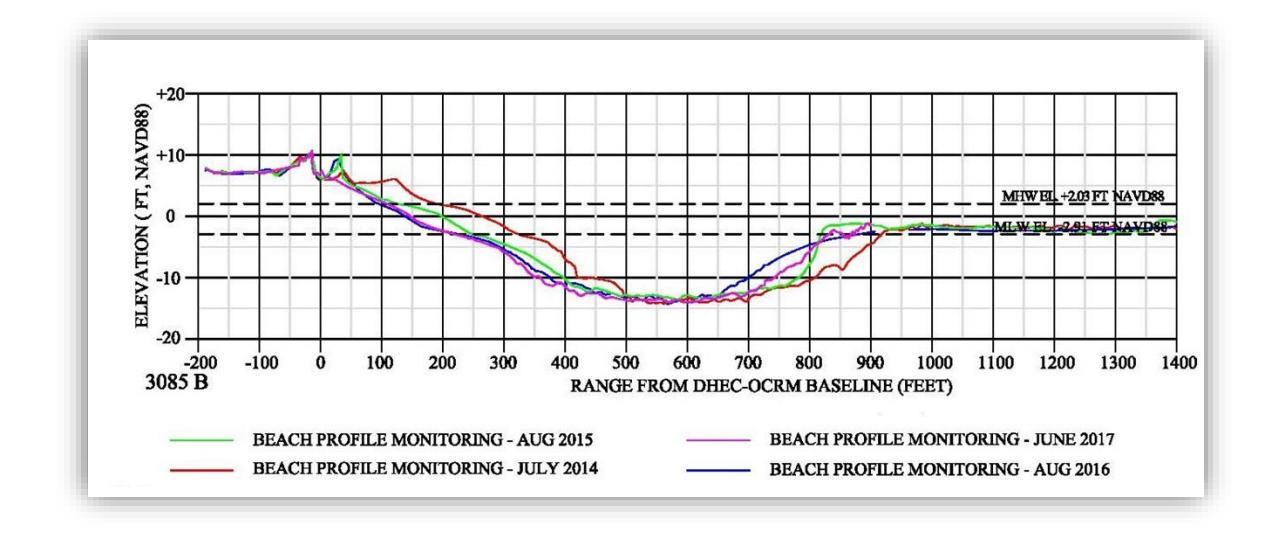
Monument 3085 is located near Station 29. This profile represents the southwest end of the groin field along northeastern Sullivan's Island. This area is influenced by both erosion control structures and the sand bar attachment events. Beach profile data indicates evidence of the 2014 sand bar attachment and the subsequent beachface erosion (Figure 28). In August 2016, another sandbar was forming and beginning to migrate onshore. By June 2017, this sand bar was subaerially exposed at high tide to the southwest.

This pocket beach between groins is stable to erosional. The high tide rack line was under the houses in 2017. No dunes are present in front of the houses. Despite the lack of dry beach at high tide, the structures appear to have stabilized this portion of the island (Figure 29 and Figure 30).

According to the 2017 volume calculation, this profile has a unit volume of 123 cy/ft.

*Figure 28. Beach profile monitoring data from 2014-2017 in cross-section view at Monument 3085.*

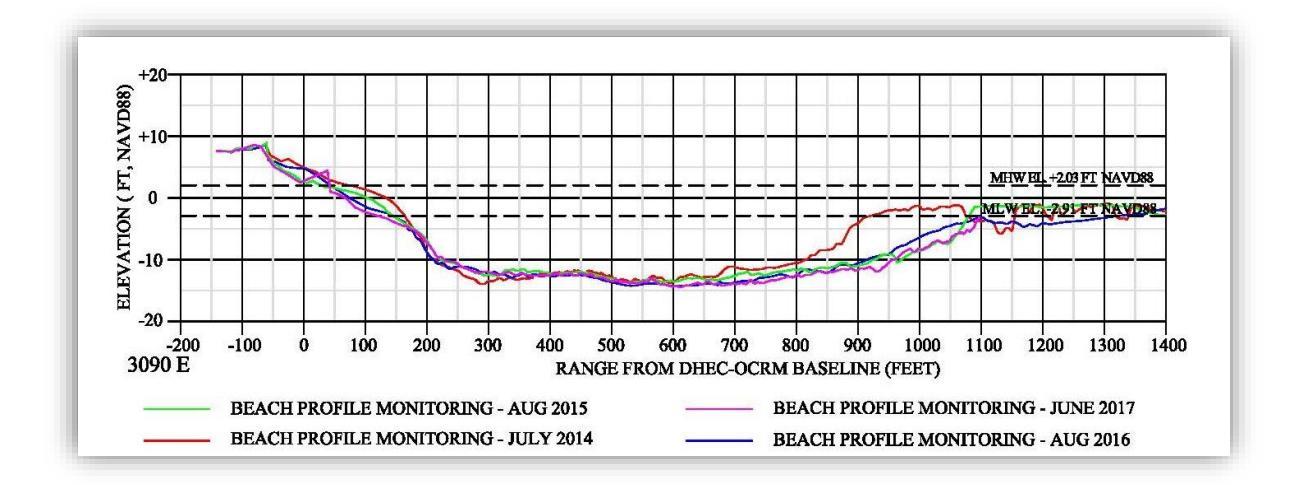
Monument 3092 is located south of Station 31 on northeastern Sullivan's Island near Breach Inlet. It represents a small (<250 ft long) pocket beach that has been stabilized between two groins. The beach profile has exhibited some change despite the stabilization structures (Figure 31). No dry beach is exposed at high tide and no dunes are present. The 2017 condition is the most eroded over the past four years of monitoring. The structures appear to have stabilized this portion of the beach (Figure 32 and Figure 33).

*Figure 31. Beach profile monitoring data from 2014-2017 in cross-section view at Monument 3090.*

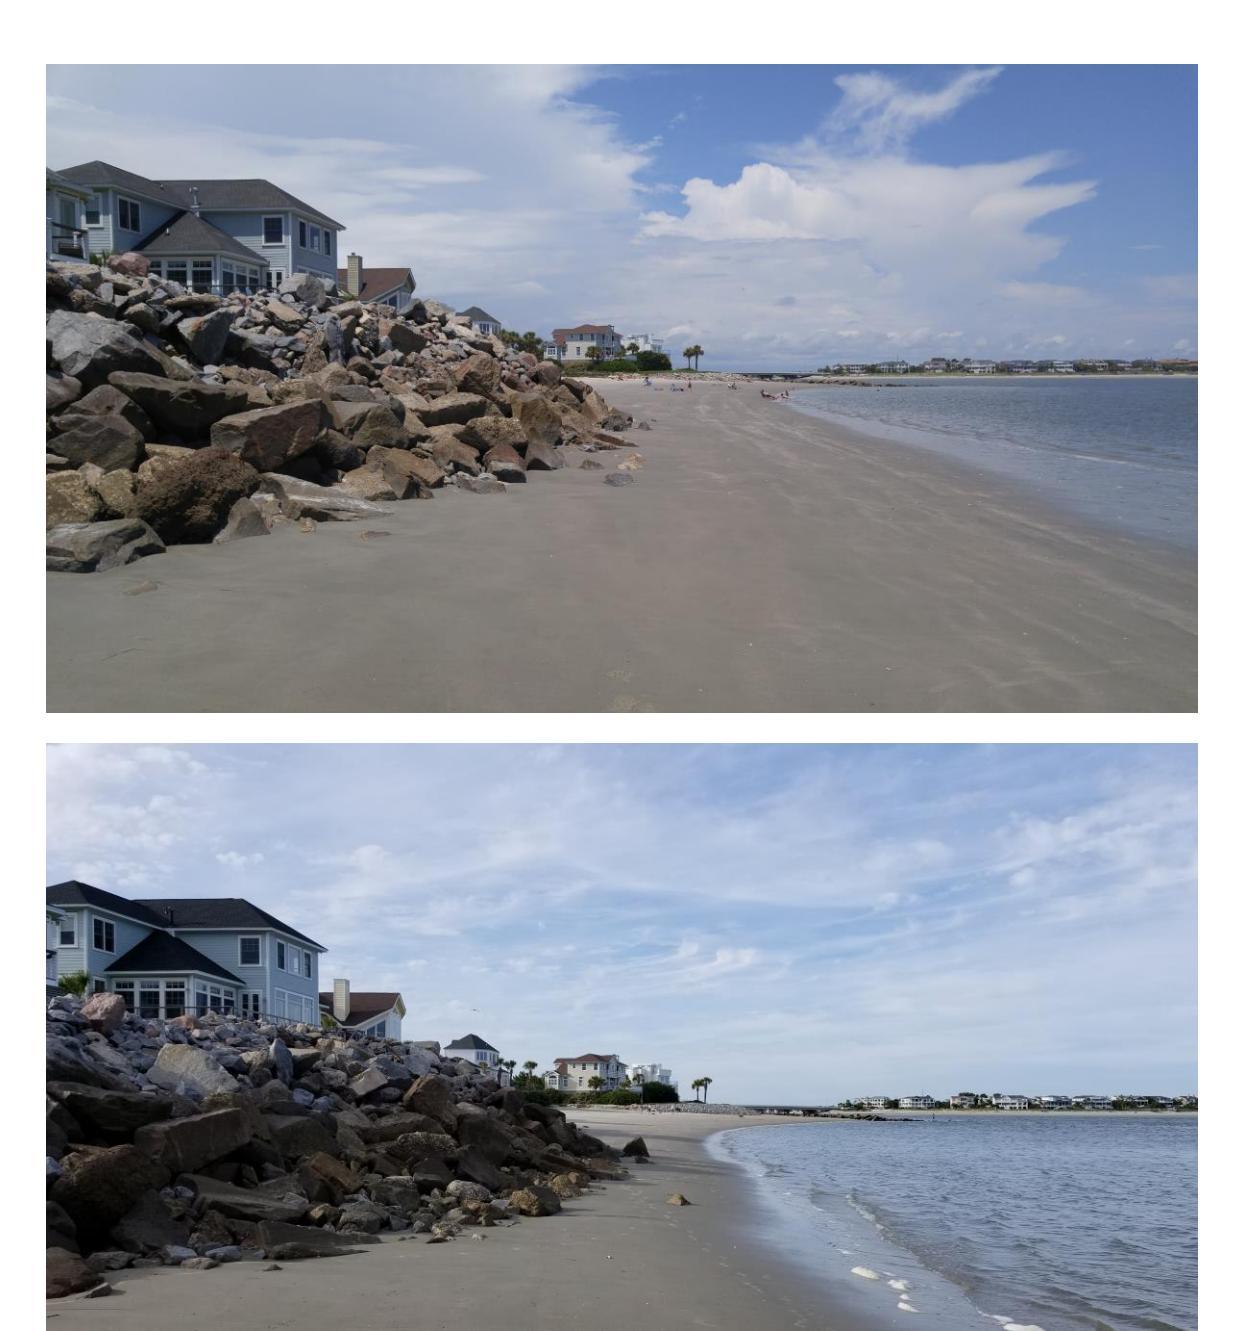
Figure 32. Ground photo taken at Monument 3090 looking north on August 4, 2016 (top) and June 12, 2017 (bottom).

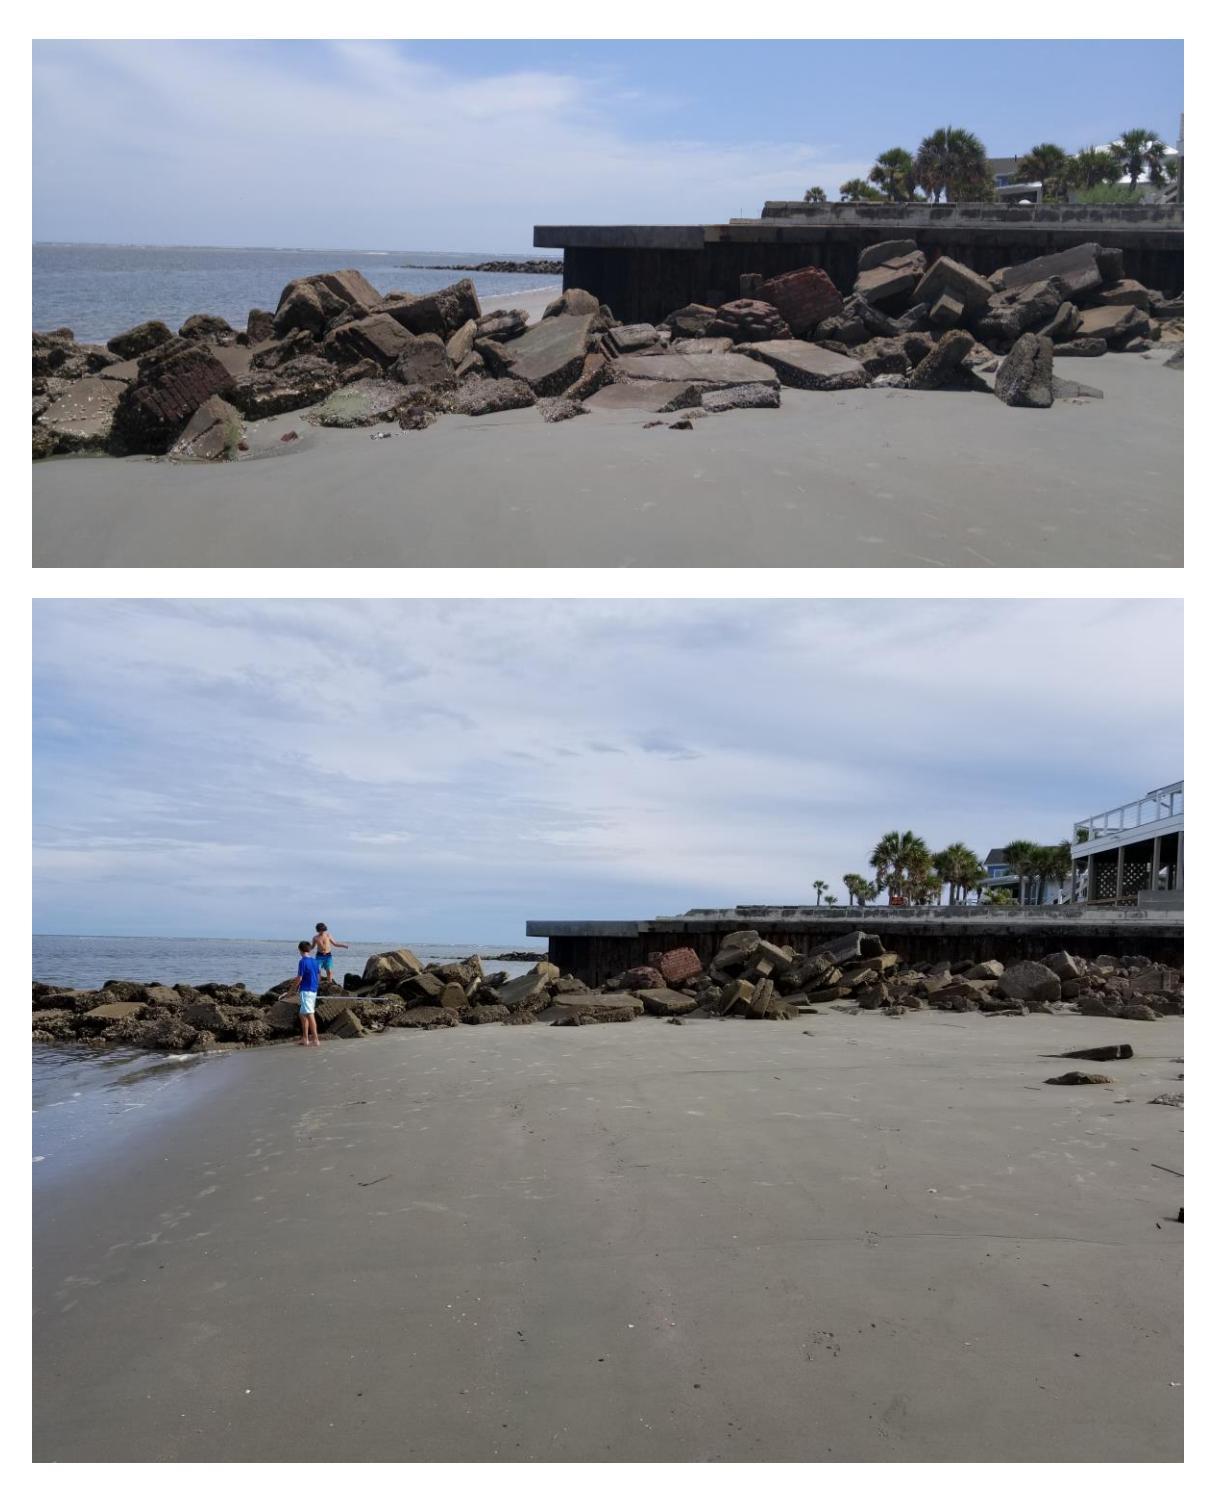
Figure 33. Ground photo taken at Monument 3090 looking southwest on August 4, 2016 (top) and June 12, 2017 (bottom).

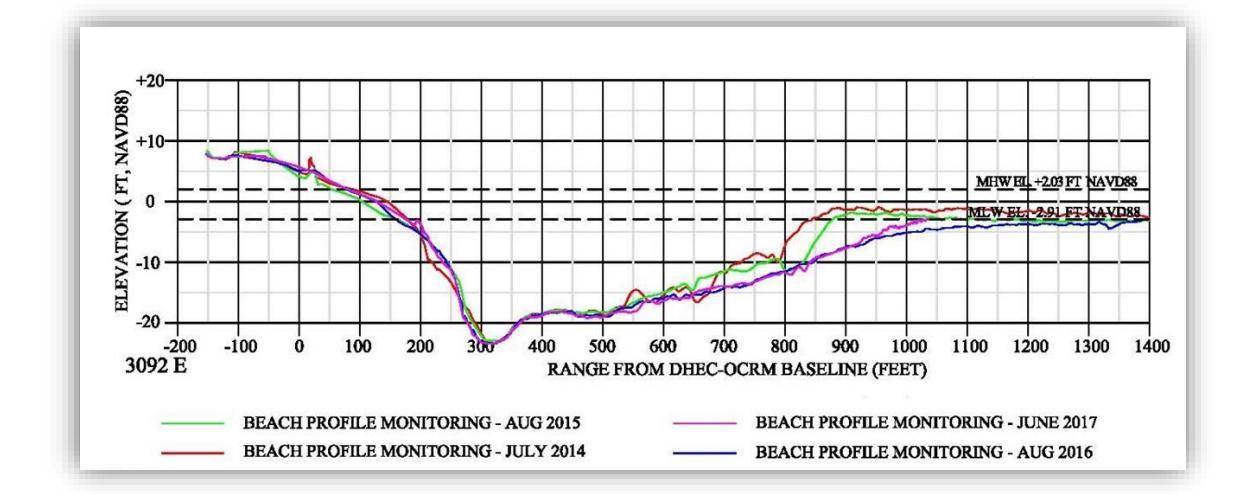
Monument 3092 is located north of Station 31 on northeastern Sullivan's Island near Breach Inlet. This profile line represents a section of the island that has been stabilized with erosion control structures. The beach profile has exhibited little change due to the stabilization structures (Figure 34). In 2016, no erosion was evident; however, little to no dry beach is exposed at high tide. In 2017, a 50-ft-wide high tide beach existed indicating some minor accretion. The structures have stabilized this portion of the beach (Figure 35 and Figure 36).

*Figure 34. Beach profile monitoring data from 2014-2017 in cross-section view at Monument 3092.*

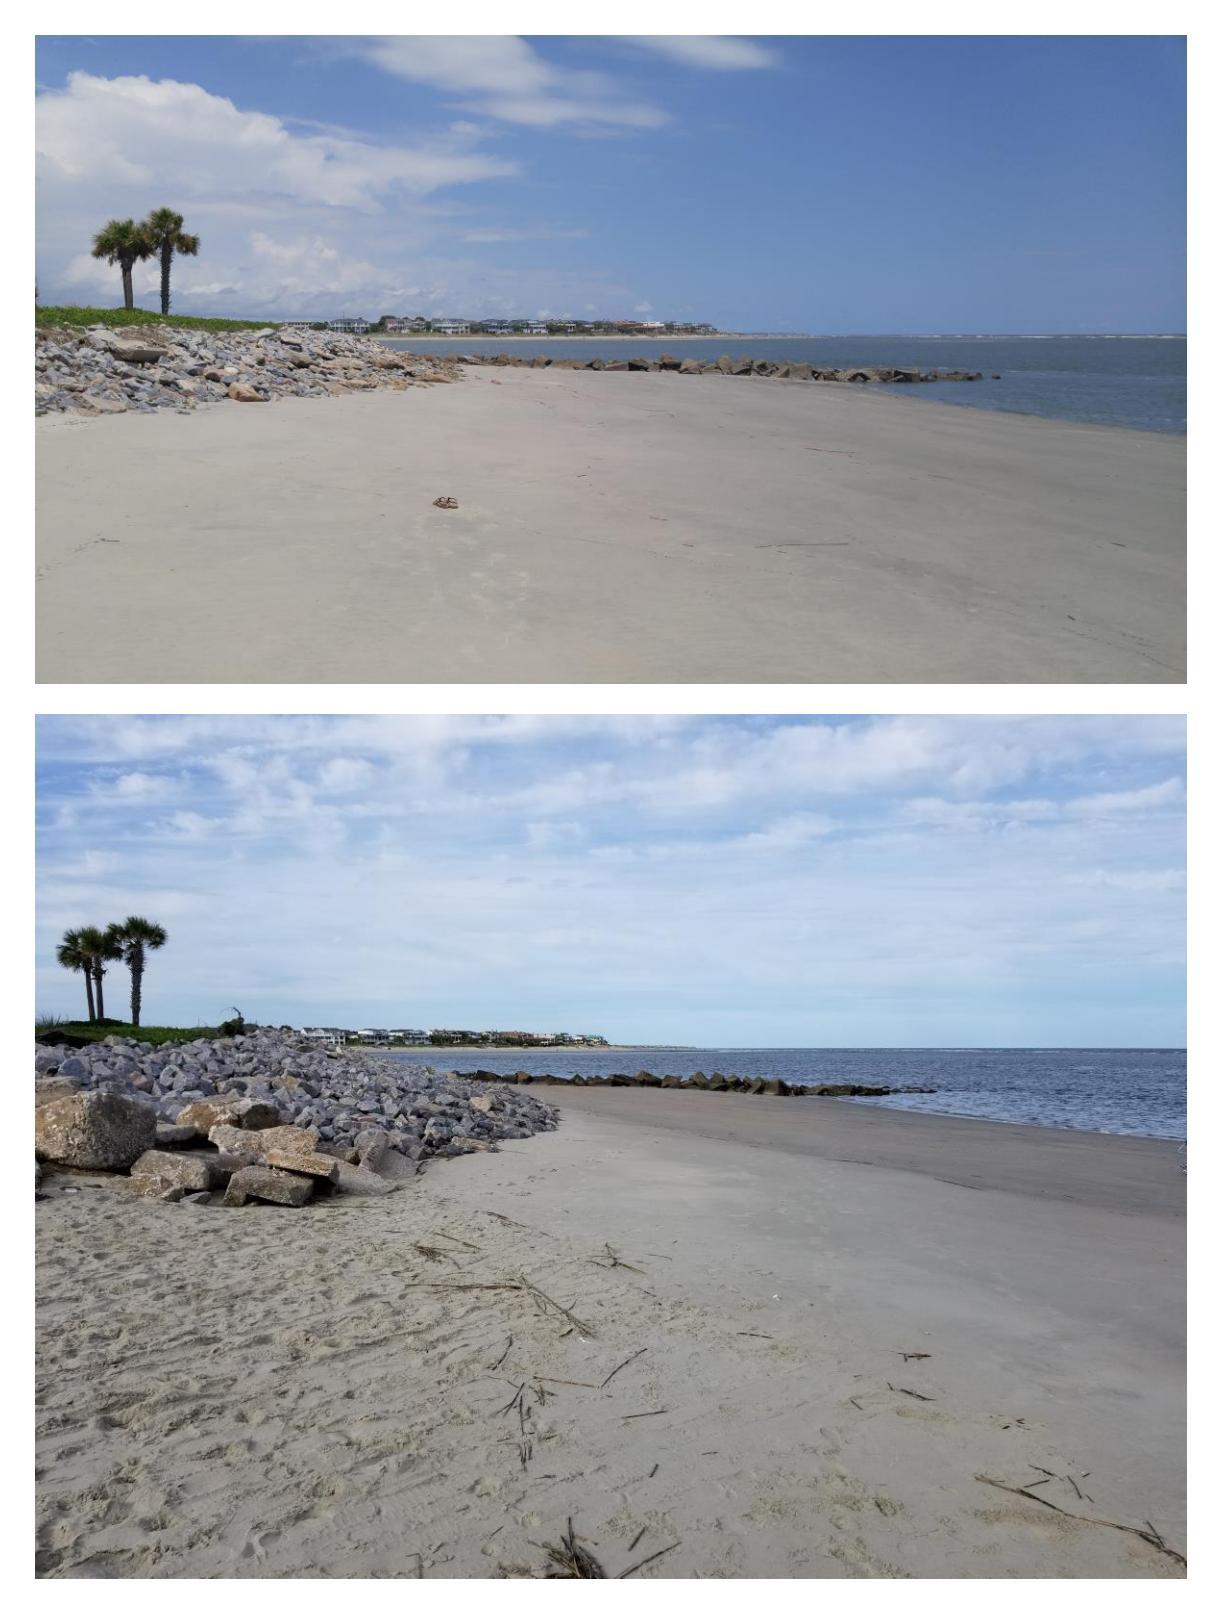
Figure 35. Ground photo taken at Monument 3092 looking north on August 4, 2016 (top) and June 12, 2017 (bottom).

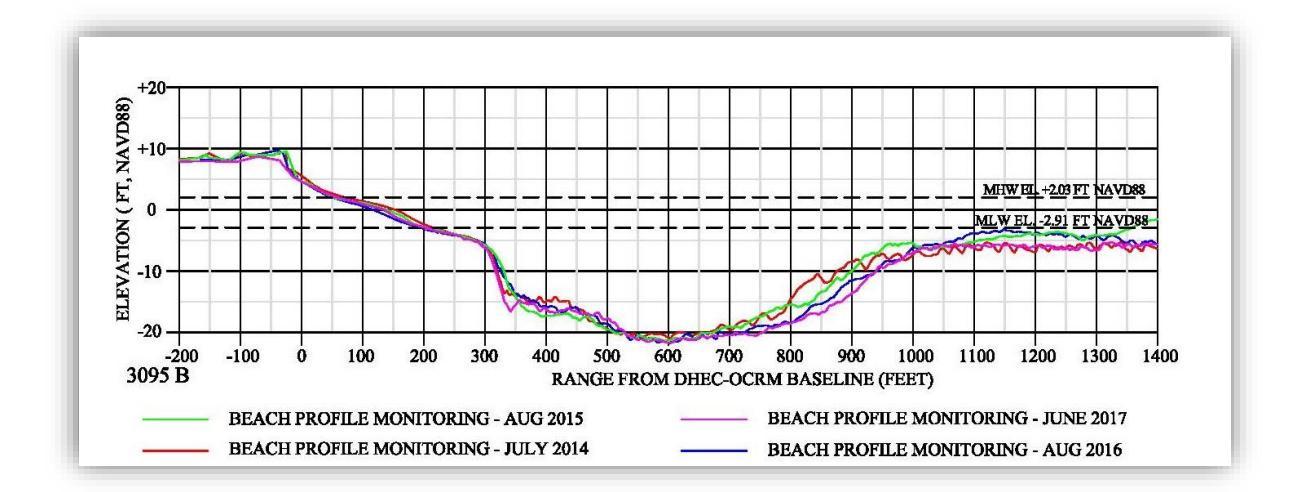
Monument 3095 is located near Station 32 at the northeastern tip of Sullivan's Island on Breach Inlet. It represents a cuspate beach anchored by erosion control structures (groins). The beach profile has exhibited little change over time due to the stabilization structures (Figure 37). In June 2017, some accretion was evident with a storm rack line 10 ft from the toe of vegetation and a 20 ft wide high tide beach. The structures have stabilized this portion of the beach (Figure 38 and Figure 39).

*Figure 37. Beach profile monitoring data from 2014-2017 in cross-section view at Monument 3095.*
