# TOWN OF SULLIVAN'S ISLAND, SC

Elko Coastal Consulting, Inc. | July 2017

# 2017 Beach Monitoring Survey: Town of Sullivan's Island, SC

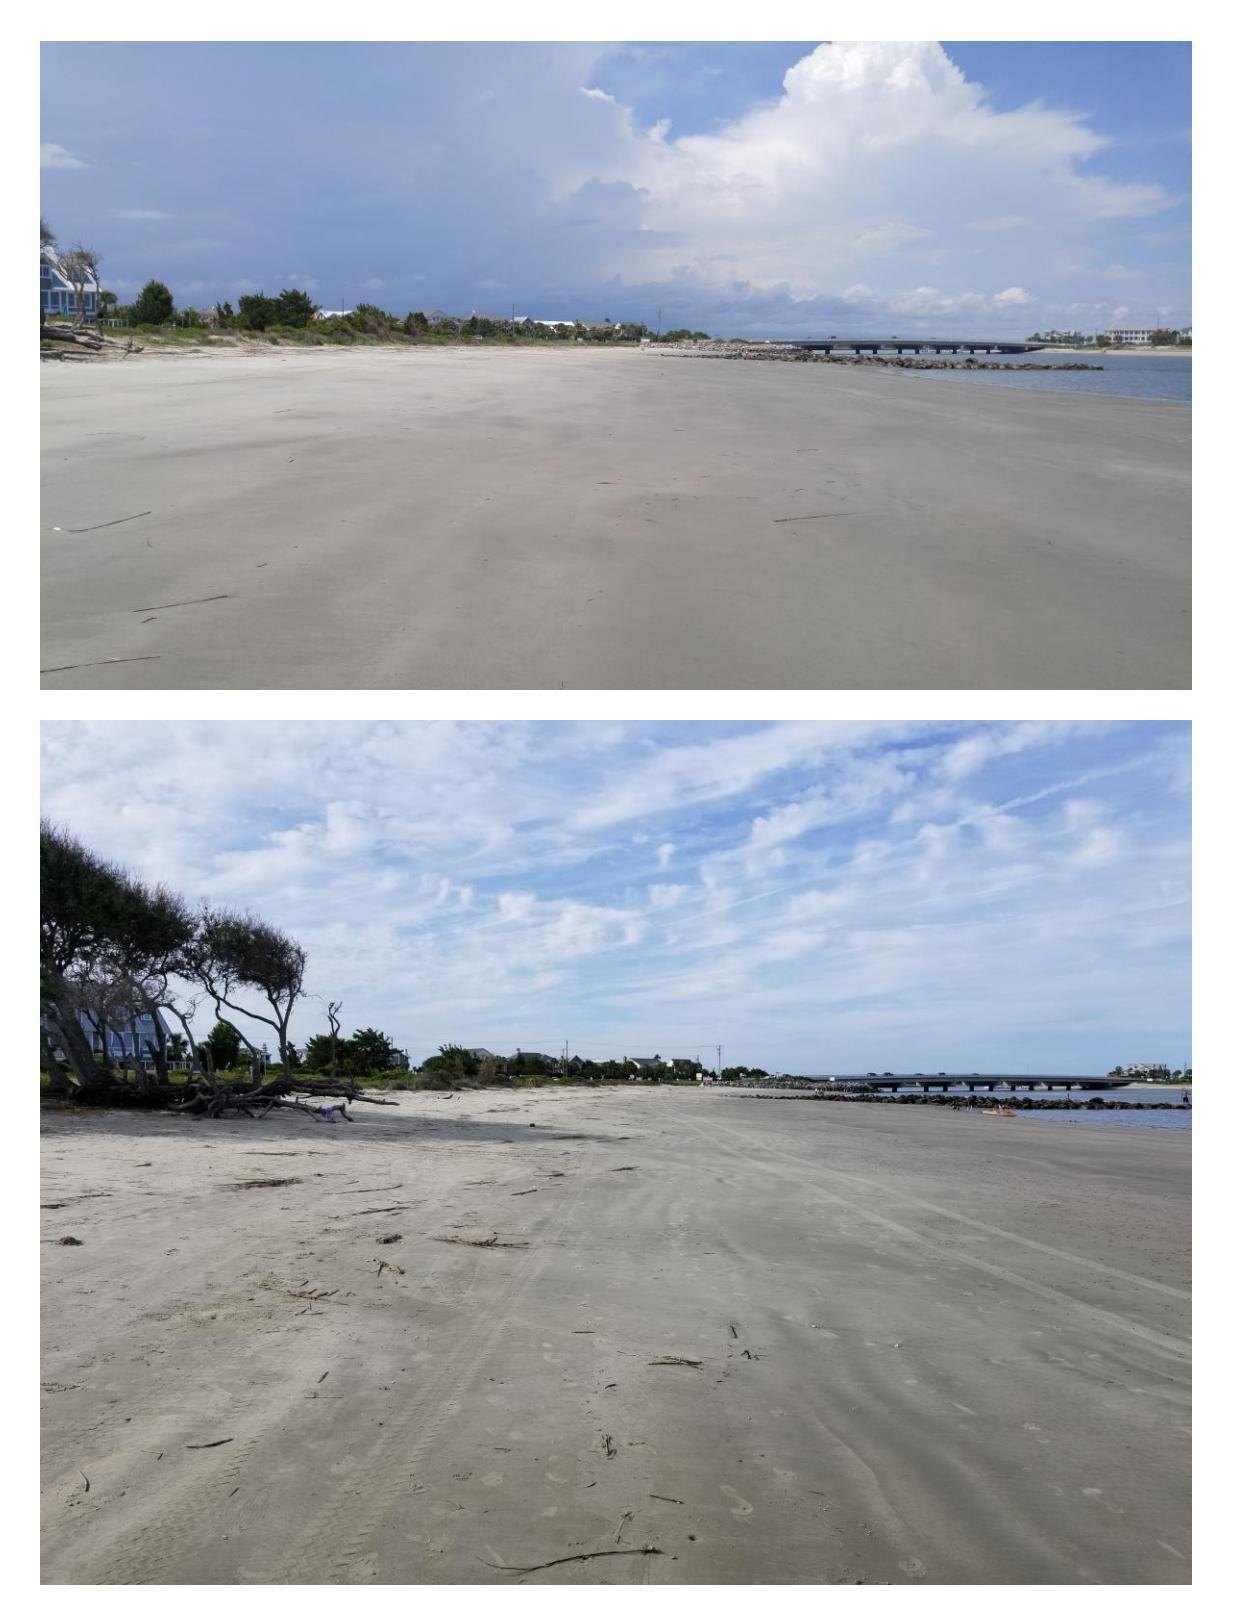
Monument 3095 is located near Station 32 at the northeastern tip of Sullivan's Island on Breach Inlet. It represents a cuspate beach anchored by erosion control structures (groins). The beach profile has exhibited little change over time due to the stabilization structures (Figure 37). In June 2017, some accretion was evident with a storm rack line 10 ft from the toe of vegetation and a 20 ft wide high tide beach. The structures have stabilized this portion of the beach (Figure 38 and Figure 39).

Figure 38. Ground photo taken at Monument 3095 looking north on August 4, 2016 (top) and June 12, 2017 (bottom).

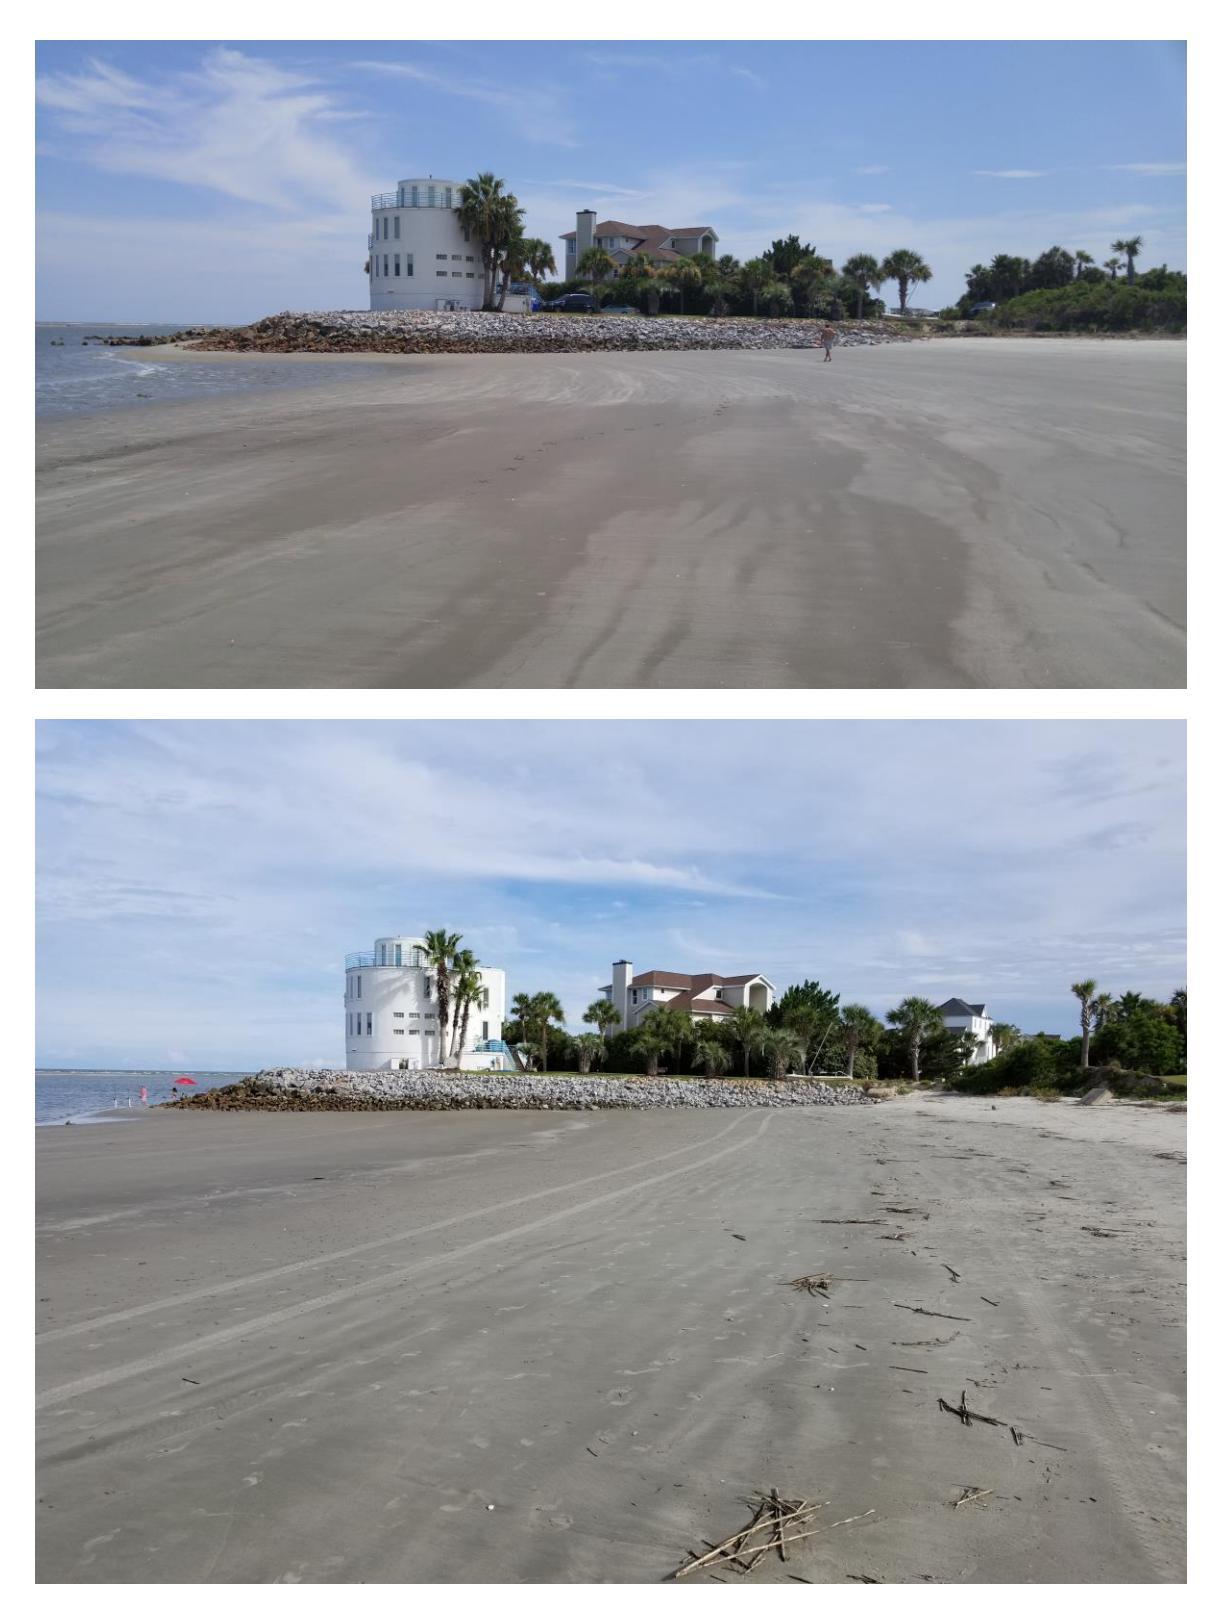
Figure 39. Ground photo taken at Monument 3095 looking south on August 4, 2016 (top) and June 12, 2017 (bottom).
