2020 Beach Monitoring Survey

TOWN OF SULLIVAN'S ISLAND, SC

Elko Coastal Consulting, Inc. | June 2020

2020 Beach Monitoring Survey: Town of Sullivan's Island, SC

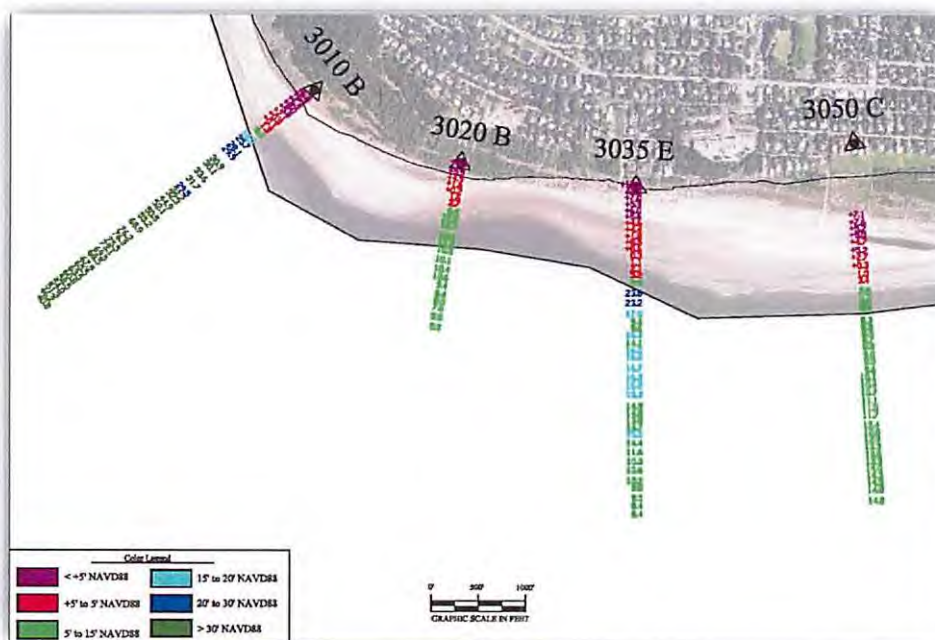
Figure 3. Topographic and bathymetric 2020 survey data illustrating the measured elevation along each line for the southwest end of Sullivan's Island.

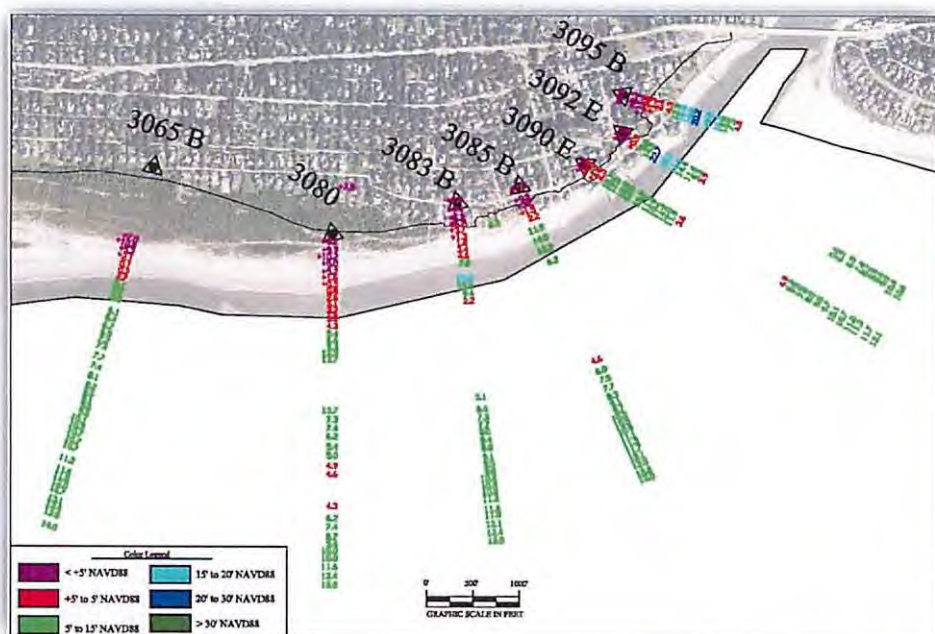
Figure 4. Topographic and bathymetric 2020 survey data illustrating the measured elevation along each line for the northeast end of Sullivan's Island.
