2021 Beach Monitoring Survey

TOWN OF SULLIVAN'S ISLAND, SC

Elko Coastal Consulting, Inc. | July 2021

2021 Beach Monitoring Survey:
Town of Sullivan's Island, SC

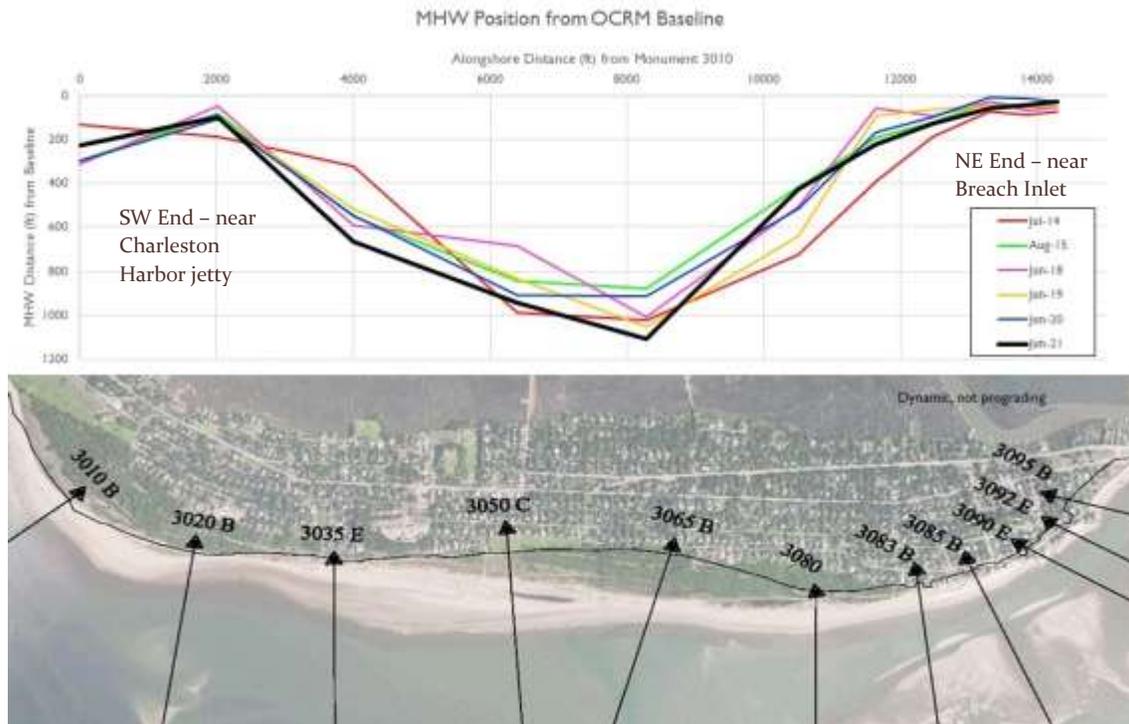
During the study period, the Sullivan's Island shoreline changed dramatically between 2014 and 2015. Between 2015 and 2019, the shoreline gradually recovered back to near the 2014 position in most cases (Figure 5). In the recent past, the shoreline along the northeastern 2/3 of the island retreated again to near 2015 conditions. In the last year, shoreline recovery was measured along this section with the exception of Monument 3080 (Sta. 28), which displayed the highest erosion rate on the island of -92.6 ft between 2020 and 2021.

The southwest end of the island, in the vicinity of the Charleston Harbor jetty, eroded over the last year. Monument 3010, closest to the channel, lost 72.7 ft of shoreline between 2020 and 2021.

At the sandbar attachment point, near Station 26 (OCRM Monument 3065), the shoreline moved nearly 200 ft seaward between 2020 and 2021. This location is represented by the bottom of the curve of the lines near 8,000 ft alongshore (Figure 5). This suggests that the sandbar continues to attach and provide sand to this area.

Perhaps most interesting observation is that the average shoreline change between 2014 and 2021 is -22.1 ft/yr (compare red and black line on Figure 5). Thus, the Sullivan’s Island shoreline has not been advancing seaward since 2014. In other words, the island is not endlessly growing seaward. As noted in the last monitoring report, the shoreline may have reached a dynamic equilibrium.

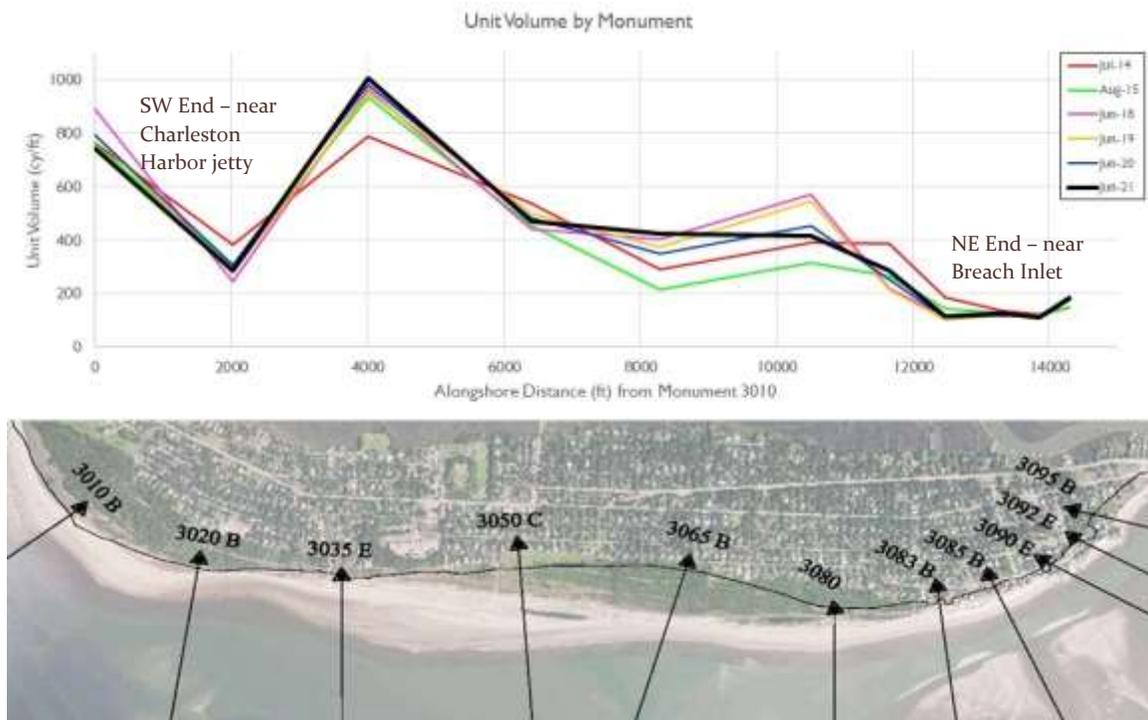
Figure 6. Annotated Unit Volume graph illustrating the change in unit volume at each profile from 2014 to 2021. Note the scale shows larger volumes toward the top of the plot.

As suggested in the MHW analysis, northeastern Sullivan’s Island has less storm protection in place than the rest of the island. Despite the narrowing beach, the average unit volume to the depth of closure (DOC) has been stable at near 130 cubic yards per foot (cy/ft) from 2016 to 2021. The rest of the island has at least 200 cy/ft of volume along each measured profile (Figure 6).

The other end of the island, near Charleston Harbor, has exhibited relatively stable unit volume measurements over the last three years. Between monuments 3020 and 3050 (Sta. 19 west to Sta. 22.5), very little volume change has been measured. As is expected adjacent to inlets, monument 3010, closest to the channel is more dynamic.

During this monitoring period, the profile line to the east of the sandbar attachment point (Monument 3080) lost volume as sediment from the previous sand bar attachment event spread out. Most profiles in the vicinity of the sandbar attachment point lost volume in the offshore portion as the sandbar attached and gained volume in the sand dunes, backbeach, and berm. These measurements are detailed by monument in the next section.

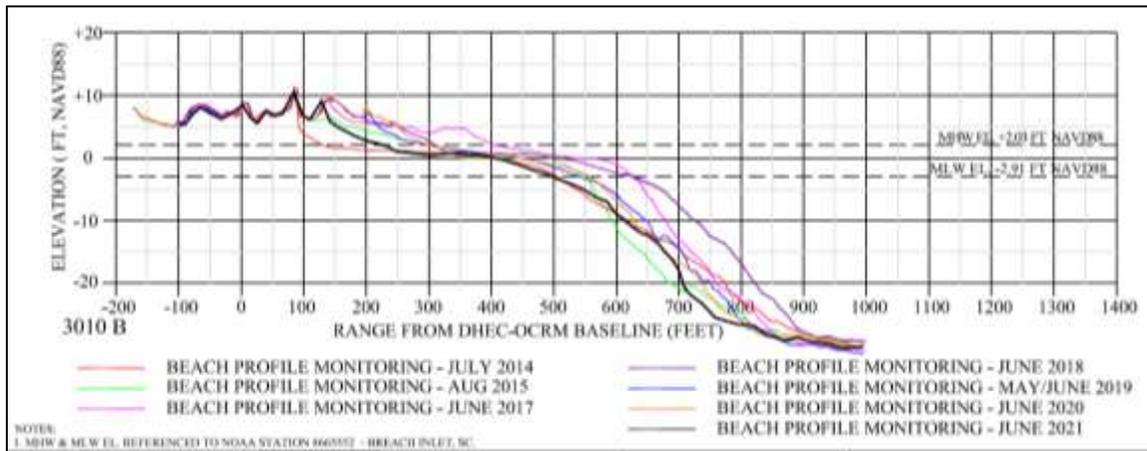
Figure 7. Beach profile monitoring data from 2014-2021 in cross-section view at Monument 3010.

This is the southwesternmost OCRM Monument on Sullivan’s Island, located along the long beach access path at Station 16 with the nature trail. The beach is located on the Charleston Harbor side (“inside”) of the jetty. This profile has experienced significant beach and dune erosion during the last year (Figure 7). Observations indicated that the rack line was at the dune toe, suggesting erosional conditions (Figure 8). Incipient dunes and a wide primary dune that had been growing at this location since 2015 eroded between 2020 and 2021 (Figure 9). According to the 2021 volume calculation, this profile has a unit volume of 743 cy/ft. This is about 50 cy less than the 2020 unit volume.

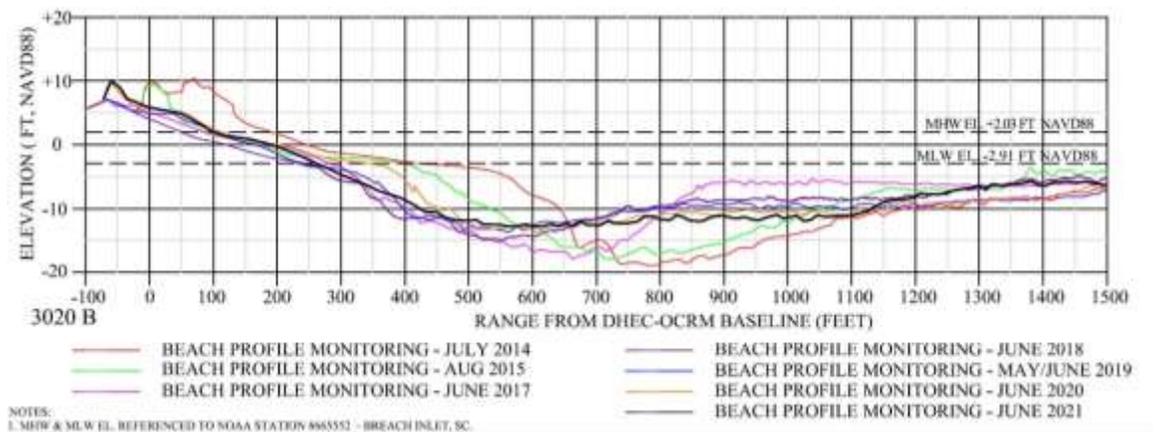
Figure 10. Beach profile monitoring data from 2014-2021 in cross-section view at Monument 3020.

Beach observations confirmed that the recovery that began in 2019 continued in 2021 with vegetation growth and dunes advancing seaward. Dead trees along the dune line were buried with sand. The beach was accreting with at least 100 ft of dry beach at high tide. A sand bar had attached to the updrift beach and the beach berm accreted (Figure 11). Dune recovery continued (Figure 12).

According to the 2021 volume calculation, this profile has a unit volume of about 305 cy/ft, which is in stark contrast to the surrounding accretional areas. This monument is influenced by its location downdrift of the Charleston Harbor jetty.

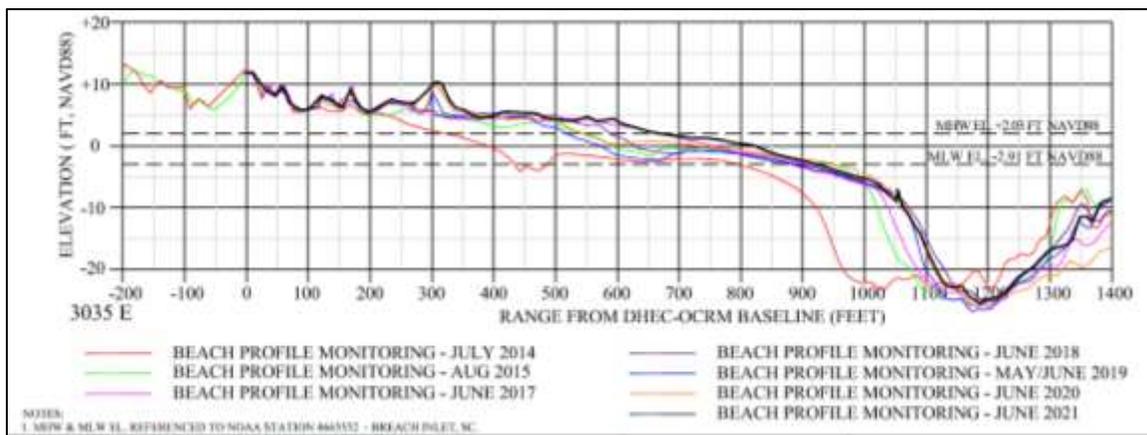
Figure 13. Beach profile monitoring data from 2014-2021 in cross-section view at Monument 3035.

Monument 3035 is located along the long beach access path at Station 19. This area has been the beneficiary of recent sandbar attachment events (Figure 13). The beach has been wide and accreting for the last several years. A new primary dune has formed since 2014. In 2021, beach observations confirmed that a wide backbeach and a wide, high berm (Figure 14 and Figure 15). Evidence of past ponding landward of the berm was observed, which is common at this location.

According to the 2021 volume calculation, this profile has a unit volume of 1,004 cy/ft. The beach profile at this monument is influenced by the sediment trapping effect of the Charleston Harbor jetty.

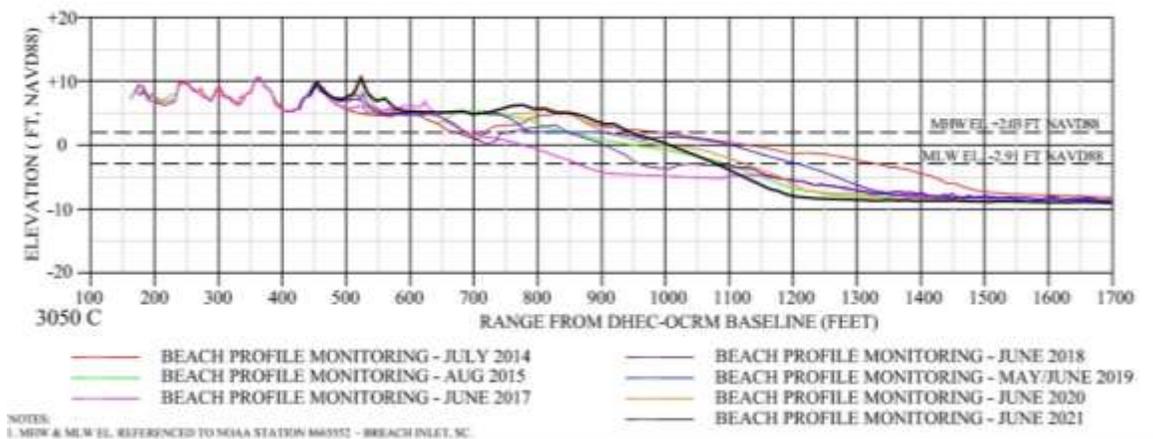
Figure 16. Beach profile monitoring data from 2014-2020 in cross-section view at Monument 3050.

The beach observations confirm that the 2021 beach was over 100 ft wide and accretional. The dunes were healthy with new growth and as with the nearby beach profiles, coppice mounds and incipient dunes that had formed in 2020 had been overtopped and replaced with a sandy berm. Evidence of past backbeach ponding was observed. This is likely a result of King tide events and may be helping to slow seaward aggradation.

According to the 2021 volume calculation, this profile has a unit volume of 471 cy/ft. The beach profile at this monument benefits from its location updrift of the Charleston Harbor jetty. Sand volume has been relatively stable at this profile fluctuating between 400 and 500 cy/ft but the shoreline position has fluctuated considerably. The data indicate stability rather than uninhibited accretion and progradation.

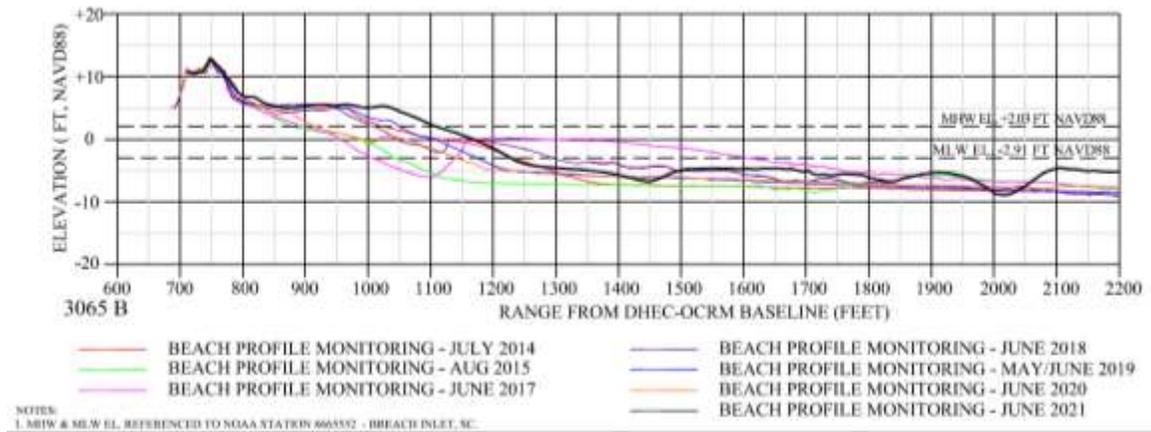
Figure 19. Beach profile monitoring data from 2014-2021 in cross-section view at Monument 3065.

The profile goes through cycles of erosion and accretion as new sand bars attach and the sand is dispersed alongshore. Note the stability in the dune and high shoreline and berm position variability in the beach profile survey (Figure 19). Between 2020 and 2021, beach width increased.

Beach observations confirm that the beach width increased to over 100 ft wide at high tide (Figure 20 and Figure 21). The primary dune was building seaward with new growth and some evidence of overtopping which as suggested previously may be helping to reduce uninhibited seaward growth. According to the 2021 volume calculation, this profile has a unit volume of 425 cy/ft.

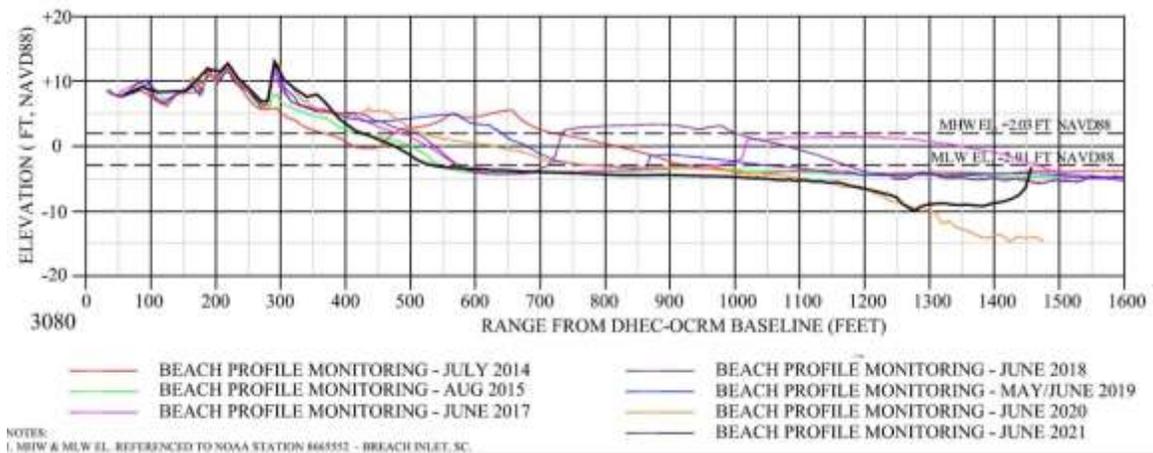
Figure 22. Beach profile monitoring data from 2014-2021 in cross-section view at Monument 3080.

Beach observations confirm that the beach at this location had lost beach width due to sand spreading (Figure 23 and Figure 24). Conditions were erosional with only about 10 feet of dry beach at high tide.

According to the 2021 volume calculation, this profile has a unit volume of 417 cy/ft. This profile continues to display relatively large volume loss due to sand from the attachment event spreading out alongshore. The beach condition now resembles the 2015 condition. More erosion is possible before the next sandbar attachment event; however, the dunes are very wide, offering more than sufficient storm protection.

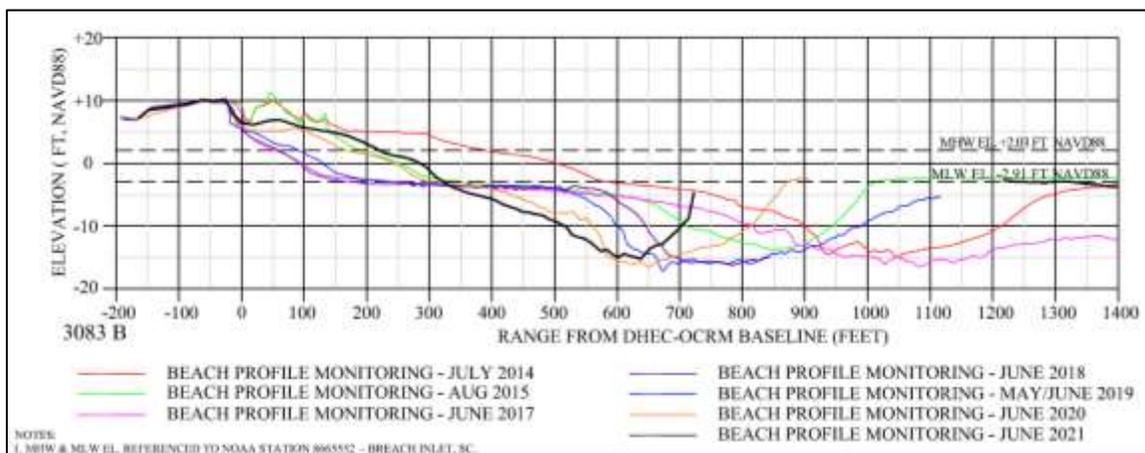
Figure 25. Beach profile monitoring data from 2014-2021 in cross-section view at Monument 3083.

Prior to this monitoring event, the shoreline here had retreated nearly 300 ft since the last sand bar attachment event in 2014 (Figure 25), including the loss of three rows of low sand dunes. In 2021, fairly significant beach recovery was measured. The shoreline advanced 50 ft seaward between 2020 and 2021 due to sand from the most recent attachment event migrating to this area. Another sand bar was beginning to migrate onshore as well (Figure 25).

According to the 2021 volume calculation, this profile has a unit volume of 285 cy/ft, about 80 cy/ft larger than in 2019.

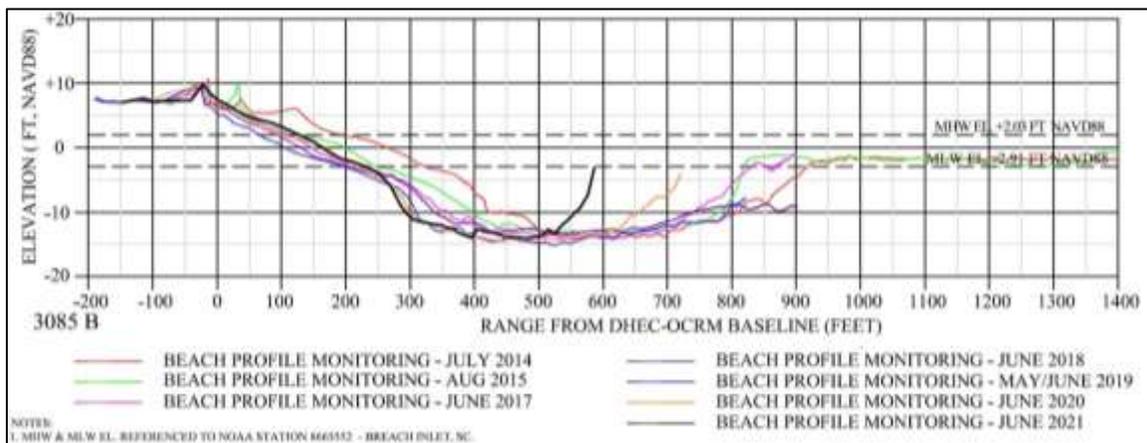
Figure 28. Beach profile monitoring data from 2014-2021 in cross-section view at Monument 3085.

Monument 3085 is located near Station 30. While this area had been eroding since the sand bar attachment event in 2014, accretion was measured during the last two monitoring periods. Beach profile data indicates evidence of fairly stable conditions with some dune recovery between 2020 and 2021 (Figure 28).

According to the 2021 volume calculation, this profile has a unit volume of 114 cy/ft, a slight increase from the 2020 volume.

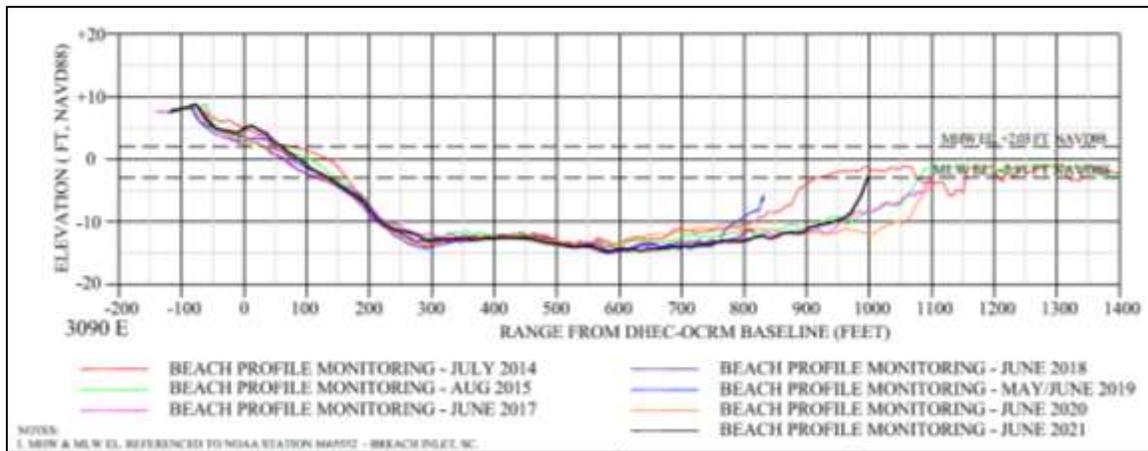
Figure 31. Beach profile monitoring data from 2014-2021 in cross-section view at Monument 3090.

Monument 3090 is located just south of Station 31 on northeastern Sullivan’s Island near Breach Inlet. It represents a small (<250 ft long) pocket beach between two groins. The beach is nearly completely armored. The beach profile has exhibited erosion despite the stabilization structures (Figure 31). No dry beach is exposed at high tide and no dunes are present (Figure 32 and Figure 33).

Beach observations in 2021 confirm these measurements. While some dry sand was present between the road and access path, at the time of the observations there was no dry beach in front of the seawalls.

According to the 2021 volume calculation, this profile has a unit volume of 124 cy/ft, the same as 2019 and 2020.

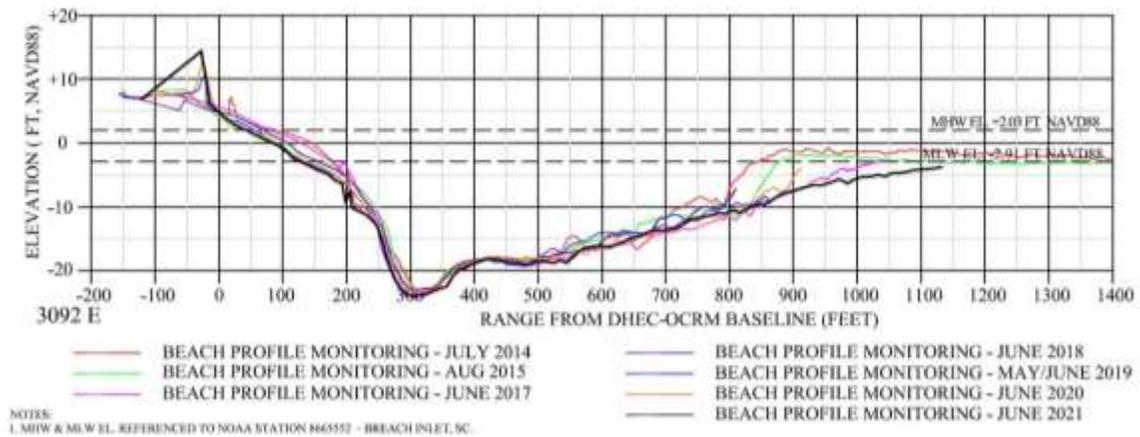
Figure 34. Beach profile monitoring data from 2014-2021 in cross-section view at Monument 3092.

Monument 3092 is located south of Station 32 on northeastern Sullivan’s Island near Breach Inlet. This profile line represents a section of the island that has been armored with erosion control structures. During this monitoring interval, the profile was fairly stable and a private dune restoration project was in place (Figure 34). The recent sand bar attachment event has not resulted in sediment being transported to this area.

According to the 2021 volume calculation, this profile has a unit volume of 108 cy/ft, nearly the same as in 2019 and 2020.

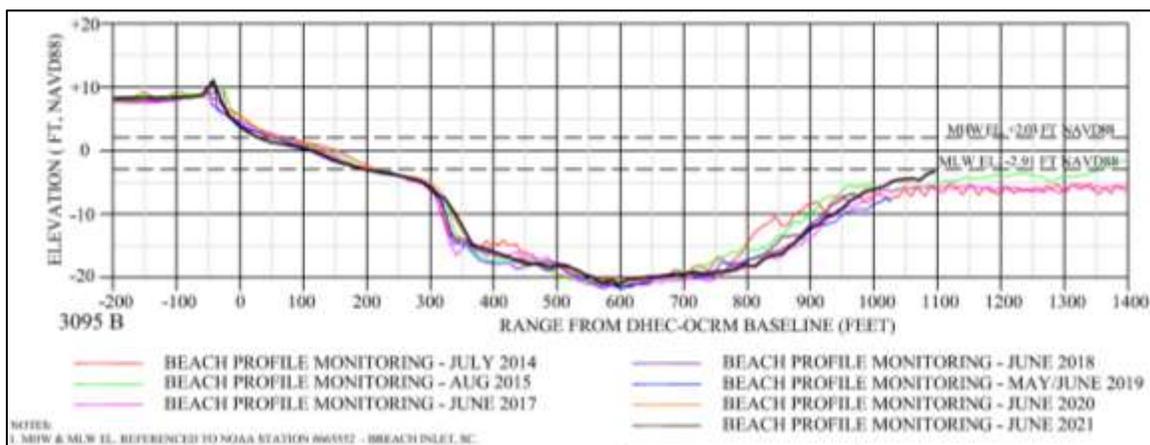
Figure 37. Beach profile monitoring data from 2014-2021 in cross-section view at Monument 3095.

Monument 3095 is located on Station 32 at the northeastern tip of Sullivan’s Island on Breach Inlet. It represents a cusped beach anchored by groins. The beach profile has exhibited little change over time due to the stabilization structures (Figure 37).

According to the 2021 volume calculation, this profile has a unit volume of 180 cy/ft slightly less than in 2020.
