# TOWN OF SULLIVAN'S ISLAND

# TREE COMMISSION

# TREE COMMISSION STAFF REPORT

# 2114 JASPER BOULEVARD

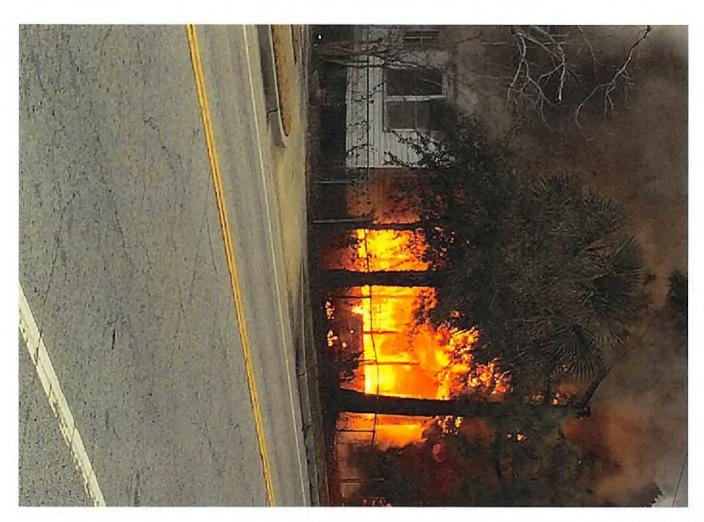
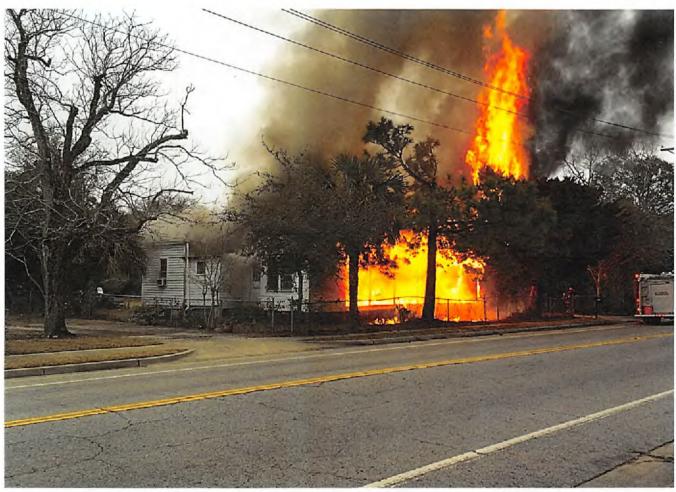
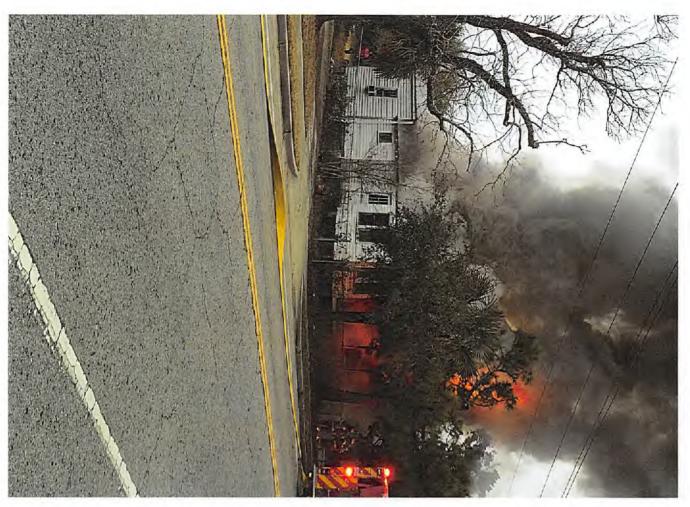
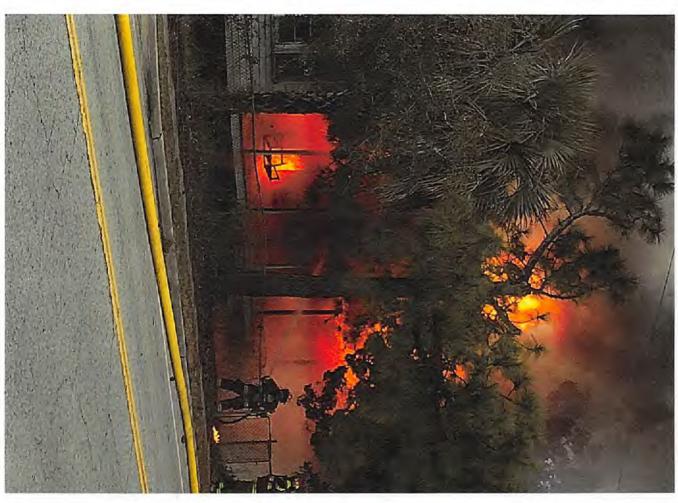
The applicant proposes to remove two Category 1 trees: 1 pine and 1 red cedar. The provided arborist letter of recommendation deem both to be in severe decline, citing the red cedar's decline because the tree burned during the structure fire of 2015 (picture enclosed). The pine tree has also been topped by the power utility company over the years creating an unusual and dangerous growth pattern.

Staff recommends consideration of the tree removal in accordance with 21-162 (B) 7. Both trees do appear to be in poor health due to the fire damage.
