WELCOME TO 2415 MIDDLE

**2415 Middle Street
Sullivan's Island, SC**

The following report concerns an investigation conducted by Glen Heagerty, PE, LLC regarding the structural condition of the above grade foundation elements, floor framing, wall framing, ceiling framing and roof framing for the residential structure @ 2415 Middle St.

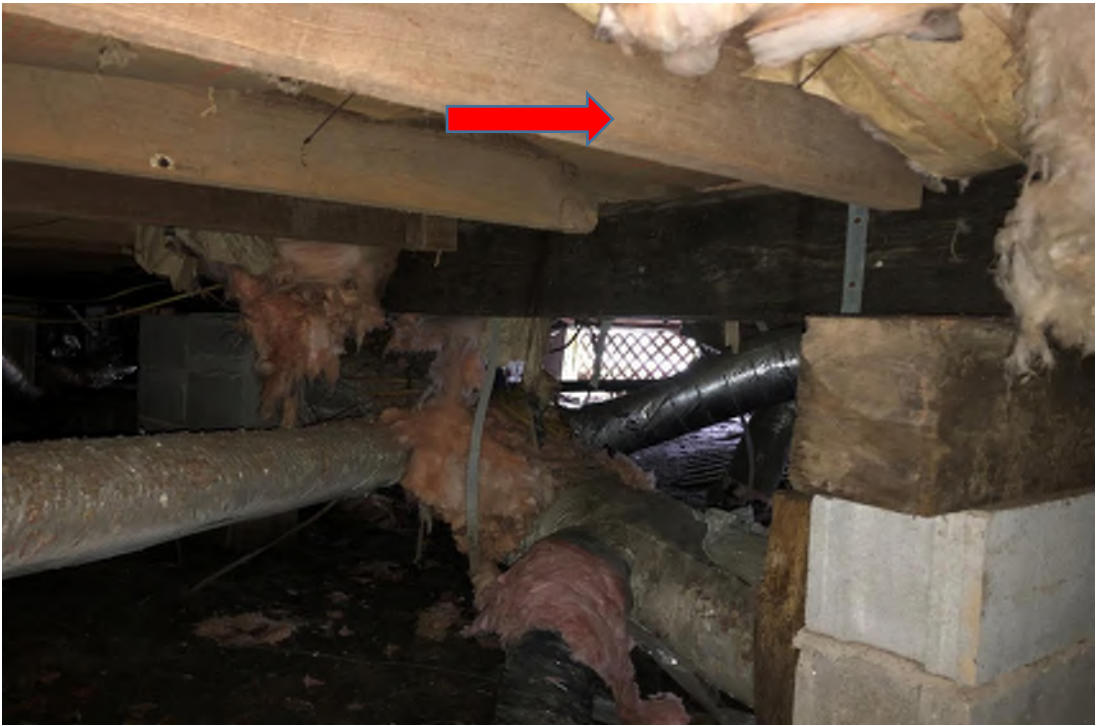
Fig. 1-8 & Fig. 1-9 shows an image of a heavy timber floor girder in good condition. Floor joists are shown in Fig. 1-10, which appear to be in good condition. Moving on to the interior of the house, the first floor floors are sloping, as shown in Fig. 1-11. The slope is due to uneven pier heights and soil settlement. The walls on the right hand side of the kitchen are leaning outwardly as shown in Fig. 1-12. The right hand exterior wall of Fig. 1-13 shows a lean/ bowing outwardly of roughly 5 degrees. Fig. 1-14 shows the 1st floor ceiling sloping from left to right in the picture. The 2nd floor has sloping floors throughout, as shown in Fig. 1-15. The uneven foundation and the right hand wall bowing outwardly is causing the 2nd floor to slope.

Fig. 1-11. 1st floor floors are sloping due to unevenness of CMU piers below.

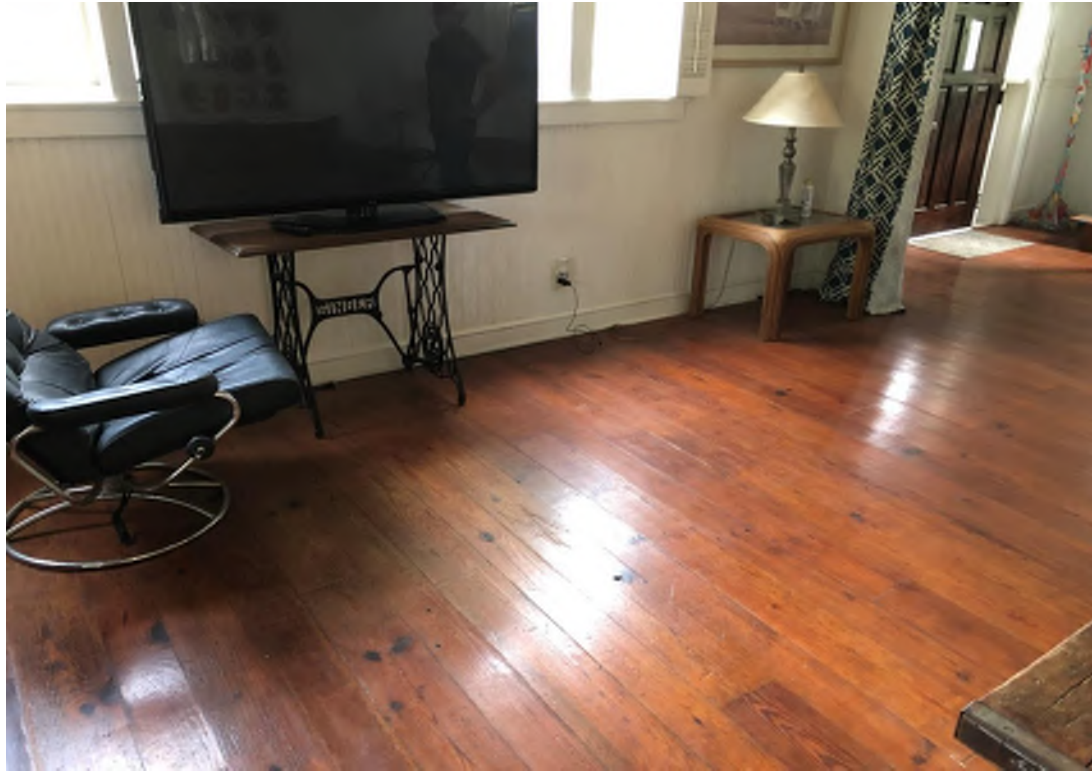
The right hand wall is leaning outwardly due to the CMU piers and CMU wall leaning. The problem is progressive in that the exterior framed walls and foundation will continue to rotate and lean even more than it is right now. Steps should be taken to correct this situation. If nothing is done to correct the right hand walls (1st & 2nd floor walls) and foundation lean, on the right side of the house, it is conceivable that the 2nd floor, and right hand walls could collapse in the near future. (The 2nd floor is supported by the first floor wall). The other walls and 3 sides of the foundation (left, front and back) do have a slight lean but in Glen Heagerty, PE, LLC's opinion but are not in need of immediate repair right now but should be monitored and possibly repaired/straightened in the near future. The 1st floor floors are sloping some but they are not likely to collapse in the near future. Several interior CMU piers support only 1st floor joists and not load bearing walls, so the loads are not that heavy compared to CMU piers and CMU block walls that support exterior load bearing walls. The interior piers, for the most part have rotated slightly or not at all.

Fig. 1-12. Wall in kitchen is leaning outwardly, due CMU piers rotation underneath in crawlspace.

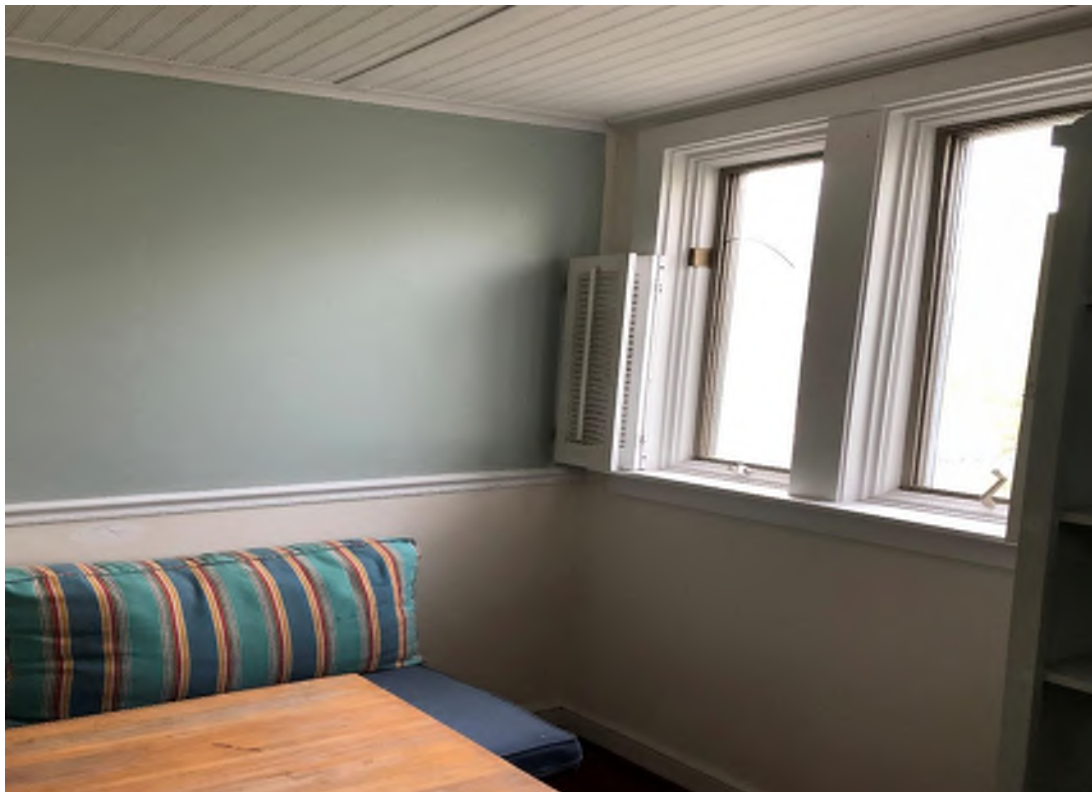
Fig. 1-13. Exterior wall leaning outwardly approximately 5 degrees.

- Plumb remainder of existing wood frame walls of main house -
- Pour new continuous footings and place CMU piers under all exterior walls of the main house and under load bearing wall areas on interior of main house. Also, add approximately 20 helical piers to support new footings
- Replace all existing CMU piers that have timber wedges on top of piers w/ a new top course of CMU block
- Re-attach bridging/ blocking between joists, in floor system of rear apartment
- Reframe roof
- Add guardrail to existing deck over apartment

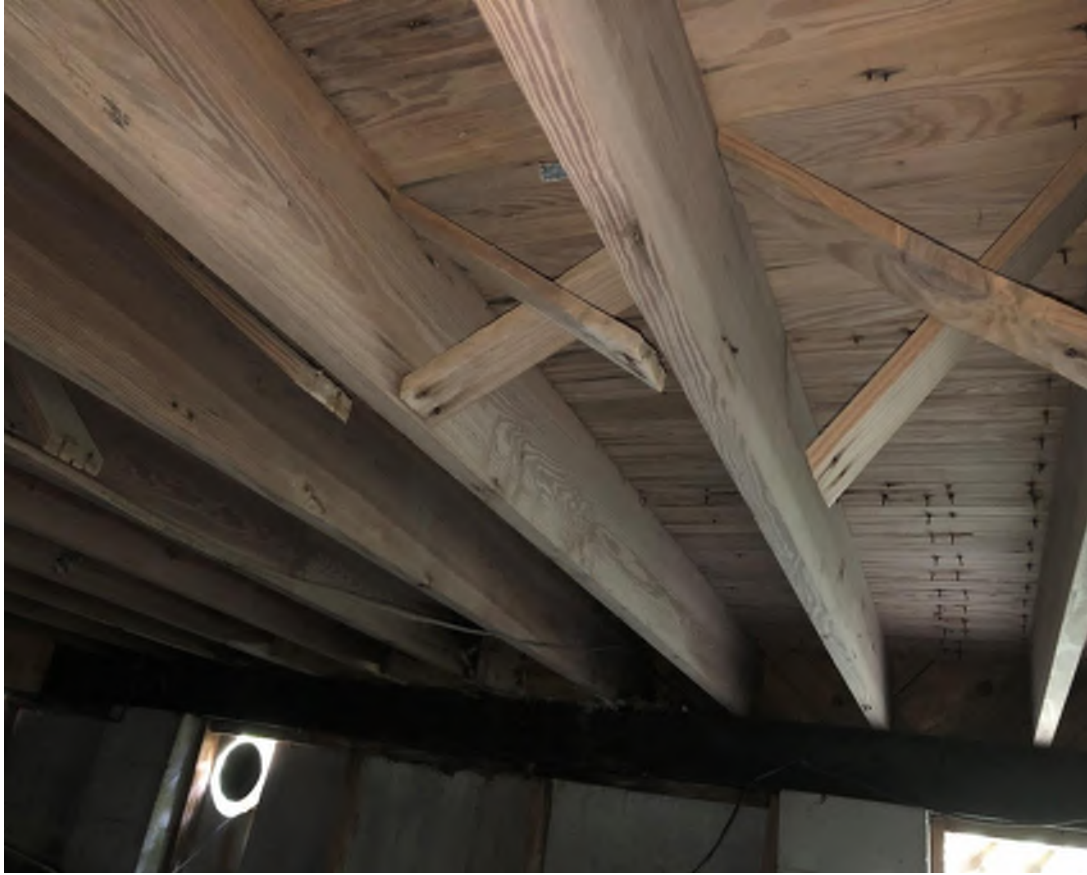
The pier supporting the steps at the apartment entrance (right rear of the house) is supported by an improperly built CMU pier (Fig. 1-18). The pier should be built in a manner that you don't see the cells (holes) in the blocks and the blocks should be joined w/ mortar. The apartment appears to be in decent condition. The floors bounce a little. The joist blocking is dislodged in several areas under the apartment (Fig. 1-19).

Fig. 1-19. The floor joists blocking are dislodged (under rear apartment).

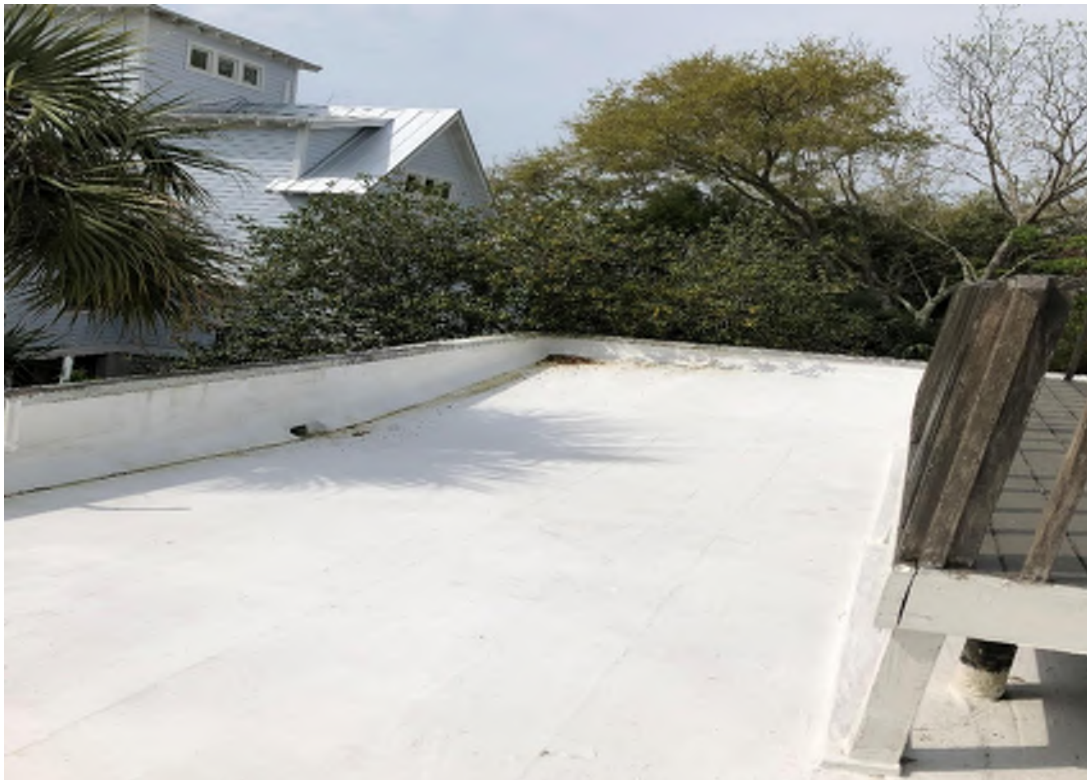
There is a commercial style roof on top of the rear apartment (Fig. 1-20). The roof is flat with some undulations / valleys to catch and dispose of water. The roof material is likely an EPDM (Ethylene Propylene Diene Terpolymer). A licensed roofing contractor would be the best person to verify material. The roof appears to be in satisfactory condition.

Fig. 1-20. The rear apartment has a commercial style roof, likely a EPDM (Ethylene Propylene Diene Terpolymer) roof.
