# 2019 Beach Monitoring Survey

TOWN OF SULLIVAN'S ISLAND, SC

Elko Coastal Consulting, Inc. | July 2019

Technical Report

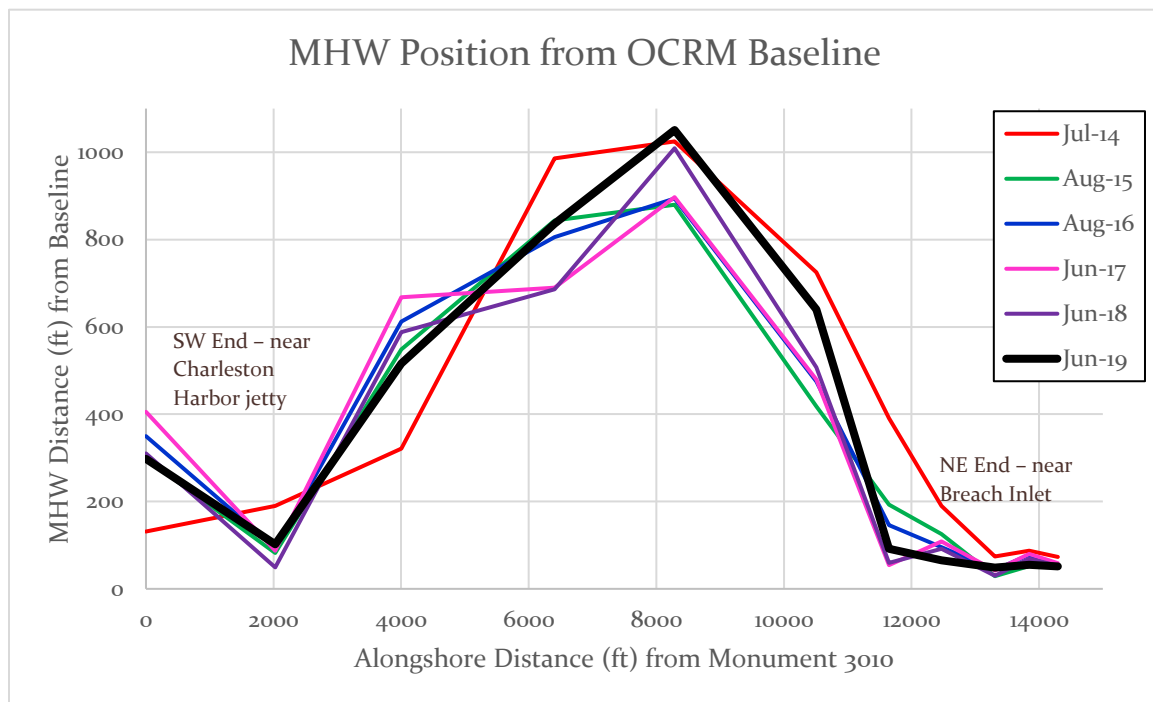
During the study period, the Sullivan's Island shoreline changed dramatically between 2014 and 2015, and between 2015 and 2019 the shoreline has gradually recovered back to near the 2014 position in most cases (Figure 5). Several areas were flagged in previous monitoring reports and are discussed below.

The northeast end of the island, between Monuments 3090 and 3095 and adjacent to Breach Inlet, was flagged in the 2016 report. It is under continual erosional pressure due to the southwesterly migration of Breach Inlet, but has been stabilized by erosion control structures. Minor shoreline change has occurred along this northeastern end over the last four years (i.e., stability); however, the small distance between the shoreline and the OCRM baseline suggests erosional pressure and the need for continued monitoring. There is little storm damage protection at this location.

Along the central portion of the island, the shoreline between Station 31 and 22 (between OCRM Monuments 3050 and 3085) was also flagged in the 2016 report because the shoreline position moved landward an average of 180 ft between 2014 and 2016 (Figure 5). This dramatic shoreline retreat has stopped and the shoreline is advancing at all of the monuments in this section. As noted above, the shoreline has nearly recovered to its 2014 position. The shoreline along this portion of the island tends to fluctuate in response to Breach Inlet shoal attachment events<sup>2</sup>.

Figure 5. Annotated MHW Position graph illustrating the change in shoreline position from 2014 to 2019, as well as the distance between the shoreline and baseline.

At the sandbar attachment point, Station 26 (OCRM Monument 3065), the shoreline moved about 100 ft landward between 2017 and 2018. This location is represented by the peak of the black line near 8,000 ft alongshore (Figure 5). To the southwest at Station 28 (monument 3080), the shoreline advanced over 130 ft landward between 2018 and 2019. To the northeast at Station 22.5 (monument 3050), the shoreline advanced nearly 150 ft between 2018 and 2019. These large consecutive shoreline advancements illustrate the downdrift migration of the sand bar. The June 2019 MHW position line is approaching the July 2014 line (Figure 5) indicating that the sand bar attachment events may follow a general pattern represented by accretion and erosion along the central portion of the island. The only location on the island that has exhibited shoreline advancement since 2014 is at Station 19 (monument 3035)

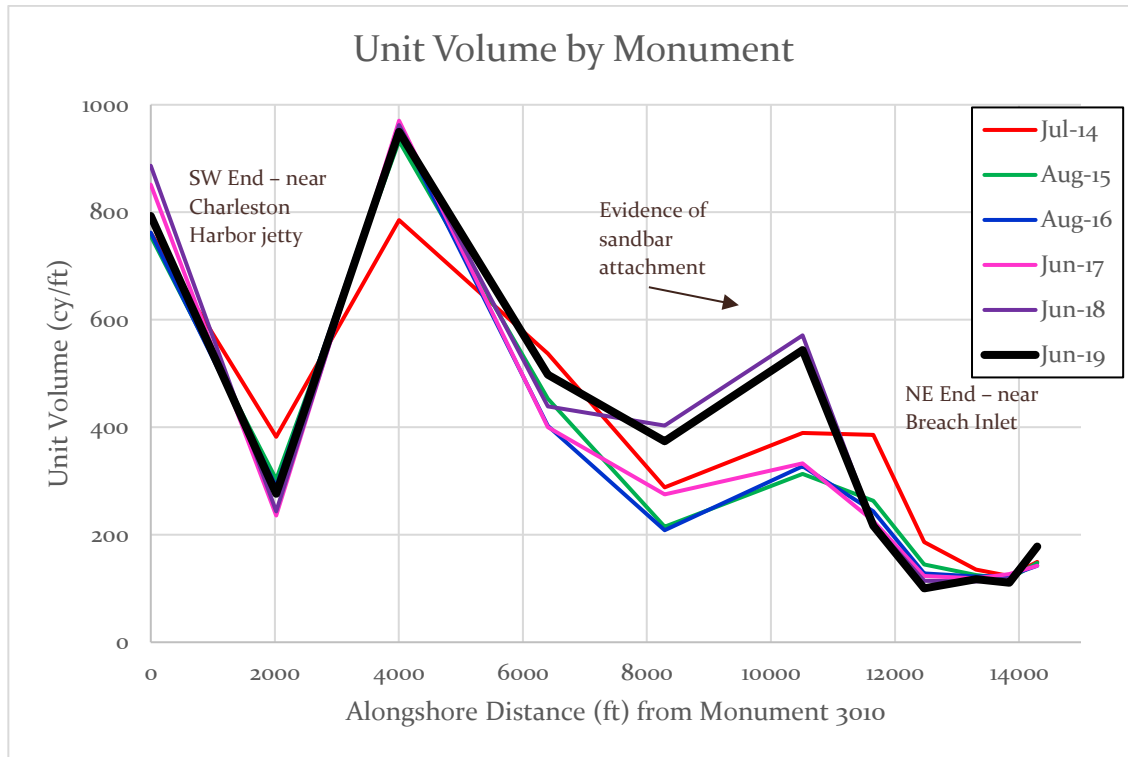
As suggested in the MHW analysis, northeastern Sullivan’s Island has less storm protection in place than the rest of the island. Despite the narrow beach, the average unit volume to the depth of closure (DOC) has been stable at near 130 cubic yards per foot (cy/ft) from 2016 to 2019. The rest of the island has at least 200 cy/ft of volume along each measured profile (Figure 6).

The 2016 monitoring report detailed a sandbar attachment event that occurred in 2014. Another sandbar attachment was documented in 2018. This sandbar began spreading in both directions alongshore during this monitoring period. The June 2018 and 2019 lines (purple and black) in Figure 6 illustrate a substantial increase in volume between about 7,000 (3065; Sta. 26) and 11,000 (3080; Sta. 28) feet along shore. The next section details this sandbar attachment using beach profile data from each monument.

Figure 6. Annotated Unit Volume graph illustrating the change in unit volume at each profile from 2014 to 2019.

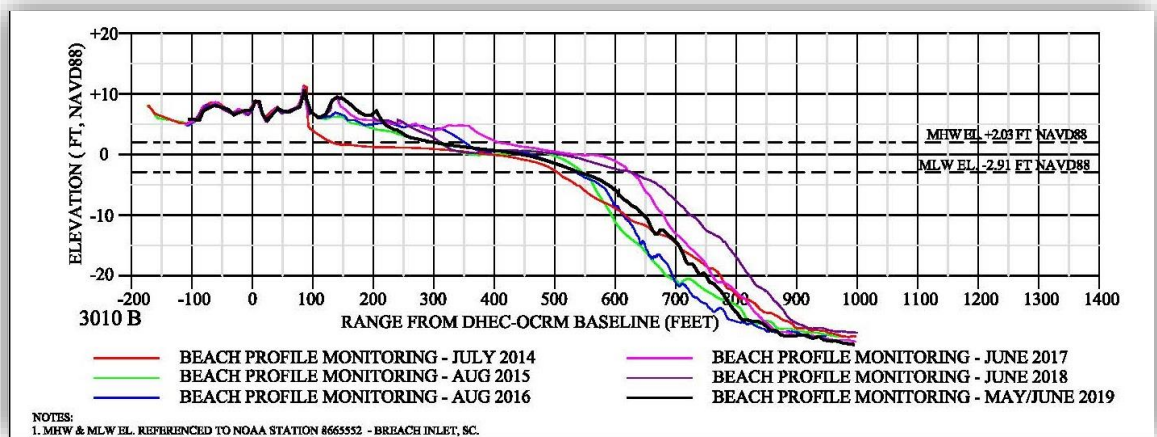
Compared to the 2016 conditions, the dunes are higher and accreting seaward with incipient dune vegetation observed to the northeast (Figure 8). Minor dune scarping was observed to the southwest (Figure 9). According to the 2019 volume calculation, this profile has a unit volume of 793 cy/ft.

Figure 7. Beach profile monitoring data from 2014-2019 in cross-section view at Monument 3010.

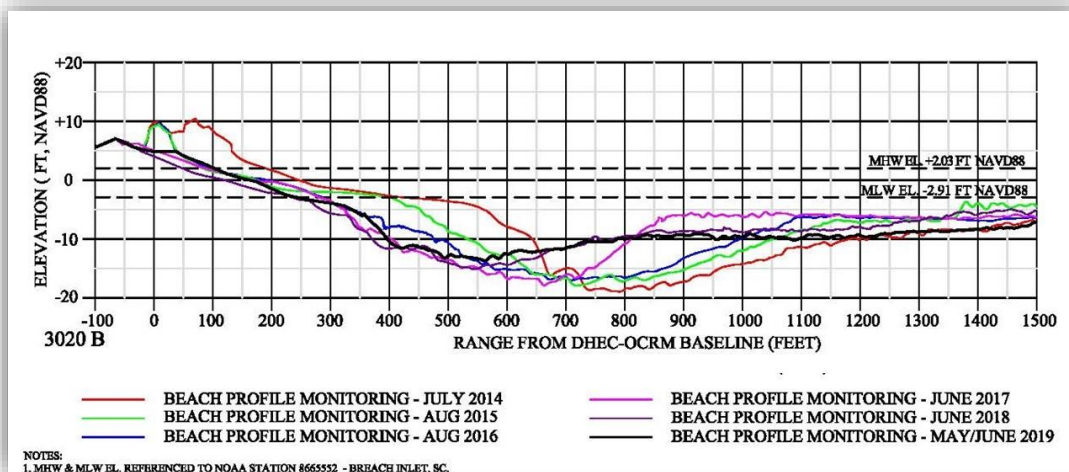
Monument 3020 is located along the long beach access path at the Sand Dunes Club. Significant erosion had taken place here since 2014 that included loss of a large dune and submerged nearshore sand body (Figure 10). Now, sediment in the offshore sandbar is accumulating and the bar is slowly migrating onshore.

According to the 2019 volume calculation, this profile has a unit volume of only 276 cy/ft, which is in stark contrast to the surrounding accretional areas. This monument is influenced by its location downdrift of the Charleston Harbor jetty.

Figure 10. Beach profile monitoring data from 2014-2019 in cross-section view at Monument 3020.

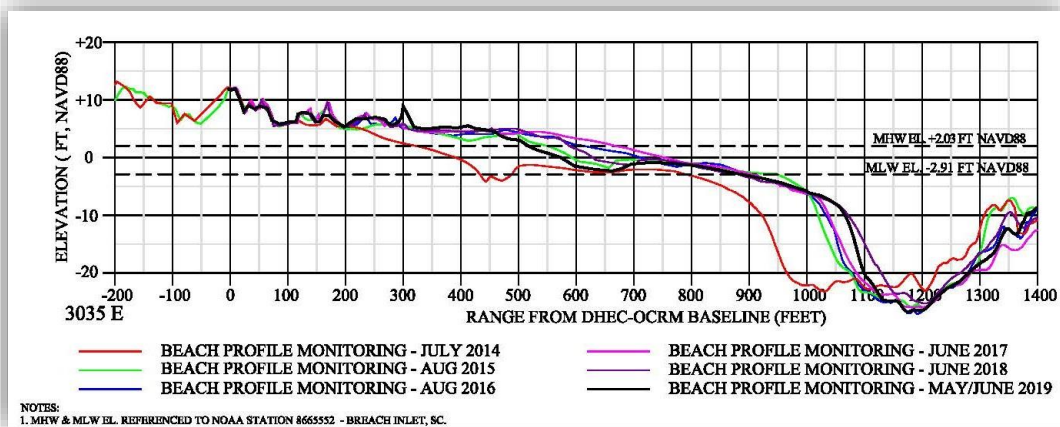
Monument 3035 is located along the long beach access path at Station 19. This area has been the beneficiary of the 2014 sandbar attachment event (Figure 13). The beach has been wide and accreting between August 2016 and June 2019 with more than 100 ft of dry beach between the vegetation line and the high tide line (Figure 14 and Figure 15). Over the past two years, a wide hummocky foredune field developed on the backbeach (Figure 15). In contrast to 2016 and 2017, no ponding was observed in the backbeach (Figure 14), suggesting the berm and backbeach elevation have increased.

According to the 2019 volume calculation, this profile has a unit volume of 950 cy/ft. The beach profile at this monument is influenced by the sediment trapping effect of the Charleston Harbor jetty.

Figure 13. Beach profile monitoring data from 2014-2019 in cross-section view at Monument 3035.

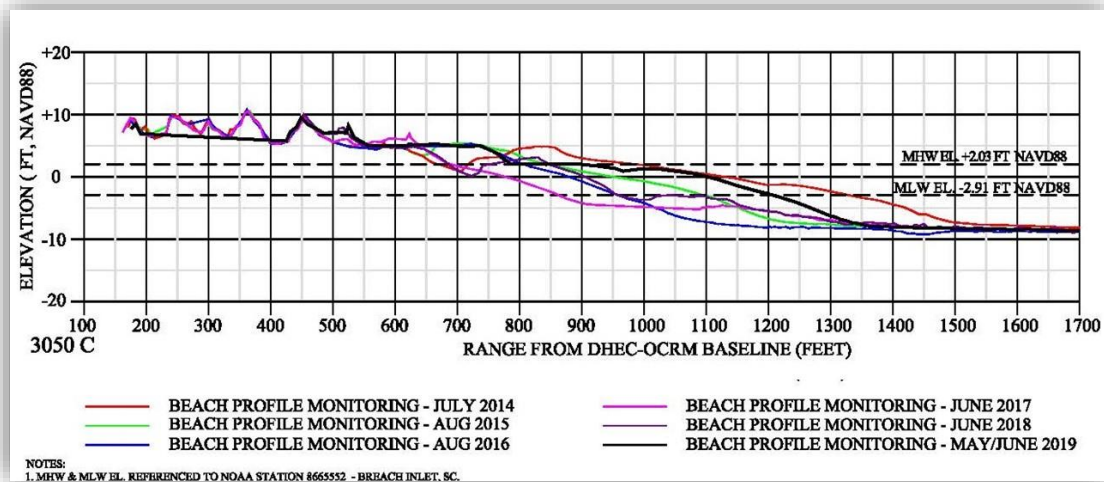
In 2019, the beach was over 150 ft wide and accretional. Two ridge and runnel systems were attaching to the shoreface. The dunes were healthy with new growth. Very little backbeach ponding was observed.

The elevation at the seaward end of the dune access path is low relative to the adjacent dunes, leaving a discontinuity in the dune system. According to the 2019 volume calculation, this profile has a unit volume of 498 cy/ft. The beach profile at this monument benefits from its location updrift of the Charleston Harbor jetty and indications are that accretion will continue.

Figure 16. Beach profile monitoring data from 2014-2019 in cross-section view at Monument 3050.

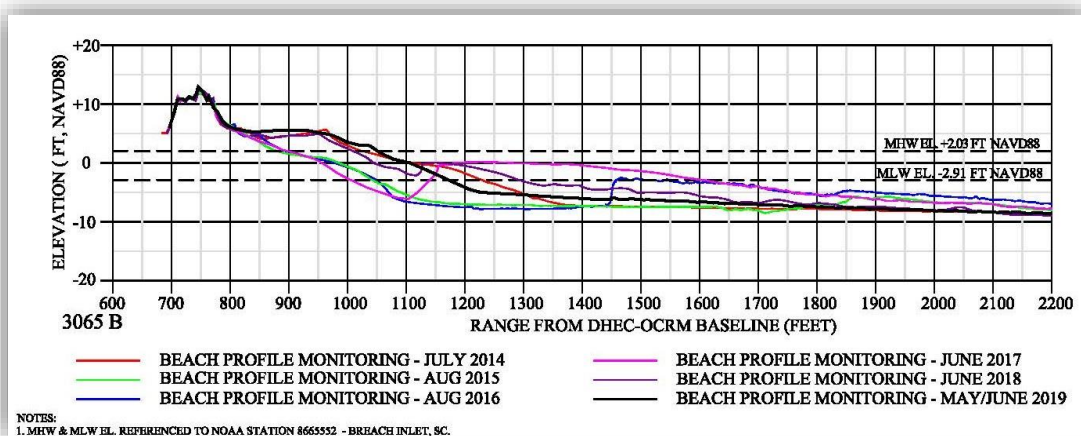
The profile goes through cycles of erosion and accretion as new sand bars attach and the sand is dispersed alongshore. For example, past beach profile data indicated substantial beachface erosion following the 2014 attachment event (Figure 19) as the sediment spread along the beach. This year, beach width was reduced considerably as the sand spreads downdrift.

Figure 19. Beach profile monitoring data from 2014-2019 in cross-section view at Monument 3065.

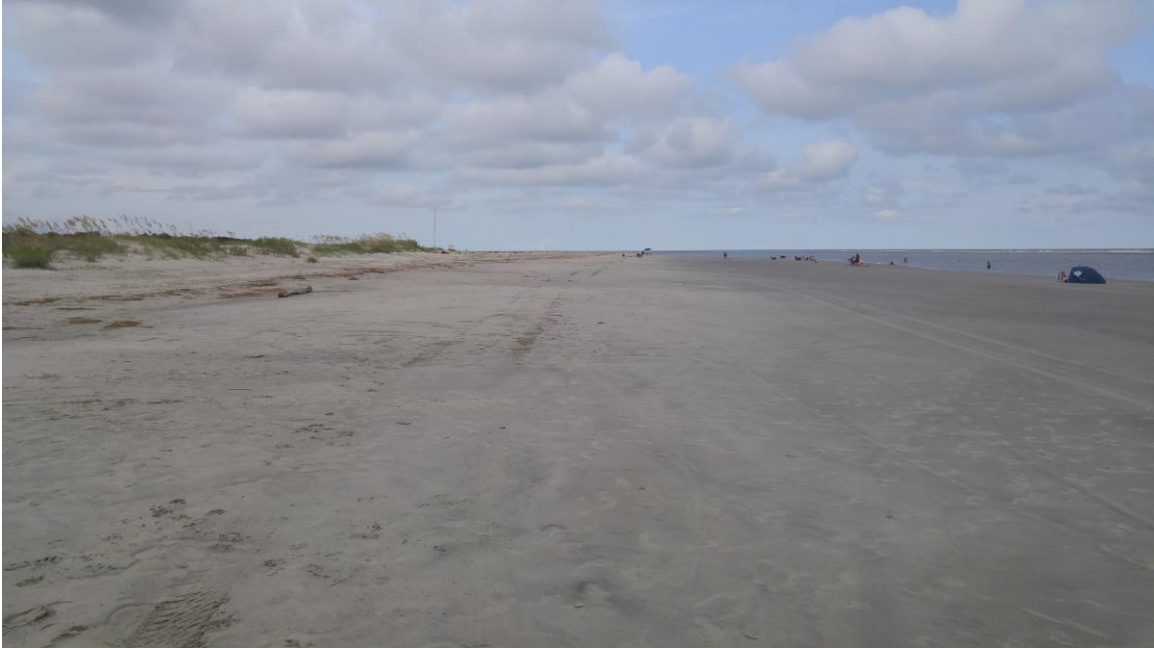
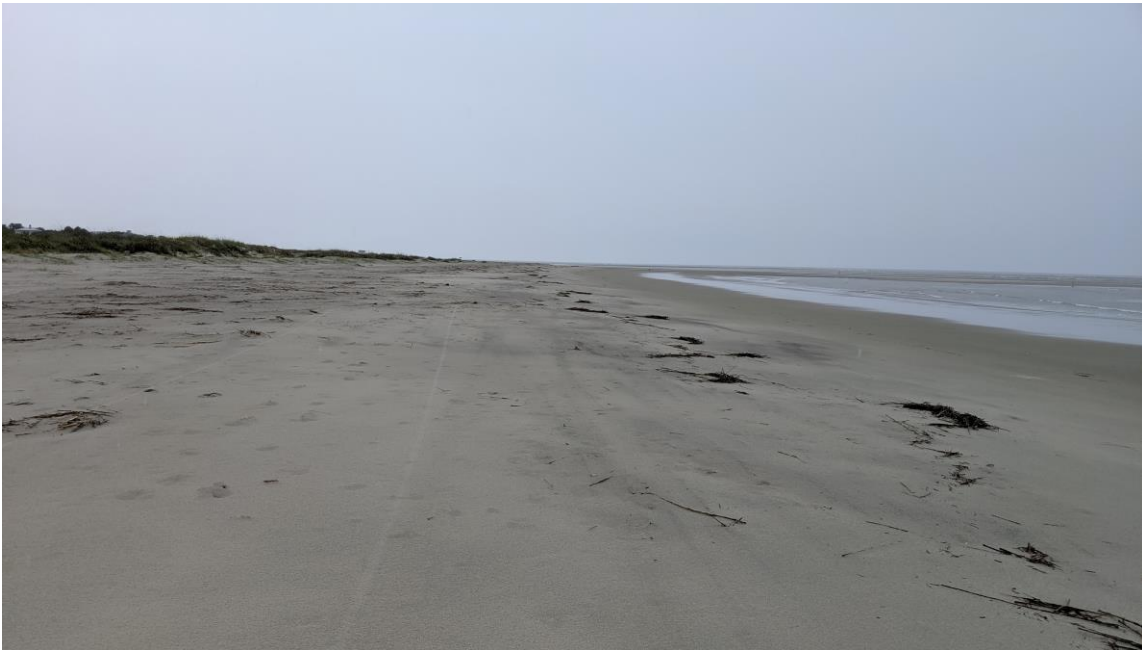
In 2019, a recent storm rack line reached the toe of vegetation. The dry beach was about 100 ft wide at high tide and exhibits a wide, gently sloping low tide terrace and a robust dune system (Figure 20 and Figure 21). According to the 2019 volume calculation, this profile has a unit volume of 374 cy/ft.

*Figure 20. Ground photo taken at Monument 3065 looking northeast on August 4, 2016 (top) and June 6, 2019 (bottom).*

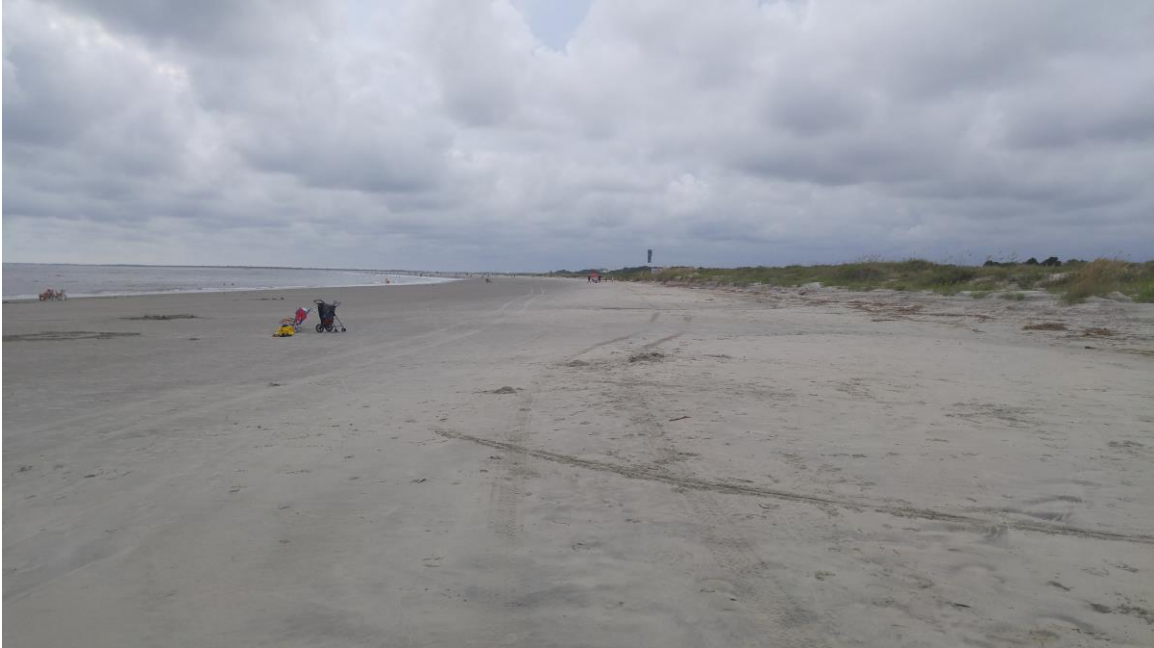
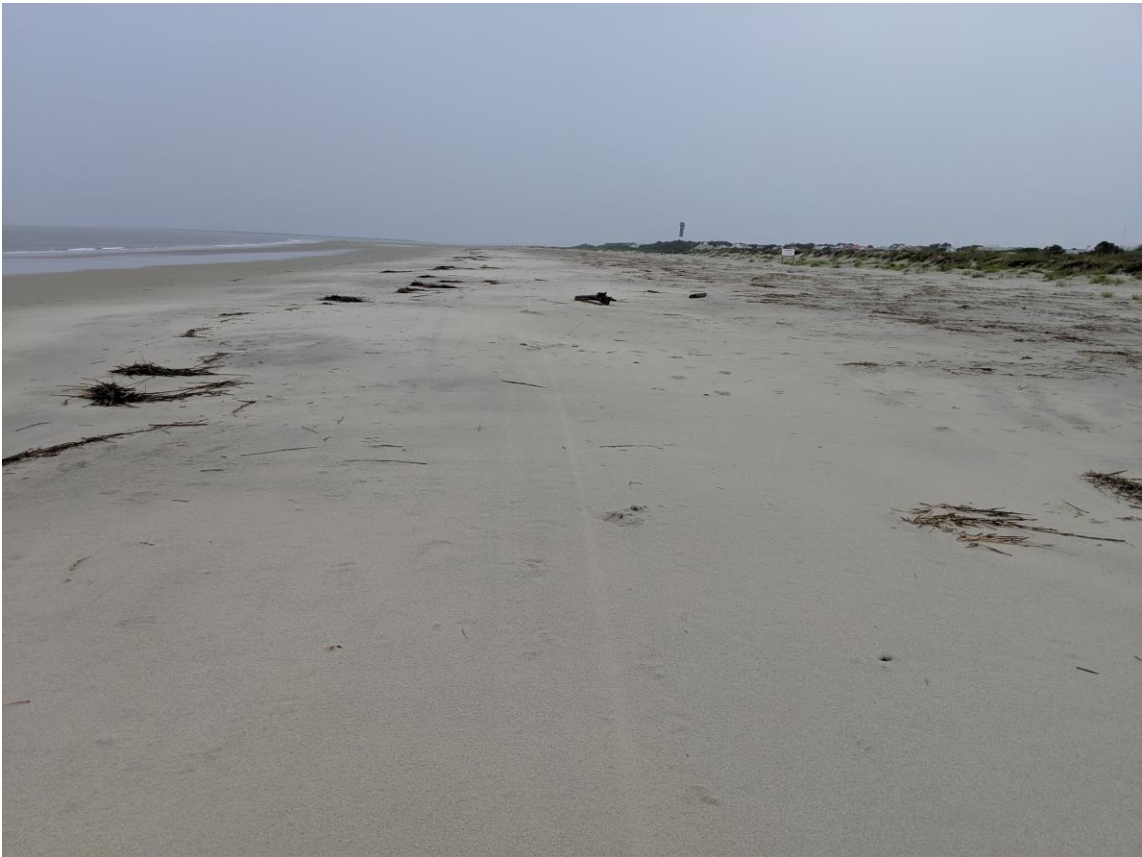
*Figure 21. Ground photo taken at Monument 3065 looking southwest on August 4, 2016 (top) and June 6, 2019 (bottom).*

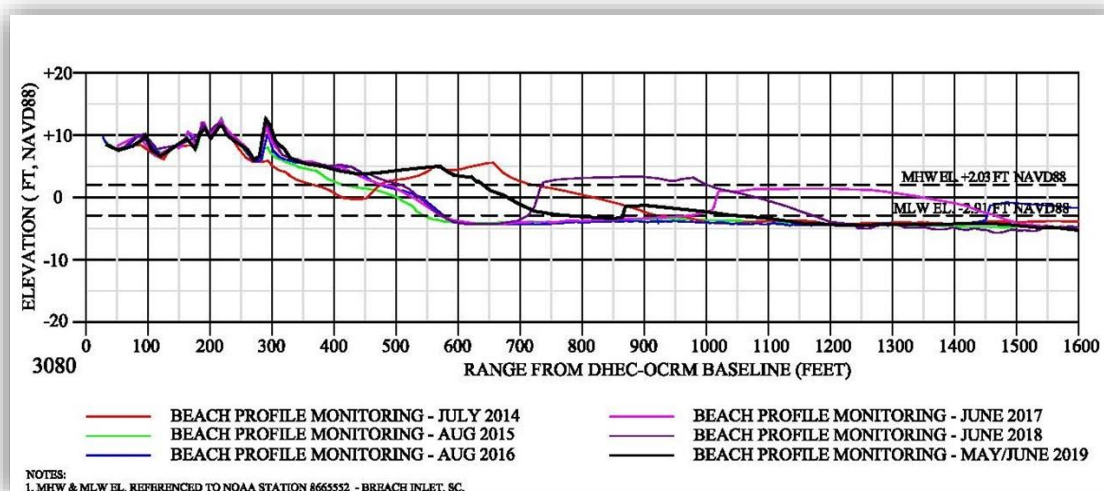
According to the 2019 volume calculation, this profile has a unit volume of 543 cy/ft.

Figure 22. Beach profile monitoring data from 2014-2019 in cross-section view at Monument 3080.

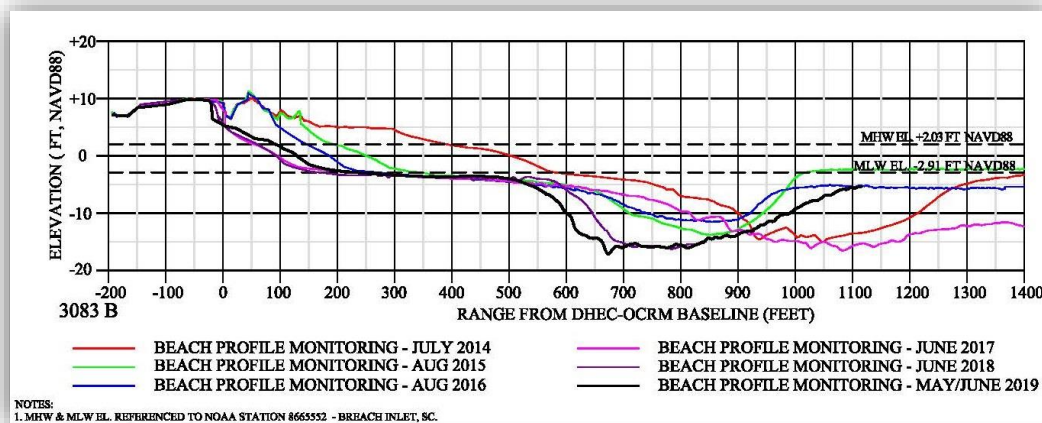
Monument 3083 is located near Station 29 and is in an area of critical erosion. This profile represents the southwest end of the groin field along northeastern Sullivan's Island. The shoreline here has retreated nearly 300 ft since the last sand bar attachment event in 2014 (Figure 25), including the loss of three rows of low sand dunes. In 2019, conditions were no better. There is no recreational beach at high tide. Sand bags have been placed and/or exposed at the toe of the dune scarp. Groins and seawalls dominate this portion of the island.

According to the 2019 volume calculation, this profile has a unit volume of 216 cy/ft.

Figure 25. Beach profile monitoring data from 2014-2019 in cross-section view at Monument 3083.

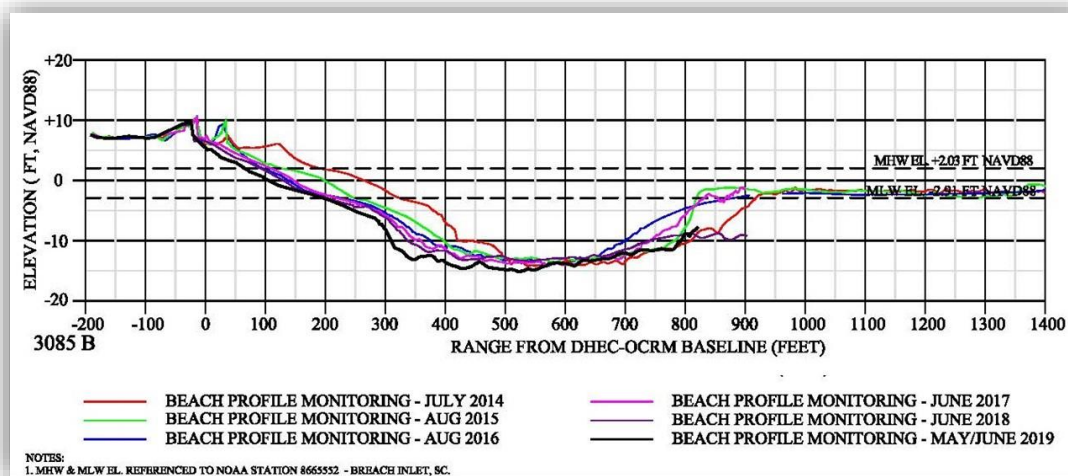
Monument 3085 is located near Station 30. This area has not received sediment from a sand bar attachment event since 2014. Beach profile data indicates evidence of the 2014 sand bar attachment and the subsequent beachface erosion (Figure 28) but nothing similar since then. Although a sandbar is attaching to the island in 2019, there is no evidence of sediment delivery to this part of the island. No recreational beach exists at high tide.

According to the 2019 volume calculation, this profile has a unit volume of 100 cy/ft.

Figure 28. Beach profile monitoring data from 2014-2019 in cross-section view at Monument 3085.

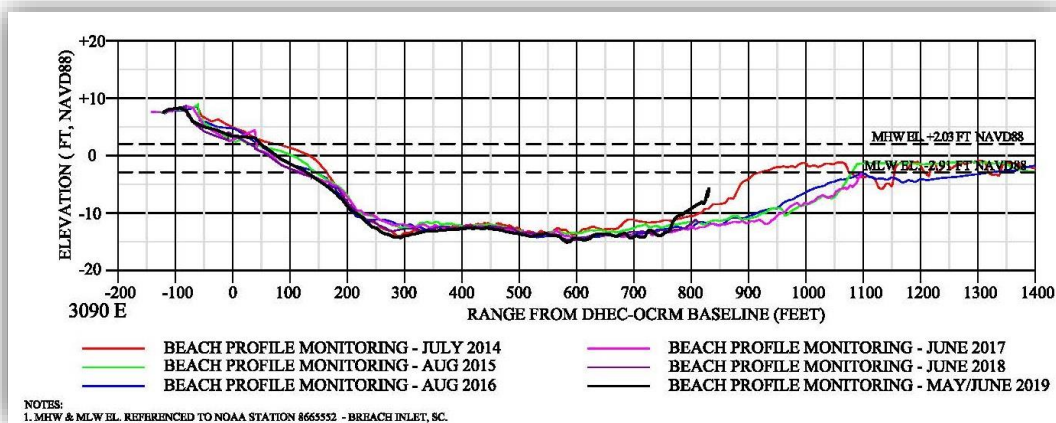
Monument 3090 is located just south of Station 31 on northeastern Sullivan's Island near Breach Inlet. It represents a small (<250 ft long) pocket beach between two groins. The beach is nearly completely armored. The beach profile has exhibited erosion despite the stabilization structures (Figure 31). No dry beach is exposed at high tide and no dunes are present. Upland erosion continued in 2019 with the high tide reaching nearly up to the road between the seawalls (Figure 32 and Figure 33).

According to the 2019 volume calculation, this profile has a unit volume of 117 cy/ft.

Figure 31. Beach profile monitoring data from 2014-2019 in cross-section view at Monument 3090.

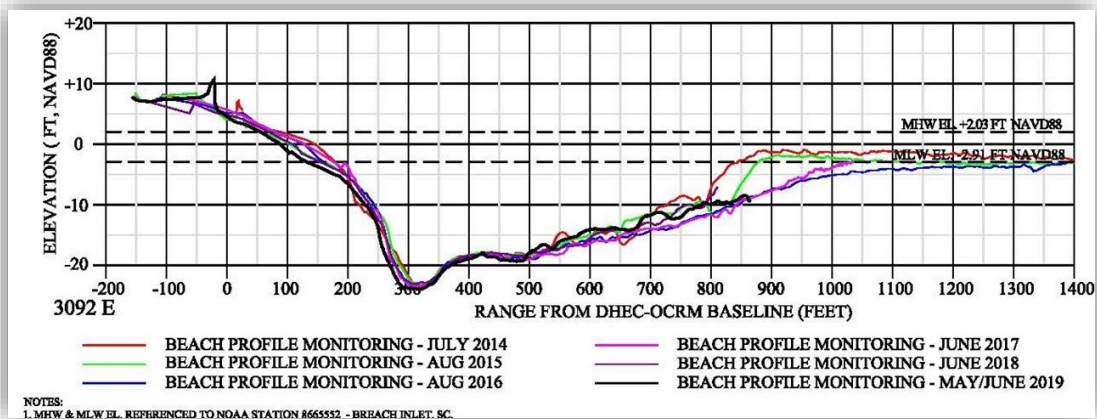
Monument 3092 is located south of Station 32 on northeastern Sullivan's Island near Breach Inlet. This profile line represents a section of the island that has been armored with erosion control structures; however, erosion continues (Figure 34). In 2019, no high tide beach existed despite a recent small-scale beach and dune restoration project installed by one of the homeowners here. The structures have somewhat stabilized this portion of the beach, but erosion continues (Figure 35 and Figure 36).

According to the 2019 volume calculation, this profile has a unit volume of 111 cy/ft.

Figure 34. Beach profile monitoring data from 2014-2019 in cross-section view at Monument 3092.

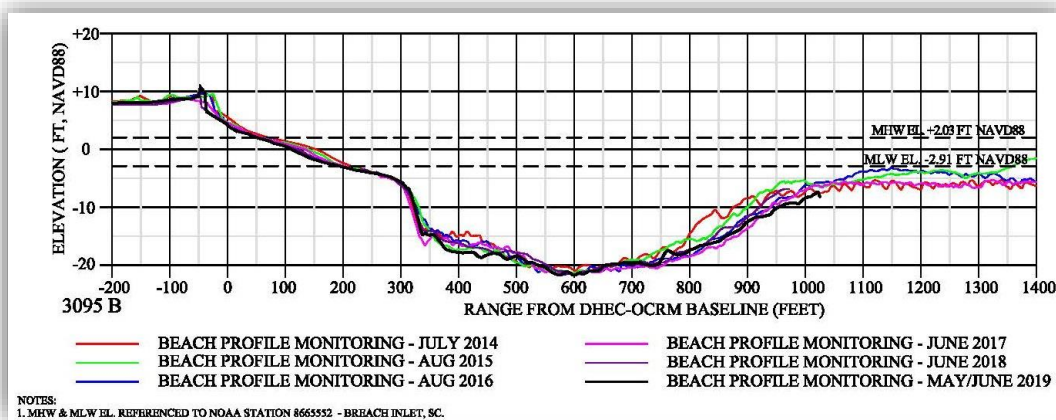
Monument 3095 is located on Station 32 at the northeastern tip of Sullivan's Island on Breach Inlet. It represents a cusped beach anchored by erosion control structures (groins). The beach profile has exhibited little change over time due to the stabilization structures (Figure 37) with the exception of continuous upland erosion and beach face deflation. In June 2019, the upland "bluff" on the southwest side of the pocket beach had retreated significantly. The spring high tides are reaching the toe of vegetation and no high tide beach exists (Figure 38 and Figure 39).

According to the 2019 volume calculation, this profile has a unit volume of 178 cy/ft.

Figure 37. Beach profile monitoring data from 2014-2019 in cross-section view at Monument 3095.
