GYMNASIUM VEHICLE ACCESS OPENING

1714 Middle Street - Fort Moultrie Post Exchange / Broome House, 1906  
Sullivan's Island Landmark, contributing to the listed National Register district

Gymnasium Vehicle Access Opening - Design Review Board, FINAL APPROVAL - Meeting of November 18, 2026 - Owner: William J. Sandvig  
November 2026 - Dimensions from field measurement. Structural, mechanical and interior access design by others.

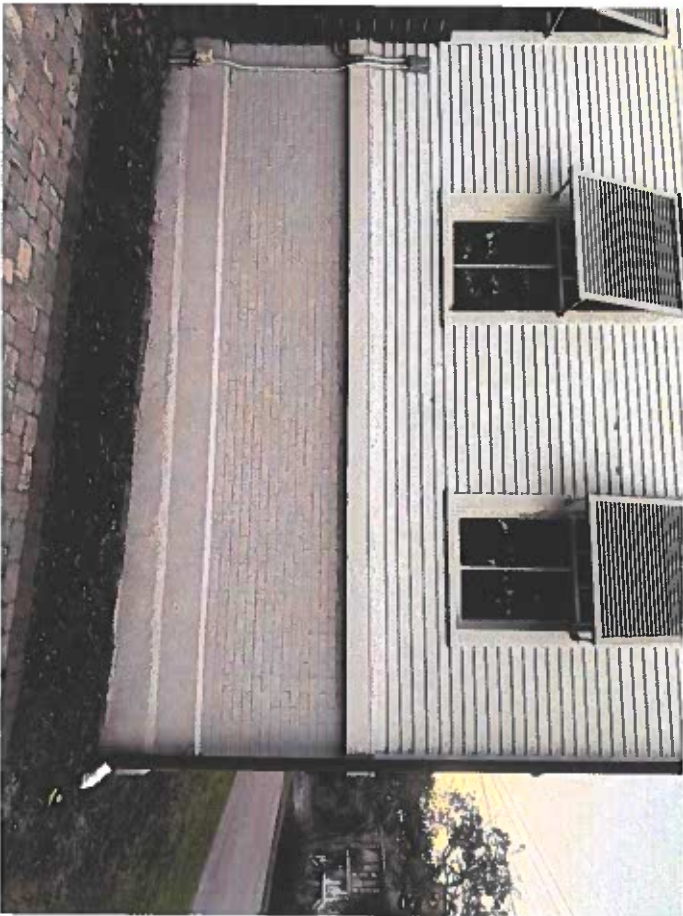
EXISTING - SIDE (DRIVEWAY) ELEVATION

- The proposed opening is 8'-0" wide x 8'-0" high, right jamb 1'-0" from the building corner, centered beneath the existing window above.
- All lines of the opening are set out from the building, not from the ground. The head and the threshold are level and parallel to the water table, the brick coursing and the gymnasium floor. The existing grade falls away toward the corner; a level pad is excavated across the opening to meet the threshold.

- The door is a single rigid panel hinged at its head, which lifts outward and up. Its outer face is built as a continuation of the wall itself: painted concrete base, painted brick in matching coursing, the water-table trim board, and painted lap siding above - every horizontal line continued across the panel.

- Closed, the only evidence of the opening is a narrow vertical reveal at each jamb, raised as a masonry control joint, with headline head and threshold joints.

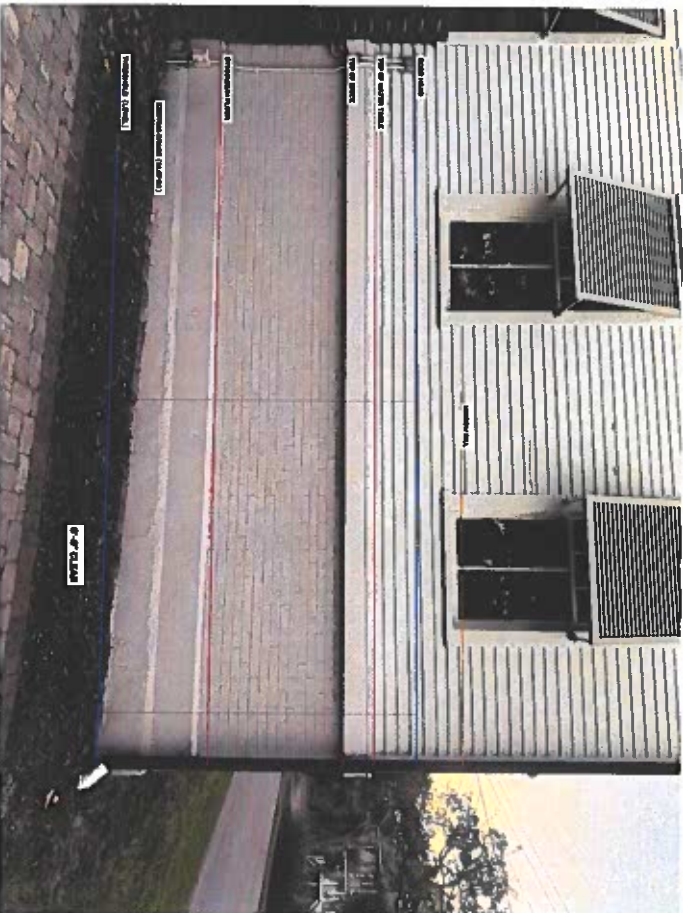
PROPOSED - DOOR CLOSED

PHOTOGRAPHIC SIMULATION

Existing conditions and proposed, door closed

Closed - which is its condition at all times except when a vehicle is being moved - the opening is very nearly invisible. The materials are the same materials. The lines are the same lines. The colours are the same colours. What a viewer sees is the wall that is there now, with two fine vertical joints in it, on an elevation that cannot be seen from Middle Street.
