WELCOME TO 2415 MIDDLE

**2415 Middle Street
Sullivan's Island, SC**

The following report concerns an investigation conducted by Glen Heagerty, PE, LLC regarding the structural condition of the above grade foundation elements, floor framing, wall framing, ceiling framing and roof framing for the residential structure @ 2415 Middle St.

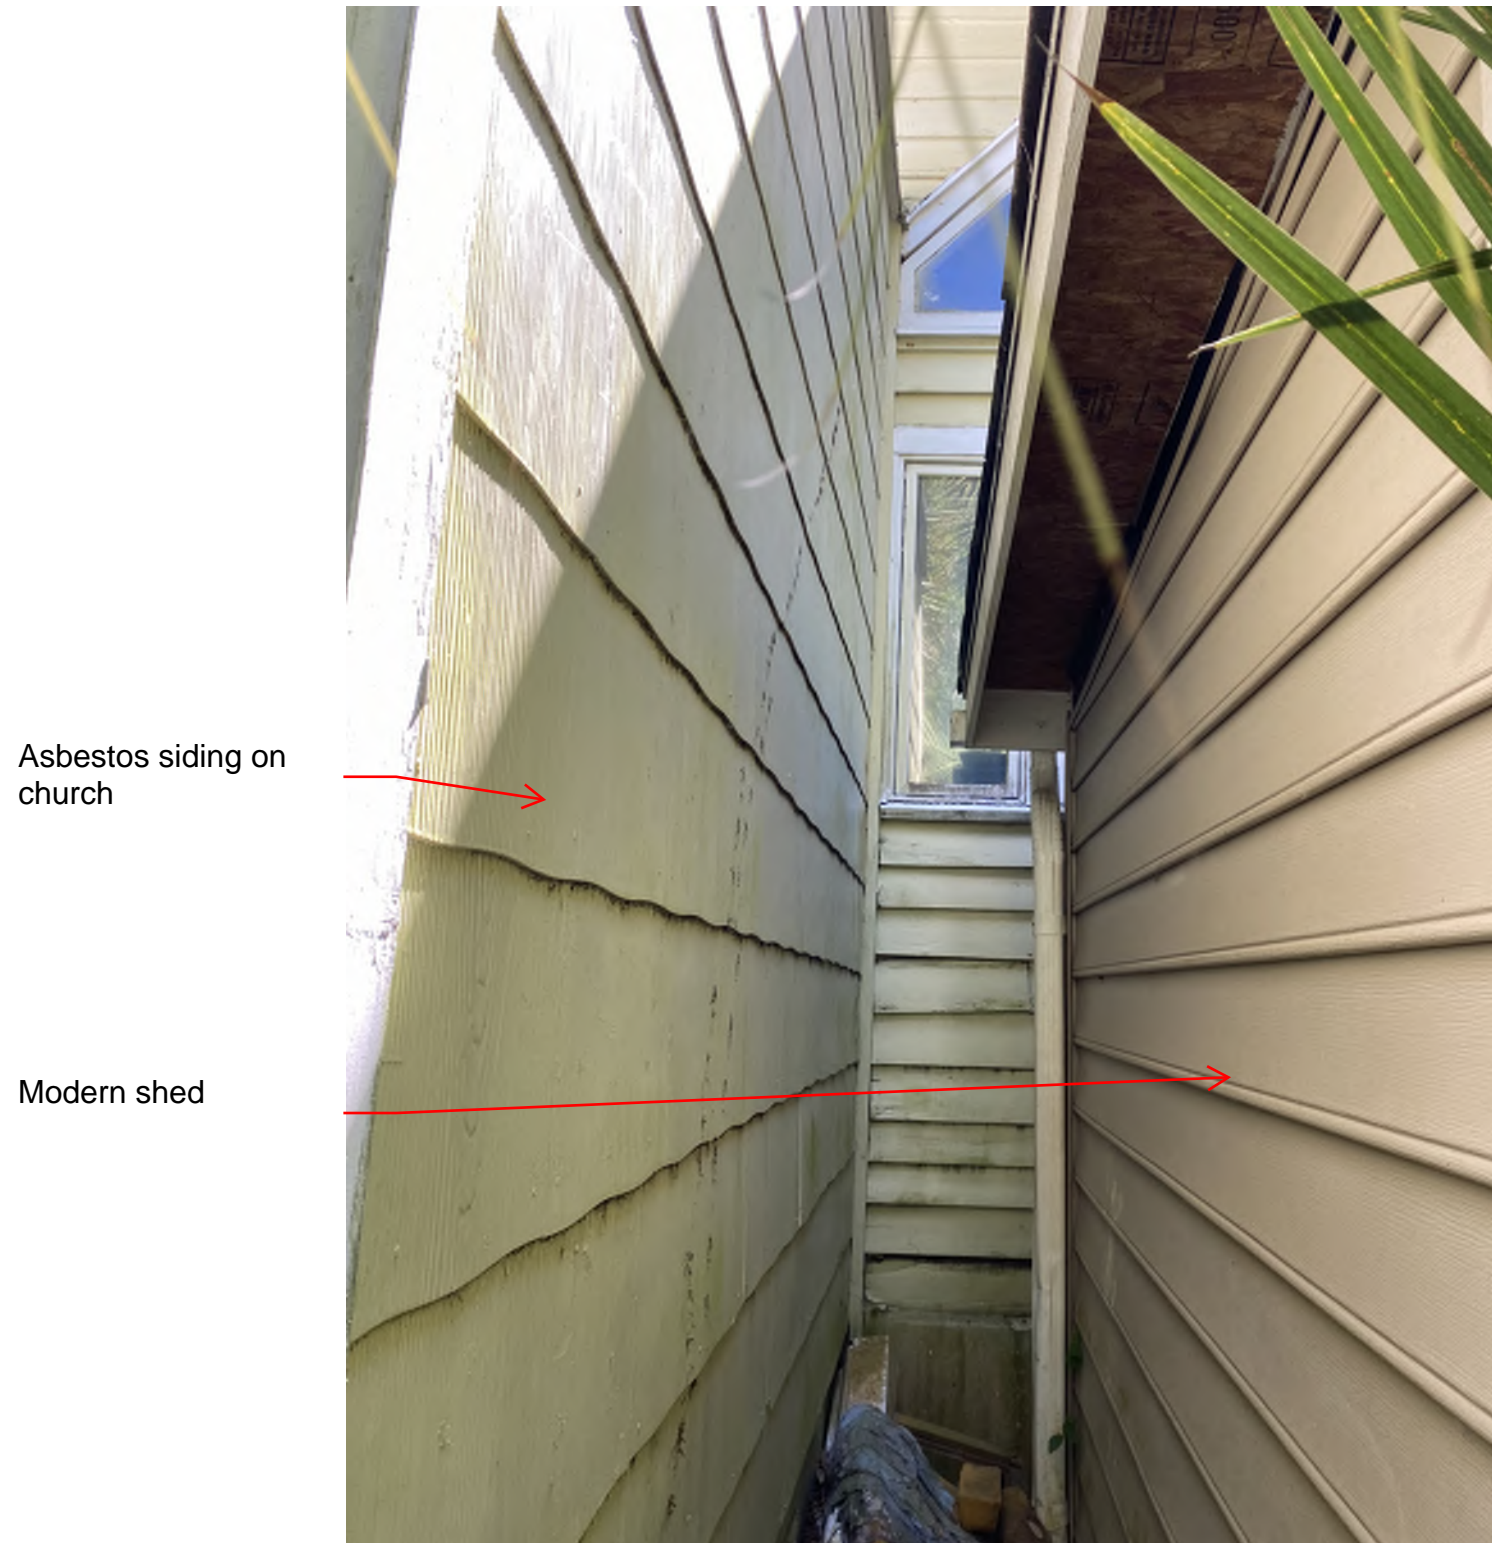
Asbestos siding on church

Modern shed

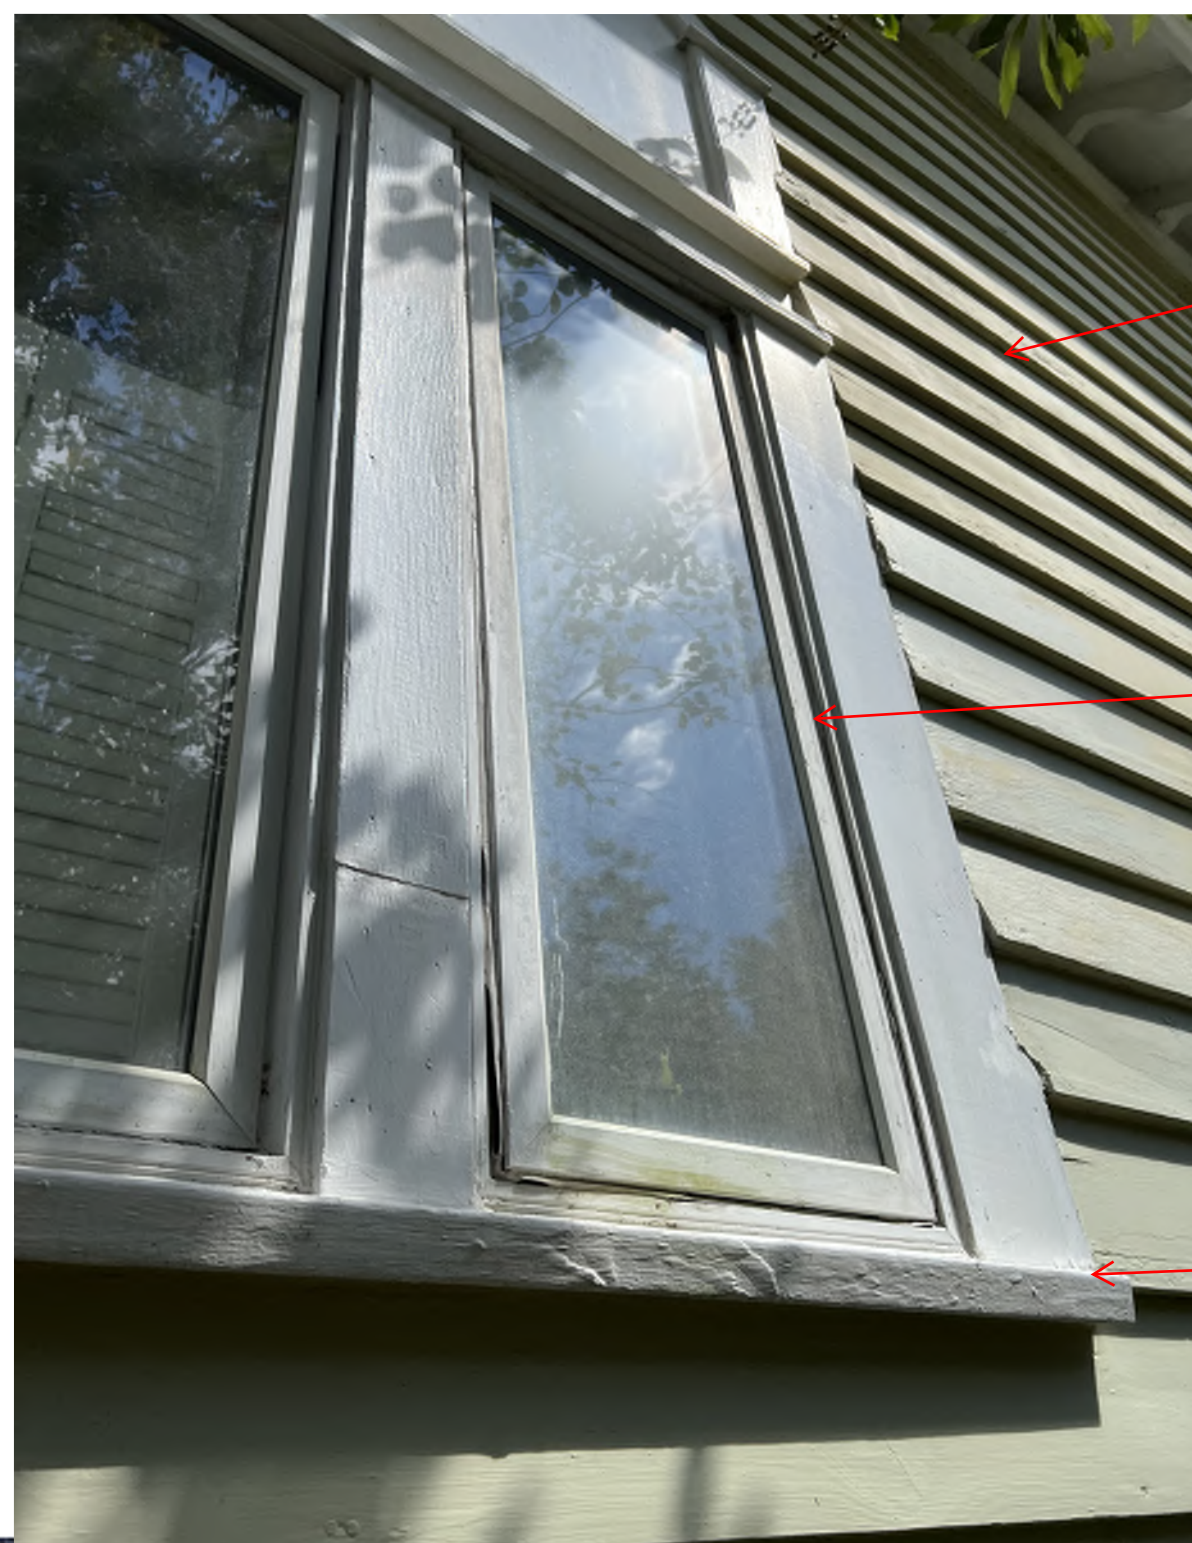
Non-original PT lap siding

Non-original windows TYP throughout

Non-original trim

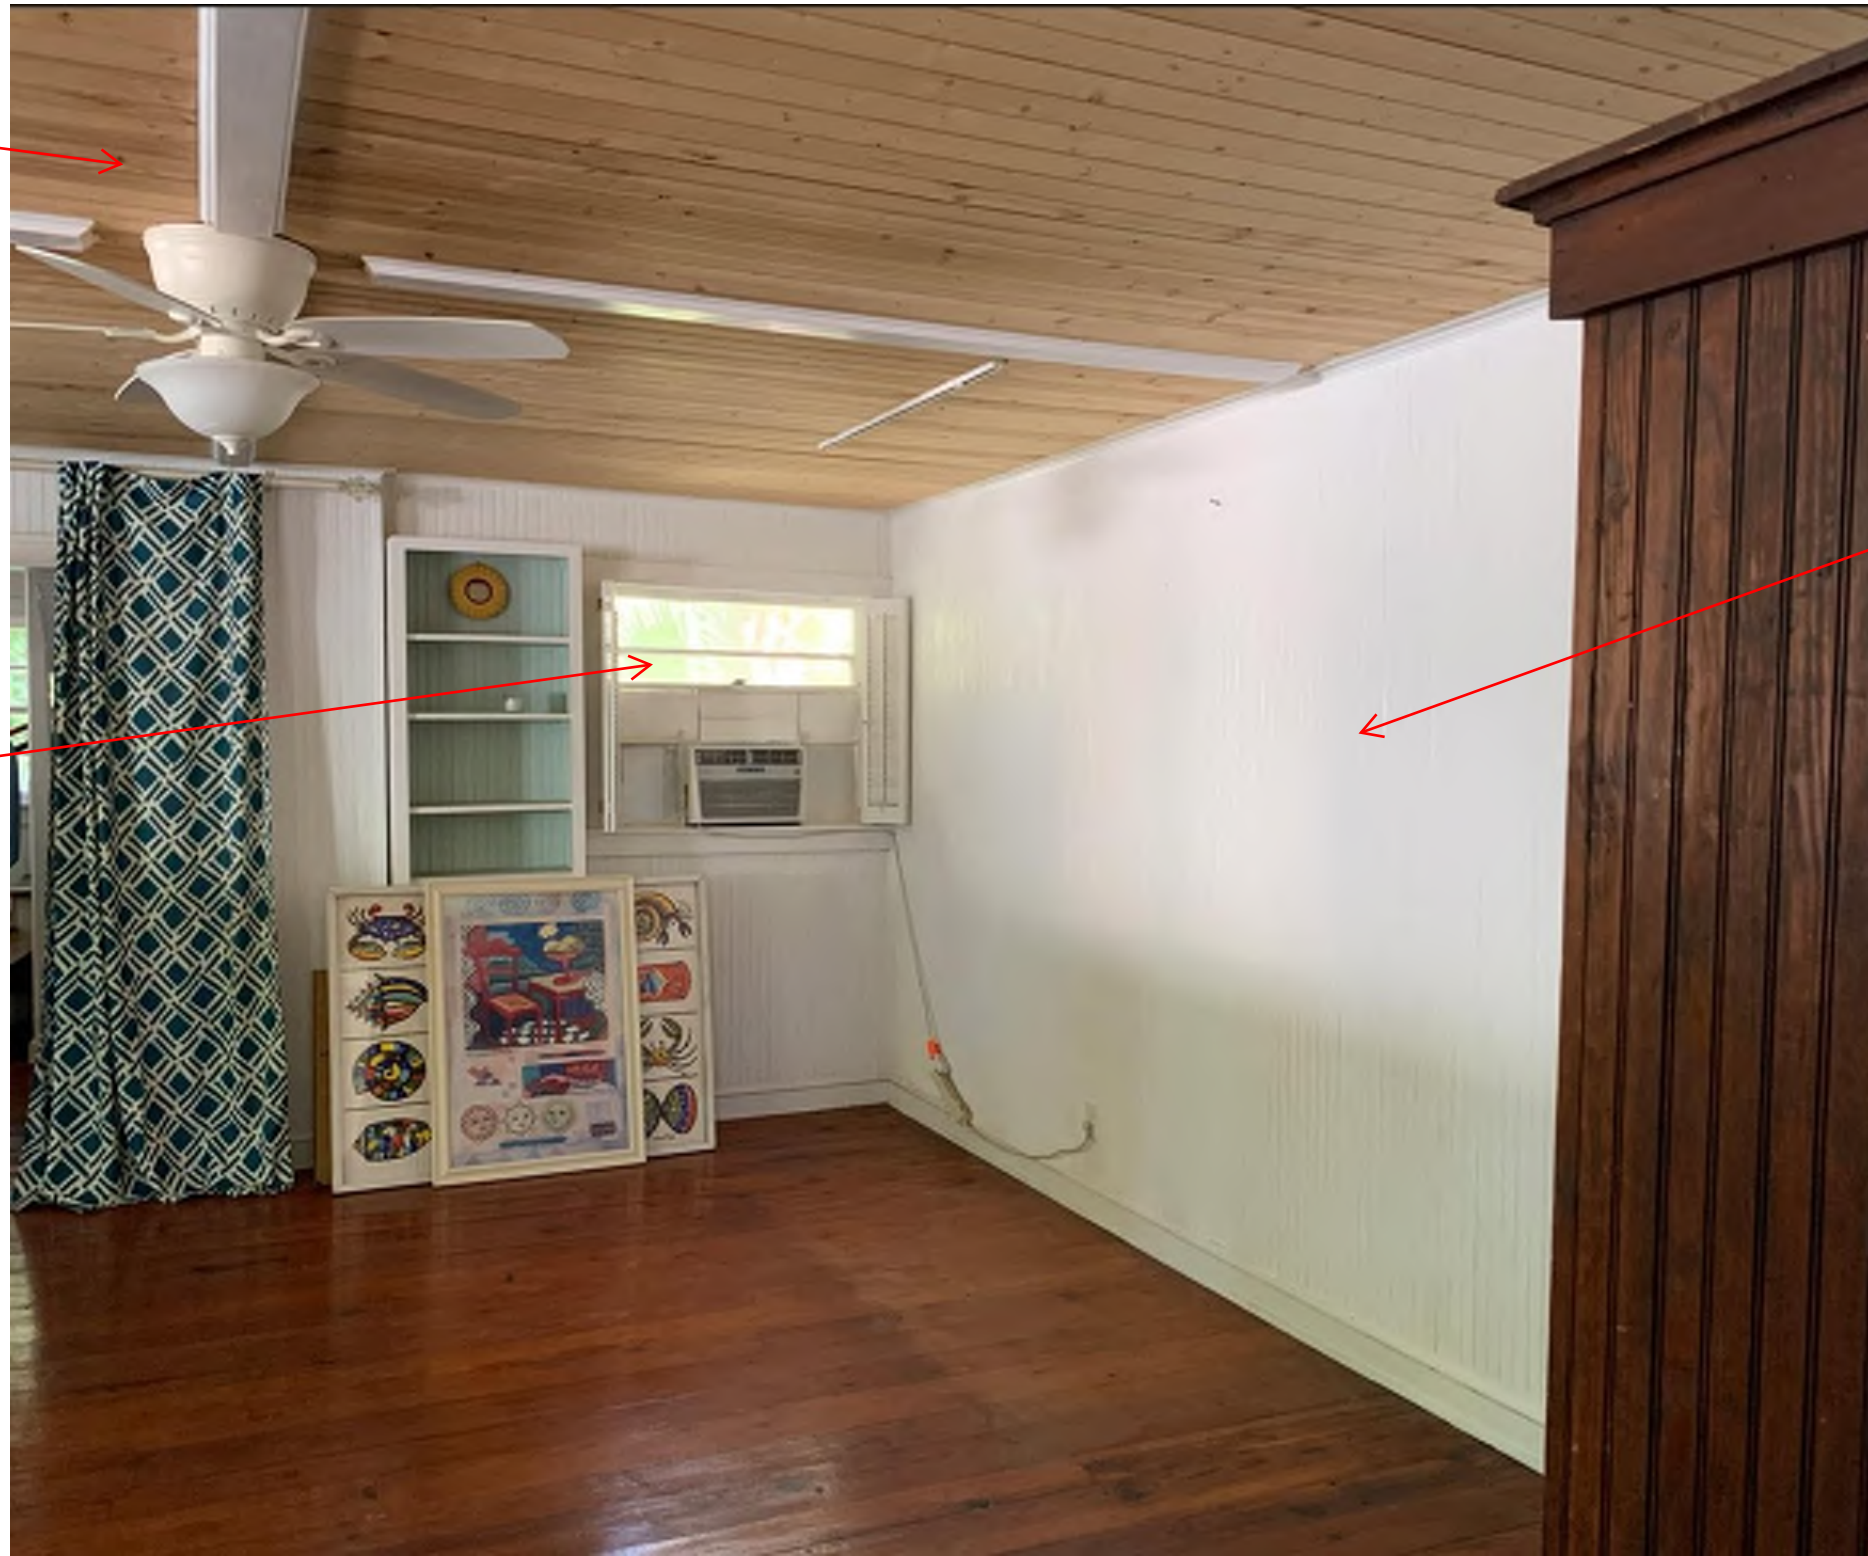
Non-historic ceiling /
second floor system -
7'10" clg height

Non-original windows
TYP throughout

Gypsum wall board

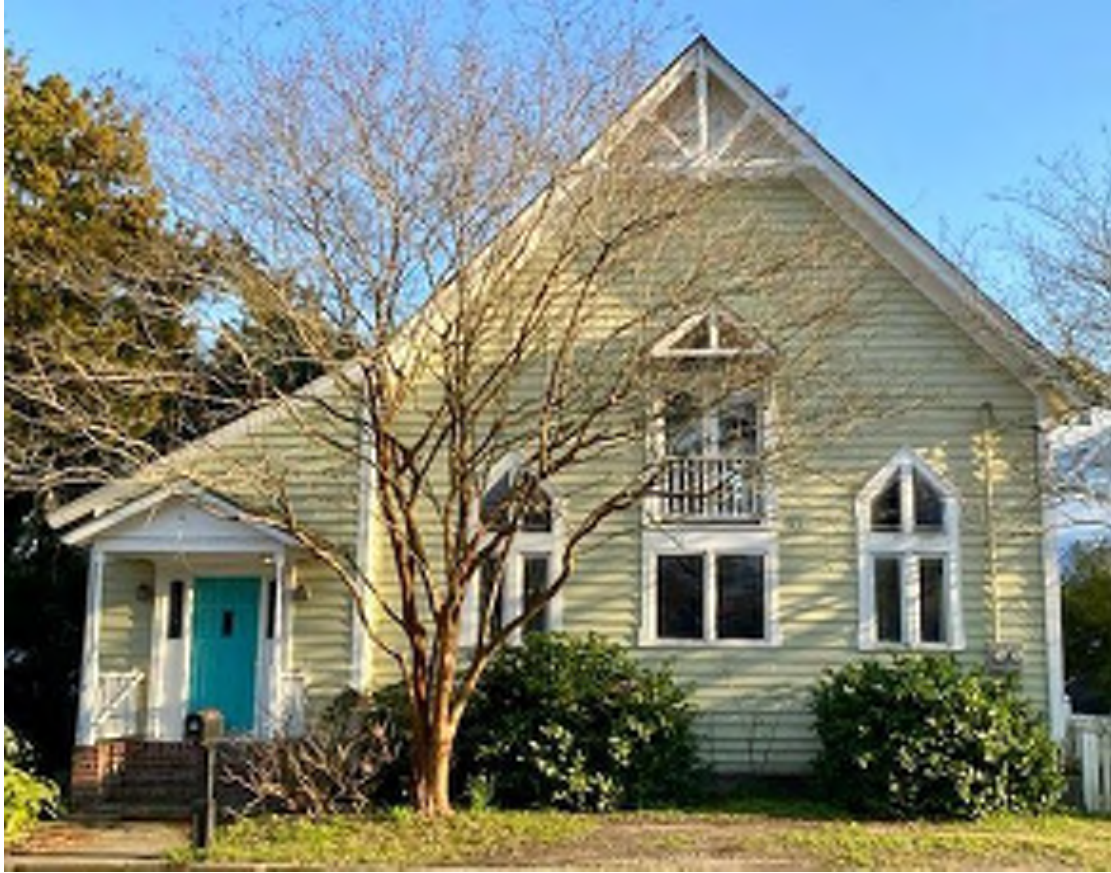
Fig. 1-1. Front view of the house.

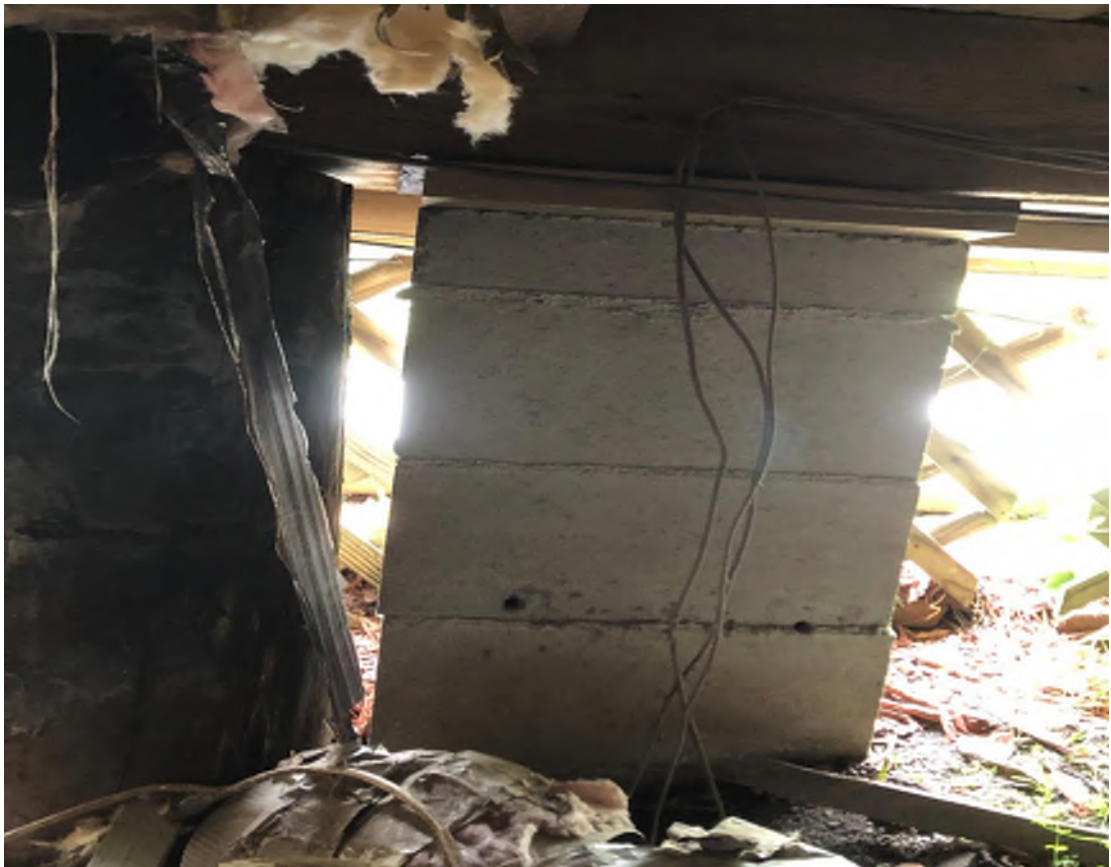
Fig. 1-2. Piers are approximately 30" tall.

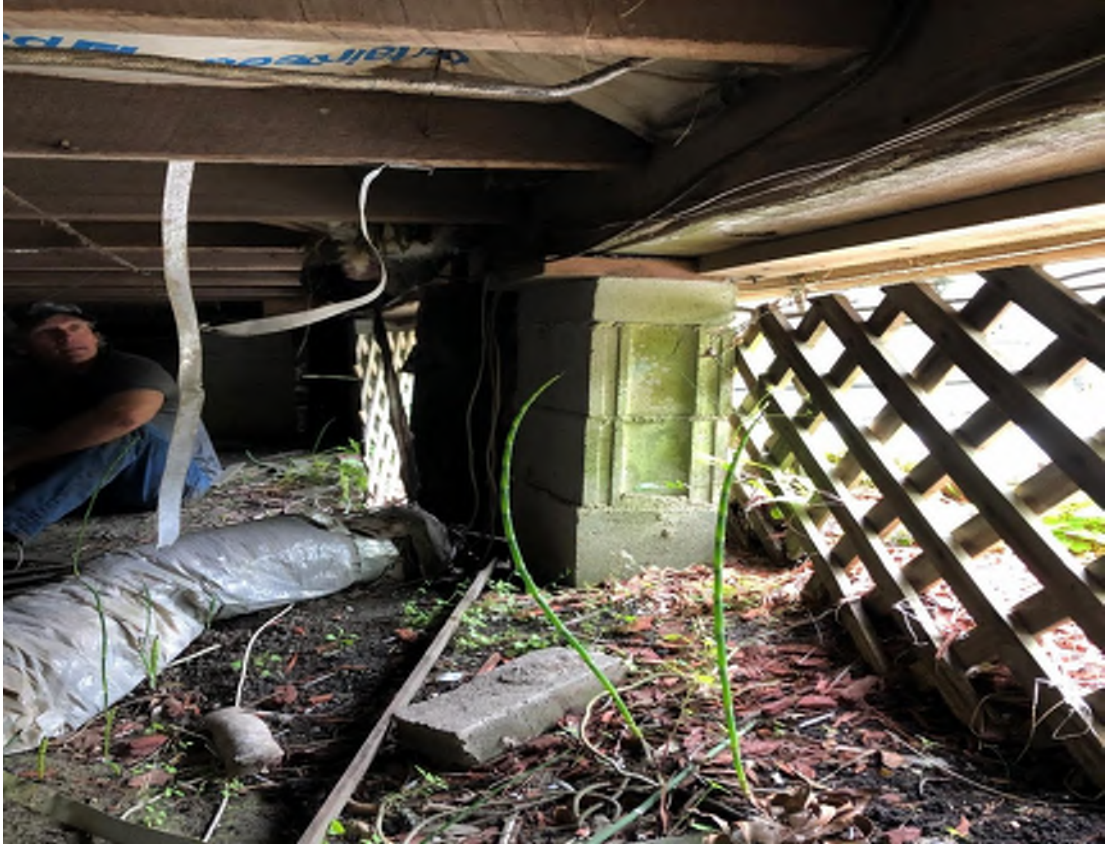
Fig. 1-3. Piers are constructed of 8"x16" CMU blocks.

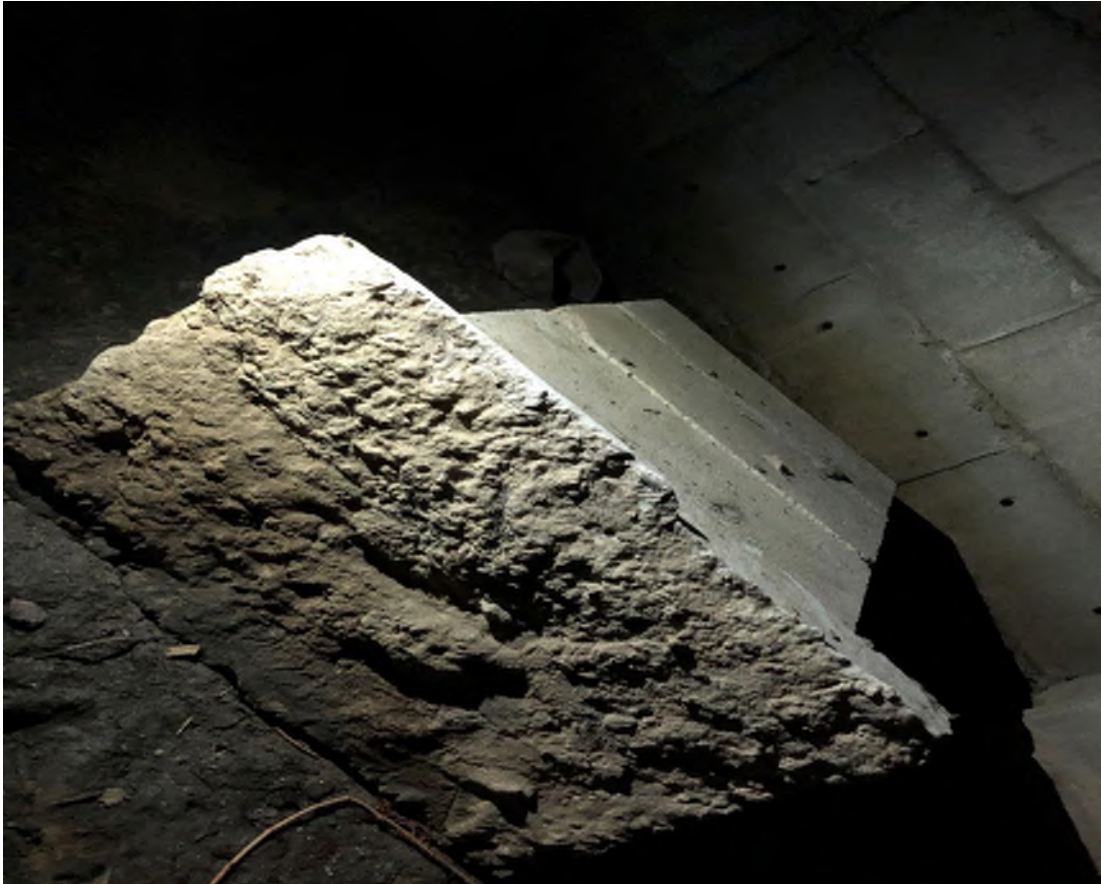
Fig. 1-4. Overturned CMU pier, near front of house, with thin rectangular footing attached to pier.

- Replace CMU pier near front of the house that has fallen over

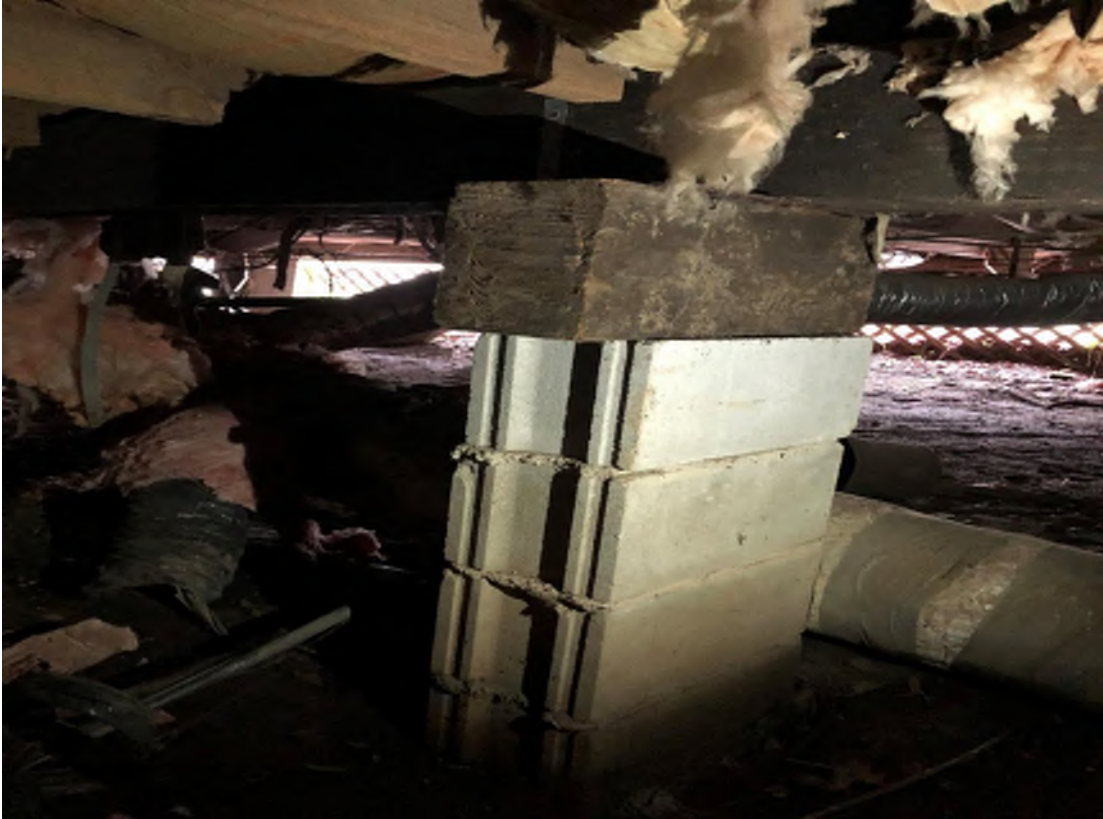
Fig. 1-5. Unconnected timber wedge between the top of pier & bottom of floor girder.

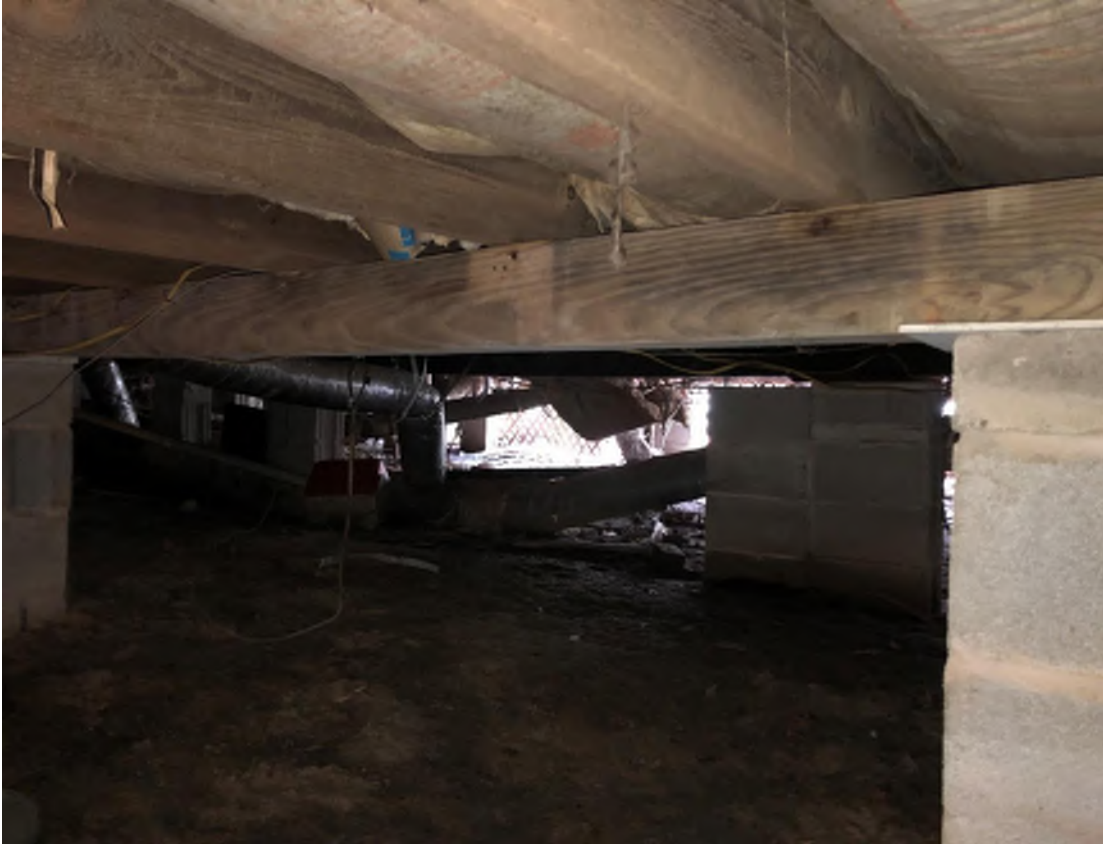
Fig. 1-6. Soil is not level in the crawlspace. Also, there is no vapor barrier present.

- Add 6 mil poly liner over soil in crawlspace to help reduce moisture

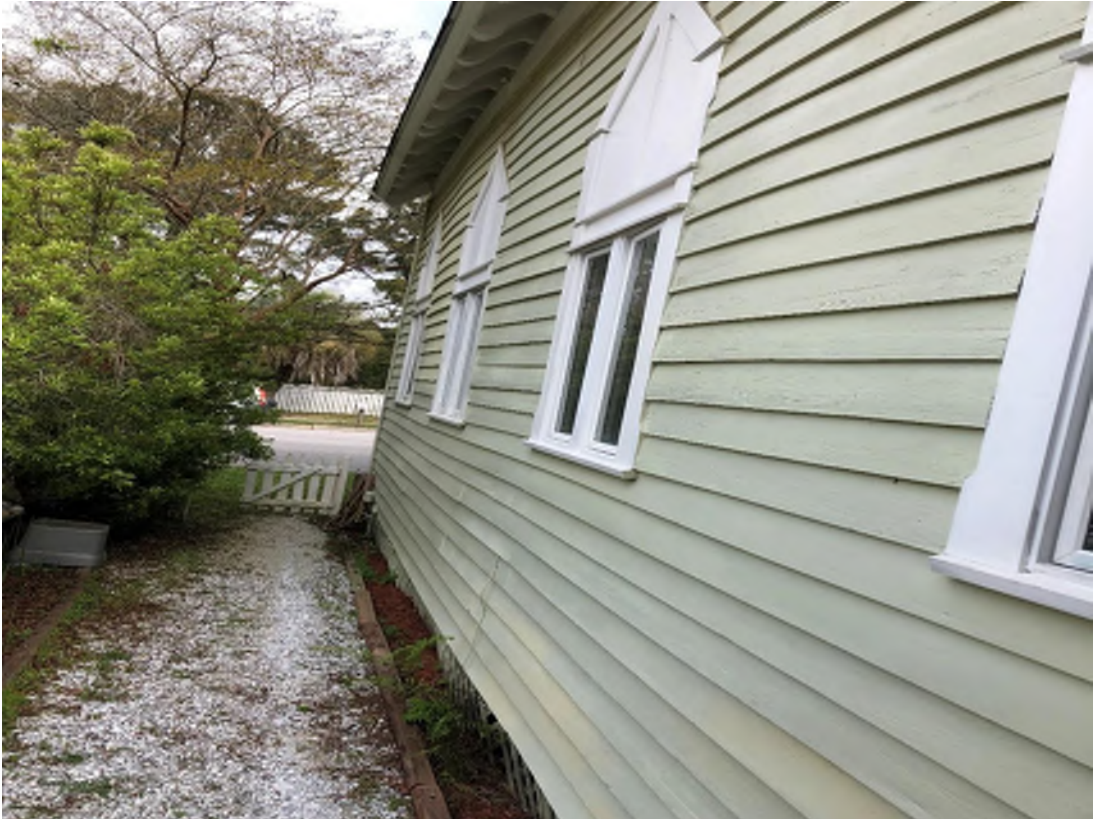
Fig. 1-14. 1st floor ceiling sloping from left to right in the picture below.

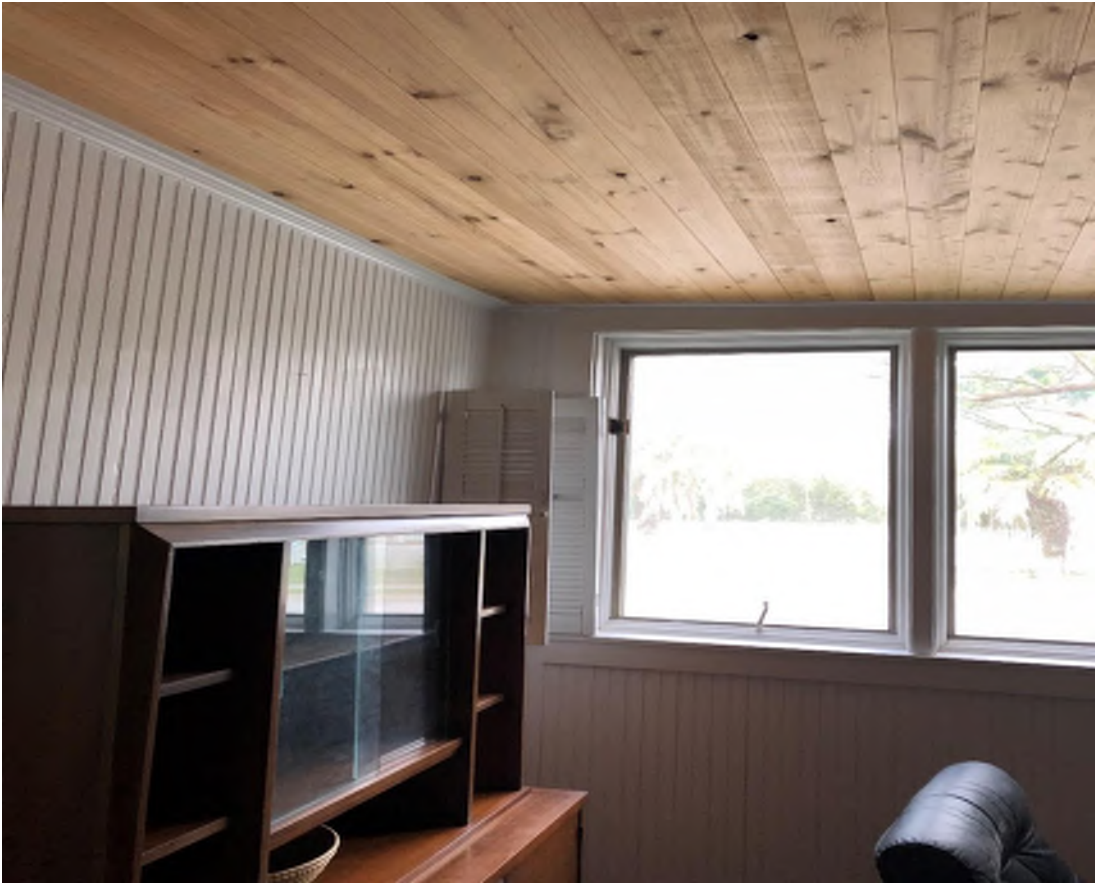
Fig. 1-8 & Fig. 1-9 shows an image of a heavy timber floor girder in good condition. Floor joists are shown in Fig. 1-10, which appear to be in good condition. Moving on to the interior of the house, the first floor floors are sloping, as shown in Fig. 1-11. The slope is due to uneven pier heights and soil settlement. The walls on the right hand side of the kitchen are leaning outwardly as shown in Fig. 1-12. The right hand exterior wall of Fig. 1-13 shows a lean/ bowing outwardly of roughly 5 degrees. Fig. 1-14 shows the 1st floor ceiling sloping from left to right in the picture. The 2nd floor has sloping floors throughout, as shown in Fig. 1-15. The uneven foundation and the right hand wall bowing outwardly is causing the 2nd floor to slope.

Fig. 1-15. 2nd floor sloping from bottom left (area w/ carpet) down towards the piano.

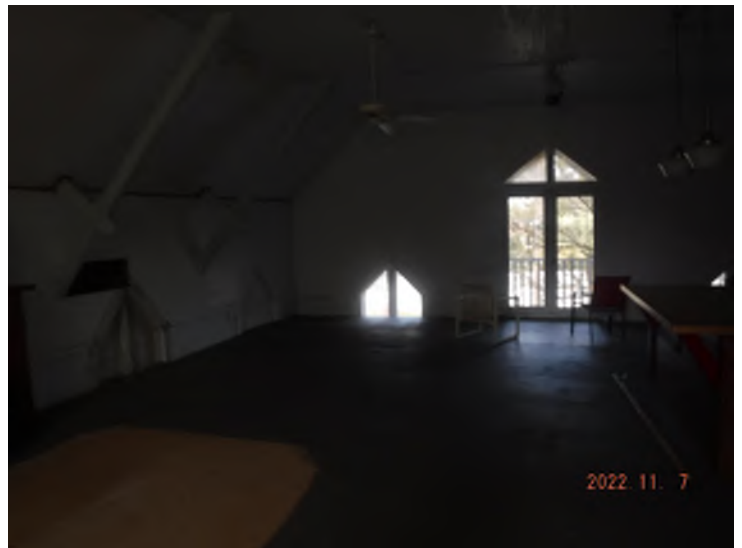
Evidence of previous subterranean termite activity and damage.

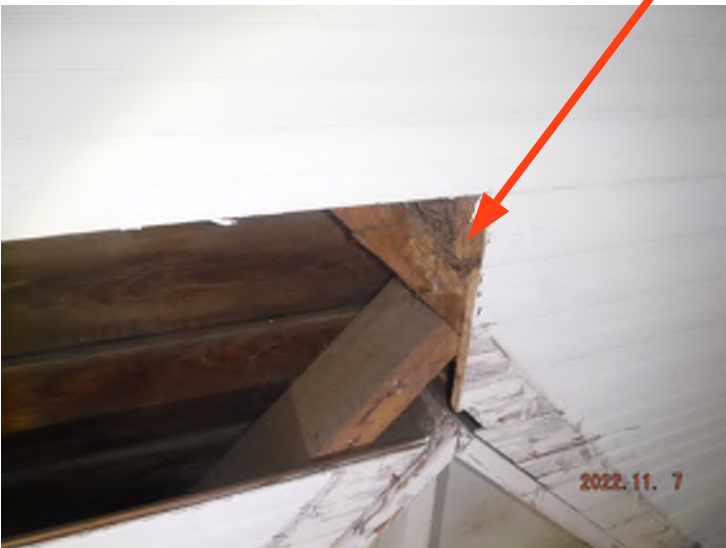
Evidence of previous subterranean termite activity and damage.

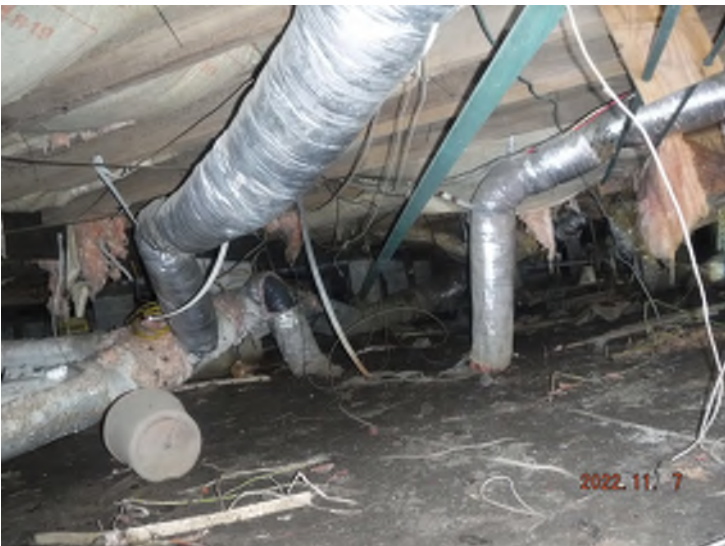
Previous subterranean termite activity and damage in the crawlspace.
